**MINERALS PROGRAM INSPECTION REPORT**  
**PHONE: (303) 866-3567**

<b>MINE NAME:</b> T.H.E. Aggregate Source	<b>MINE/PROSPECTING ID#:</b> M-1977-193	<b>MINERAL:</b> Granite, granite gneiss gravel	<b>COUNTY:</b> Fremont
<b>INSPECTION TYPE:</b> Monitoring	<b>INSPECTOR(S):</b> Timothy Cazier, P.E.	<b>INSP. DATE:</b> June 15, 2021	<b>INSP. TIME:</b> 09:10
<b>OPERATOR:</b> Tezak Heavy Equipment Co. Inc.	<b>OPERATOR REPRESENTATIVE:</b> Lu Toxvard	<b>TYPE OF OPERATION:</b> 112c - Construction Regular Operation	
<b>REASON FOR INSPECTION:</b> Normal I&E Program	<b>BOND CALCULATION TYPE:</b> None	<b>BOND AMOUNT:</b> \$732,350.00	
<b>DATE OF COMPLAINT:</b> NA	<b>POST INSP. CONTACTS:</b> None	<b>JOINT INSP. AGENCY:</b> None	
<b>WEATHER:</b> Clear	<b>INSPECTOR'S SIGNATURE:</b>

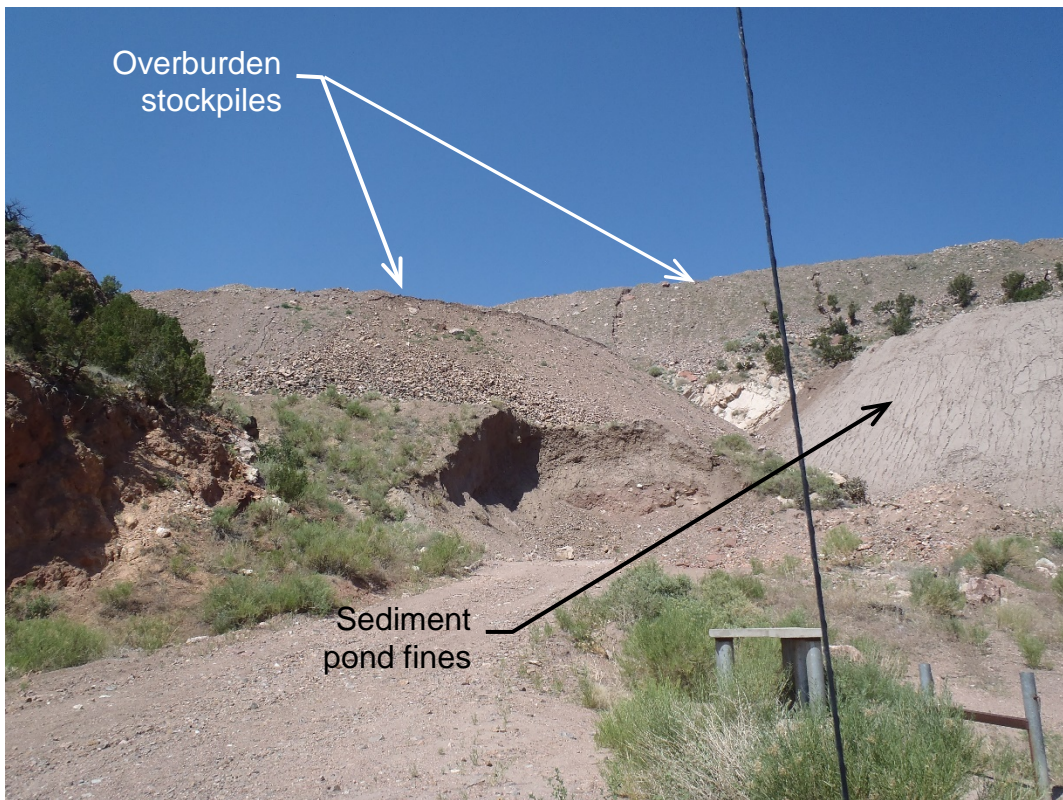
Excess Spoil and Dev. Waste: Overburden stockpiles were observed on the north end of the Phase 1 affected area (see **Photo 1**). They appeared stable with the small exception of where some material was recently borrowed.

Photo 1. Overburden & sediment pond fines stockpiles (north end of phase 1, looking west).

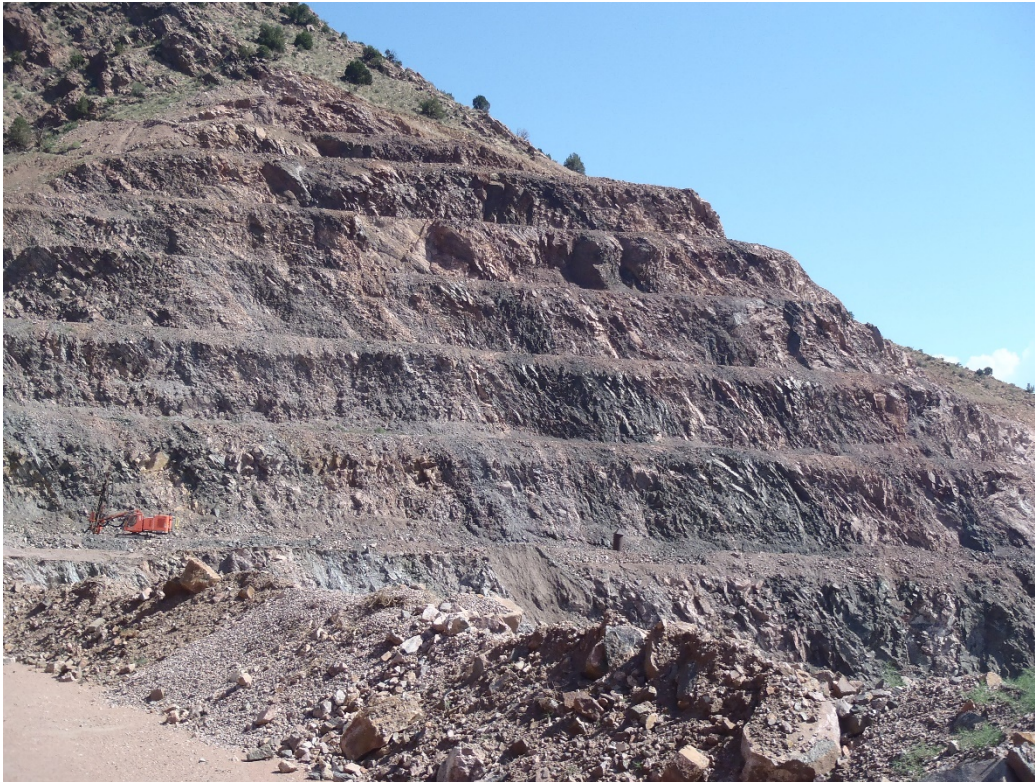
Gen. Compliance with Mine Plan: The operation appeared to be in compliance with the approved mine plan. The maximum allowed disturbed area is 253.5 acres. Google Earth was used to measure the disturbed area, which was estimated to be approximately 109 acres, based on 2019 imagery. Highwalls are 40 feet in height with 30-foot wide benches and appeared stable (see **Photo 2**). Phase 2 was being mined at the time of the inspection. Mr. Toxvard stated they were working on the technical revision to re-evaluate the bond as required prior to moving into Phase 3. As stated above, TR-10 was received on 8/10/2021.

Photo 2. Phase 2 north end highwall (looking NNE).

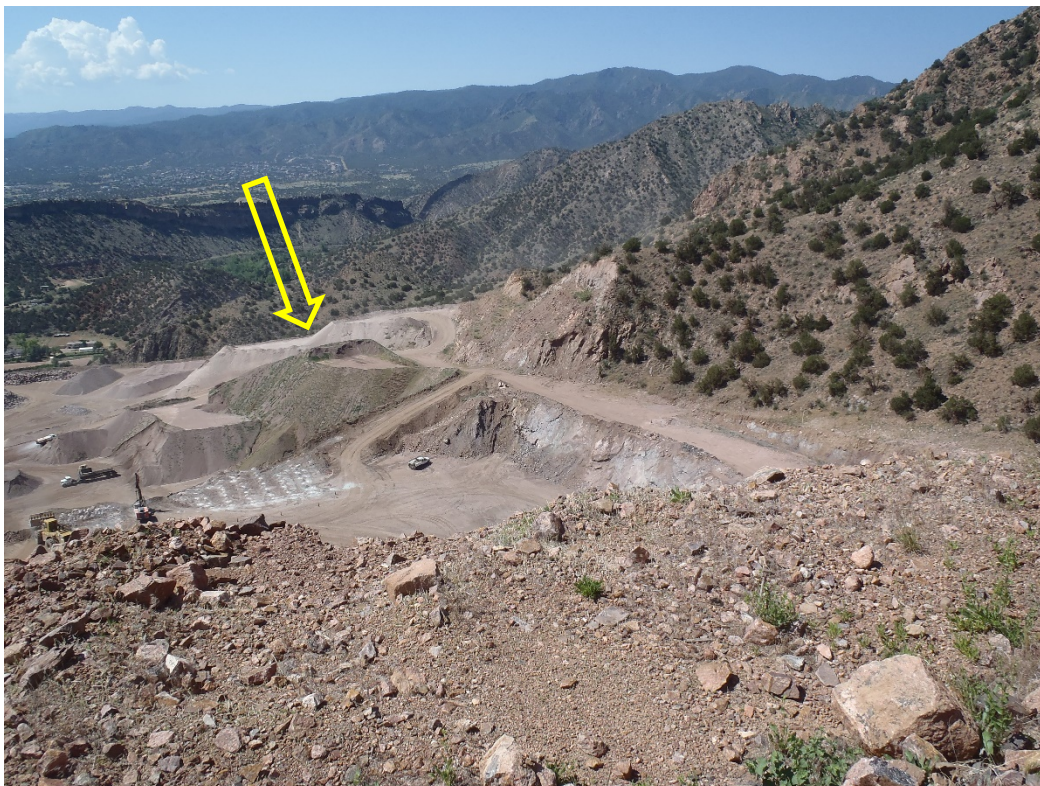
Processing Waste: A stockpile of crusher fines was observed on the south end of Phase 1 (see **Photo 3**).

Photo 3. Stockpile of crusher fines (looking south).

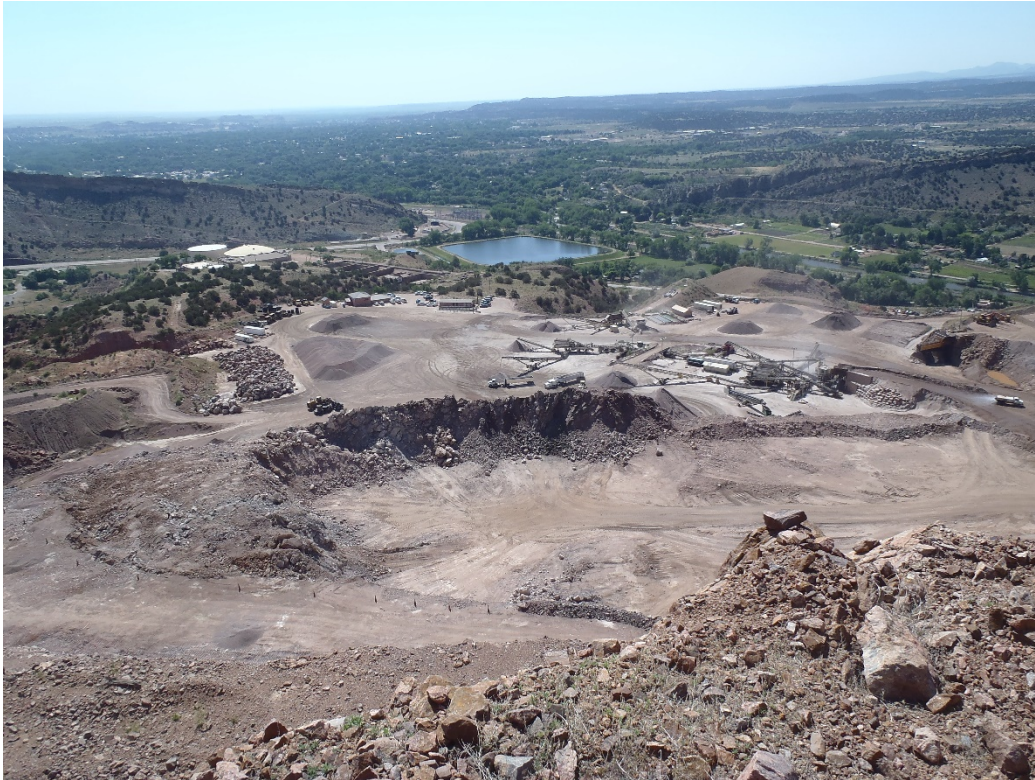
Support Facilities On-site: A screen plant, crusher, loaders, and haul trucks were observed on site (see **Photo 4**).

Photo 4. Pit floor from the phase 2 north highwall (note screen plant, loader, haul trucks - looking south).

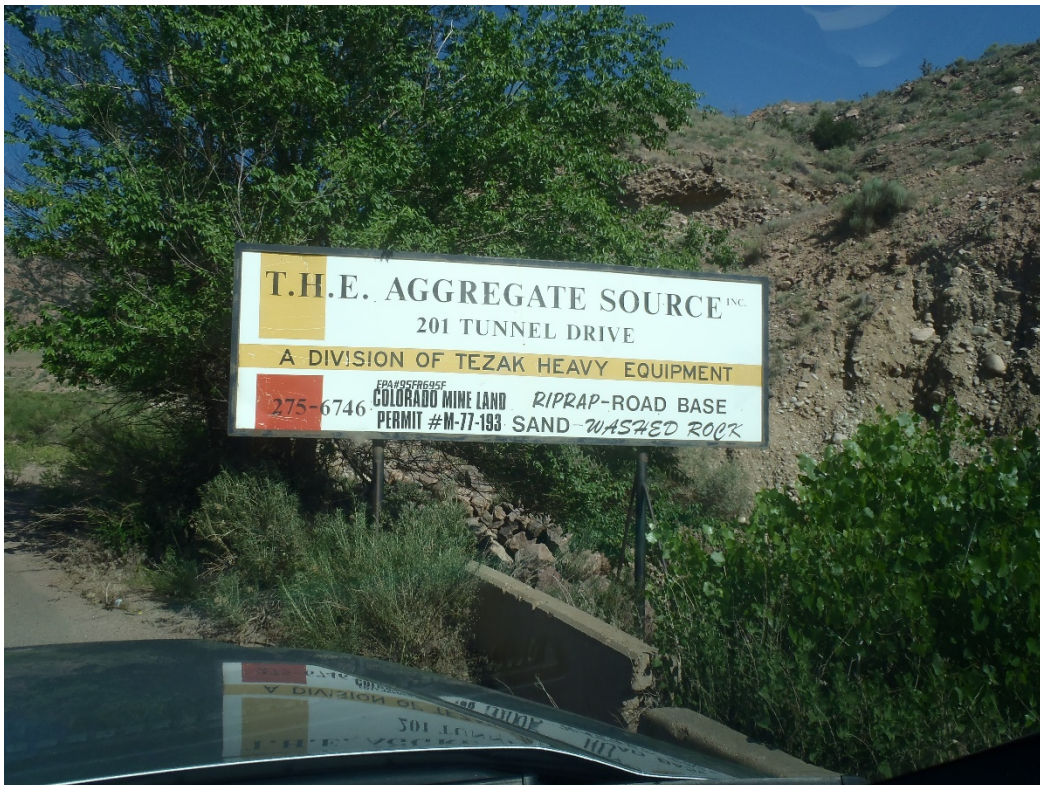
Signs and Markers: The permit sign was properly posted (see **Photo 5**) and boundary markers were observed to delineate the affected area boundary (see **Photo 6**).

Photo 5. Permit sign at entrance off Tunnel Drive.

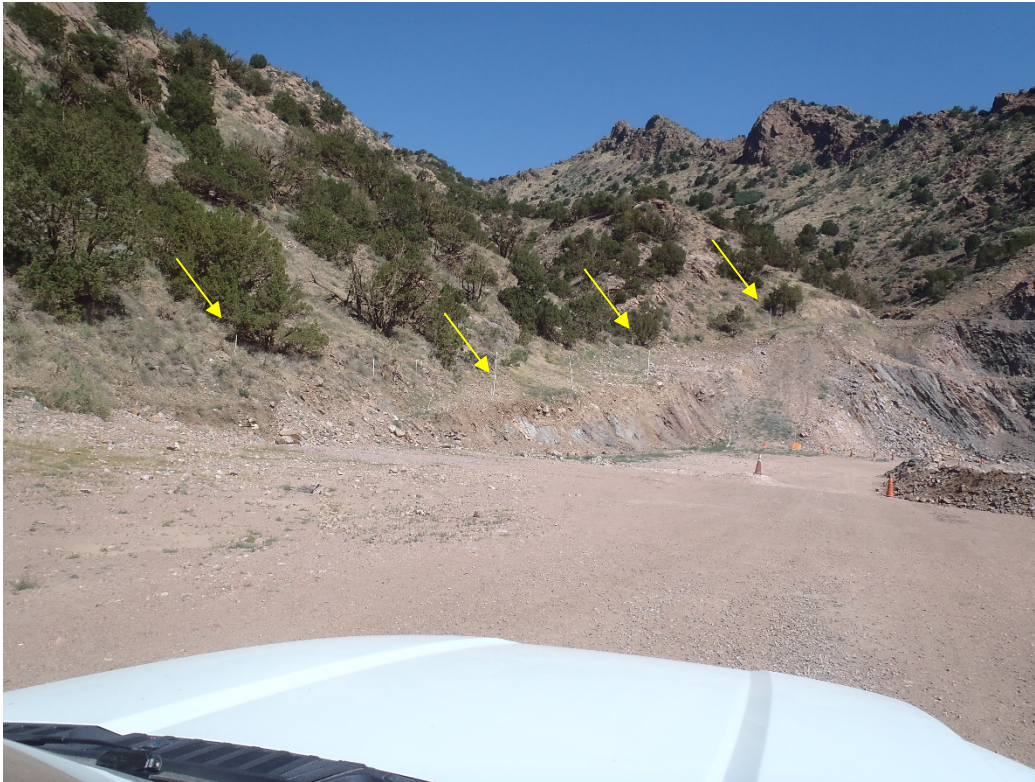
Photo 6. Boundary markers on west side of phase 2.

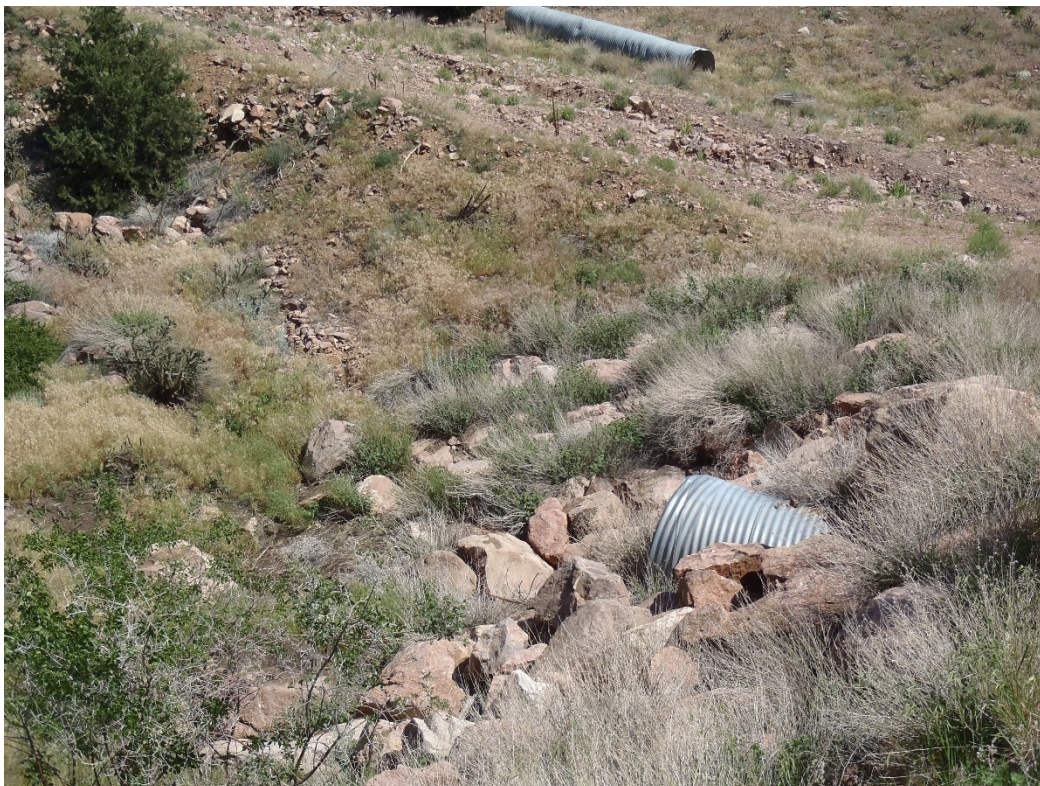
Storm Water MGT Plan: No oil or fuel spills observed. Stormwater is directed to sediment ponds on the north end of phase 1. These ponds were not observed to be retaining runoff at the time of the inspection. Observed culverts were open (see **Photo 7**).

Photo 7. Typical open culvert – no maintenance required.
