MINERALS PROGRAM INSPECTION REPORT

MINE NAME: Lamb Lakes	MINE/PROSPECTING ID#: M-2018-039	MINERAL: Aggregate	COUNTY: Larimer
INSPECTION TYPE: Monitoring	INSPECTOR(S): Amy Eschberger	INSP. DATE: May 26, 2021	INSP. TIME: 10:30
OPERATOR: North Weld County Water District	OPERATOR REPRESENTATIVE: Julie Mikulas	TYPE OF OPERATION: 112c - Construction Regular Operation	
REASON FOR INSPECTION: Normal I&E Program	BOND CALCULATION TYPE: None	BOND AMOUNT: \$0.00	
DATE OF COMPLAINT: NA	POST INSP. CONTACTS: None	JOINT INSP. AGENCY: None	
WEATHER: Clear	INSPECTOR'S SIGNATURE:

LAMB LAKES
NORTHERN WELD COUNTY
WATER DISTRICT
LARIMER COUNTY, CO

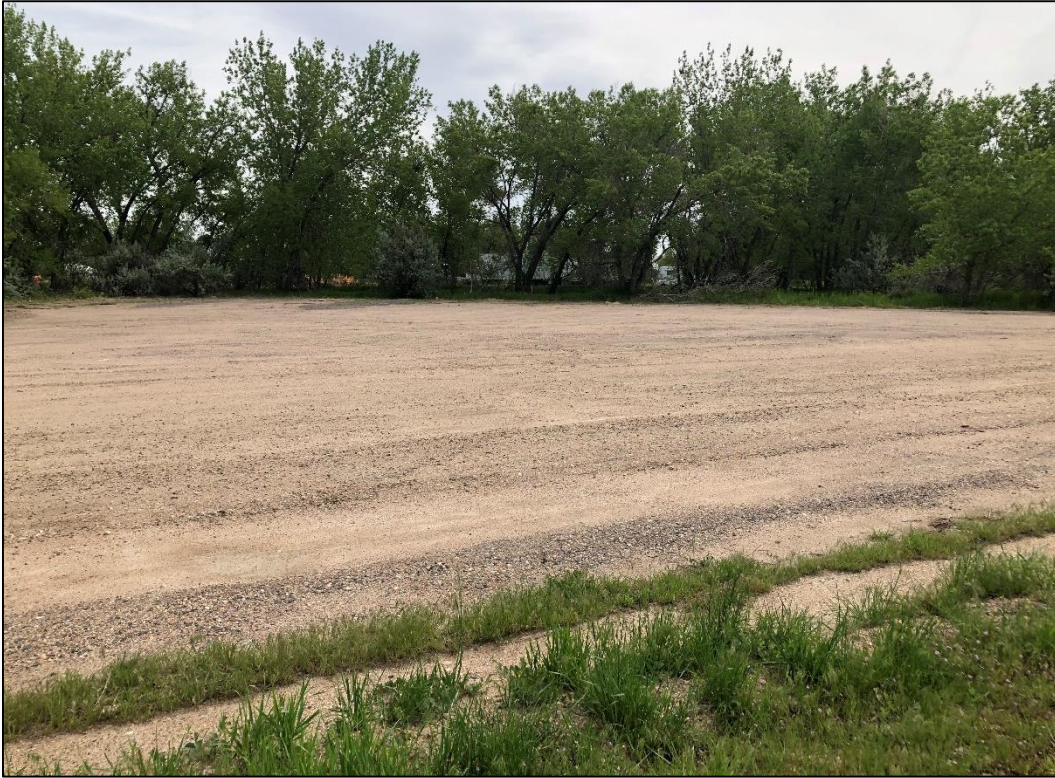
Photo 1. View looking northeast across unvegetated area at northern edge of permit area to be used for equipment storage and scale/scale house.

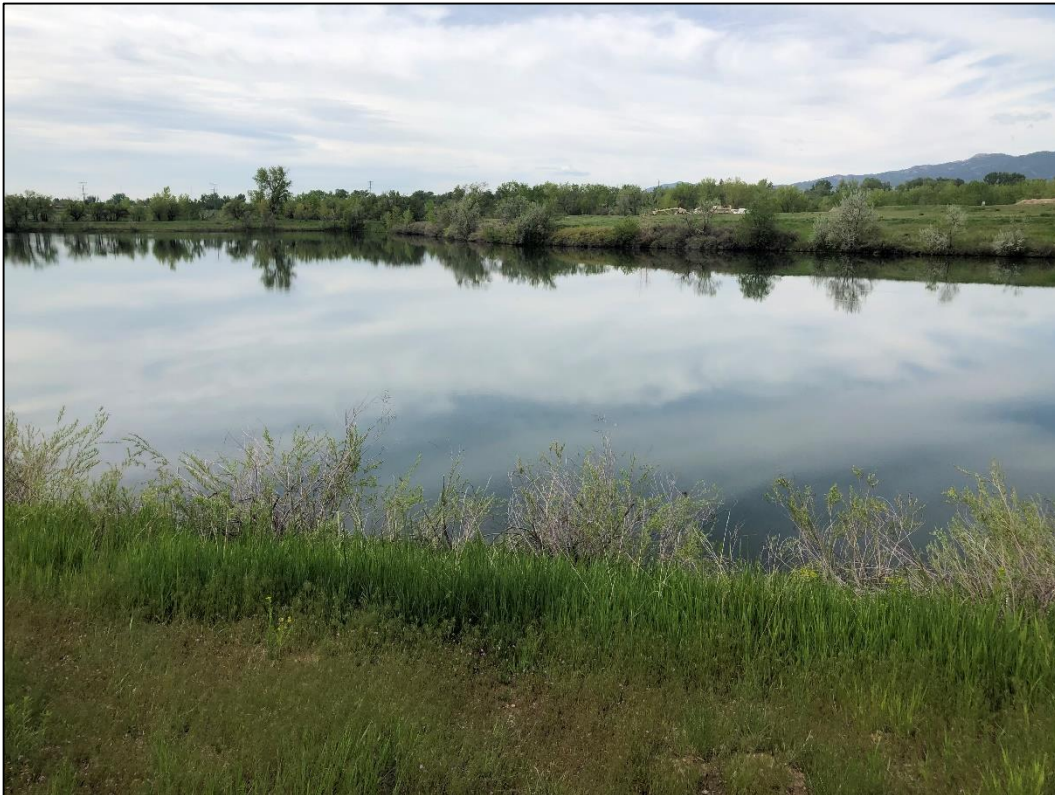
Photo 2. View looking southwest across Lamb Lake A. Note pond shorelines stable with good vegetative cover including grasses, forbs, shrubs, and trees.

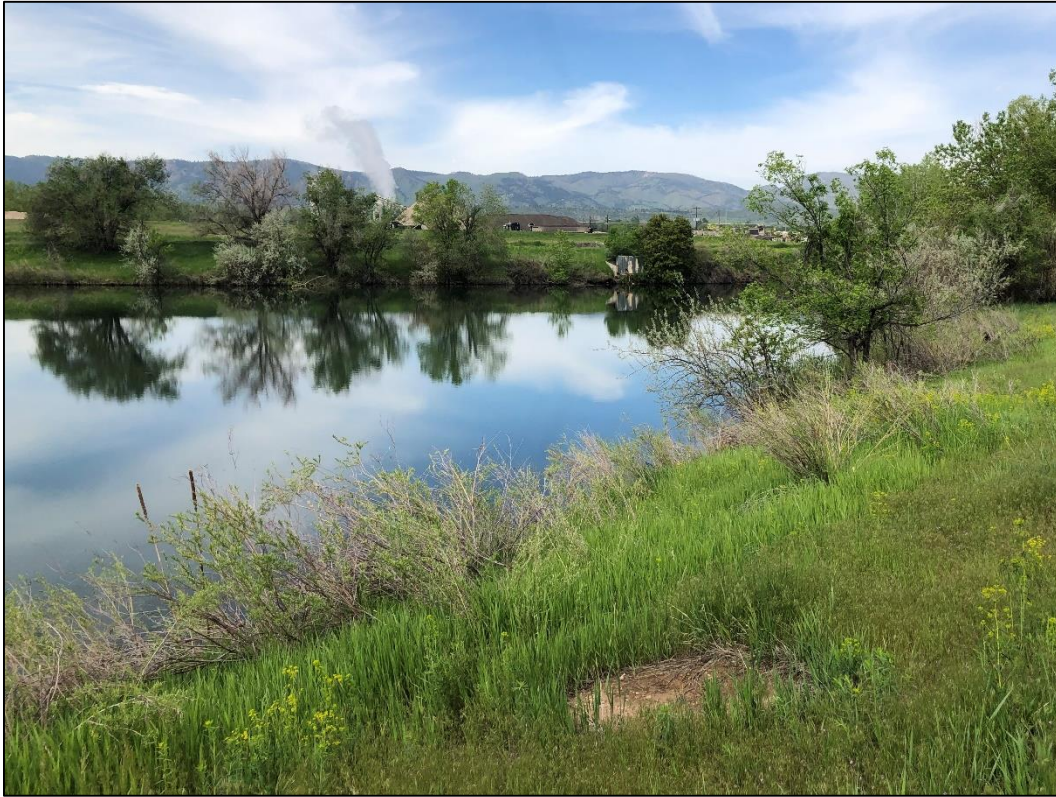
Photo 3. View looking west across northern portion of Lamb Lake A. Note pond shorelines stable with good vegetative cover including grasses, forbs, shrubs, and trees.

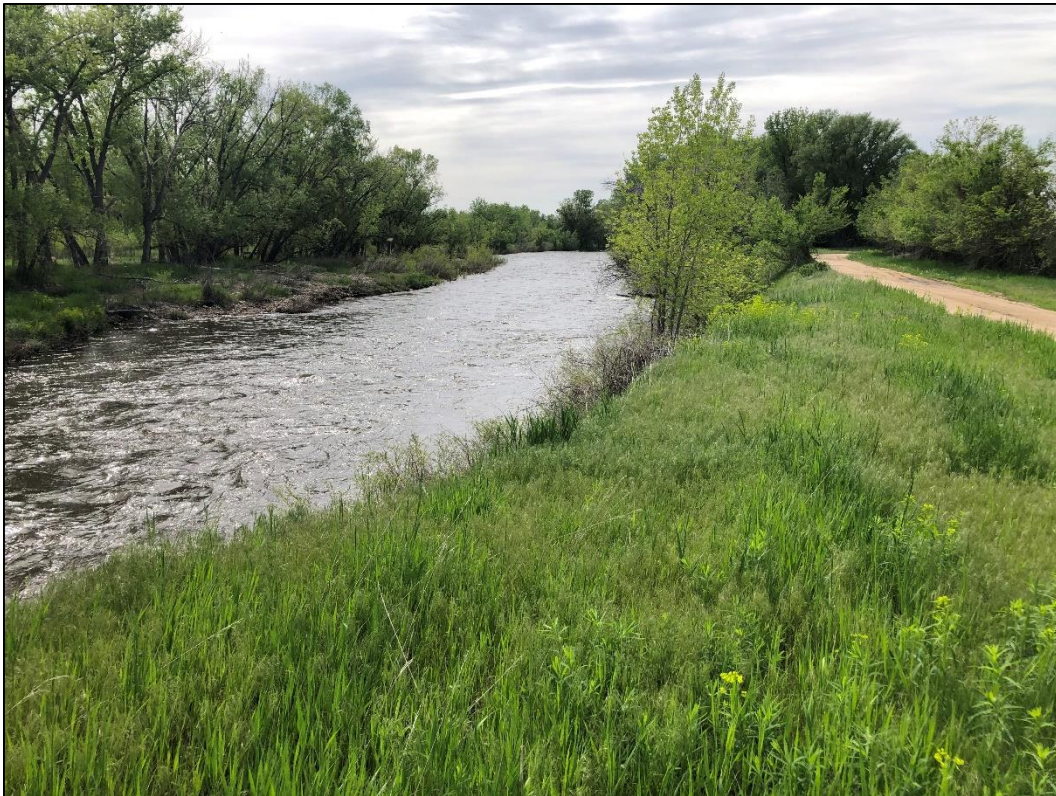
Photo 4. View looking southeast (downstream) at portion of Cache La Poudre River located within permit area (east of Lamb Lake A).

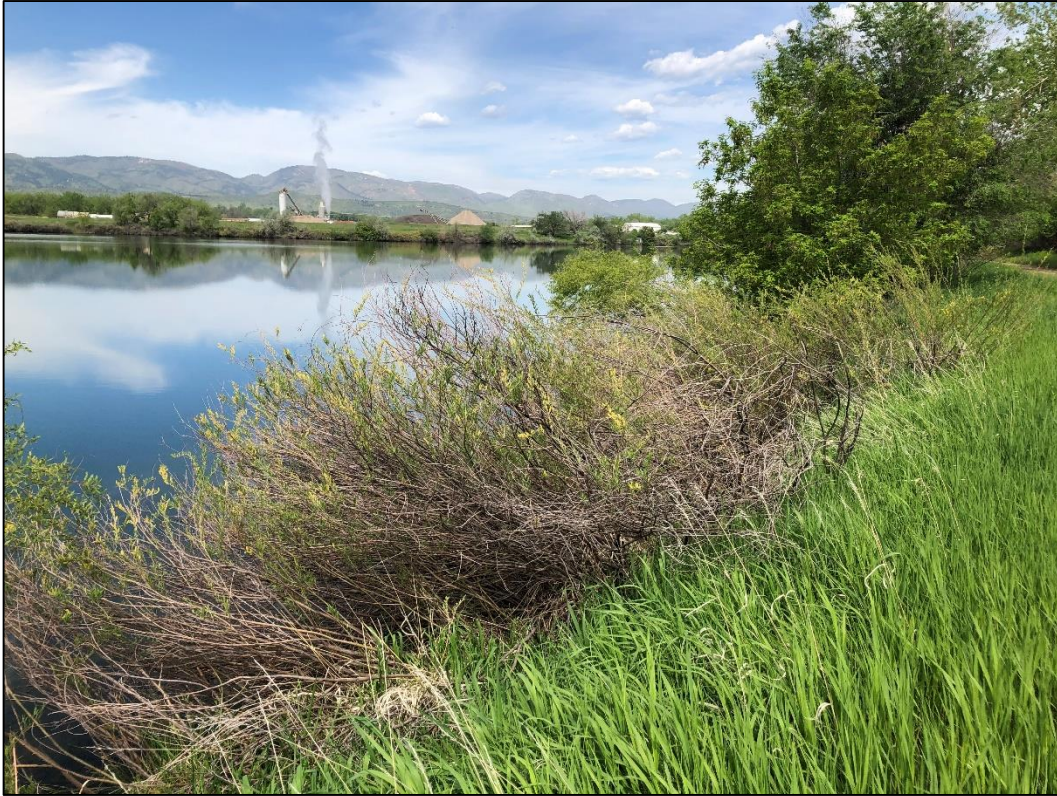
Photo 5. View looking west across northeastern shoreline of Lamb Lake A. Note pond shorelines stable with good vegetative cover including grasses, forbs, shrubs, and trees.

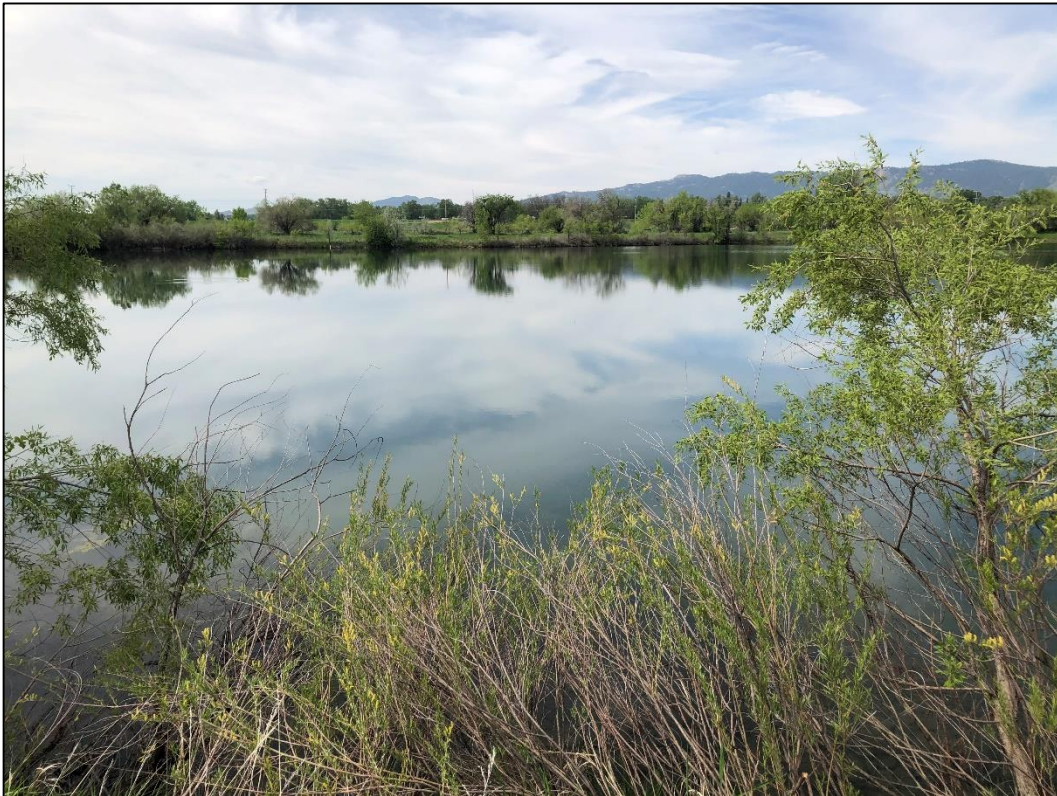
Photo 6. View looking south across Lamb Lake A. Note pond shorelines stable with good vegetative cover including grasses, forbs, shrubs, and trees.

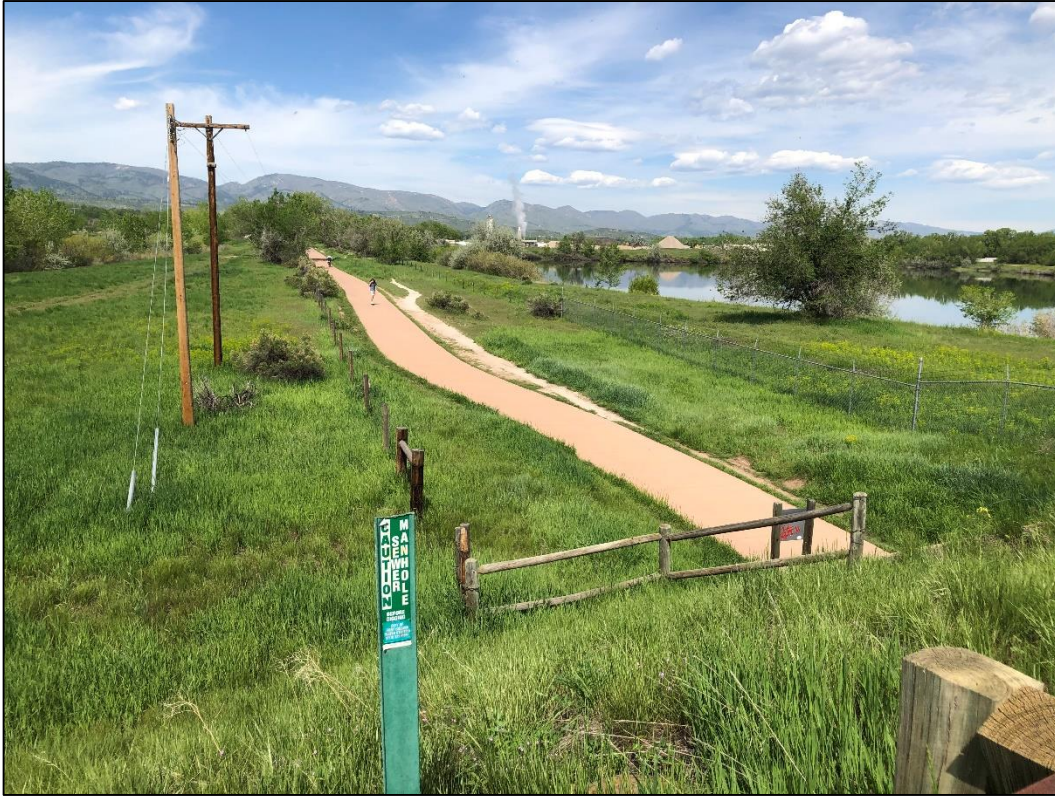
Photo 7. View looking west from top of construction bridge at Poudre River Trail, which crosses site between Lamb Lakes A and B. Southern edge of Lamb Lake A visible in background, at right.

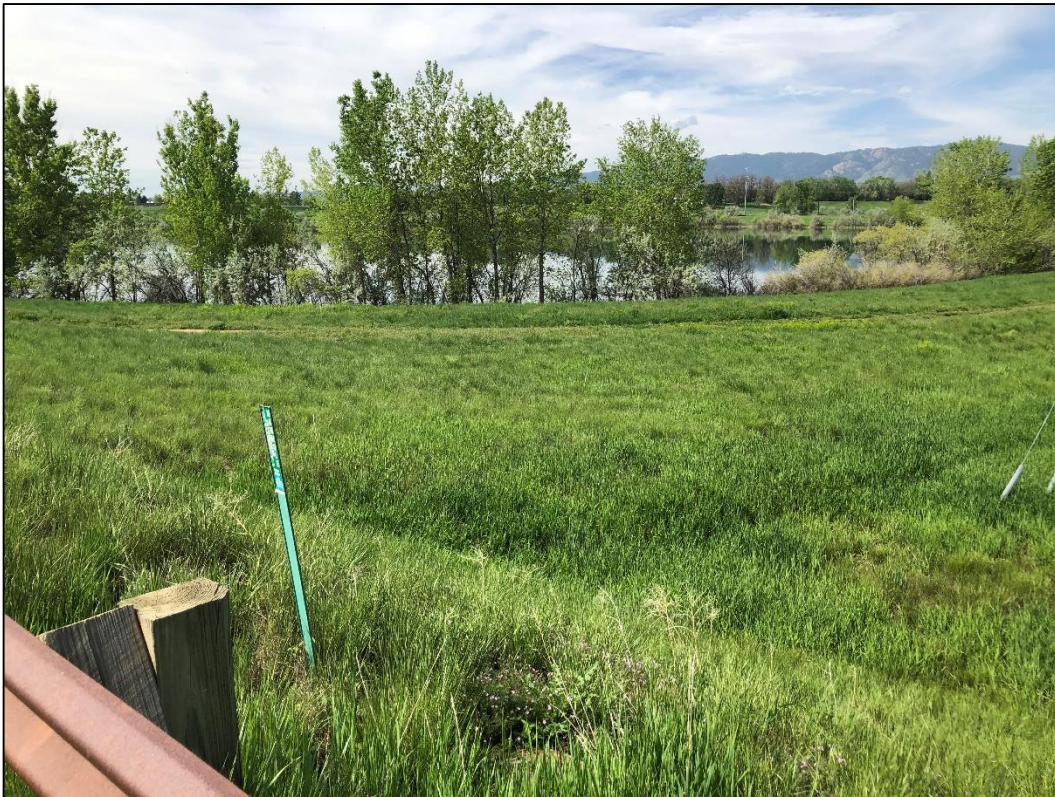
Photo 8. View looking southwest from top of construction bridge at northern edge of Lamb Lake B.

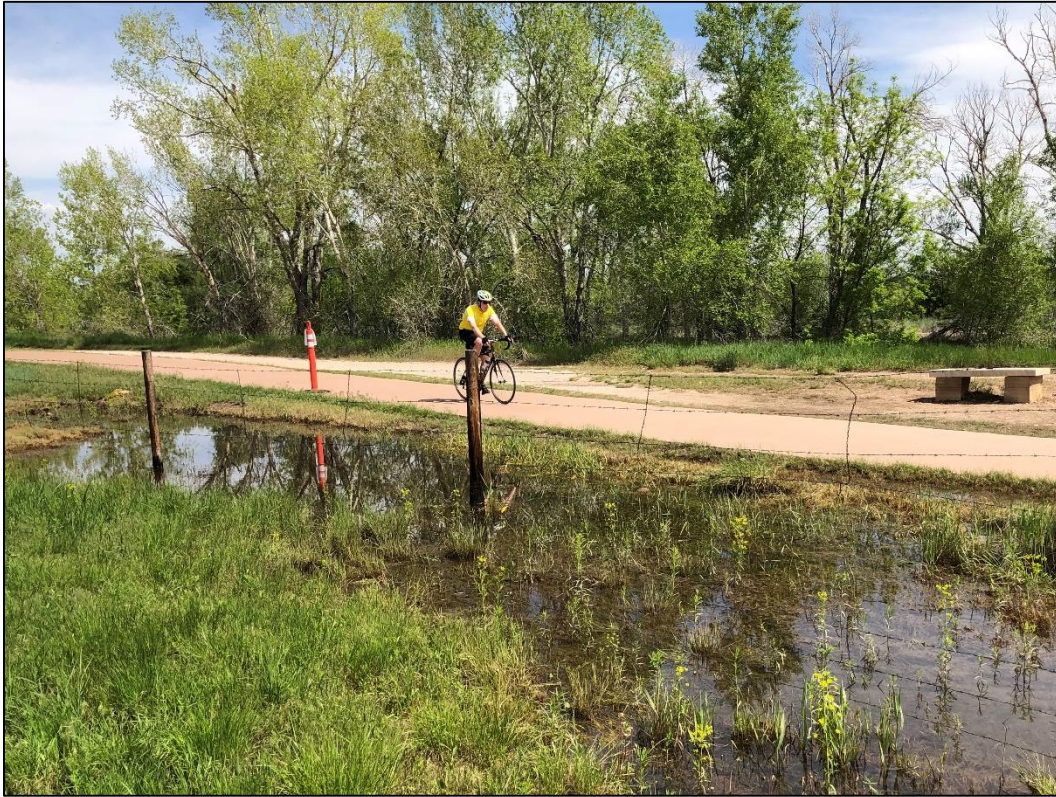
Photo 9. View looking northeast across portion of Poudre River Trail which runs along outside edge of eastern permit boundary (adjacent to Lamb Lakes B and C).

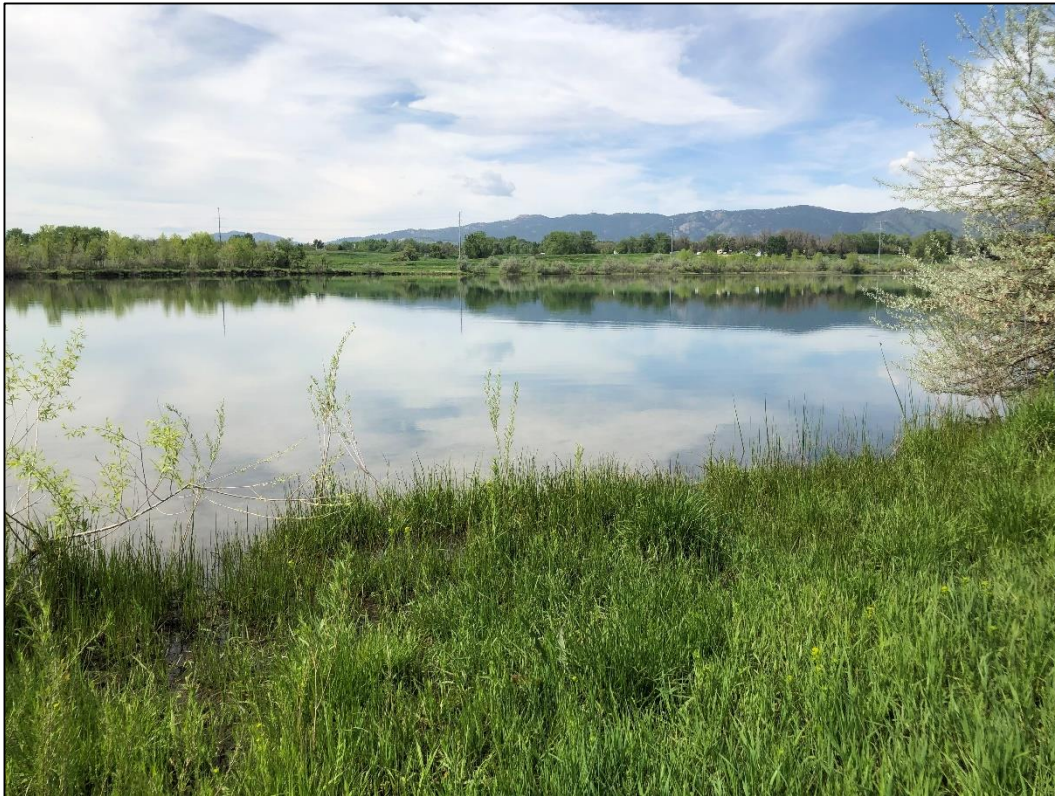
Photo 10. View looking southwest across Lamb Lake C. Note pond shorelines stable with good vegetative cover including grasses, forbs, shrubs, and trees.

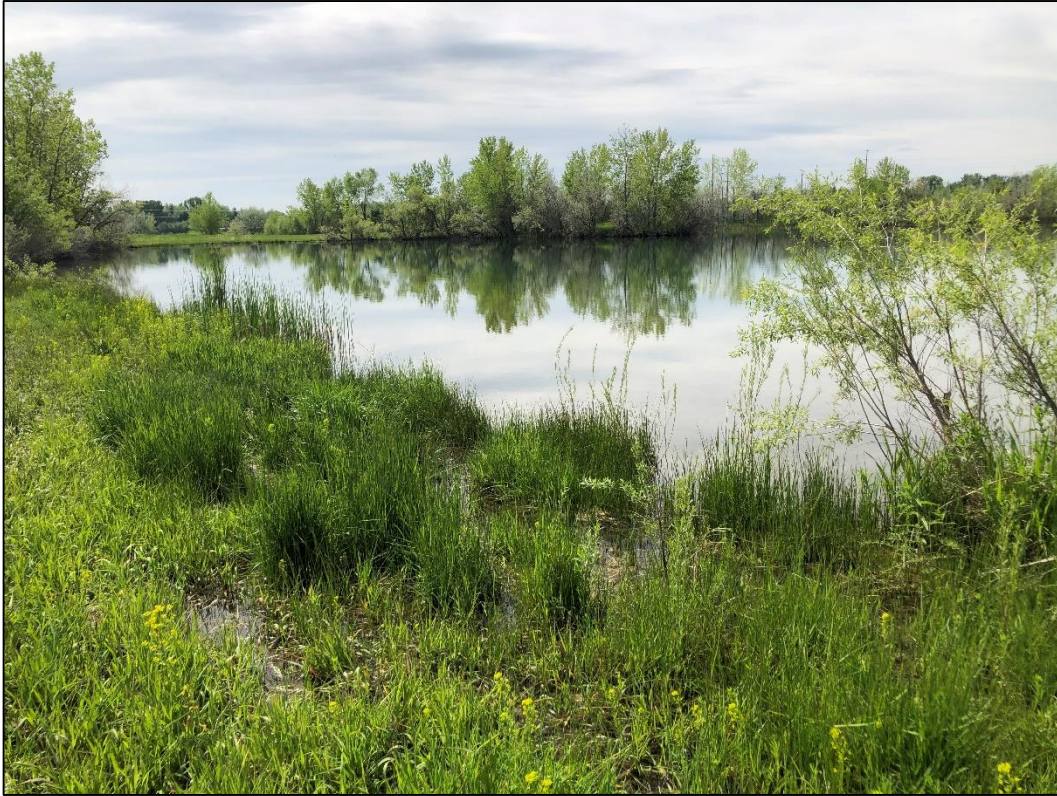
Photo 11. View looking south across Lamb Lake C. Note pond shorelines stable with good vegetative cover including grasses, forbs, shrubs, and trees.

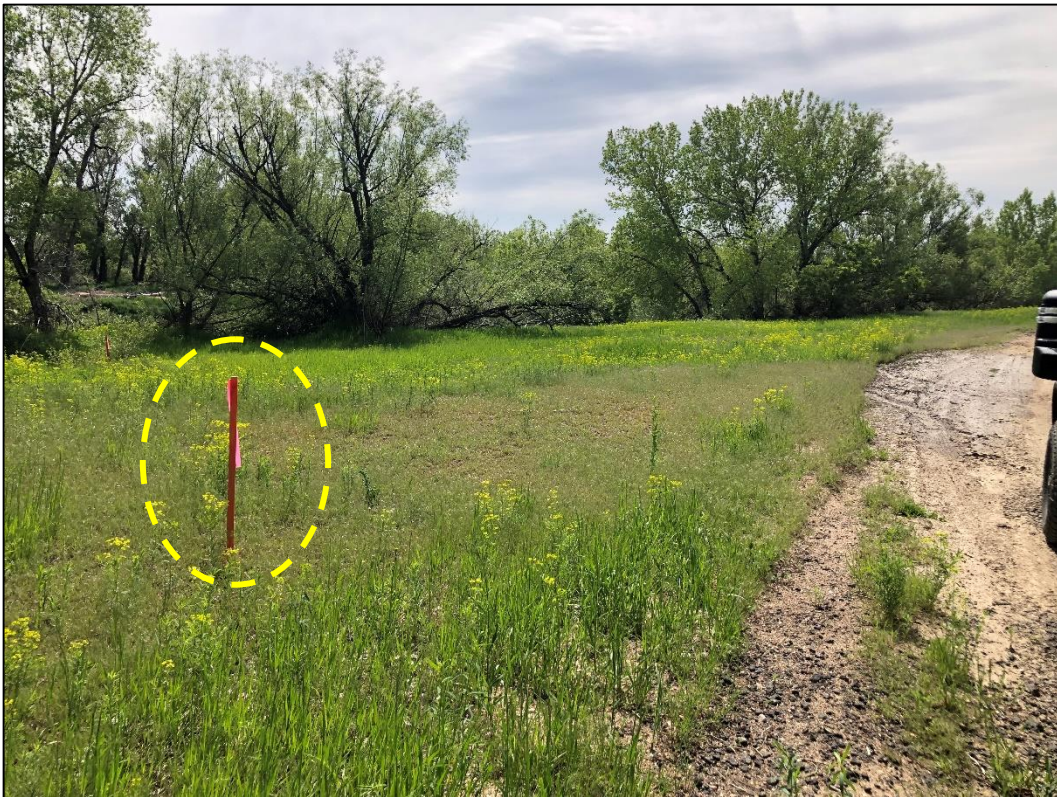
Photo 12. View looking northwest from access road, showing orange post (circled) marking northern permit boundary (adjacent to Home Office Mine permit).
