MINERALS PROGRAM INSPECTION REPORT
PHONE: (303) 866-3567

| MINE NAME: Riverbend Operation | MINE/PROSPECTING ID#: M-2000-016 | MINERAL: Sand and gravel | COUNTY: Weld |
| INSPECTION TYPE: Monitoring | INSPECTOR(S): Peter Hays | INSP. DATE: July 29, 2021 | INSP. TIME: 13:00 |
| OPERATOR: Martin Marietta Materials, Inc. | OPERATOR REPRESENTATIVE: Julie Mikulas | TYPE OF OPERATION: 112c - Construction Regular Operation | |

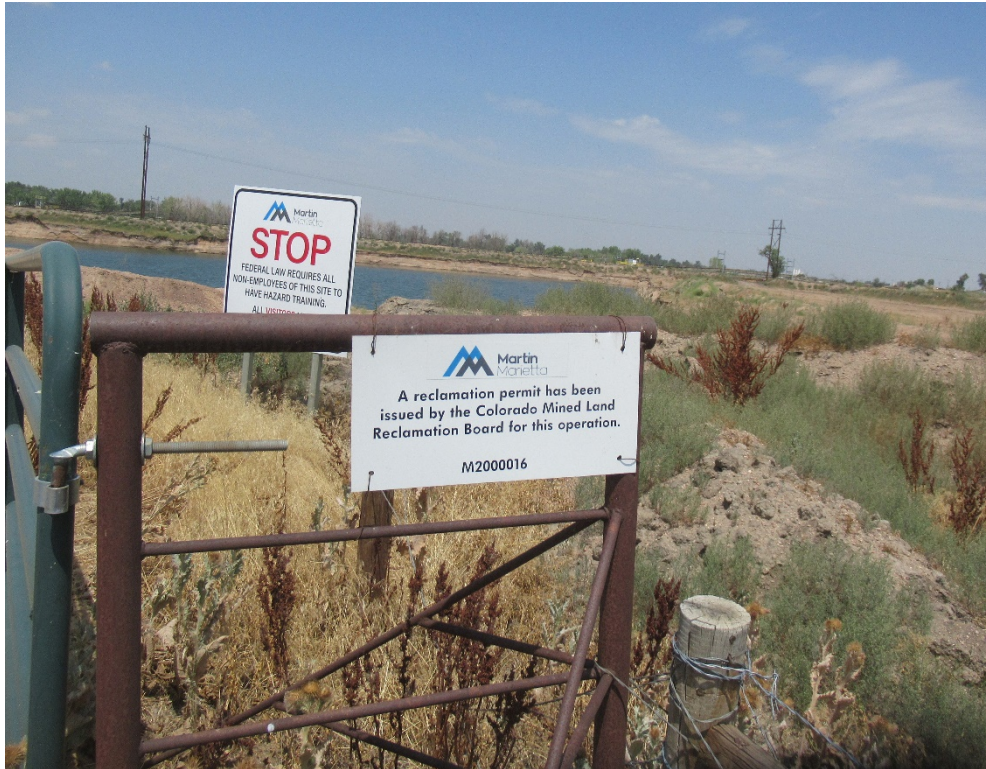
Riverbend Operation mine sign

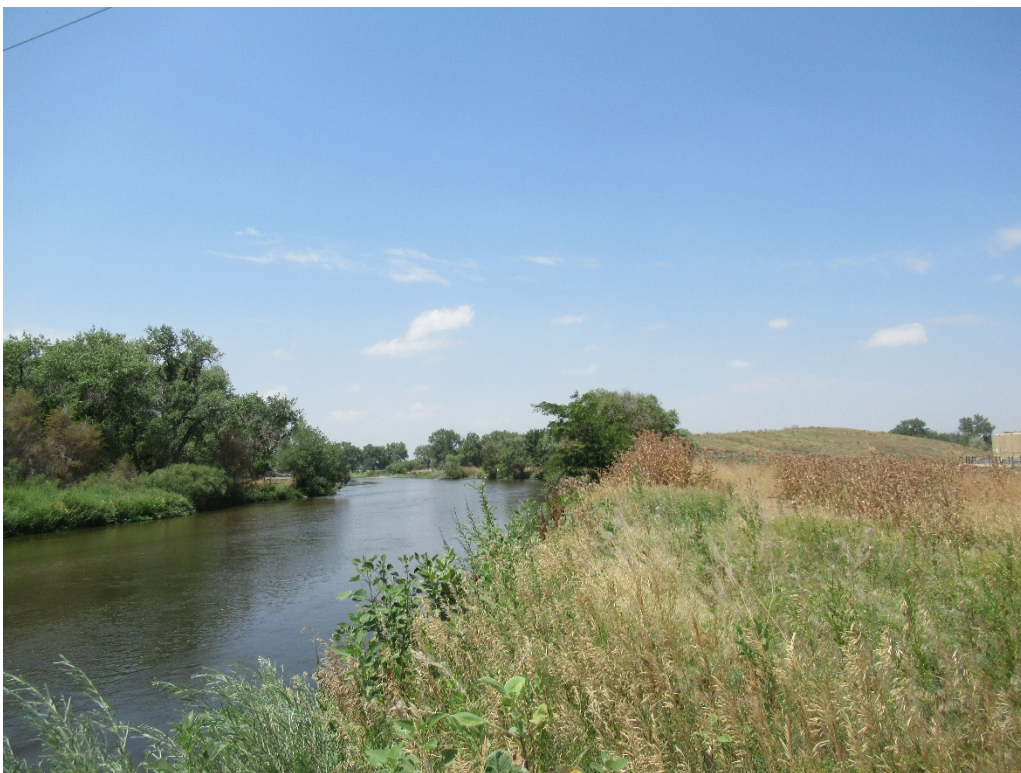
View of the Phase 1/Cell 1 South Reach looking downstream of the Platte River

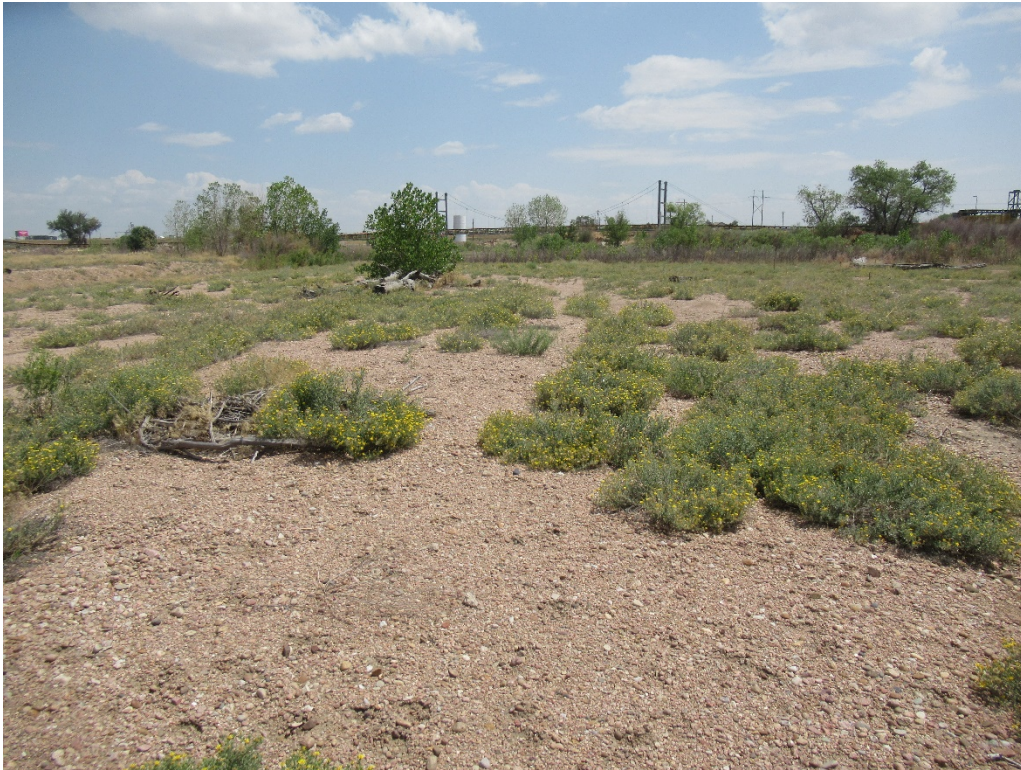
View of the Phase 1/Cell 1 Northeast Reach sandbar looking south from the Platte River towards Phase 1/Cell 1

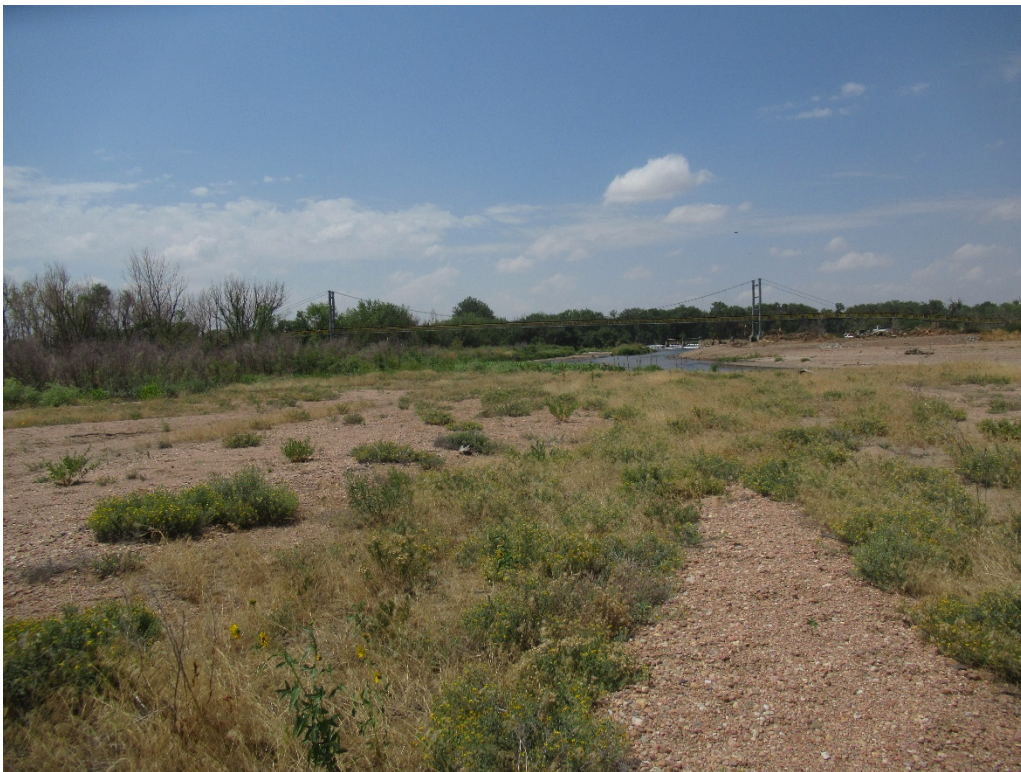
View of the Phase 1/Cell 1 Northeast Reach sandbar looking east, upstream of the Platte River

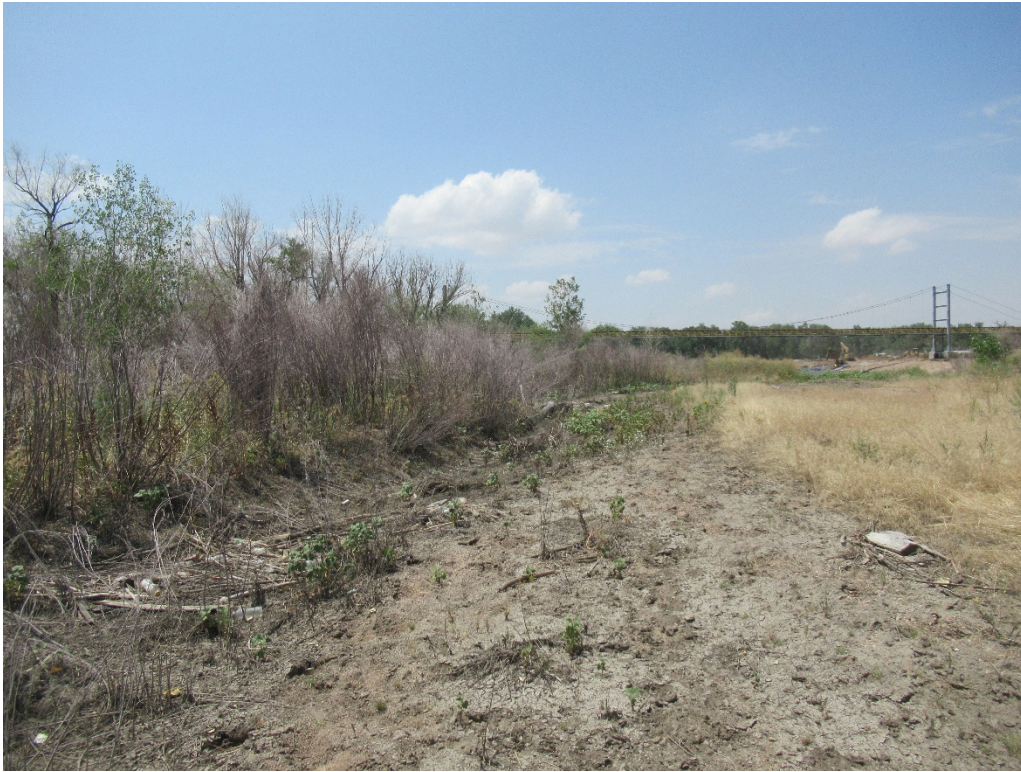
View of a dry channel located in the Phase 1/Cell 1 Northeast Reach sandbar looking east,
upstream of the Platte River
