Bowie 2 Report

COLORADO
Division of Reclamation,
Mining and Safety
Department of Natural Resources

Permit Number: C-1996-083 Mine Name: Bowie No. 2 Mine Operator: Bowie Resources, LLC Operator Address: Mr. Basil Bear P.O. Box 1488 Paonia, CO 81428	County: Delta Operation Type: Underground Permit Status: Active Ownership: Private
	Operator Representative Present: Basil Bear
Operator Representative Signature: (Field Issuance Only)

Inspection Start Date: August 17, 2021 Inspection Start Time: 11:30 Inspection End Date: August 17, 2021 Inspection End Time: 15:40		Inspection Type: Coal Complete Inspection Inspection Reason: Normal I&E Program Weather: Clear	
Joint Inspection Agency: None		Joint Inspection Contacts:	
Post Inspection Agency: None		Post Inspection Contacts:	
Inspector(s): Robert Zuber, P.E.	Inspector's Signature: <i>Robert D. Zuber</i>		Signature Date: 8/19/2021

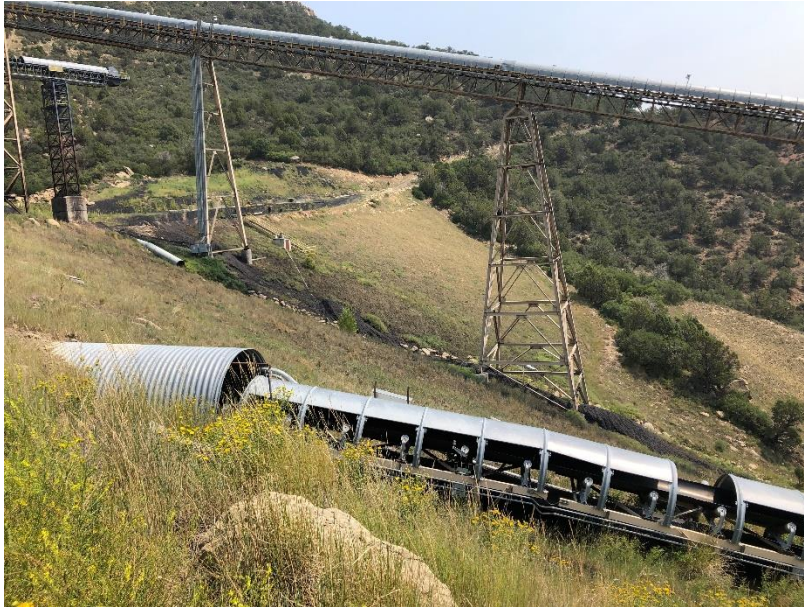
No problems were identified at the facility areas. All benches appeared stable with no signs of erosion beneath them. These include the pads for the B Portal and the D Portal. Other comments on facilities:

Area below the bench for the D Portal

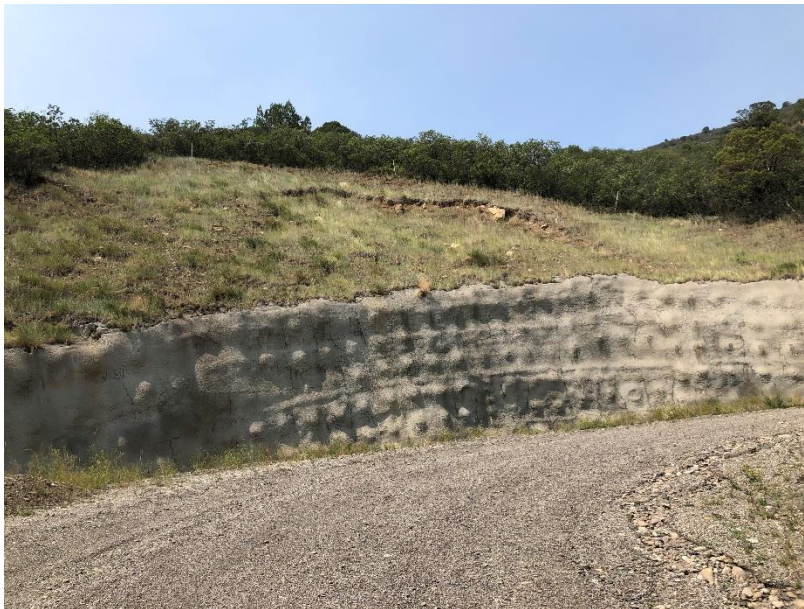
It appears that slumps have not moved significantly in the recent past. These include slumps by the B Portal and by Curve Number 11 along the Haul Road.

Slump at Curve 11

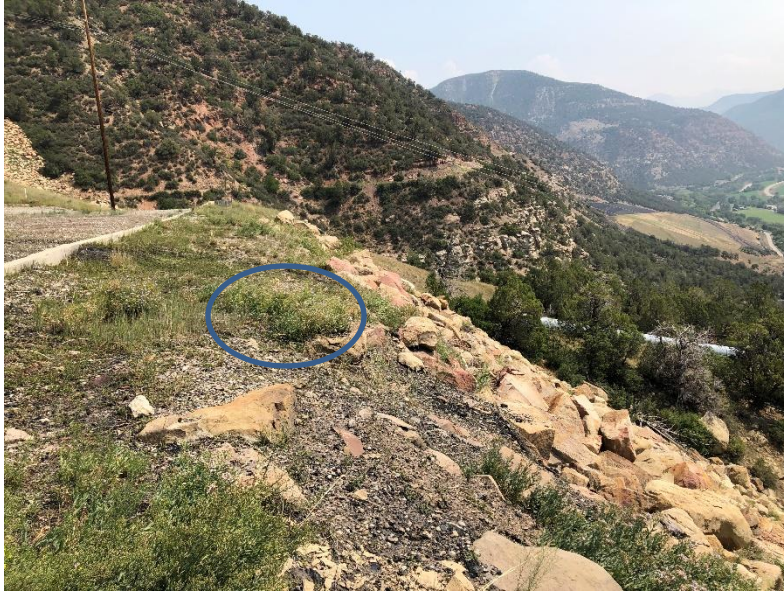
- Many mullein plants along the road to the Utility Bench
- Knapweed in many locations, including the drainage below the Utility Bench and near the Pond C outlet ditch
- Halogeton at Gob Pile #2 and along the haul road
- Hoary cress at Topsoil Stockpile A (along the road to the portals).

Area below the bench for the B Portal (knapweed is circled)

Weeds were observed at the following locations and should be controlled:

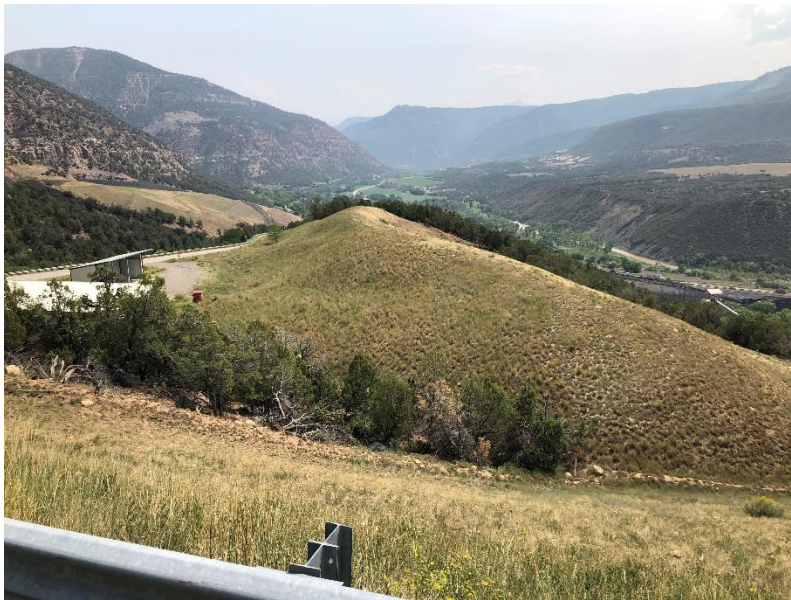
At topsoil stockpiles and coverfill piles, berms, vegetation, and silt fence are keeping these resources in place.

Topsoil Stockpile A, with Gob Piles 2 and 4 in the background

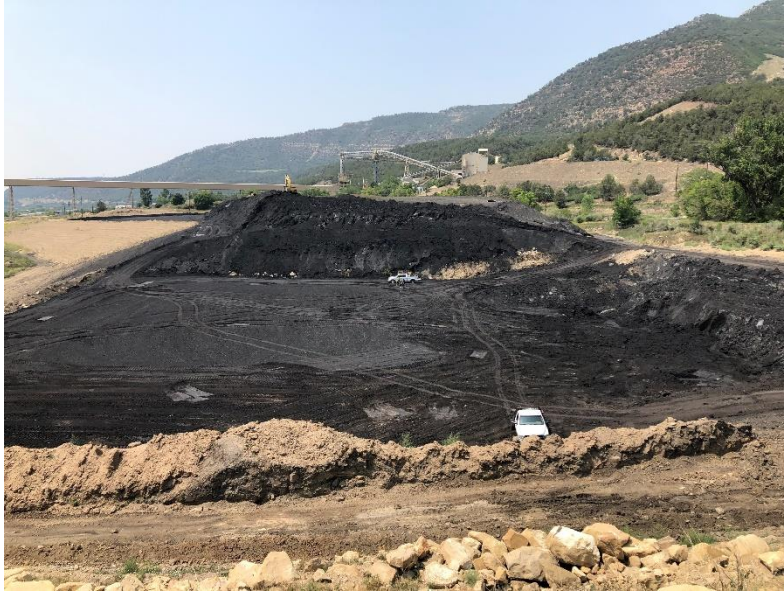
BRL continues to focus their efforts on Gob Pile #3. During the inspection, BRL's engineering consultant (Huddleston-Berry Engineering & Testing) was performing compaction testing on the east portion of the pile. The material on the east side (shown in photos in past inspections) has mostly been moved to the west side of this pile. During the inspection, the crew was moving material off of the top of Gob Pile #3 and moving it to lower areas to be spread and compacted.

No issues were seen at Gob Pile #3, where BRL staff have been focusing their reclamation activities. Material from the subsoil pile on the east side has been moved to the west side as part of the reclamation.

Gob Pile #3 with crew performing compaction test in middle of the photo

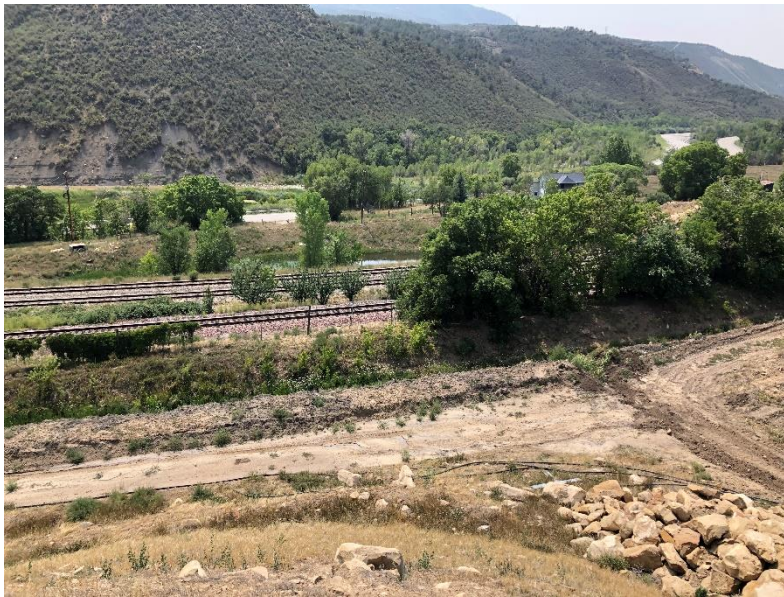
Ditch and Pond J below Gob Pile #3

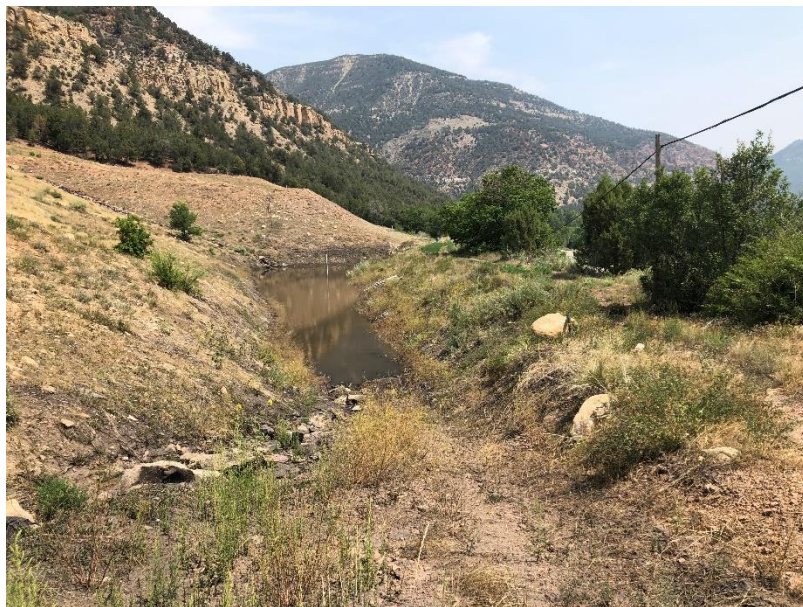
Six sediment ponds were inspected: B, C, D, F, J, and K. None of the ponds were discharging. All of the ponds contained water from recent precipitation, but none of the ponds were close to full. (In Pond K, there was no standing water but the soil was muddy.) The water in Pond F was approximately ten feet below the emergency spillway. No significant problems were identified with embankments, spillways, inlet channels, or other features of the ponds.

Pond F, taken from west inlet

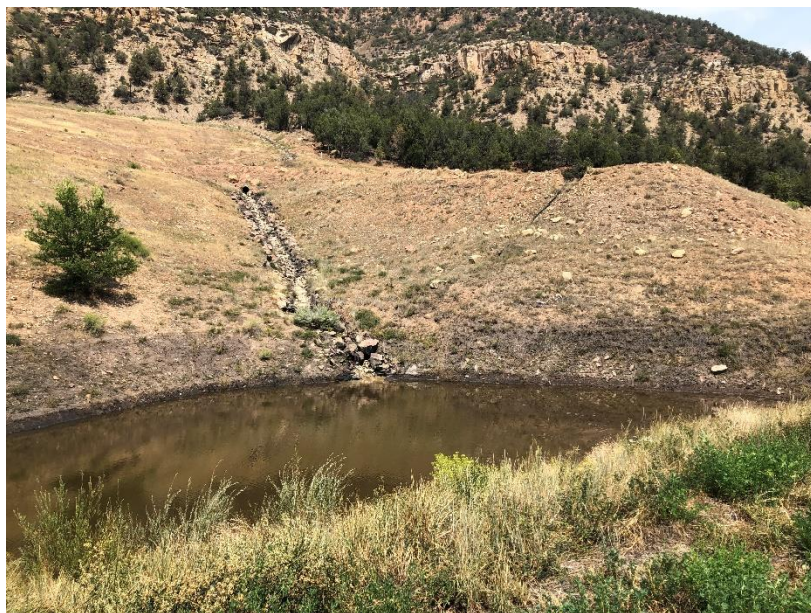
Pond F and coverfill pile, taken from embankment

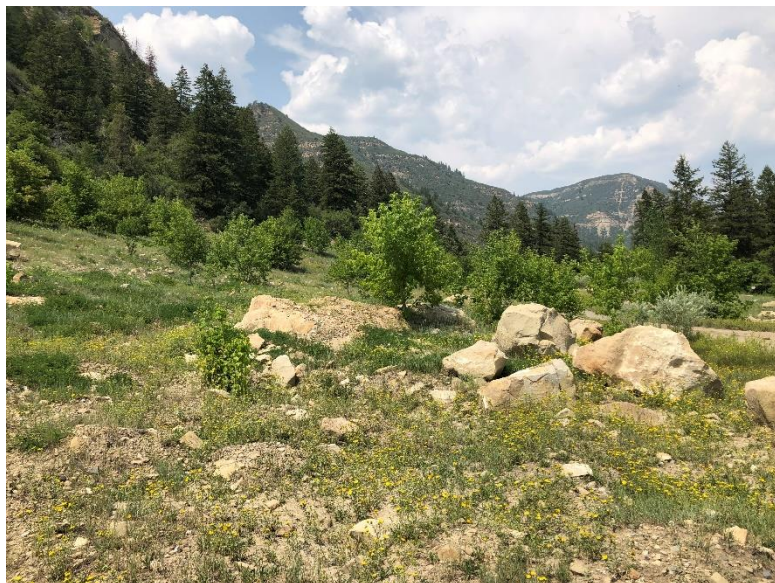
No problems were seen at the sites along the Hubbard Creek Road. This includes the reclaimed pad at the former Hubbard Creek Vent Shaft and the Rock Laydown area.

Reclaimed pad for Hubbard Creek Vent Shaft

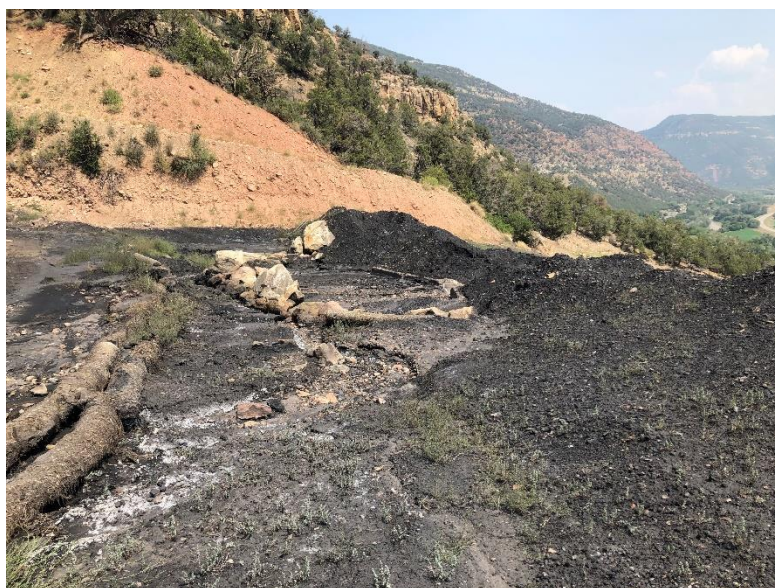
Gob Piles #1, #2 and #4 looked stable. On the upper and lower lifts of Gob Pile #2 only small rills were observed. Most of the drainage control practices on the upper (flat) portion of this pile appear to be functioning well. Check dams have been repaired. No puddles were observed.

Gob Pile #2 sediment sump
