MINERALS PROGRAM INSPECTION REPORT

MINE NAME: Bijou Clay Mine	MINE/PROSPECTING ID#: M-1997-007	MINERAL: Clay (general)	COUNTY: Elbert
INSPECTION TYPE: Monitoring	INSPECTOR(S): Amy Eschberger	INSP. DATE: June 17, 2021	INSP. TIME: 11:30
OPERATOR: The Denver Brick Company	OPERATOR REPRESENTATIVE: Richard Murphy	TYPE OF OPERATION: 112c - Construction Regular Operation	
REASON FOR INSPECTION: Normal I&E Program	BOND CALCULATION TYPE: Complete Bond	BOND AMOUNT: \$196,124.37	
DATE OF COMPLAINT: NA	POST INSP. CONTACTS: None	JOINT INSP. AGENCY: None	
WEATHER: Clear	INSPECTOR'S SIGNATURE: 	SIGNATURE DATE: August 24, 2021

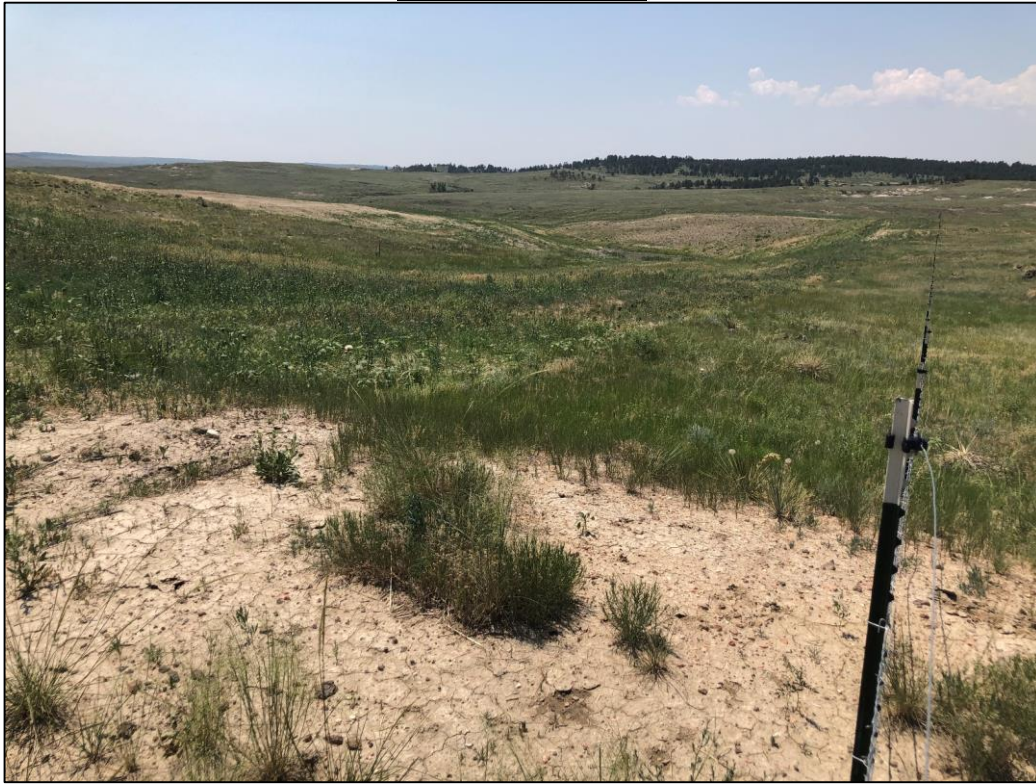
Photo 1. View looking southeast from western permit boundary across southern portion of permit area. Note barbed wire fence (at right) delineating permit boundary.

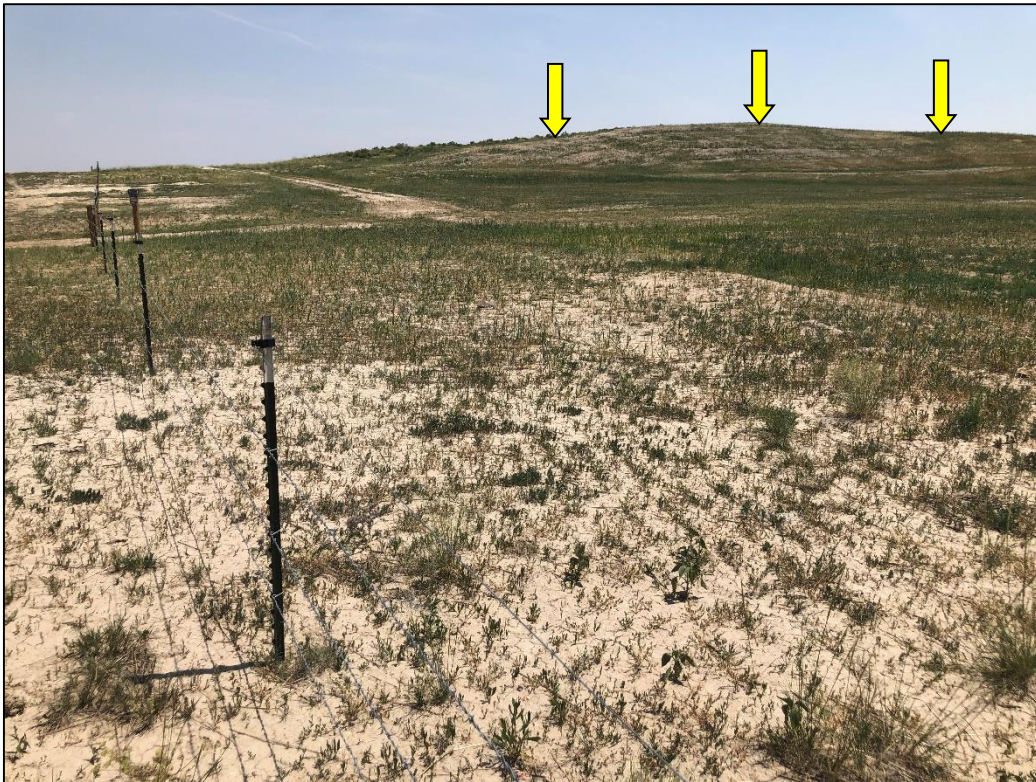
Photo 2. View looking northeast from western permit boundary across relatively flat central portion of permit area which was used for stockpiling. Graded "overburden highwall" visible in background (indicated).

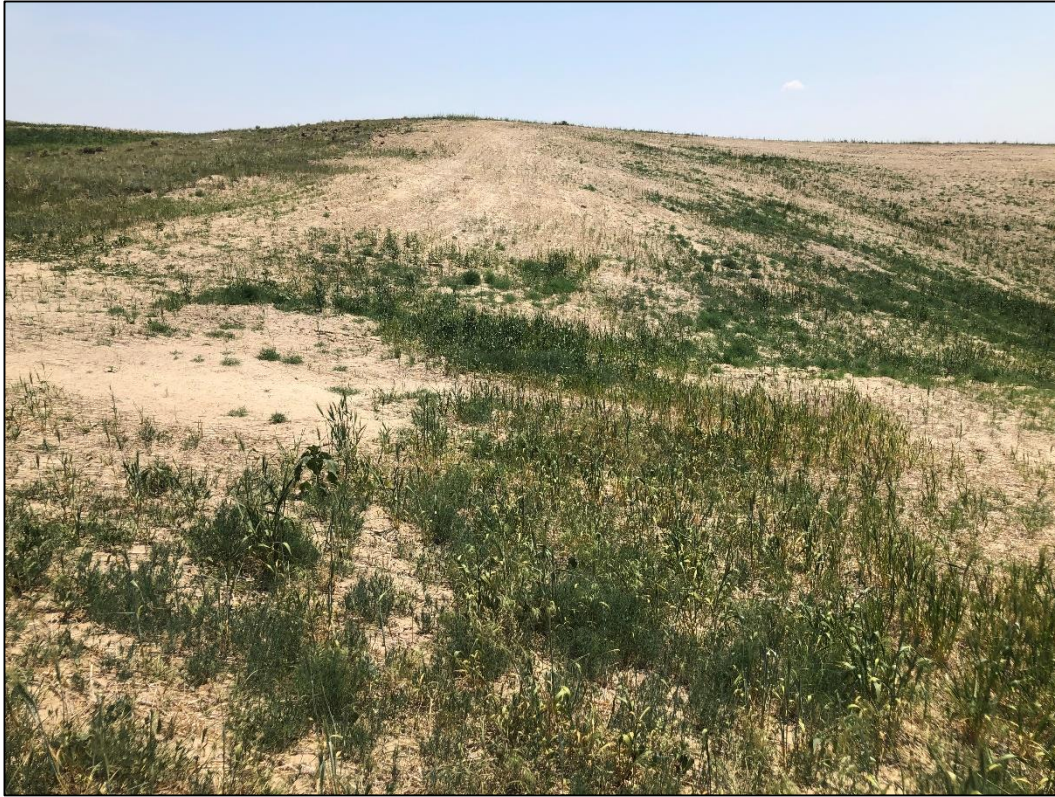
The required grading and initial seeding has been completed at the site. All that remains is to achieve successful revegetation of disturbed areas. During the inspection, the Division observed a wheat cover crop growing throughout much of the site. Evidence of a straw mulch application remained. Grasses were observed growing in some areas, along with some annual weeds. The vegetative cover was very sparse in some areas, particularly

Photo 3. View looking southeast across northern slope of phase 4 pit (in southern portion of permit area), showing slopes graded 3H:1V or flatter. Note sparse vegetative cover along top of slope which may require additional seeding.

along the tops of graded slopes. The operator indicated they will reseed the site this fall, if necessary. The Division recommends the operator continue to monitor revegetation progress at the site, and reseed and/or fertilize as needed. The operator should also continue to monitor the growth and spread of weeds in the affected area, particularly of any state-listed noxious weed species, and implement the approved weed control plan as needed. Revegetation of the site is off to a great start. However, it will be very important during this phase to keep the weeds from interfering with the growth of the desired vegetation.

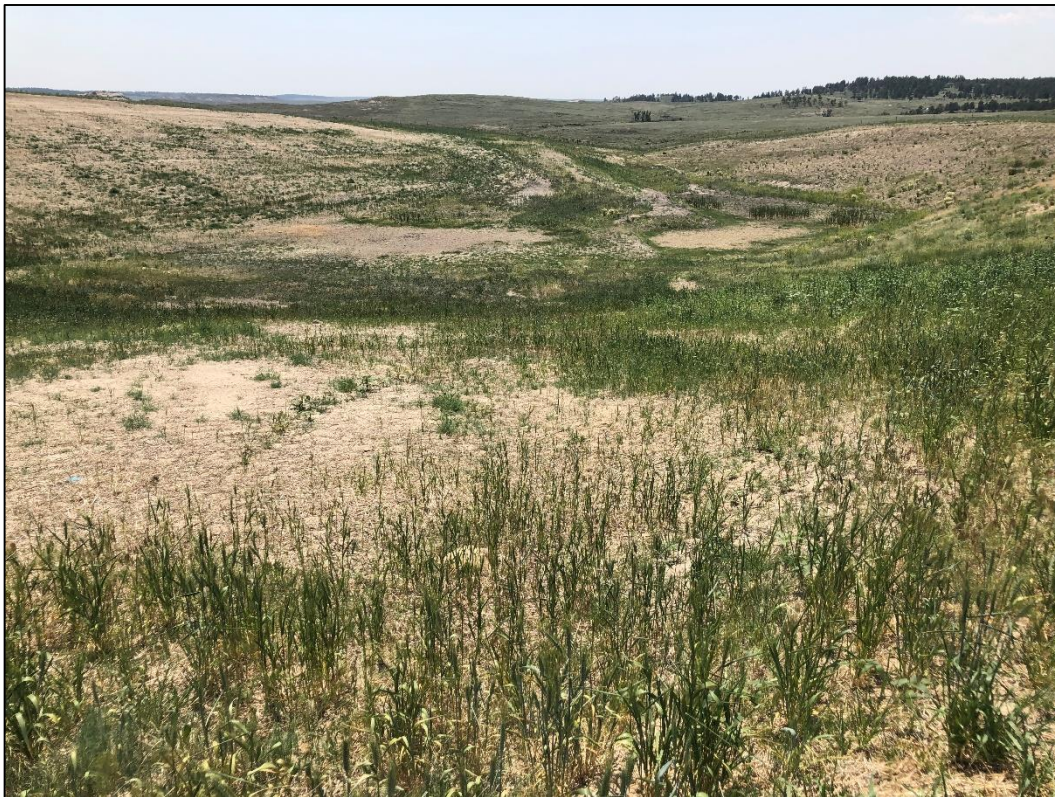
Photo 4. View looking southeast across phase 4 pit (in southern portion of permit area), showing slopes graded to 3H:1V or flatter. Note sparse vegetative cover along top of slopes and in a few areas on the pit floor which may require additional seeding.

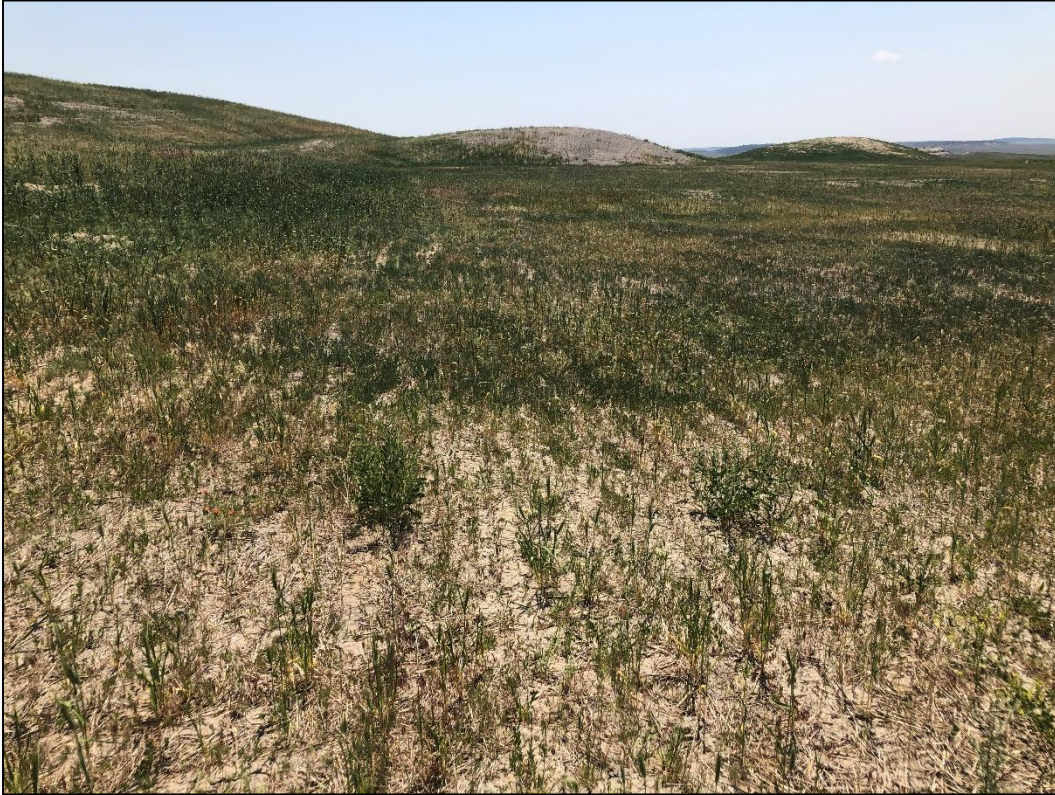
Photo 5. View looking east across relatively flat central portion of permit area which was used for stockpiling. All slopes in this area are graded to 3H:1V or flatter.

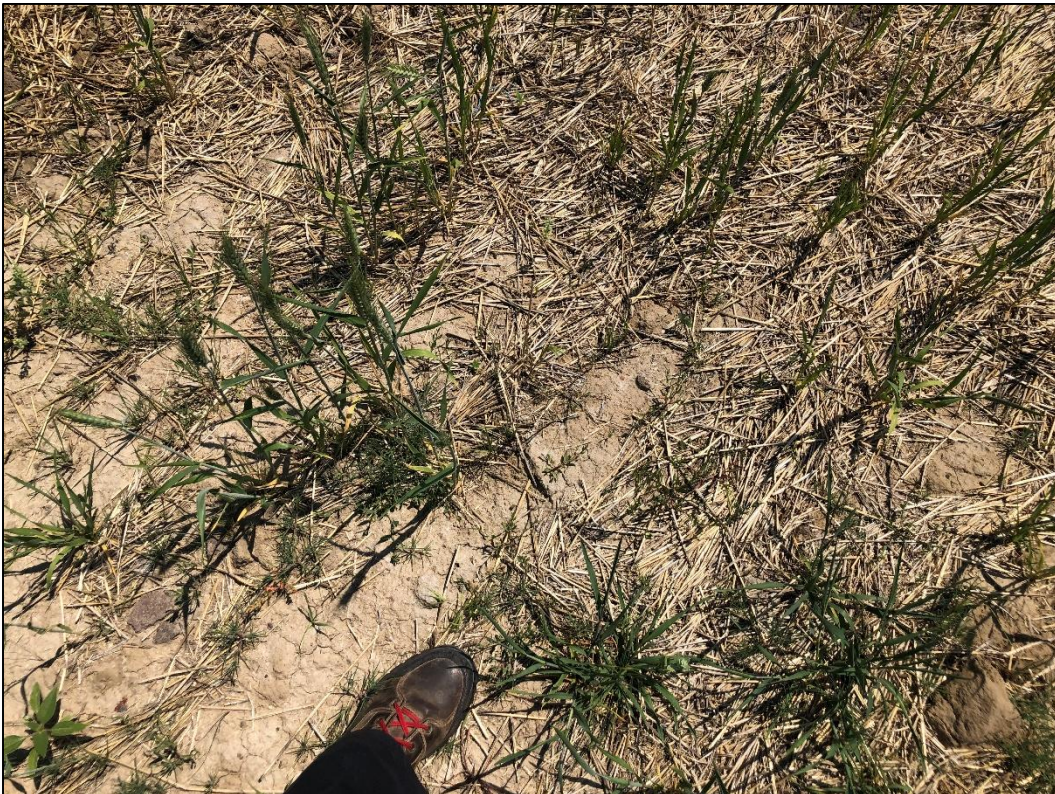
Photo 6. Ground view in central portion of permit area, showing wheat cover crop, remaining straw mulch, and some germinated grasses.

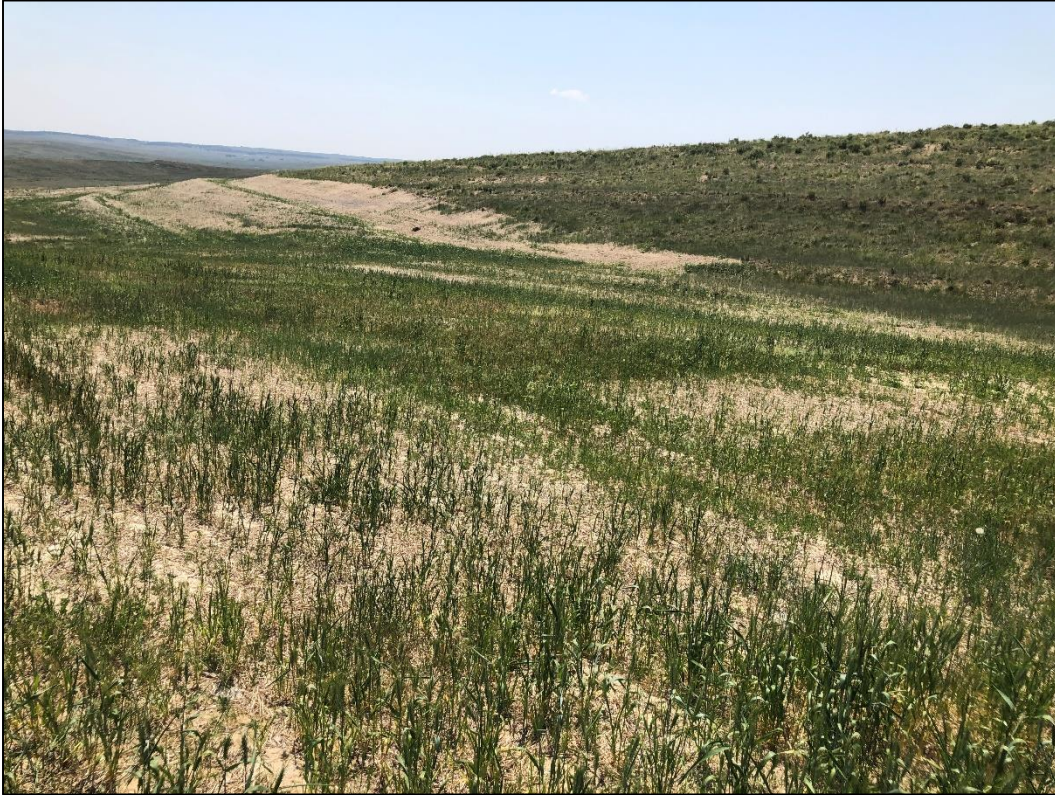
Photo 7. View looking southeast across phase 2 and 3 pit area (in northern portion of permit area), showing slopes graded to 3H:1V or flatter. Note sparse vegetative cover in some areas which may require additional seeding.

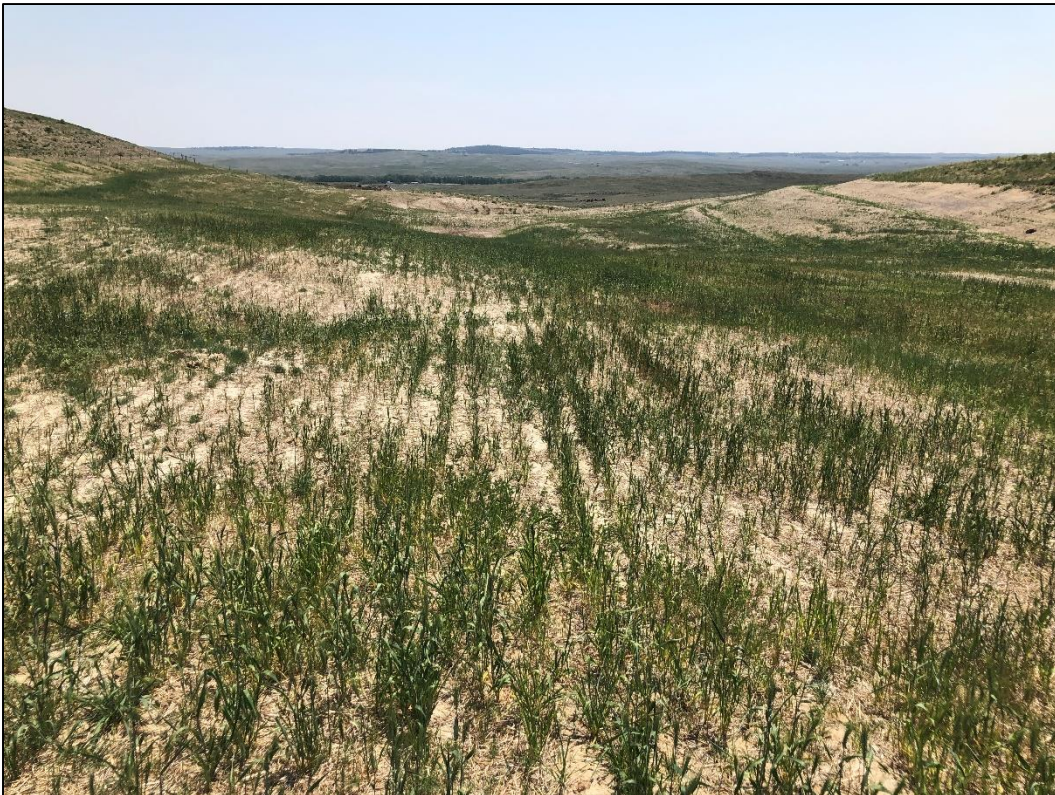
Photo 8. View looking east across phase 2 and 3 pit area (in northern portion of permit area), showing slopes graded to 3H:1V or flatter. Note sparse vegetative cover in some areas which may require additional seeding.

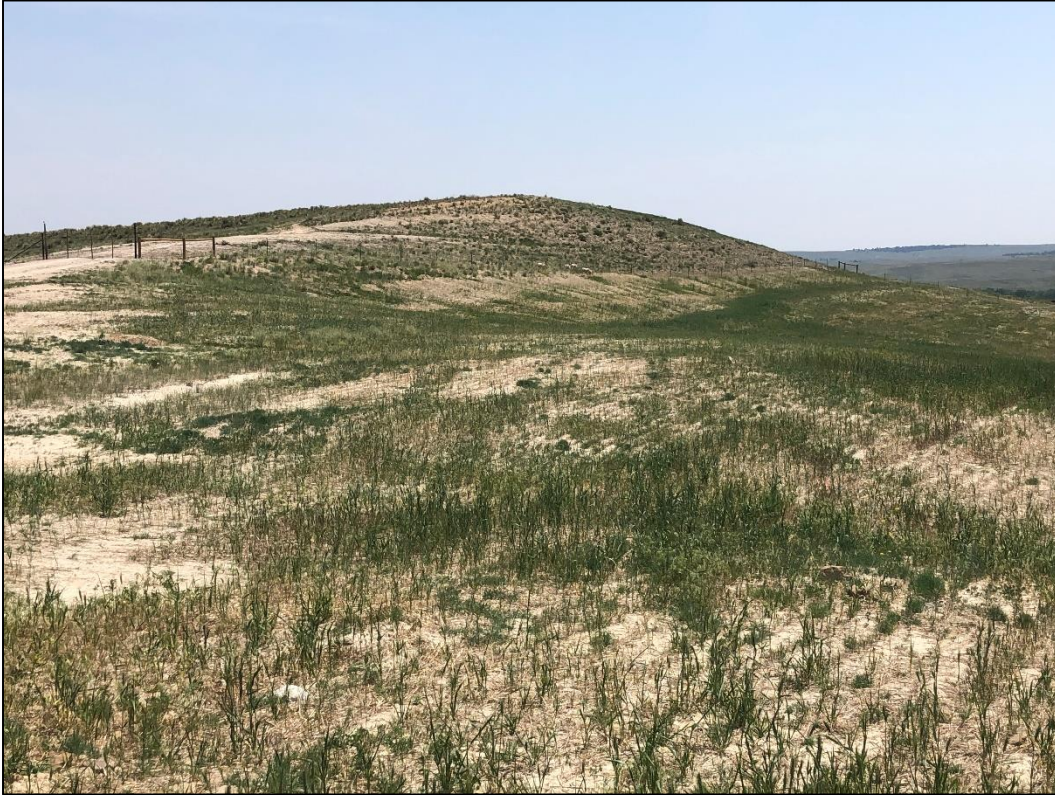
Photo 9. View looking northeast across phase 2 and 3 pit area (in northern portion of permit area), showing slopes graded to 3H:1V or flatter. Note sparse vegetative cover in some areas which may require additional seeding.

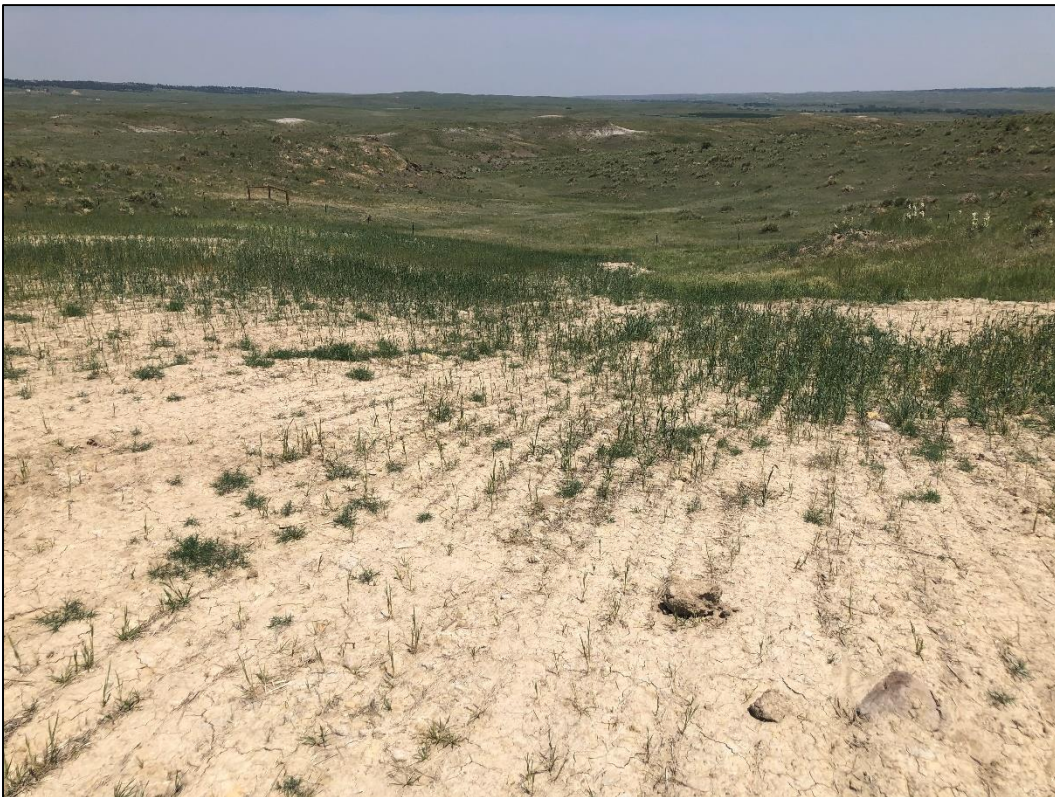
Photo 10. View looking north across northwestern corner of permit area where a large topsoil stockpile had been stored. This topsoil was used for reclamation of the site. Note area in foreground with very sparse vegetative cover which may require additional seeding.

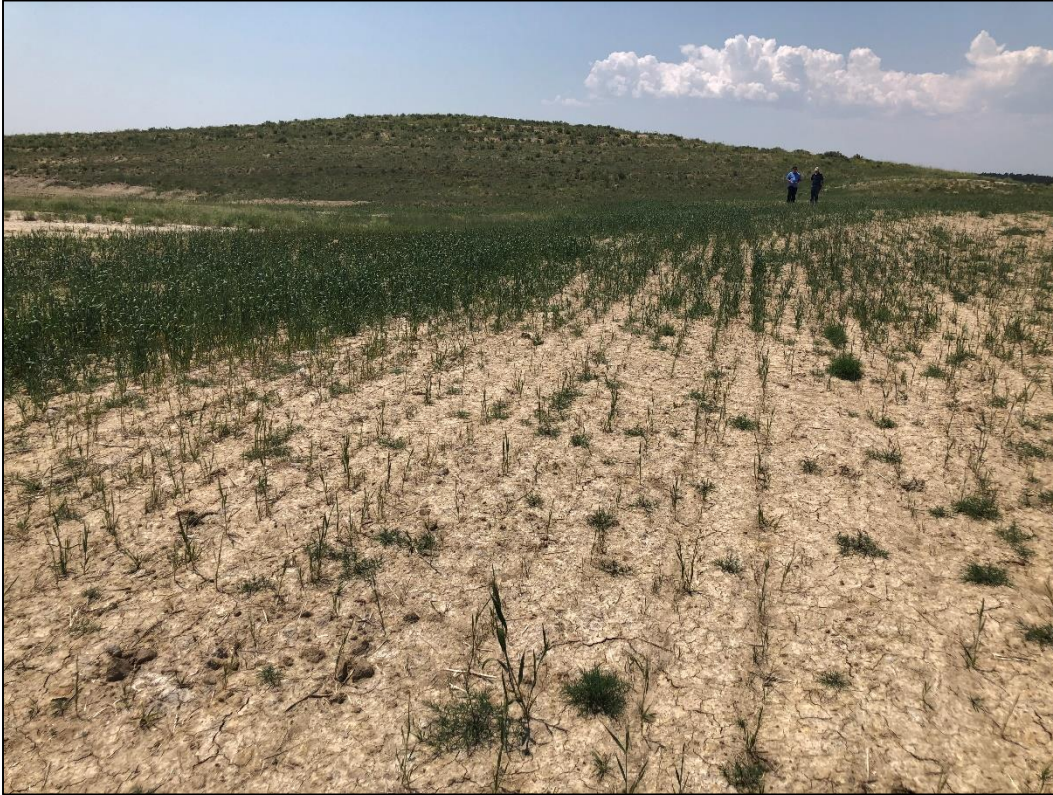
Photo 11. View looking south across phase 2 and 3 pit area (in northern portion of permit area), showing slopes graded to 3H:1V or flatter. Note area in foreground with very sparse vegetative cover which may require additional seeding.

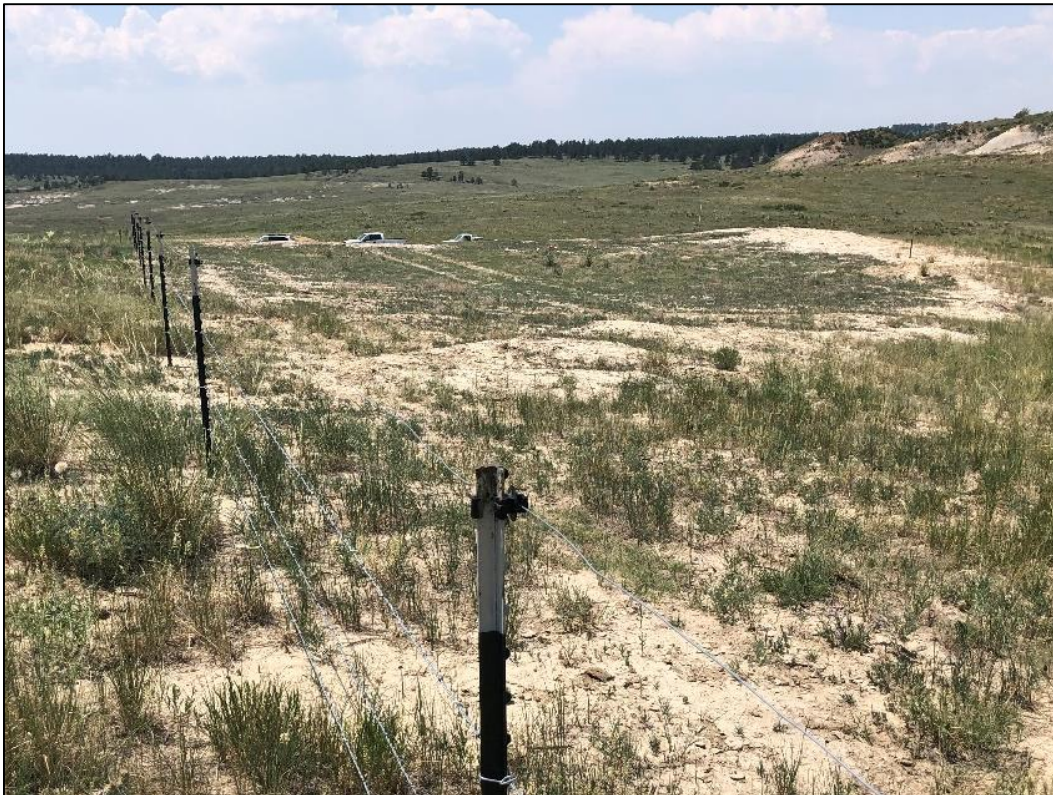
Photo 12. View looking southwest across triangular shaped western portion of permit area (delineated with white PVC posts) where material had been stockpiled adjacent to access road. This area may require additional seeding.
