## **PERMIT INFORMATION**

# **INSPECTION INFORMATION**

Inspection Start Date: July 27, 2 Inspection Start Time: 12:00 Inspection End Date: July 27, 20 Inspection End Time: 03:00			Inspection Type: Coal Partial Inspection Inspection Reason: Normal I&E Program Weather: Clear
Joint Inspection Agency:		Joint	Inspection Contacts:
None			
Post Inspection Agency:		Post	Inspection Contacts:
None			
Inspector(s):	Inspector	Inspector's Signature: Signature I	
Tabetha Lynch	Titha	Typ	8/6/21

This was a partial inspection of the Foidel Creek Mine; DRMS Permit No. C-1982-056, operated by Twentymile Coal, LLC. (TC). This inspection was conducted by Tabetha Lynch with the Colorado Division of Reclamation, Mining, and Safety (Division). Overall the weather was clear and hot during the inspection.

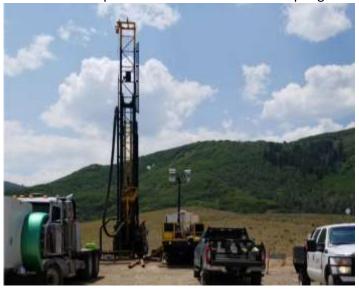
At the time of inspection a drill was on site attempting to re-develop the 16L dewatering borehole. Photo below

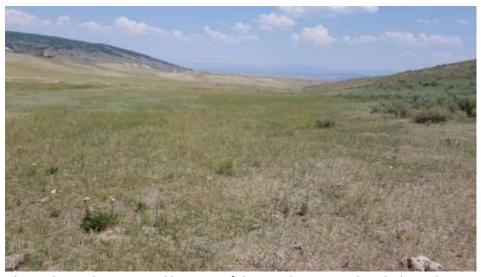
Above shows the proposed location of the 18L dewatering borehole Looking NE

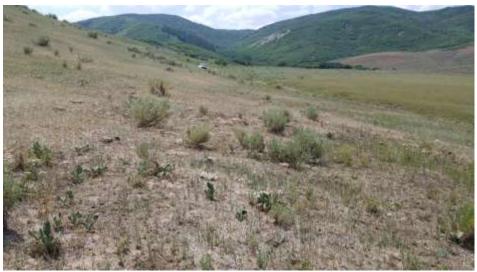
Above shows the proposed location of the 18L dewatering borehole looking SW to proposed access road
