PERMIT INFORMATION

Permit Number: C-1982-056 Mine Name: Foidel Creek Mine Operator: Twentymile Coal, LLC Operator Address: Ms Miranda Kawcak 29515 Routt County Road No. 27 Oak Creek, CO 80467	County: Routt Operation Type: Underground Permit Status: Active Ownership: Private
Operator Representative Present: Miranda Kawcak	
Operator Representative Signature: (Field Issuance Only)

INSPECTION INFORMATION

Inspection Start Date: July 30, 2021 Inspection Start Time: 12:00 Inspection End Date: July 27, 2021 Inspection End Time: 13:00	Inspection Type: Coal Aerial Inspection Inspection Reason: Normal I&E Program Weather: Clear/Smokey
Joint Inspection Agency: None	Joint Inspection Contacts:
Post Inspection Agency: None	Post Inspection Contacts:
Inspector(s): Tabetha Lynch Brock Bowles	Inspector's Signature:

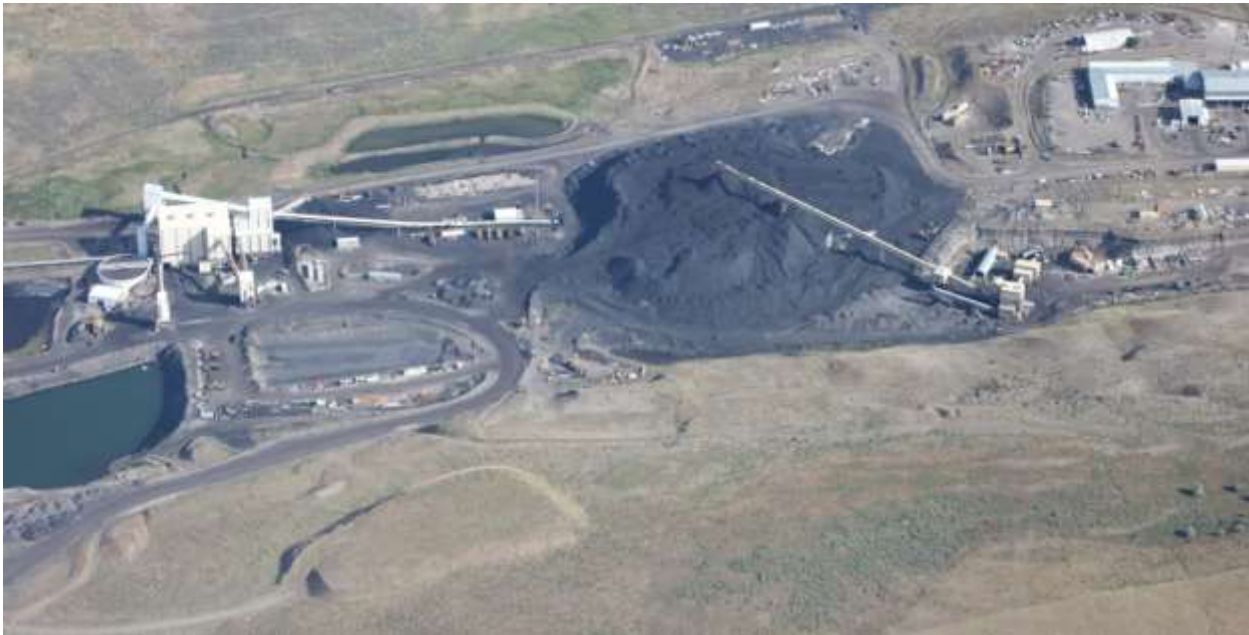
The photo below shows the coal stockpile, wash plant, Pond E at the top middle, and the pit pond and pond D to left. Ponds D and E appear to need to be cleaned out. Top soil pile at the bottom left of the photo appears stable.

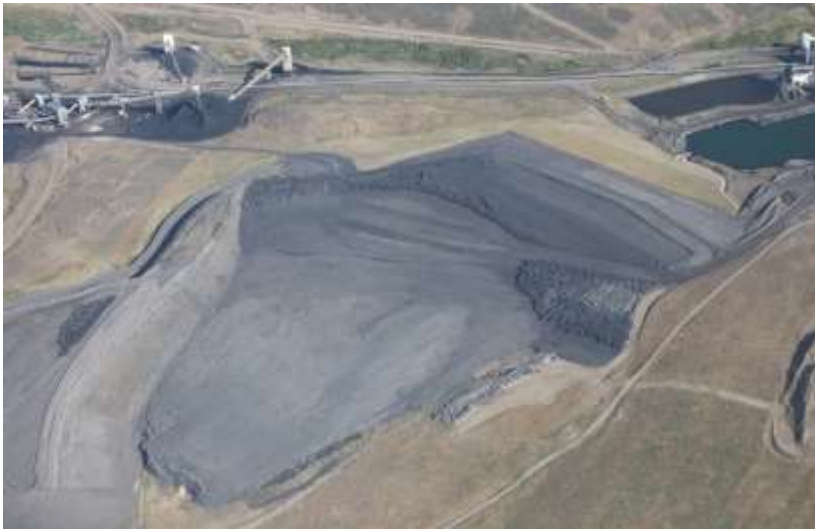
Photo above shows the waste pile, pond D and the pit pond at the top right, pond B at the top left. Ponds B and D appear to need to be cleaned. No issues are noted with the waste pile.

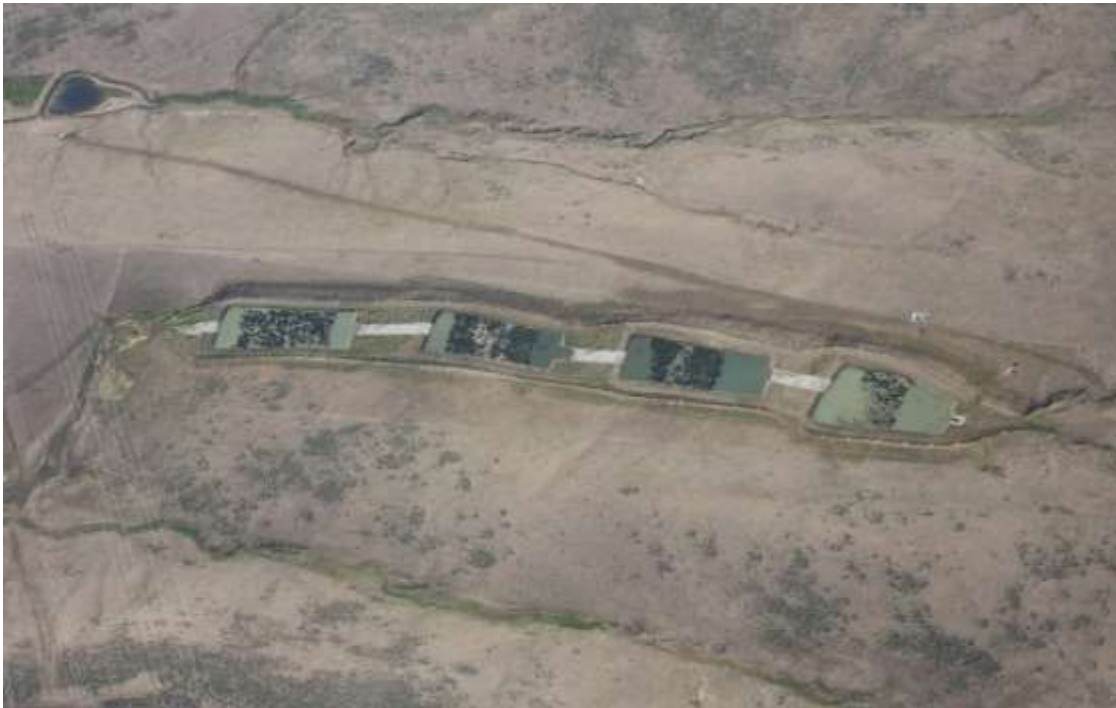
The passive treatment ponds near the 6MN reservoir are shown above. Wetland plants appear to be establishing well. Flow in the photo is from right to left. The system does not appear to be discharging at the time of the photo. Vegetation on the banks around the system appear to be improving. No cattle appear to be present within the fenced area. Slopes and rock check dams in the diversion ditches appear stable.
