**COLORADO**  
Division of Reclamation,  
Mining and Safety  
Department of Natural Resources

<b>Permit Number:</b> C-1992-081 <b>Mine Name:</b> Hayden Gulch Loadout <b>Operator:</b> Hayden Gulch Terminal, LLC <b>Operator Address:</b> Ms Miranda Kawcak  P.O. Box 670 Hayden, CO 81639	<b>County:</b> Routt <b>Operation Type:</b> Loadout <b>Permit Status:</b> Active <b>Ownership:</b> Private  <b>Operator Representative Present:</b>  none
<b>Operator Representative Signature: (Field Issuance Only)</b>

<b>Inspection Start Date:</b> July 28, 2021 <b>Inspection Start Time:</b> 13:30 <b>Inspection End Date:</b> <b>Inspection End Time:</b>		<b>Inspection Type:</b> Coal Partial Inspection <b>Inspection Reason:</b> Normal I&E Program <b>Weather:</b> Clear	
<b>Joint Inspection Agency:</b>  None		<b>Joint Inspection Contacts:</b>  	
<b>Post Inspection Agency:</b>  None		<b>Post Inspection Contacts:</b>  	
<b>Inspector(s):</b>  Tabetha Lynch	<b>Inspector's Signature:</b>

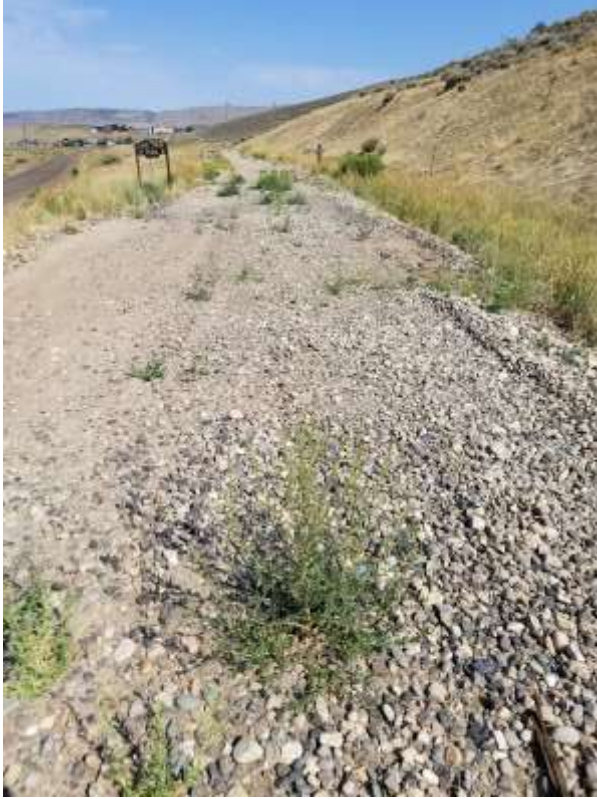
**Weeds were noted in the parking lot and all around the previous rail line, now being used as a community trail. Weed control will need to be mitigated in these areas. Photos below.**

**Weeds on trail shown above.**

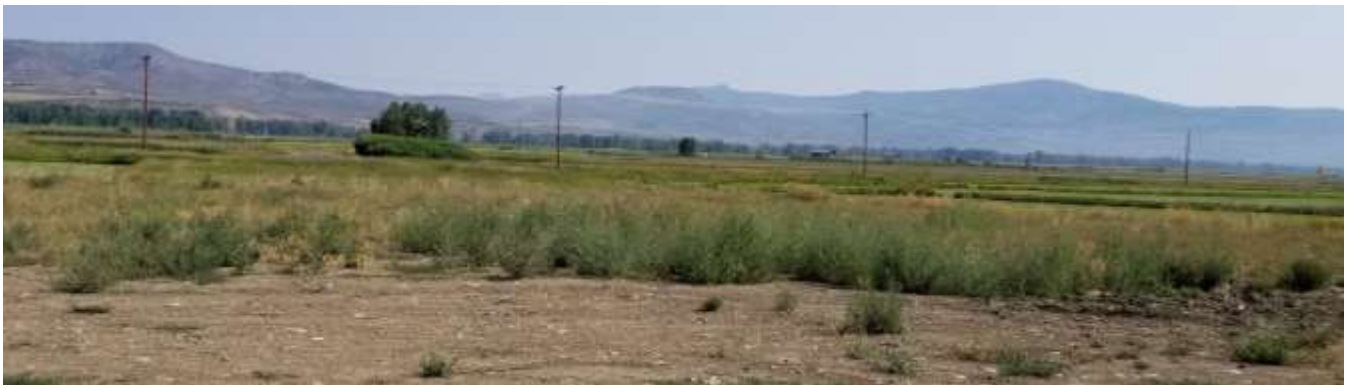
**Weeds in parking lot shown below looking north.**
