COLORADO
Division of Reclamation,
Mining and Safety
Department of Natural Resources

Permit Number: C-1992-081 Mine Name: Hayden Gulch Loadout Operator: Hayden Gulch Terminal, LLC Operator Address: Ms Miranda Kawcak P.O. Box 670 Hayden, CO 81639	County: Routt Operation Type: Loadout Permit Status: Active Ownership: Private Operator Representative Present: none
Operator Representative Signature: (Field Issuance Only)

Inspection Start Date: July 30, 2021 Inspection Start Time: 13:30 Inspection End Date: Inspection End Time:		Inspection Type: Coal Aerial Inspection Reason: Normal I&E Program Weather: Clear/Smokey	
Joint Inspection Agency: None		Joint Inspection Contacts: 	
Post Inspection Agency: None		Post Inspection Contacts: 	
Inspector(s): Tabetha Lynch Brock Bowles	Inspector's Signature:

This was an aerial inspection of the Hayden Gulch Loadout; DRMS Permit No. C-1992-081, operated by Hayden Gulch Terminal, LLC. The photos were taken by Brock Bowles on 7/30 and reviewed by Tabetha Lynch with the Colorado Division of Reclamation, Mining, and Safety (Division).

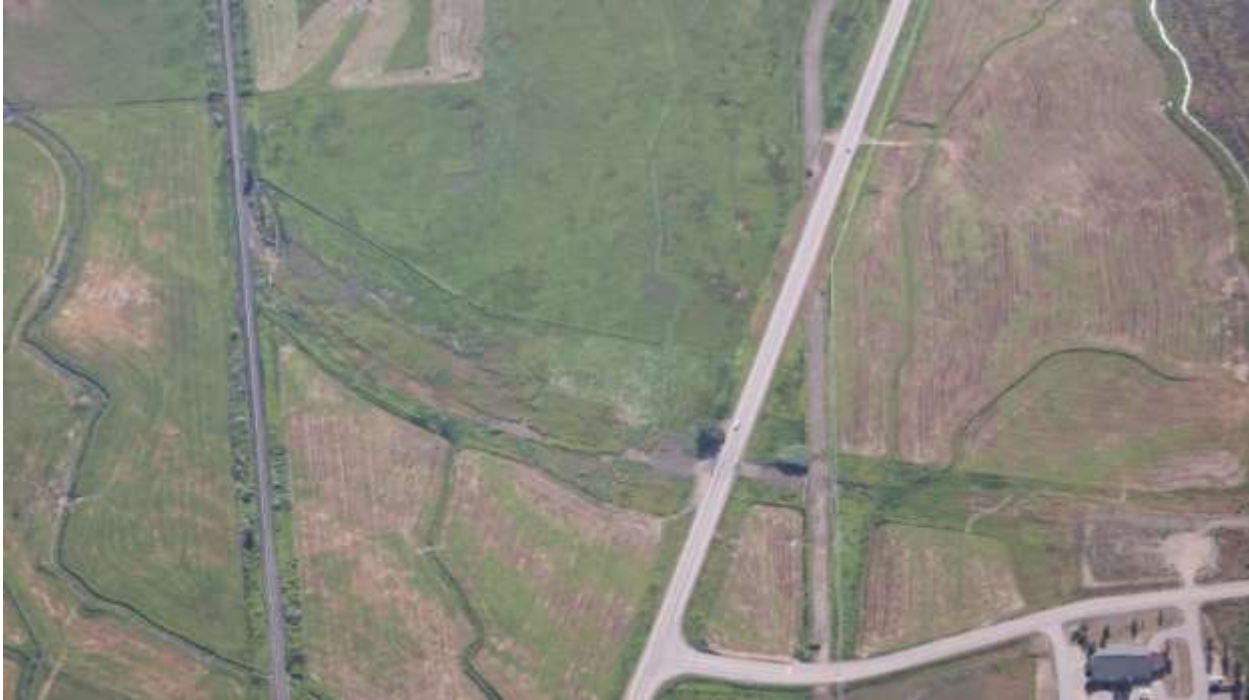
Above shows the reclaim area just north and south of Hwy 40 where the tracks have been removed. North is roughly the left side of the photo and south to the right.

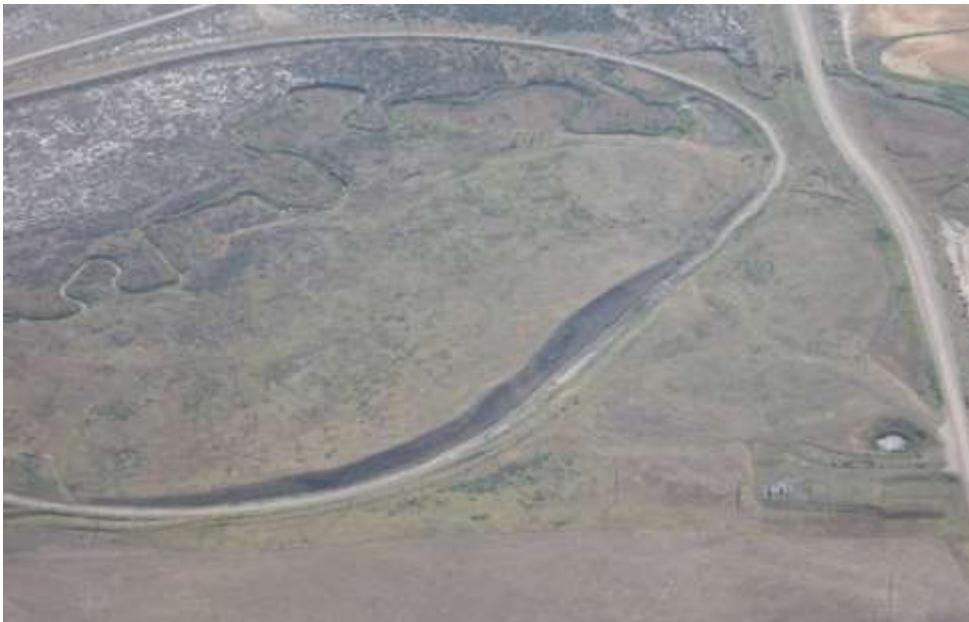
Drainage Control 4.05.1, 4.05.2, 4.05.3; Siltation Structures 4.05.5, 4.05.6; Discharge Structures 4.05.7, 4.05.10; Diversions 4.05.4; Effluent Limits 4.05.2; Ground Water Monitoring 4.05.13; Surface Water Monitoring 4.05.13; Drainage – Acid and Toxic Materials 4.05.8; Impoundments 4.05.6, 4.05.9; Stream Buffer Zones 4.05.18: Ponds are dry.

Shown above are the two dry ponds. Dry creek also appears to be dry.
