**COLORADO**  
Division of Reclamation,  
Mining and Safety  
Department of Natural Resources

| <b>Permit Number:</b> C-1981-041<br><b>Mine Name:</b> Roadside Portals<br><b>Operator:</b> Snowcap Coal Company, Inc.<br><b>Operator Address:</b><br>Ms. Tonya Hammond<br>P.O. Box 1430<br>Palisade, CO 81526 | <b>County:</b> Mesa<br><b>Operation Type:</b> Underground<br><b>Permit Status:</b> Active<br><b>Ownership:</b> Private |

| <b>Inspection Start Date:</b> August 10, 2021<br><b>Inspection Start Time:</b> 10:00<br><b>Inspection End Date:</b> August 10, 2021<br><b>Inspection End Time:</b> 14:00 | | <b>Inspection Type:</b> Coal Partial Inspection<br><b>Inspection Reason:</b> 10 Day Notice Follow-up<br><b>Weather:</b> Clear | |

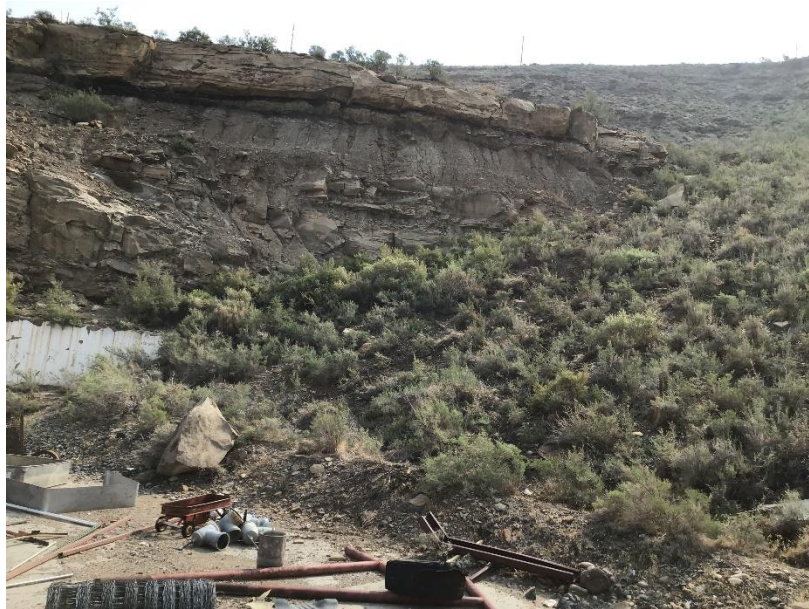
The first location visited was the reclaimed mine portals. The reclaimed mine portals were Phase III released by the Division with the approval of bond release No. 6 (SL-6). The slope of the backfilled portals was stable with vegetative cover (Photo 1). There were no indications or observations of erosional features. Through a Division approved french drain system, any water that potentially would back up behind the portals would be drained to a

diversion ditch. The diversion ditch was dry at the time of the inspection. There were no indications of seepage coming from the reclaimed portals at the time of the inspection.

**Photo 1:** The reclaimed mine portals. No water was observed seeping from the reclaimed slope or flowing out of the French drain.

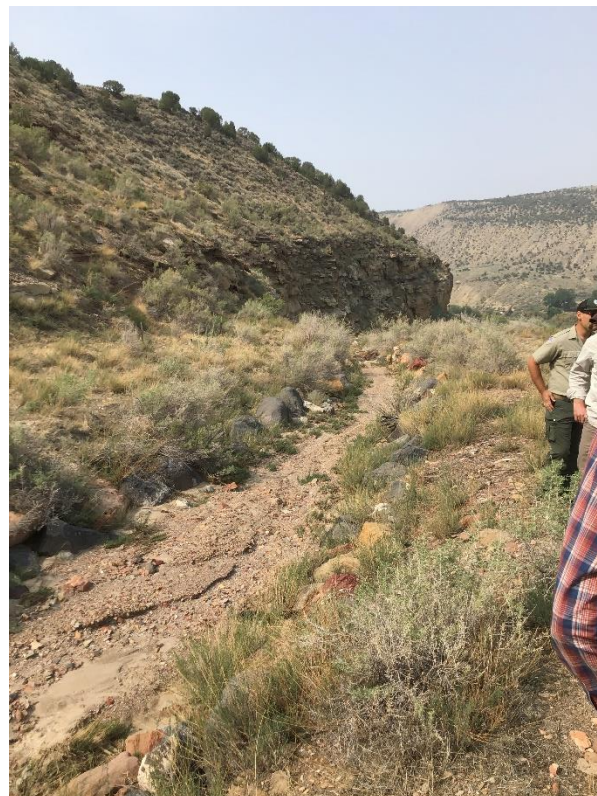
The reclaimed refuse pile located on the south end of the main facilities area was the second stop during the inspection. The top of the pile where the upland diversion ditch is located was where Mr. Fontanari discussed his concern for the stability of the refuse pile. Mr. Fontanari was concerned that the application of water on Tract 71 could contribute more water to the diversion ditch and affect its operational capacity, thus impacting the stability of the reclaimed refuse pile.

The last reclaimed portions of the refuse pile were Phase III released with bond release No. 6 (SL-6) and the ditch was Phase III released with bond release No. 8 (SL-8). The upland diversion ditch was designed to handle flows of 8.83 cfs during a 100 yr 24 hour storm event (Appendix 14-6) at the time of the full Phase III bond release. The diversion ditch was dry at the time of the inspection (Photo 2). There were no indications or observations of downcutting or erosion of the reclaimed refuse pile embankments. There were no observed blockages in the diversion ditch. The reclaimed refuse pile was vegetated and stable. There were no erosional features identified or observed on the reclaimed refuse pile.

**Photo 2:** The upland diversion ditch for the reclaimed refuse pile.

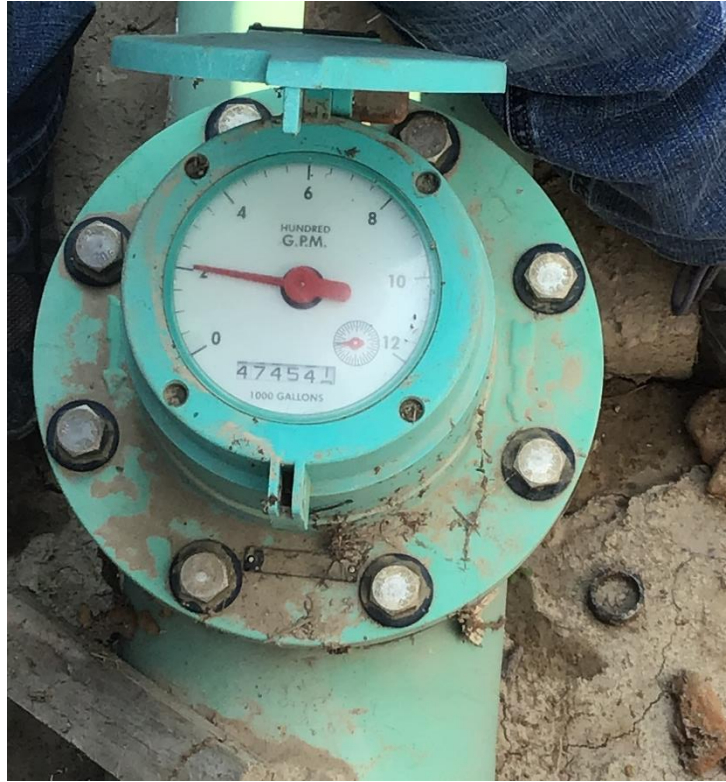
The gauge located on the outlet of 016 was inspected (Photo 3). The flow was recorded by the gauge at ~200 gpm. The gauge was fluctuating between numeric readings between 100 and 275 gpm and a recalibration of the guage may be required. As a maintenance note, the Division will require SCC to ensure that the guage is functioning as designed and recalibrated by the next on the ground coal regulatory inspection.

**Photo 3:** The gauge for the 016 discharge monitoring point.

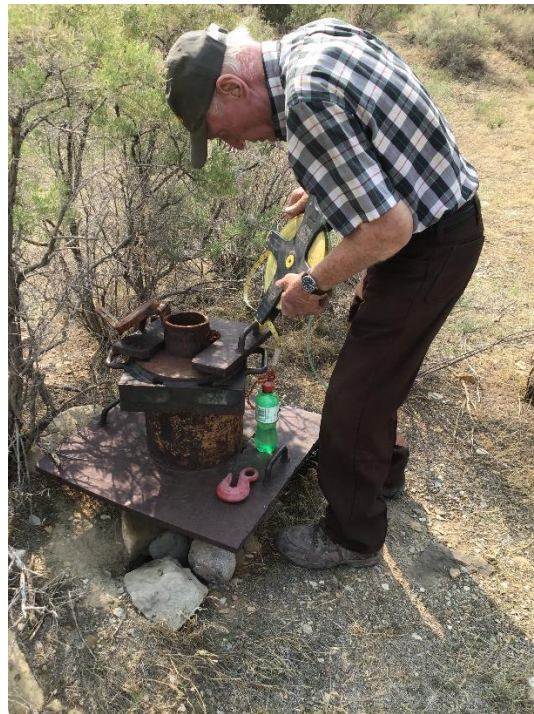
The N1 well was the fourth stop of the inspection. The N1 well is utilized by SCC to determine the depth to water in the abandoned mine workings. Mr. Fontanari expressed concern about what the water level in the mine is. Mr. Fontanari used a 100' tape and a plastic water bottle as a measuring device to record the level of the water in the well (Photo 4). Fontanari's measurement was 76 feet from the well casing to the top of the water level. Tonya Hammond of SCC brought a Solinst Model 101 water level meter (Photo 5). Her device recorded the level of the water to be at 75.4 feet in the well.

**Photo 4:**Mr. Fontanari using his measuring device at the N1 well.

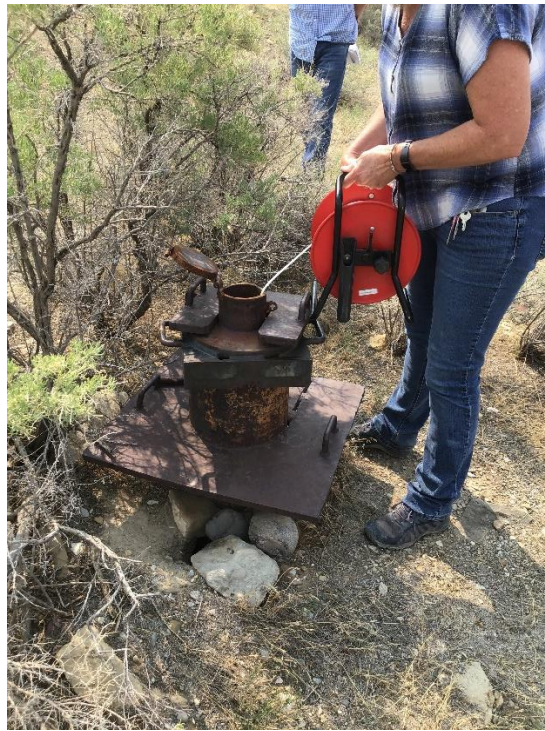
**Photo 5:** Tonya Hammond using a Solinst Model 101 water level meter at the N1 Well.

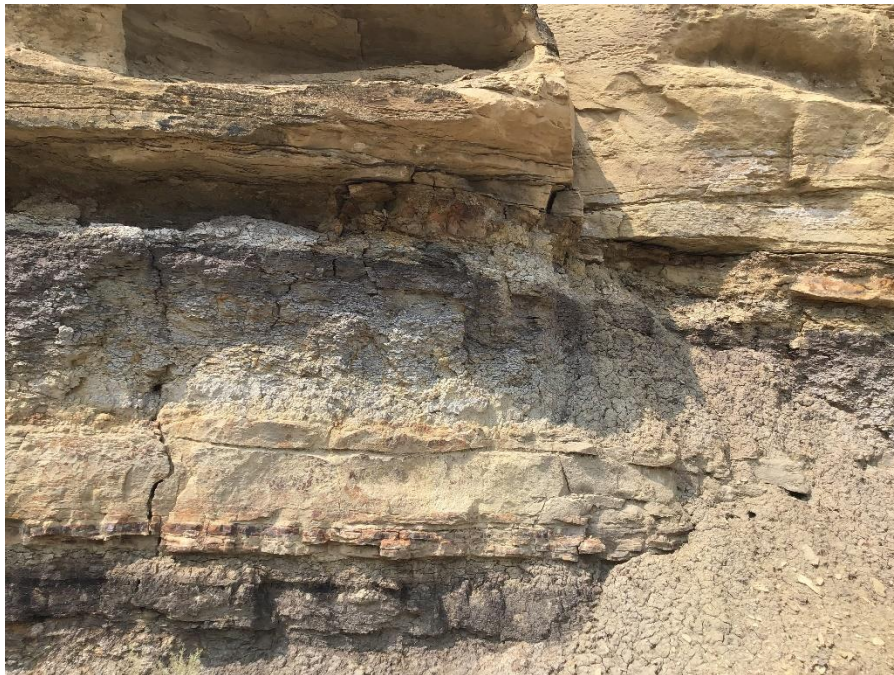
This location was along the access road leading up to Tract 70 from the North Decline. The location was a road cut that exposes a stratigraphic profile from the top of the Tract to the access road (~15'). The exposed stratigraphic profile illustrated an outcrop of sandstone with an overburden of colluvial material. Mr. Fontanari wanted to point out the cracks and fractures in the face of the outcrop (Photo 6). Mr. Fontanari stated that he believes these cracks and fractures in the face of the outcrop were created due to subsidence from mining. Mr. Fontanari claimed that he frequently has to pick up rock fall on this portion of the access road, further stating that he believes the rocks fall due to subsidence activity from mining.

**Photo 6:** The outcrop along the access road up the North Decline.

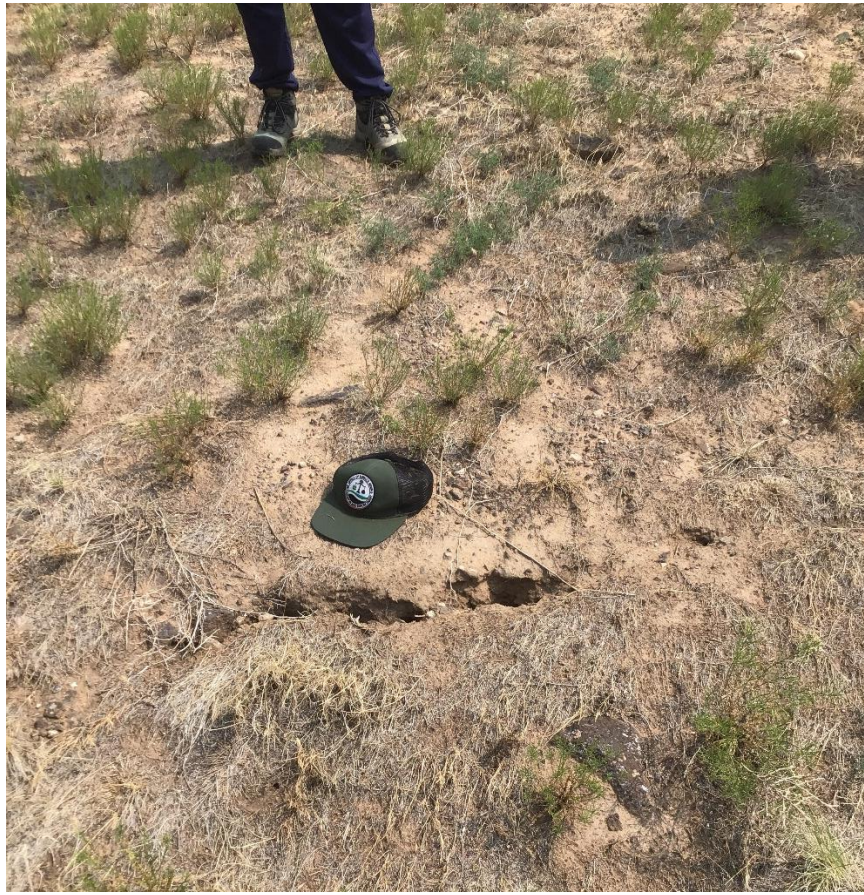
The inspection group stopped on top of the northern portion of the Tract 70 Mesa. Mr. Fontanari pointed out a feature on the west side of the access road. The feature was approximately three feet in length, a couple of inches wide and a couple of inches deep (Photo 7). Mr. Fontanari stated to the Division that he believes this feature to be a surface crack developed from mine subsidence. The feature was observed to generally be trending in an east/west direction. The feature did not appear to be a component of a larger feature. No other linear surface

feature was observed directly east or west of this location. The area of location #6 was Phase III released with the approval of bond release SL-11. The area is within the permit boundary

**Photo 7:** The feature Mr. Fontanari pointed out to the inspection party on top of the north end of the Tract 70 Mesa. A hat was used for scale.

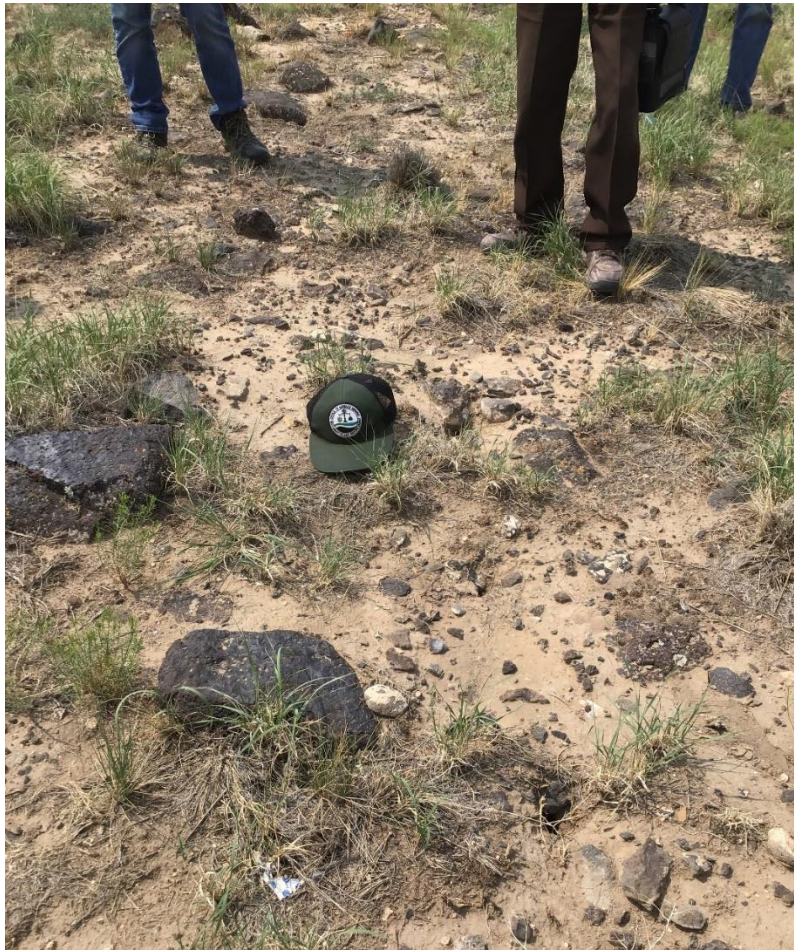
Mr. Fontanari continued to the northern point of the Tract 70 Mesa. Mr. Fontanari expressed his concern for the stability of the outcrop. In July 2019, the outcrop expressed a large amount of water initiated from trenches constructed by Mr. Fontanari. The outcrop sloughed in sections along the northern face. The large amount of water applied by Fontanari initiated a rock fall event directly above and onto Colorado Interstate 70 (I-70). Mr. Fontanari expressed his opinion to the Division that he believed that mine subsidence had created cracks in the sandstone bedrock. Fontanari noted that he believes these cracks allowed water to weaken the face of the outcrop causing the rockfall. The sandstone layer in this outcrop is the same as the one inspected at Location #5. There was no water expressed from the face of the outcrop above I-70 during this inspection. Mr. Fontanari pointed out a small feature in this location. The feature appeared to be weathered (Photo 8). This location is within the area Phase III released with SL-11, however the location is within the permit boundary.

**Photo 8:** The feature identified by Mr. Fontanari at the northern point of the Tract 70 Mesa. A hat was placed to the left of the feature for scale.

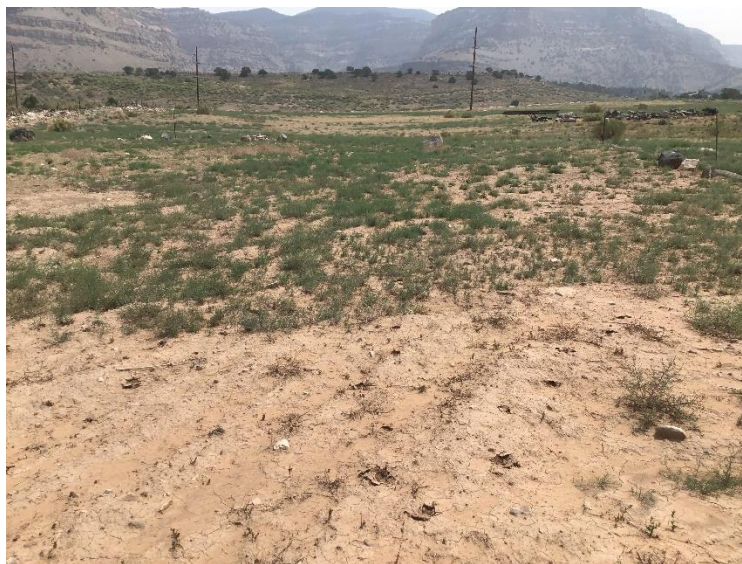
The inspection party stopped at the location of the TR-69 repair area. The site was repaired by SCC in accordance with the plan outlined in TR-69. The site was backfilled and graded to the approximate original contour. The disturbed area was reseeded with the approved seed mix from the Permit Application Package. Mr. Fontanari told the inspection party his concerns of the potential for mine subsidence on Tract 71 to create pathways to the “mine void.” The depth from the surface to the underground workings is approximately 100 feet in the area surrounding TR69. Mr. Fontanari spent time explaining his concern about the danger of water applied to this area finding its way into the workings, thus filling the “mine void” with water potentially causing another situation similar to that which happened in 2014. The 2014 event led to the discovery of the vent shaft and initiated the process that resulted in the approved TR-69 repair. The boundary of the area disturbed by the TR-69 activities is marked with metal T posts and a mine identification marker. The site was stable with vegetative cover (Photo 9). There were no indications of erosional features. During the traverse across the reclaimed area, a small animal burrow was discovered at the south east corner (Photo 10). Tailings at the entrance to the burrow were noted.

**Photo 9:** The TR-69 repair area, the photo was taken looking to the east.

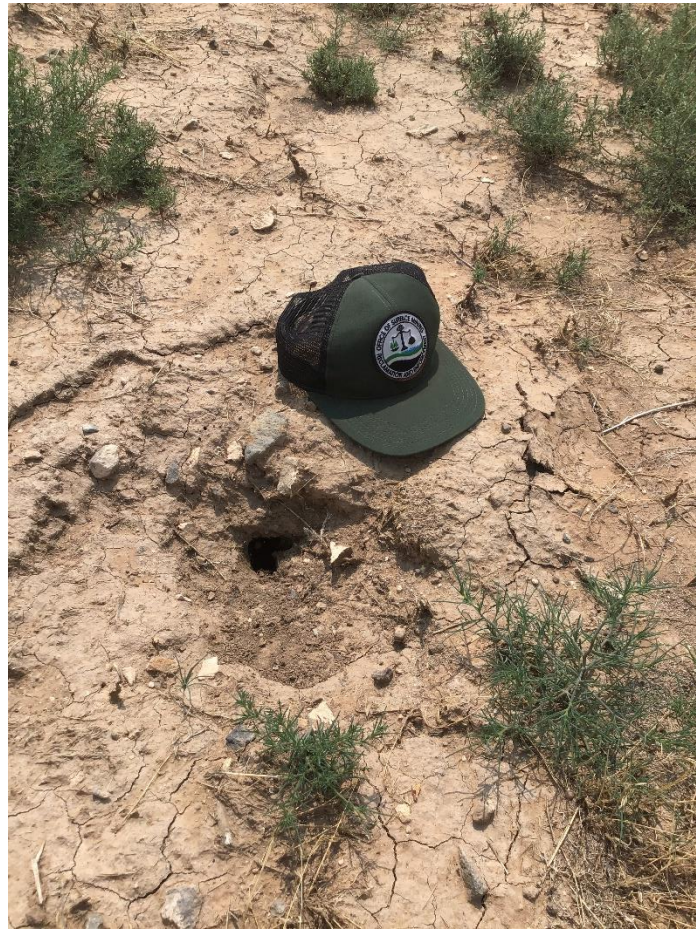
**Photo 10:** The burrow located in the southeast corner of the TR-69 repair area. A hat was used for scale.
