MINERALS PROGRAM INSPECTION REPORT PHONE: (303) 866-3567

MINE NAME: Mitchell Mine No 1	MINE/PROSPECTING ID#: M-1986-025	MINERAL: Sand and gravel	COUNTY: El Paso
INSPECTION TYPE: Surety Release Inspection	INSPECTOR(S): Timothy Cazier, P.E.	INSP. DATE: August 3, 2021	INSP. TIME: 10:45
OPERATOR: R E Monks Construction Co.	OPERATOR REPRESENTATIVE: Leroy Garcia	TYPE OF OPERATION: 110c - Construction Limited Impact

REASON FOR INSPECTION: Surety Release Requested	BOND CALCULATION TYPE: Partial Bond	BOND AMOUNT: \$11,500.00
DATE OF COMPLAINT: NA	POST INSP. CONTACTS: None	JOINT INSP. AGENCY: None
WEATHER: Clear	INSPECTOR'S SIGNATURE:

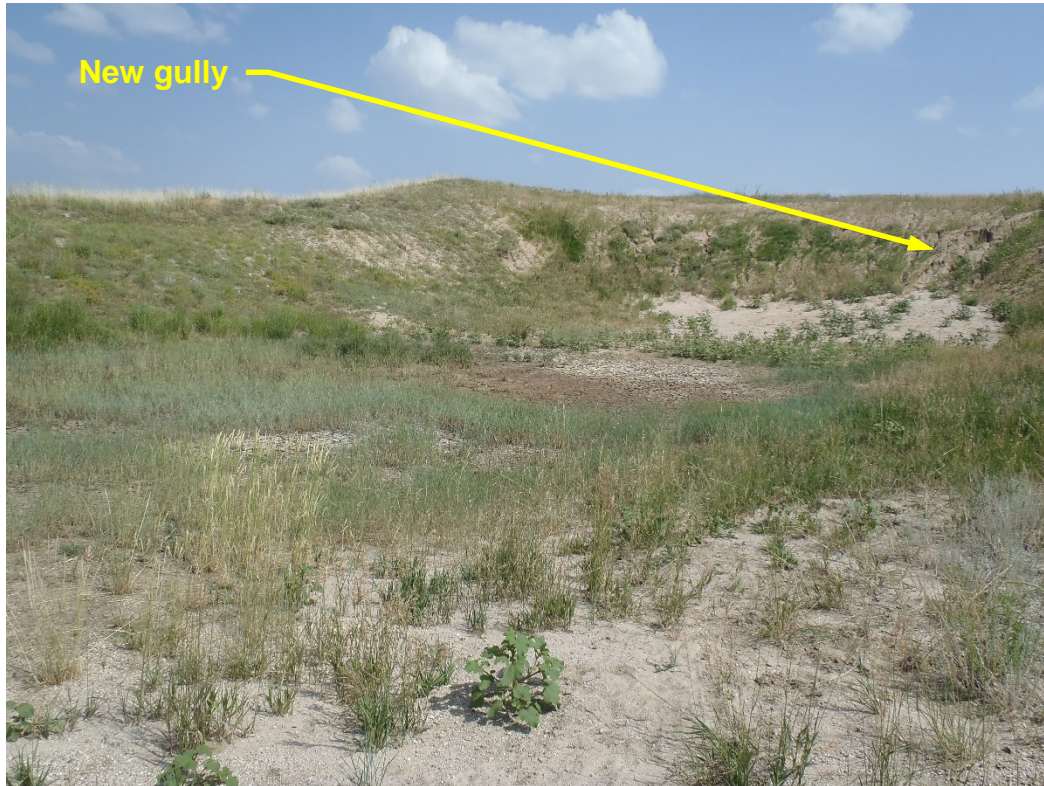
Reclamation Success: The majority of the repair work completed after last year's inspection is good (see **Photo 1**). However, a new significant erosion gully was observed (discussed below). It appears the furrowing above the crest of the slope (see **Photo 2**) was deep enough to allow temporary ponding of stormwater runoff, which eventually, probably during a heavy rainstorm, overtopped the furrows, eroding the furrow nearest the crest, and releasing the impounded water, resulting in the new gully. As this appears to be the case, the best way to avoid a recurrence is to divert runoff away from the crest of the highwall. A diversion directing runoff to the small natural drainage to the northwest (see **Photo 3**) may be the most practical. The DRMS recommends consulting a stormwater specialist prior to proceeding with a new repair.

Photo 1. Repaired and revegetated highwall (looking north).

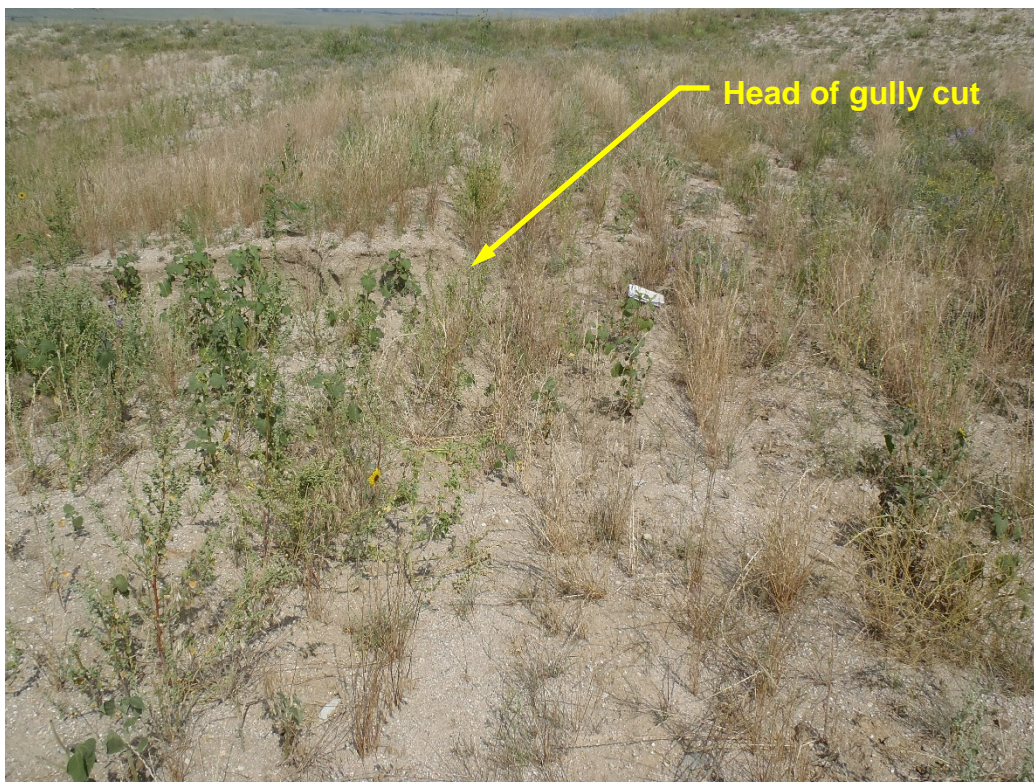
Photo 2. Deep furrows above crest (looking NW).

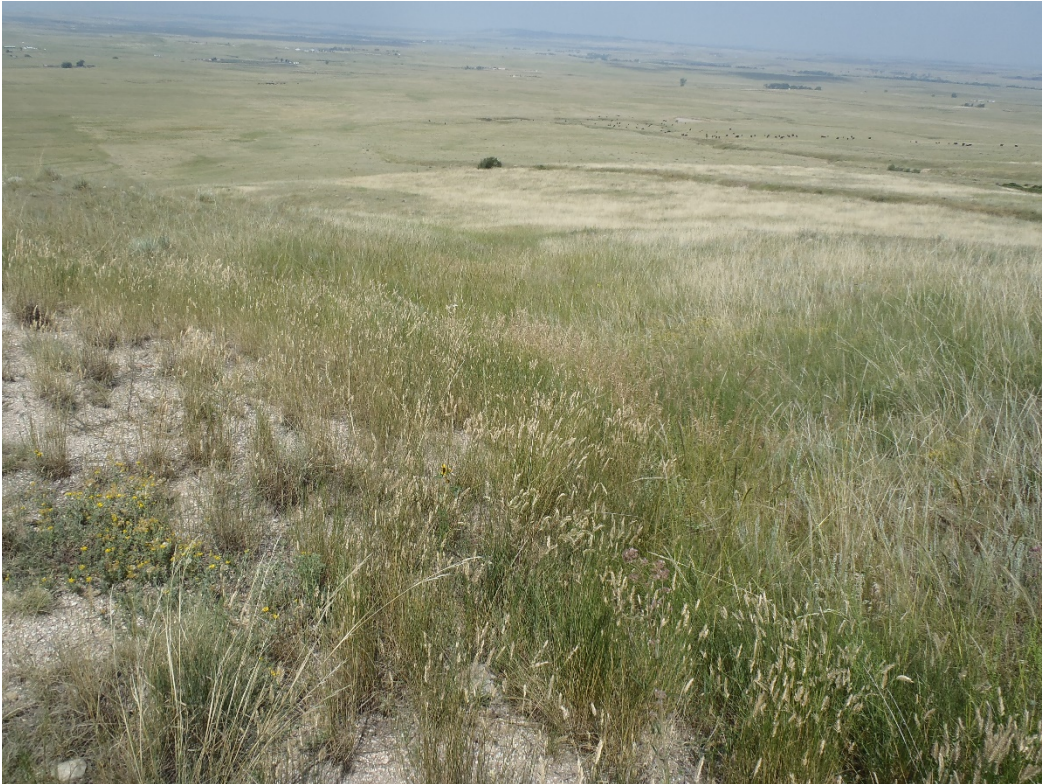
Photo 3. Small natural drainage to the northwest of highwall crest (looking NW).

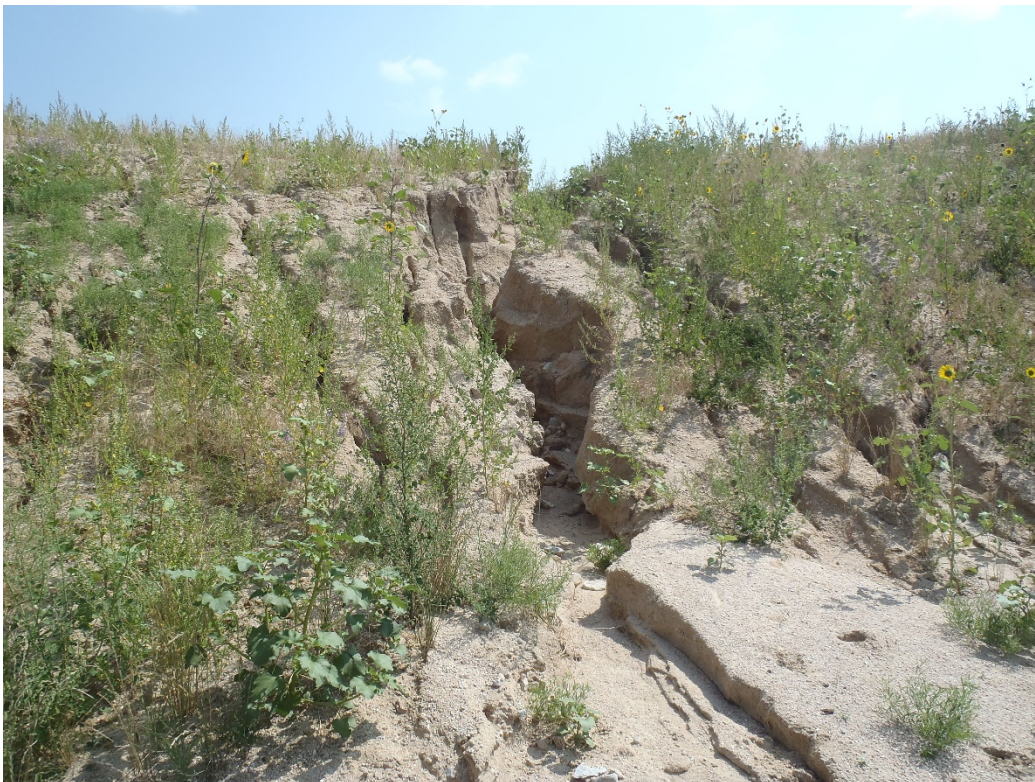
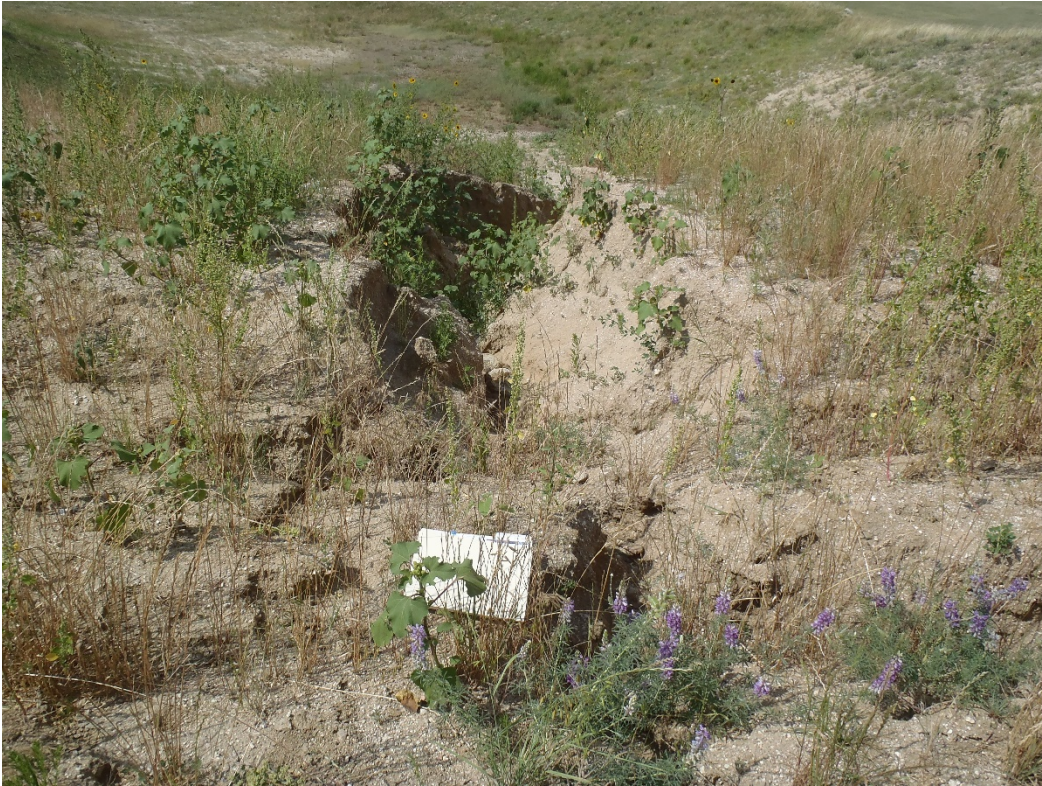
PROBLEM/POSSIBLE VIOLATION: Problem: A large erosion gully was observed on-site. This is a problem at this time for failure to protect the affected land from erosion pursuant to C.R.S. 34-32.5-116 (4) (j).

Sediment Control: A significant erosion gully (estimated to be 4 to 5 feet at its deepest section) was observed in approximately the same location as the larger gully observed last year (see **Photos 4 and 5**). **The gully is cited as a problem on page 1 of this report** and is the reason the DRMS cannot approve the surety release request at this time. See Reclamation Success above for recommendations.

Photo 4. Observed erosion gully from highwall toe (looking NE).

Photo 5. Observed erosion gully from highwall crest (looking SW).

CORRECTIVE ACTIONS: The operator shall provide photo documentation to the Division verifying the erosion gully has been repaired, and that the site has have been reconstructed and stabilized to prevent erosion damage by the corrective action date.
