Adequacy Review No. 2, TR-2, Sheep Mtn. Ranch, M2017-022

RE: Reclamation of Sheep Mountain Ranch, Permit M2017-022

Sheep Mountain Ranch Site Photographs

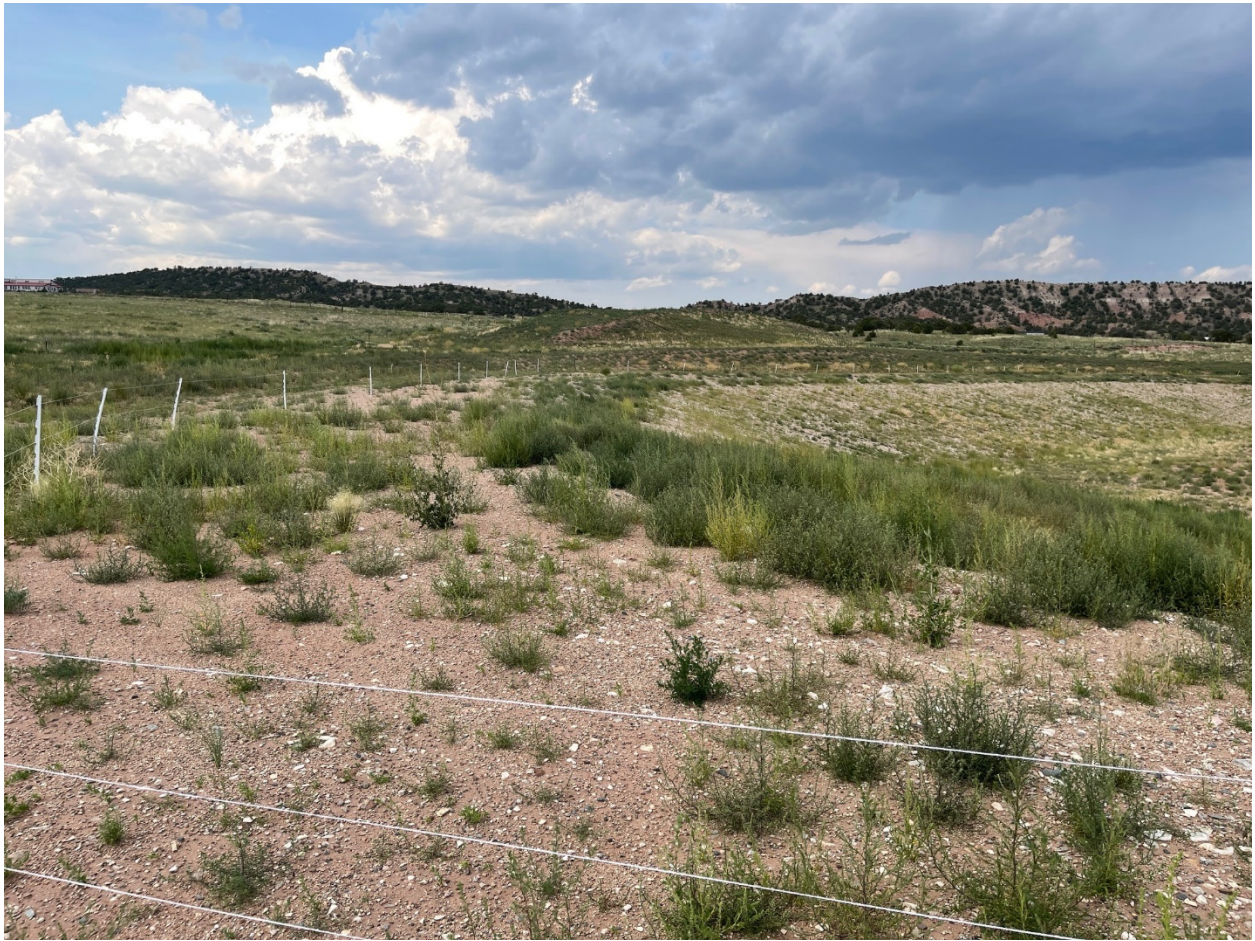
9. View of W Dam Embankment Road and N Towards Topsoil Stockpile and CR 550

We request a Technical Revision to the Reclamation Plan to include the pile of leftover topsoil west of the reservoir. The attached map indicates the location of the topsoil pile that will remain in place and be rounded off and revegetated.

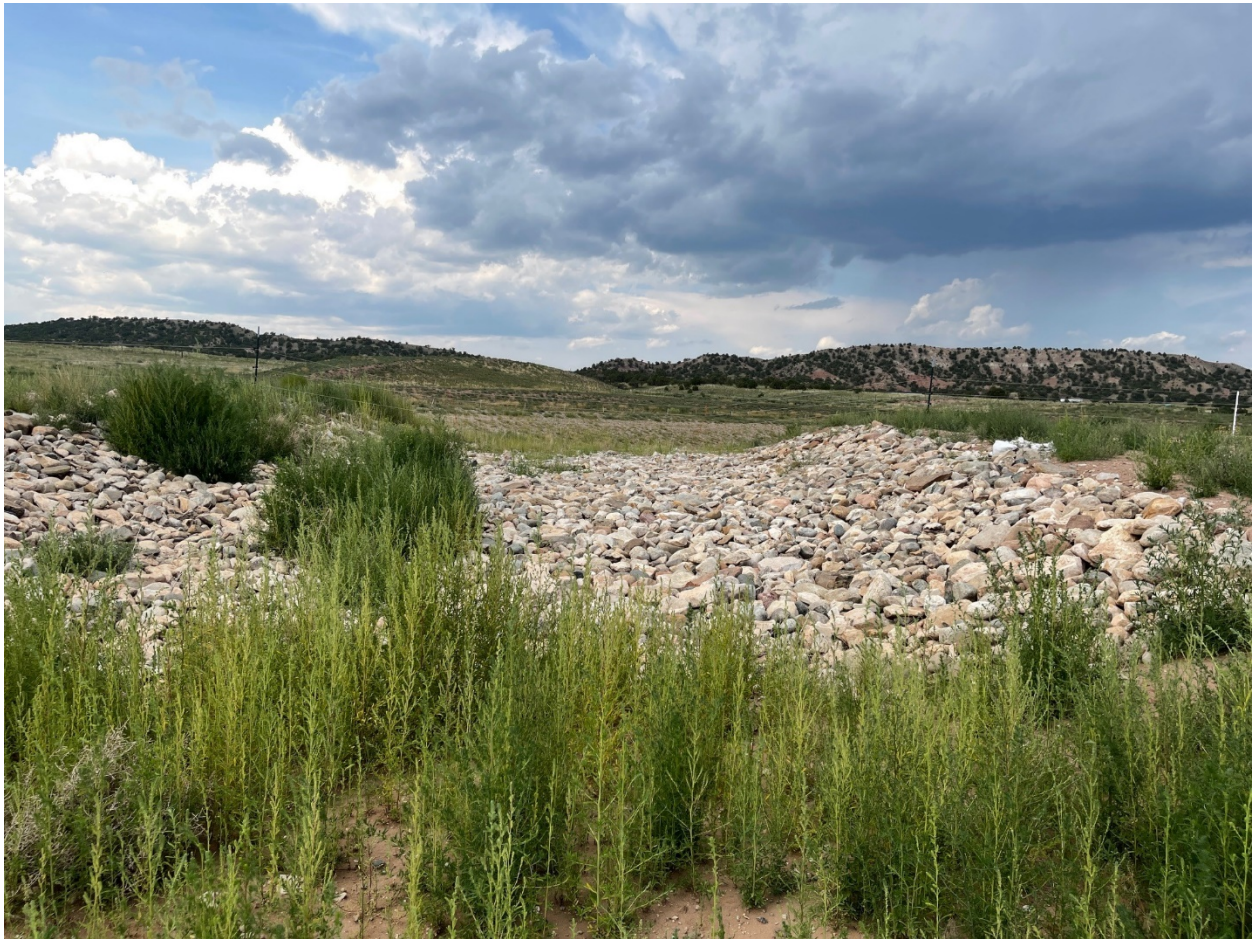
10. In Spillway Looking N Over Reservoir and Topsoil Stockpile

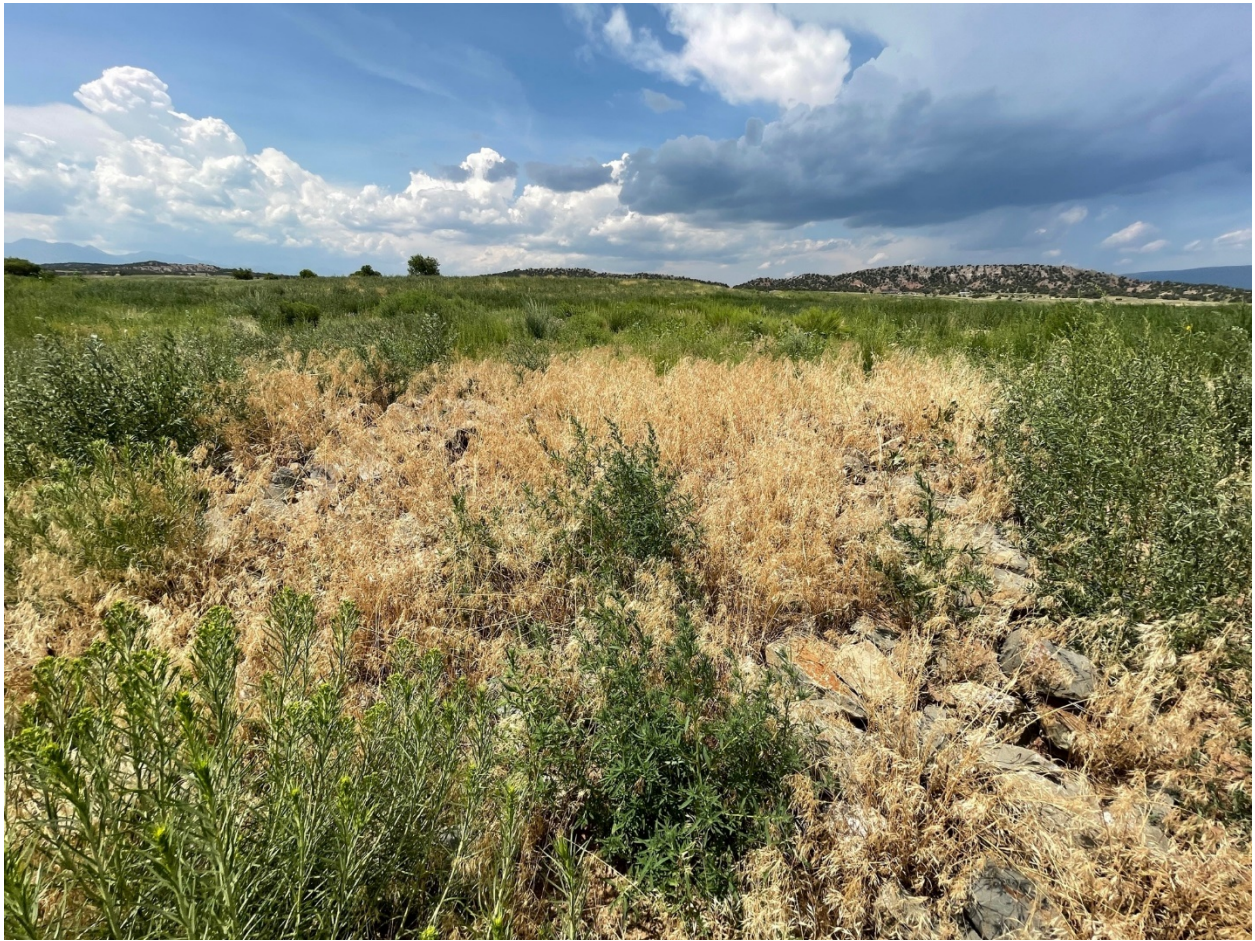
14. From Water Retention Pond Looking North

Attached is an updated map for TR-2 and the photograph appendix from the TR-2 application. From appendix photo no. 14 and aerial imagery, it appears the outfall rip rap for the irrigation pipe is outside of the permit boundary, emptying into a small retention pond south of the permit site. This has been indicated on the map.
