To: Jerald Schnabel
Continental Materials Corp.
File: July 2021 Monitoring Summary

From: Paul Kos
Denver, CO 80222
Date: August 31, 2021

Reference: July 2021 Geotechnical Monitoring Summary Pikeview Quarry

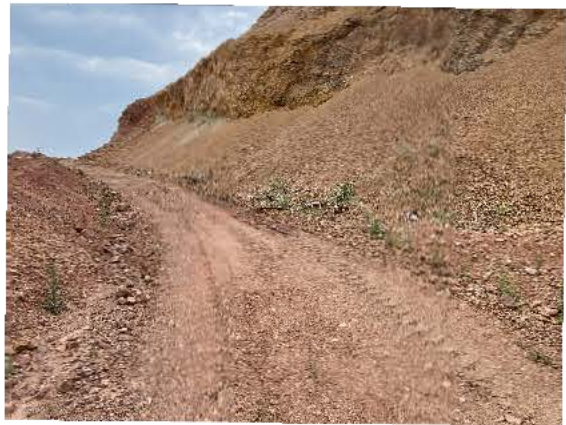
- Seepage continues on the steep slopes of the middle peak, and in some of the haul roads along the uppermost slopes. The flow is from granitic rocks and occurs near the fault line (Photo 6),

6. SEEPAGE ALONG HAUL ROADS

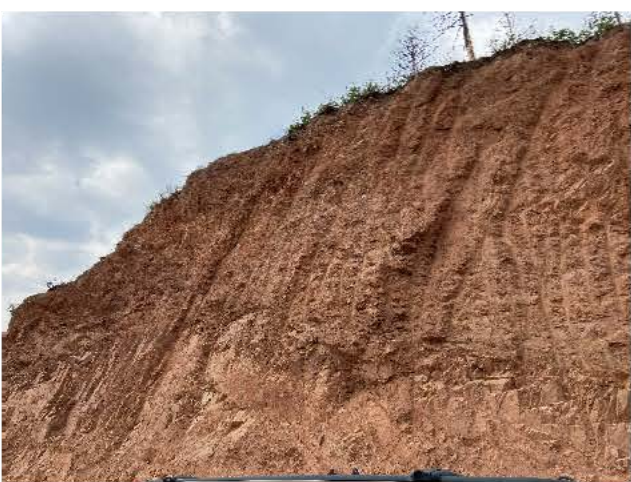
5. VIEW OF SOUTH PEAK FROM HAUL ROAD

NOTE 1:
NO CRACKS

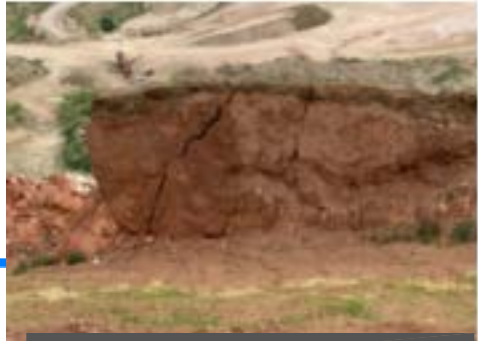
4. LARGE BOULDER WEATHERING

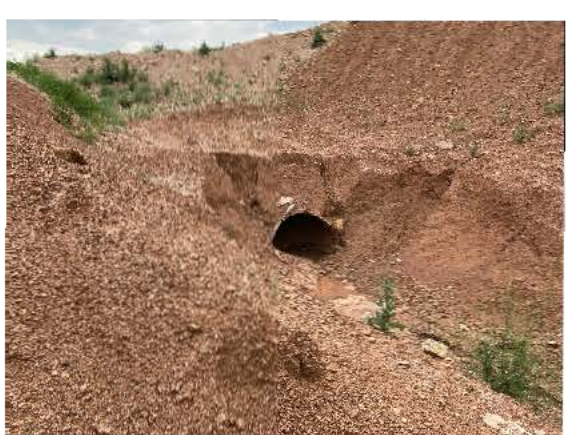
- The culvert remains cleared but mostly blocked inside. CMC has partially cleared the culvert, but access constraints, support columns inside the culvert, and the volume of sediment in the culvert have limited the sediment removal. CMC inspects the culvert for ponded water following rain events, and should any water be observed, it will be removed using pumps. To date, no ponding has been observed (Photo 3).

3. UPSTREAM END OF THE CULVERT

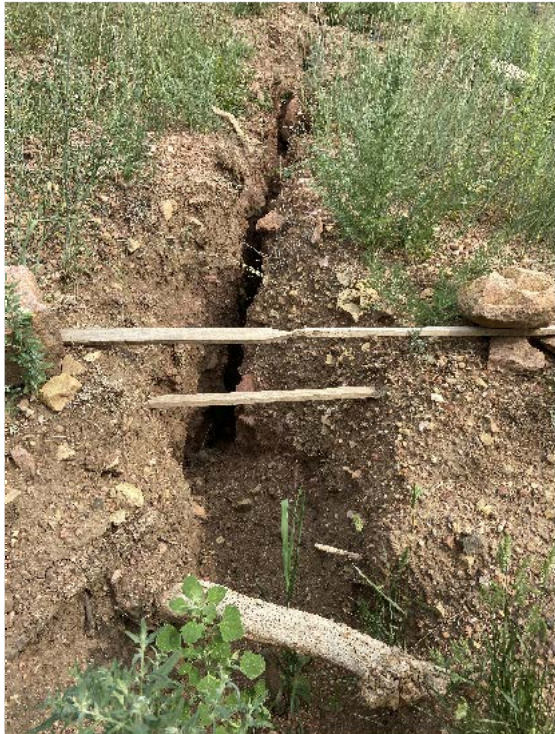
- Survey stakes were placed across a historic crack on the slope above and south of the landslide area to track any changes over the coming months. (Photo 7).

7. PICKETS AROUND ONE OF THE CRACKS

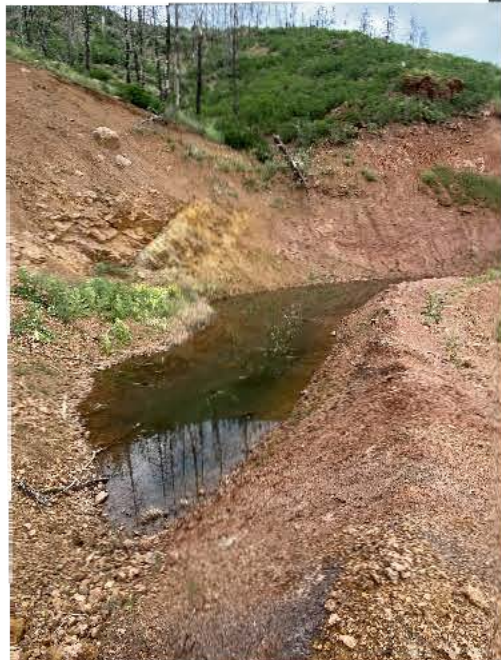
- The Pond below the Middle Peak remains partially filled and there are plans for a notch to be added to the pond's berm to keep the water level from exceeding a specific level (Photo 2).

2. POND BELOW MIDDLE PEAK

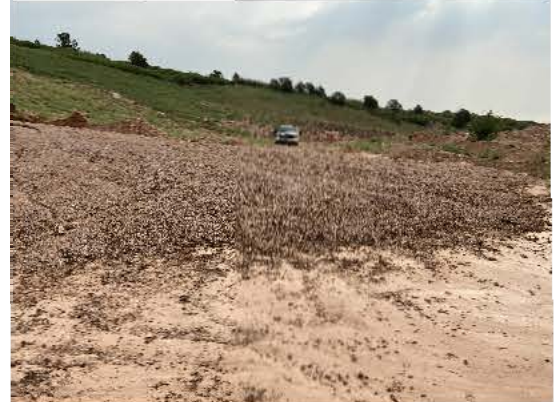
- Eroded material has collected below the culvert. (Photo 8).

8. ERODED MATERIAL BELOW CULVERT

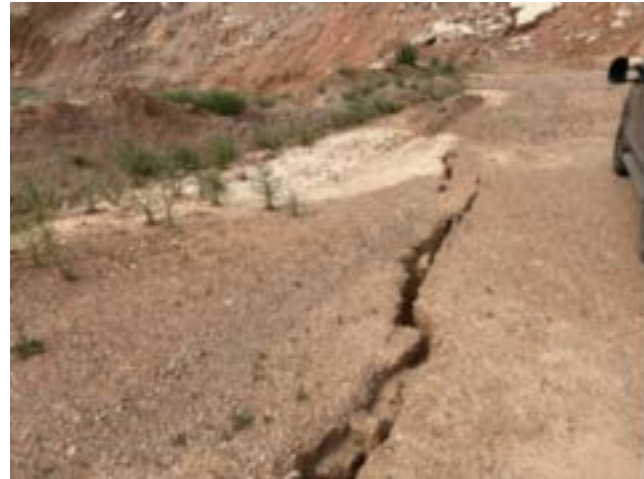
Previously Observed Cracks: Previously observed tension cracks remain on the production floor and at the crest of fill slopes. These cracks were observed following the period of heavy rain. The cracks are not believed to be a problem, they are likely due to the recent heavy rain saturating the area (Photos 1, and 4).

1. RECENT CRACKS ON PRODUCTION FLOOR AFTER RAIN

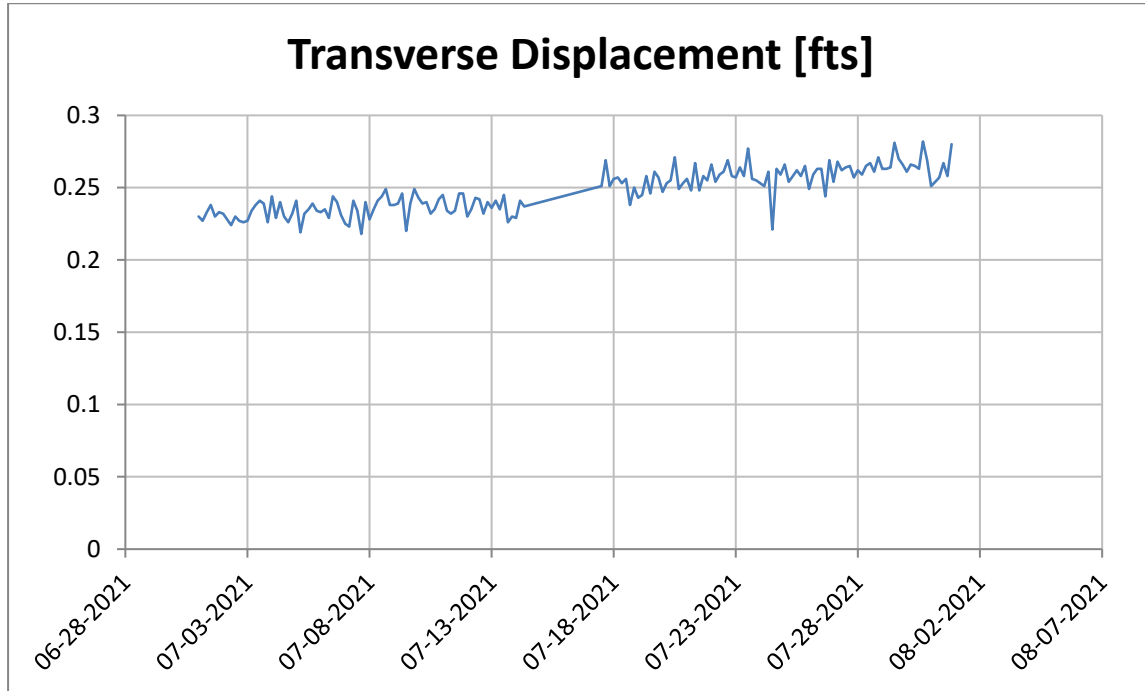
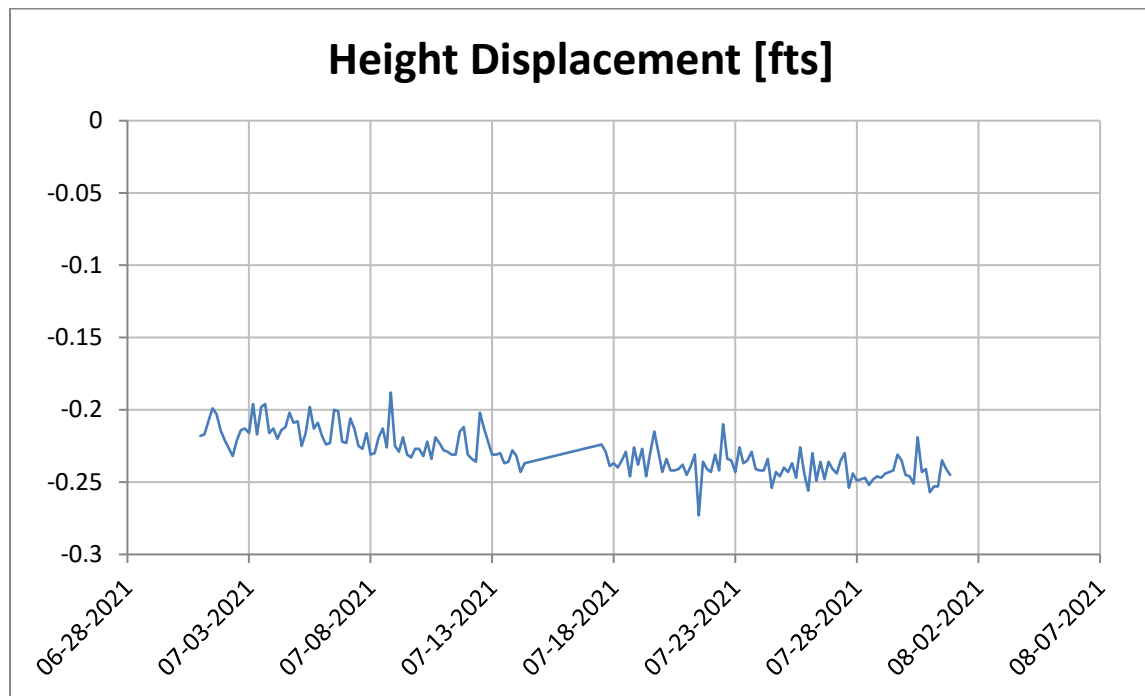
1. Survey accuracy is ± 0.016 feet.
2. Alarm threshold is ± 0.35 feet.
3. Transverse displacement is in the horizontal direction. Positive direction means closer to the robotic station.
4. Height displacement is in the vertical direction. Positive direction means higher in elevation.
5. Prism NP1 is located above loose fill. This prism recorded slope creep movements at slow velocity.

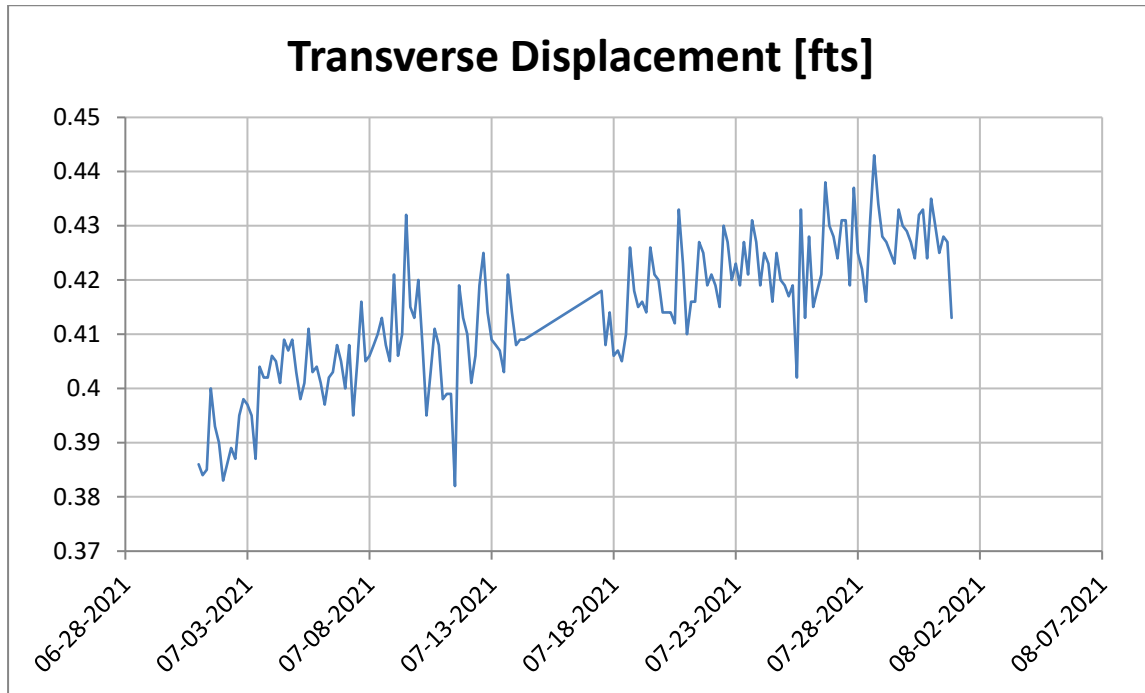
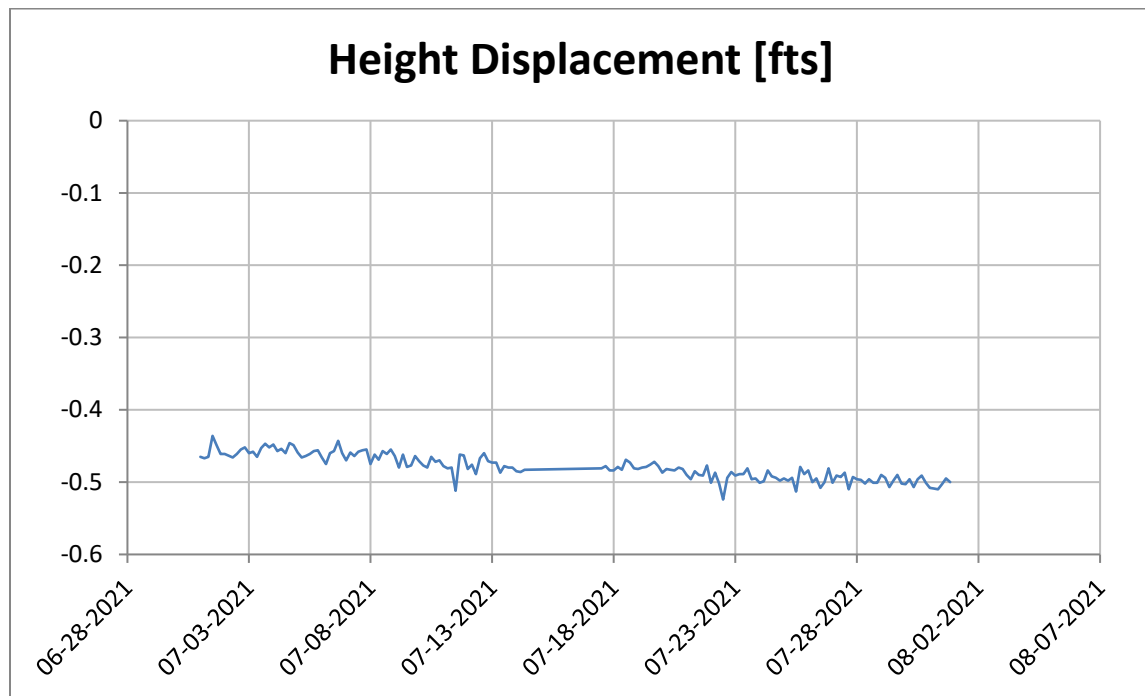
1. Survey accuracy is ± 0.016 feet.
2. Alarm threshold is ± 0.35 feet.
3. Transverse displacement is in the horizontal direction. Positive direction means closer to the robotic station.
4. Height displacement is in the vertical direction. Positive direction means higher in elevation.
5. Prism NP66 is located above the landslide. This prism recorded slope creep movements at slow velocity.

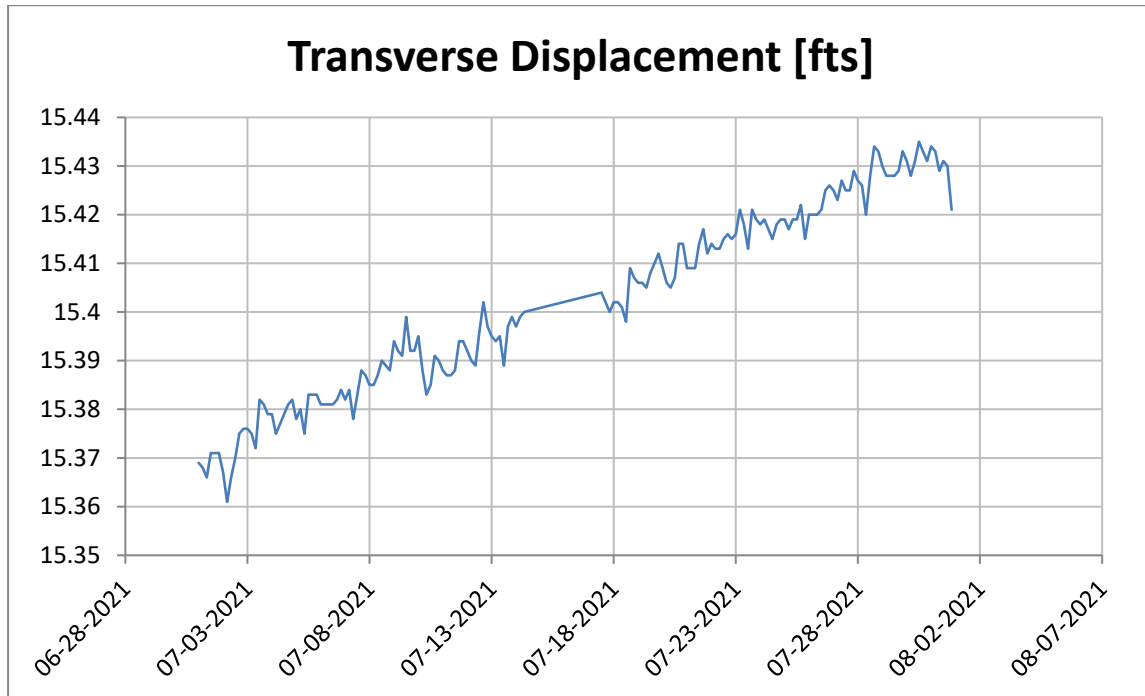
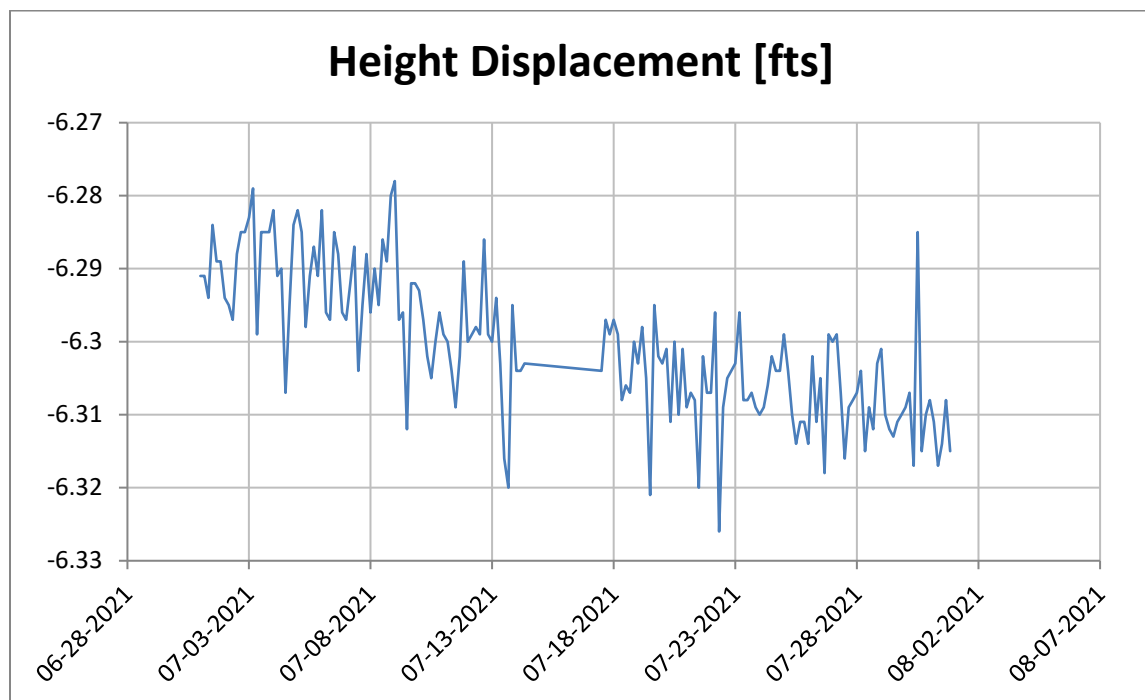
The data show stable conditions with no movement for 15 of 20 prisms with recorded displacements limited to data scatter and not actual movements. Prisms P63, TOE2, and TOE3 are located at the toe of the landslide, and these locations showed slope creep movements at slow velocities (approximately 0.001 feet per day or less). Prism NP1 is located above loose fill, and this prism recorded slope creep movements at slow velocity. Prism NP66 is located above the landslide, and this prism also recorded slope creep movements at slow velocity. This settlement is likely related to the increased moisture causing the landslide material to consolidate. Plots of the transverse and height displacements for each prism are included in Appendix B.

1. Survey accuracy is ± 0.016 feet.
2. Alarm threshold is ± 0.35 feet.
3. Transverse displacement is in the horizontal direction. Positive direction means closer to the robotic station.
4. Height displacement is in the vertical direction. Positive direction means higher in elevation.
5. Prism P63 is located at the toe of the landslide. This location showed slope creep movements at slow velocities.

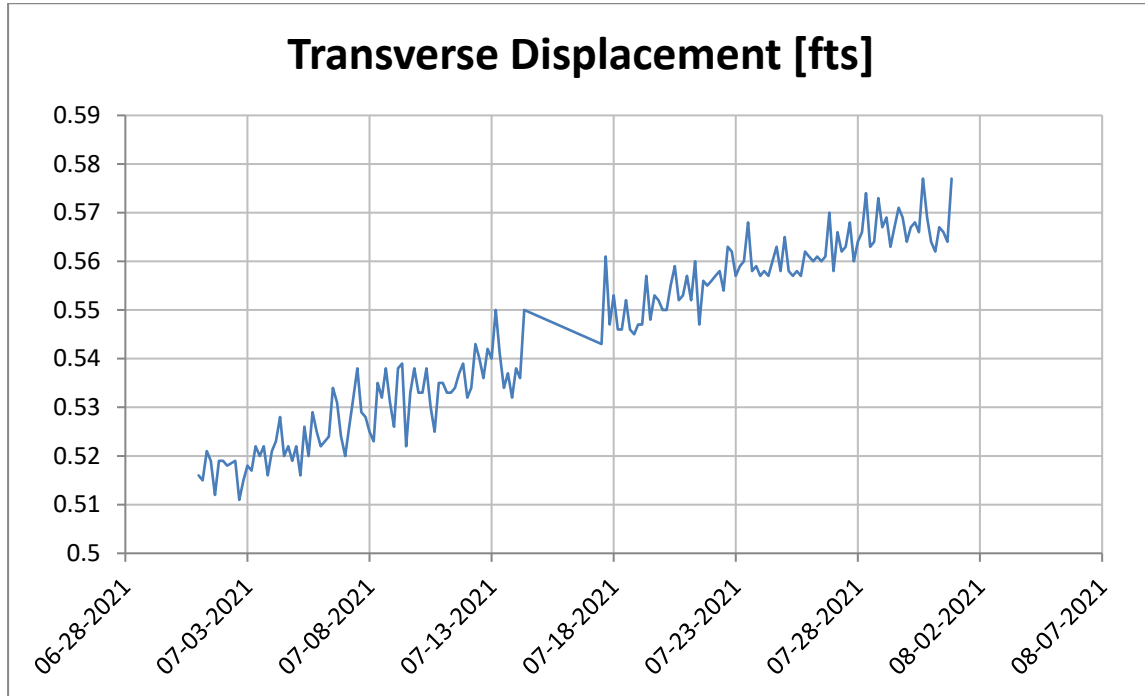
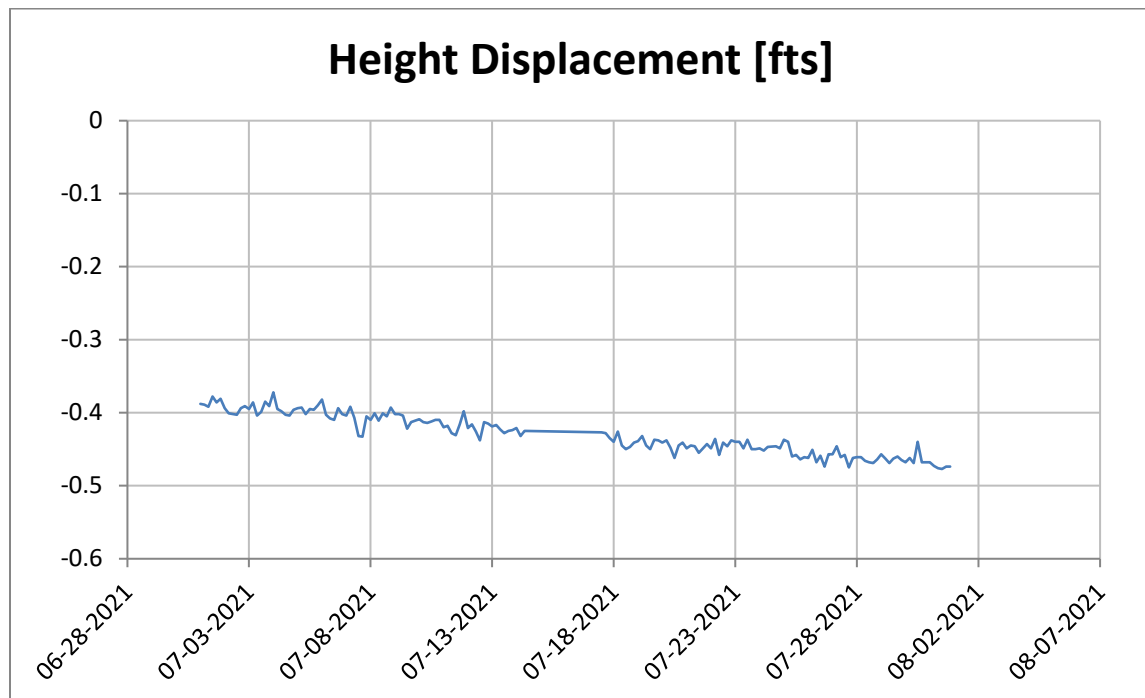
1. Survey accuracy is +/-0.016 feet.
2. Alarm threshold is +/-0.35 feet.
3. Transverse displacement is in the horizontal direction. Positive direction means closer to the robotic station.
4. Height displacement is in the vertical direction. Positive direction means higher in elevation.
5. Prism TOE2 is located at the toe of the landslide. This location showed slope creep movements at slow velocities.

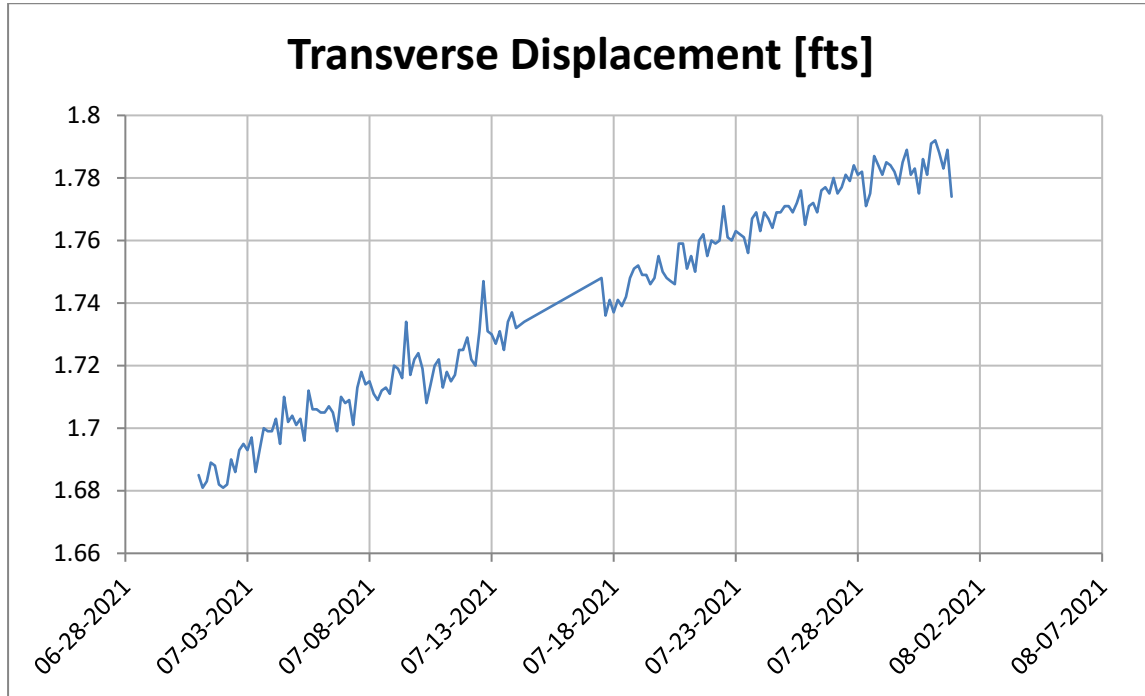
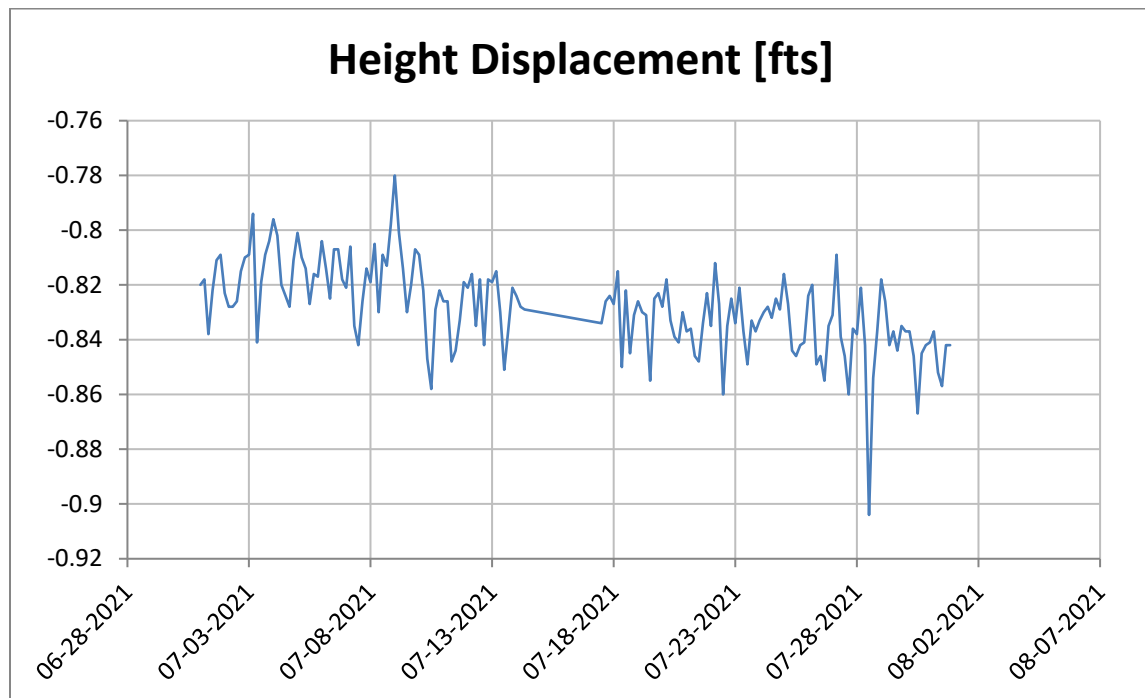
1. Survey accuracy is ± 0.016 feet.
2. Alarm threshold is ± 0.35 feet.
3. Transverse displacement is in the horizontal direction. Positive direction means closer to the robotic station.
4. Height displacement is in the vertical direction. Positive direction means higher in elevation.
5. Prism TOE3 is located at the toe of the landslide. This location showed slope creep movements at slow velocities.

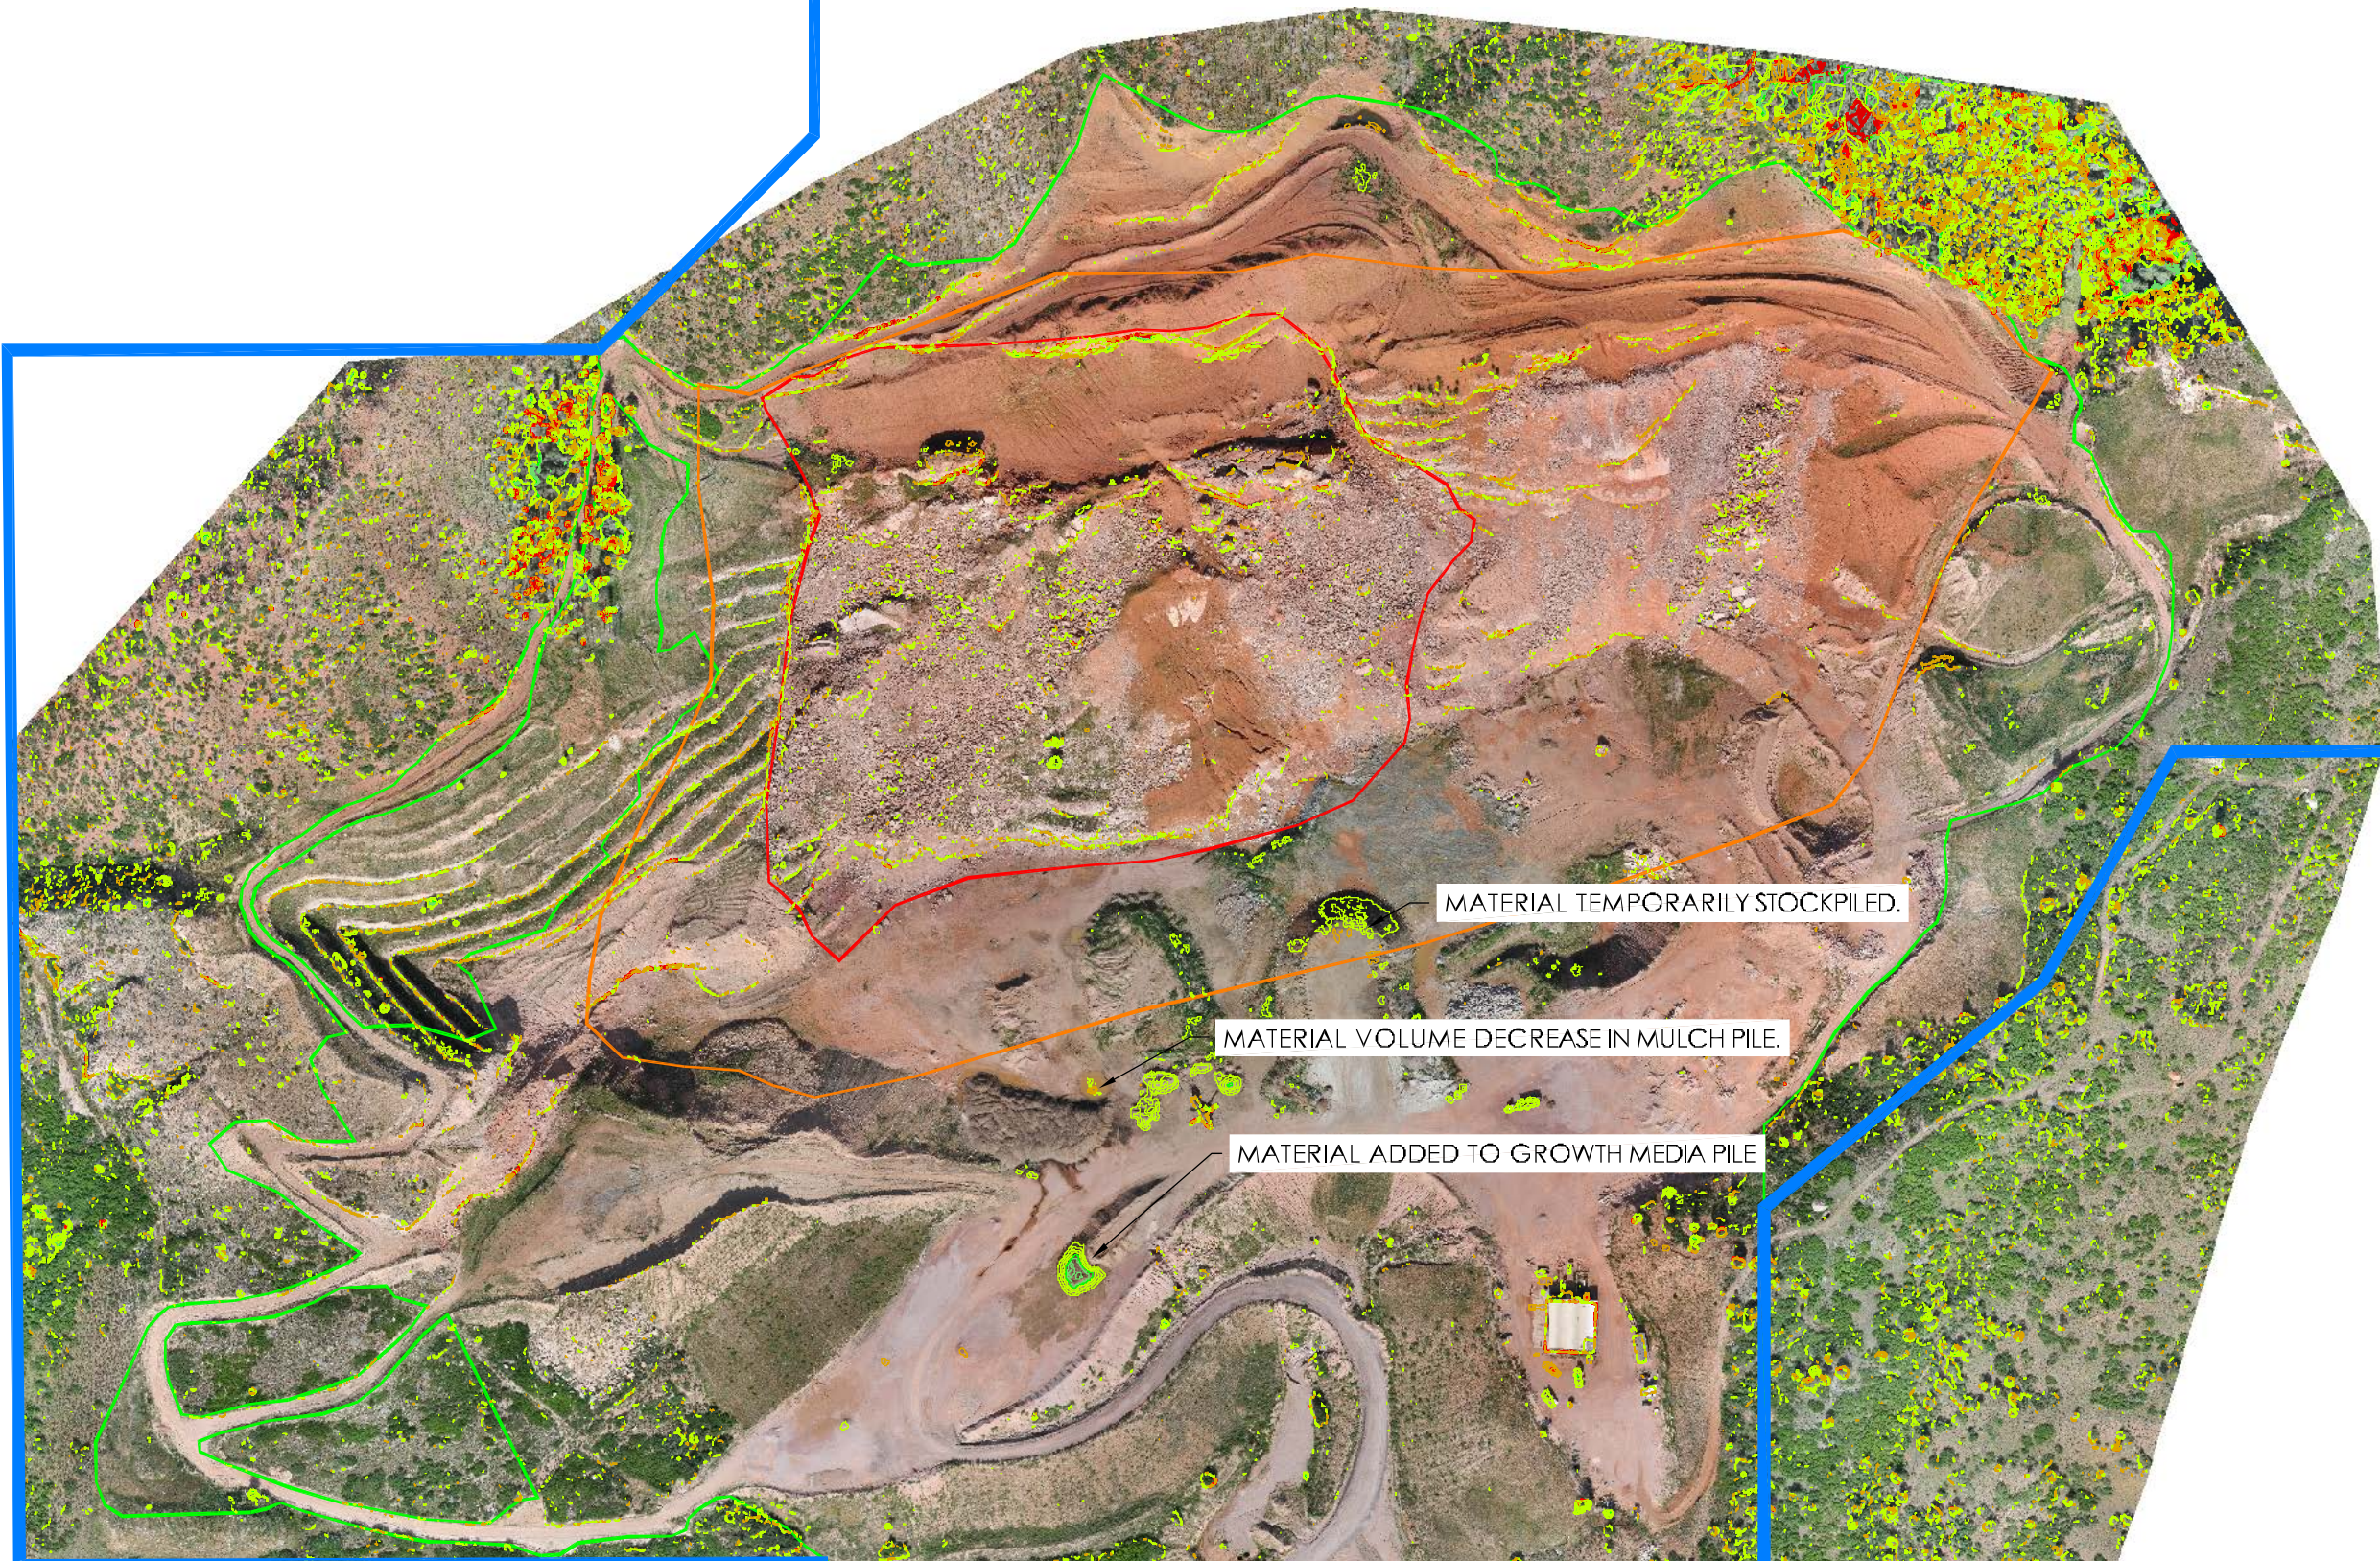
The June topography was also compared to the July topography to identify changes in the site topography. Comparison of the two surveys showed that approximately 940 yd³ of fill had been imported and temporarily placed. No slope movements or other changes in topography were identified. The current imagery and topography are included in Figures 1 and 3, and the comparison surface is included as Figure 5 in Appendix C.

As previously reported in the September 2020 monitoring report, there are limitations with the method of comparing drone surveys from different months. The drone data indicate changes in the slopes along each of the reclamation benches, buildings, and areas with trees or shrubs. These areas are stable, and the changes are the result of survey limitations on or near vertical slopes.
