MINERALS PROGRAM INSPECTION REPORT
PHONE: (303) 866-3567

MINE NAME: Riverside Pit	MINE/PROSPECTING ID#: M-1976-056	MINERAL: Sand and gravel	COUNTY: Logan
INSPECTION TYPE: Surety-Related Inspection	INSPECTOR(S): Brock Bowles	INSP. DATE: August 25, 2021	INSP. TIME: 09:00
OPERATOR: McAtee Construction Company	OPERATOR REPRESENTATIVE: Jeff Harms	TYPE OF OPERATION: 112c - Construction Regular Operation	
REASON FOR INSPECTION: Surety Related	BOND CALCULATION TYPE:	BOND AMOUNT: \$175,000.00	
DATE OF COMPLAINT: NA	POST INSP. CONTACTS: None	JOINT INSP. AGENCY: None	
WEATHER: Clear	INSPECTOR'S SIGNATURE:

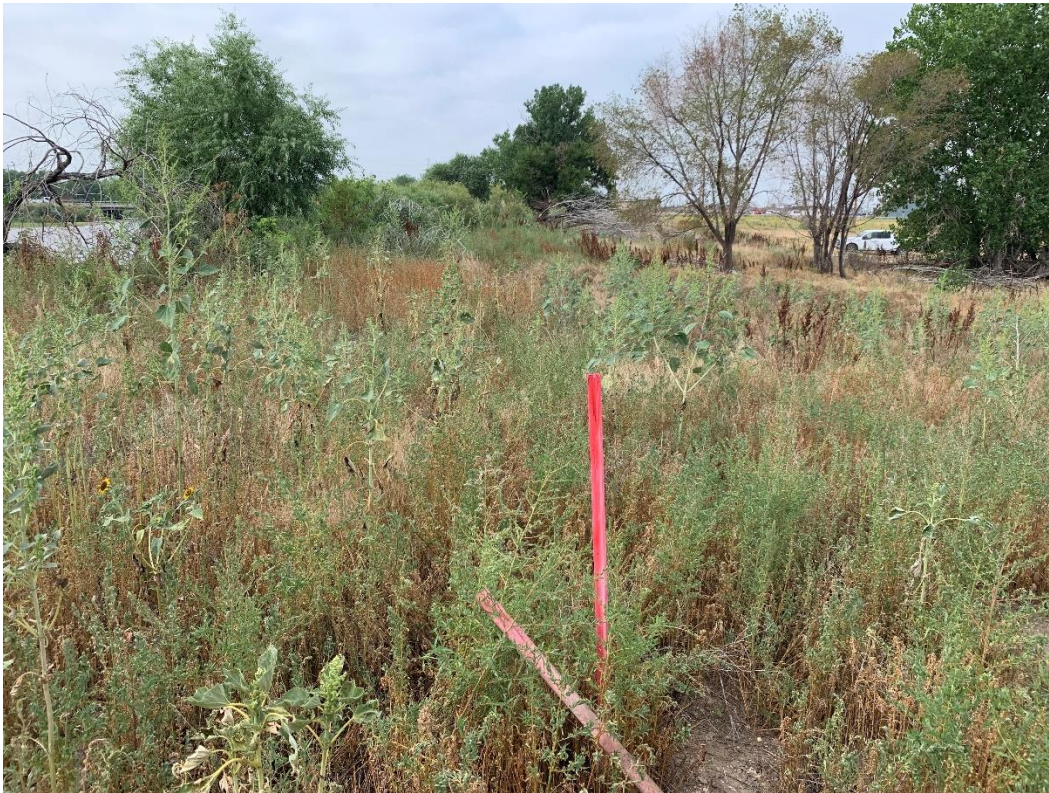
A map depicting the requested release area and the new permit boundary is in the AR3 application. The requested release area is on the southern boundary and borders the Lowline Ditch Canal. The area has not been disturbed by mining and is covered with dense grasses, forbs and some trees. Some of the grass in the area had recently been mowed. A couple of small patches of cheatgrass was seen, but these patches were very small in extent. No other noxious weed was noted. Permit boundary markers for the current boundary are in place (photos 1 & 2). These markers will have to be removed and repositioned once AR3 is approved to prevent confusion of the new boundary.

Photo 1 – Northeast corner of AR3 release area, facing south

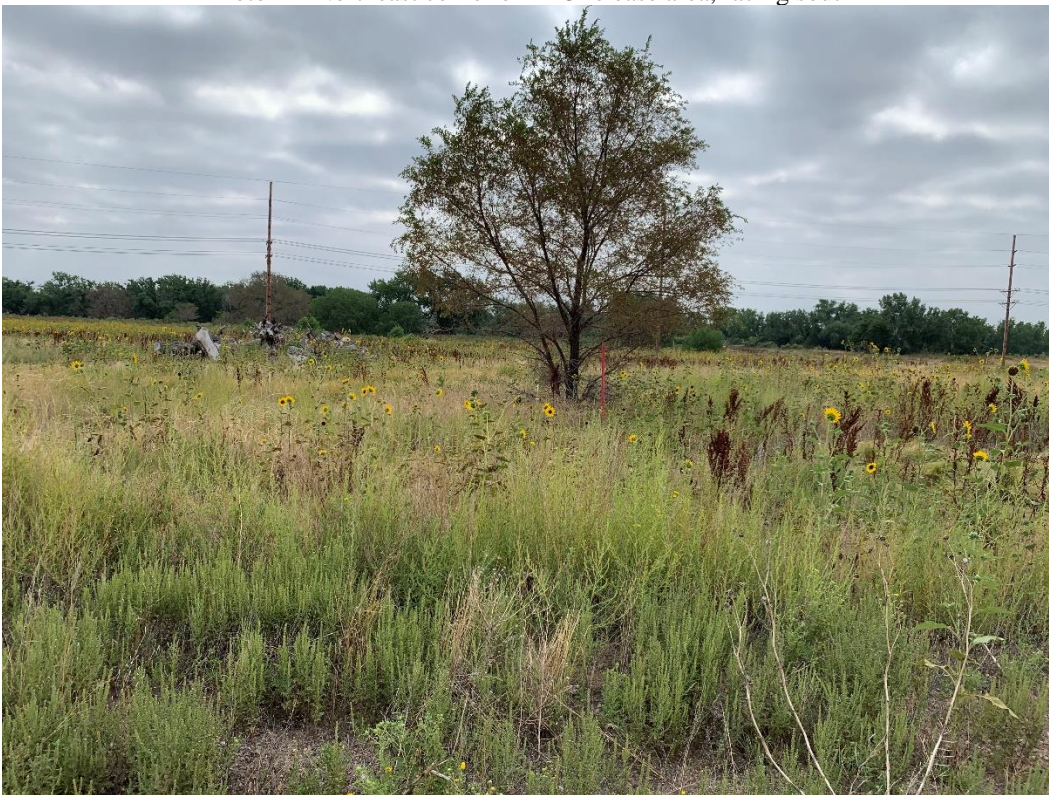
Photo 2 – Southern boundary marker. Permit area to left, AR3 area to right, facing east

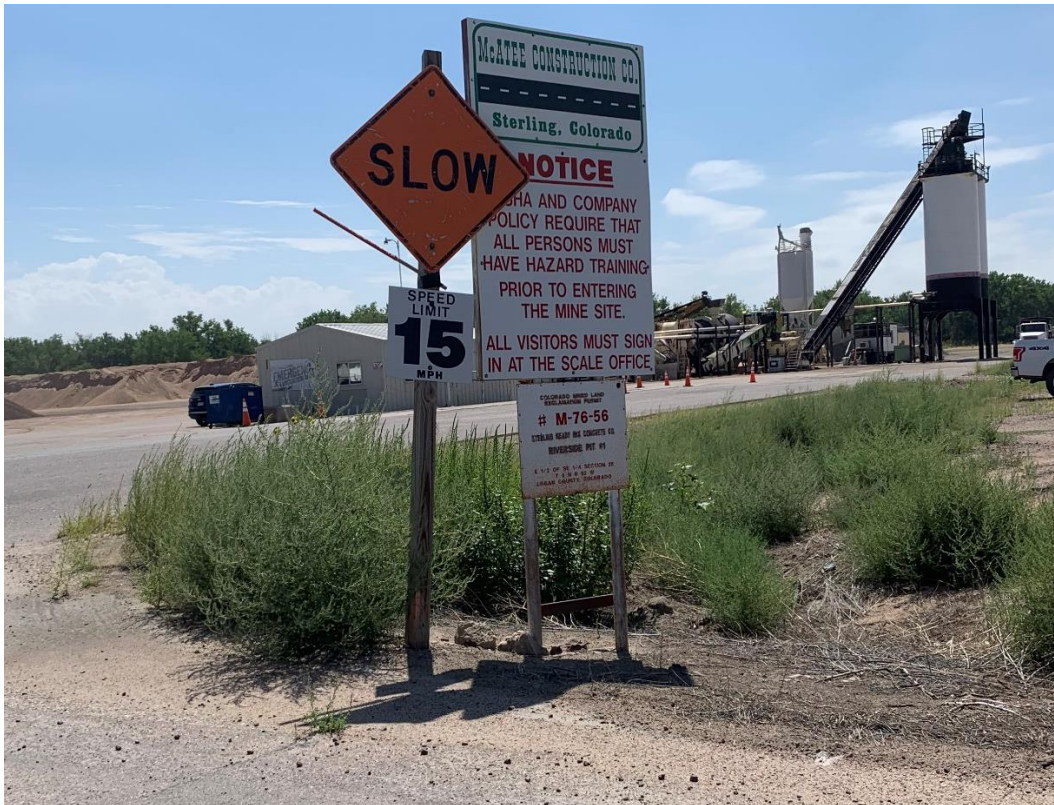
The mine entrance sign was in place on Riverside Drive (photo 3). The rest of the permit boundary markers for the entire permit area were inspected and all were in place (photo 4).

Photo 3 – Mine entrance sign facing Riverside Drive

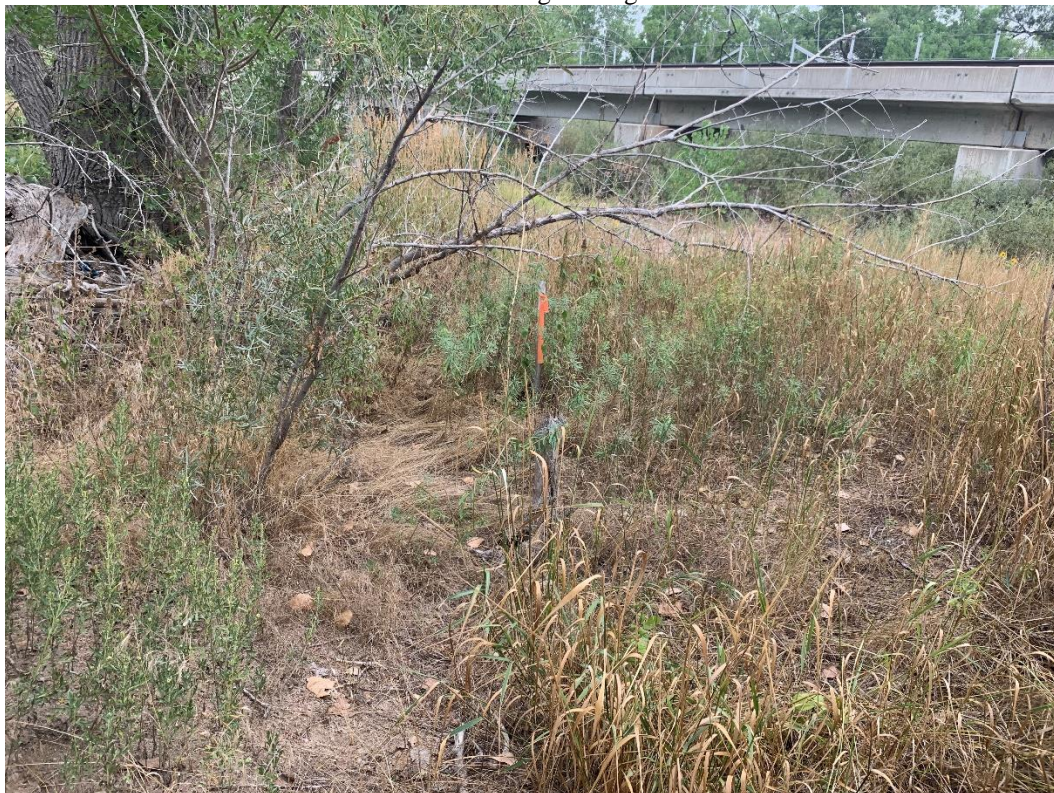
Photo 4 – Northeast corner, northeast of Lake Robert

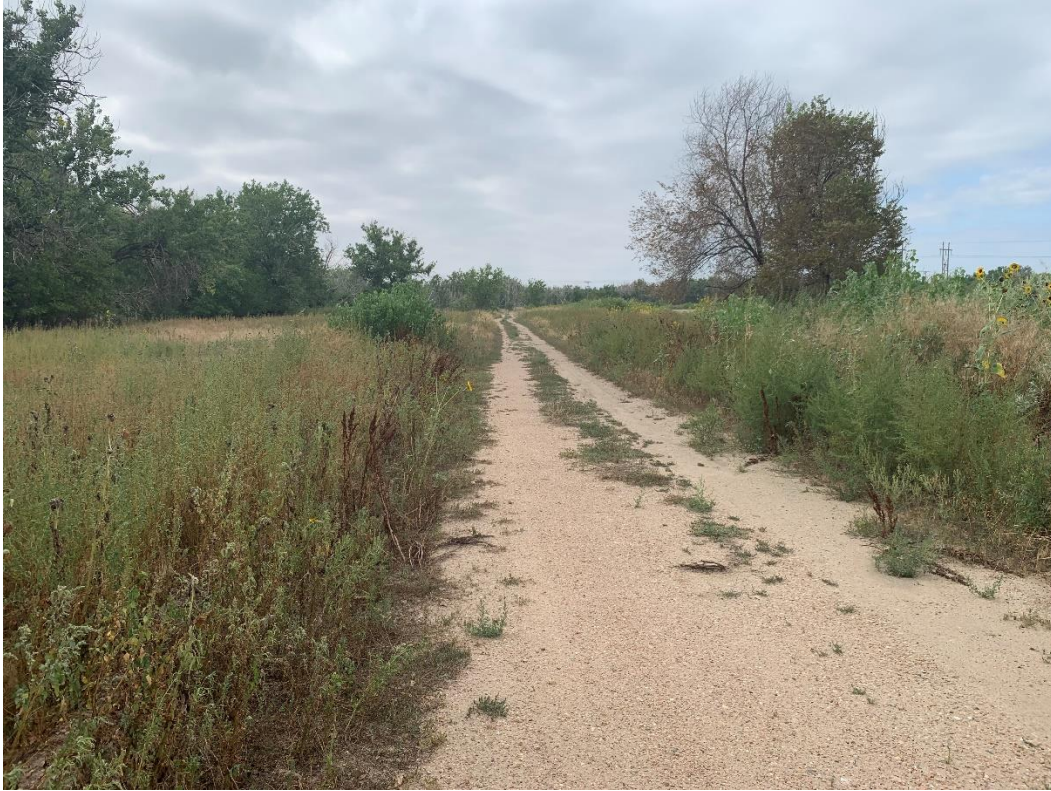
Lake Robert on the east side of the Lowline Ditch contained water. The embankment of the lake was well vegetated and appeared to be stable (photo 5). The area south of Lake Robert was filled with sand/gravel. No standing water was seen in this area. Mining was not taking place in the areas east of the Lowline Ditch at this time.

Photo 5 – Lake Robert east embankment, facing south (lake on right)

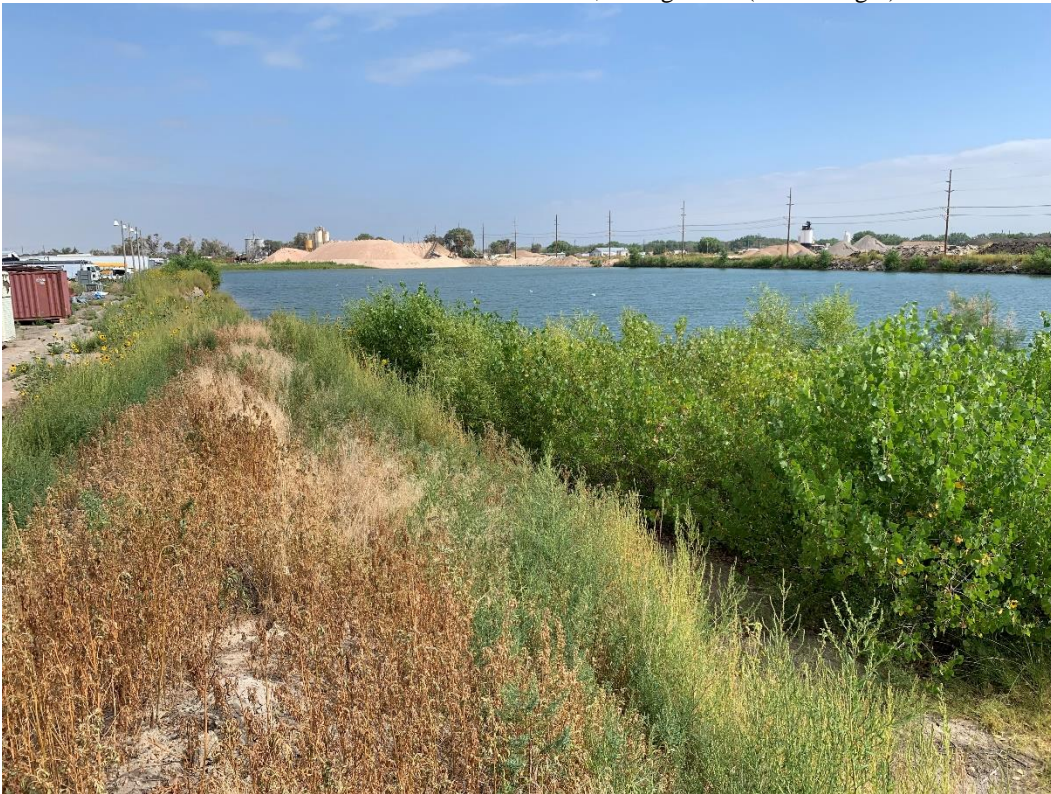
The pond on the west side, south of the batch plant also contained water (photo 6). The banks were well vegetated and appeared to be stable. The north side of the west pond was actively being mined. A large stock pile was located between the batch plant and the pond.

Photo 6 – West pond facing north, concrete batch plant far side of pond.
