**MINERALS PROGRAM INSPECTION REPORT**  
**PHONE: (303) 866-3567**

<b>MINE NAME:</b> Harley Pit #1	<b>MINE/PROSPECTING ID#:</b> M-1986-147	<b>MINERAL:</b> Sand and gravel and material for construc	<b>COUNTY:</b> Logan
<b>INSPECTION TYPE:</b> Monitoring	<b>INSPECTOR(S):</b> Brock Bowles	<b>INSP. DATE:</b> August 25, 2021	<b>INSP. TIME:</b> 10:00
<b>OPERATOR:</b> McAtee Construction Company	<b>OPERATOR REPRESENTATIVE:</b> Jeff Harms	<b>TYPE OF OPERATION:</b> 112c - Construction Regular Operation	
<b>REASON FOR INSPECTION:</b> Normal I&E Program	<b>BOND CALCULATION TYPE:</b>	<b>BOND AMOUNT:</b> \$117,150.00	
<b>DATE OF COMPLAINT:</b> NA	<b>POST INSP. CONTACTS:</b> None	<b>JOINT INSP. AGENCY:</b> None	
<b>WEATHER:</b> Overcast	<b>INSPECTOR'S SIGNATURE:</b>

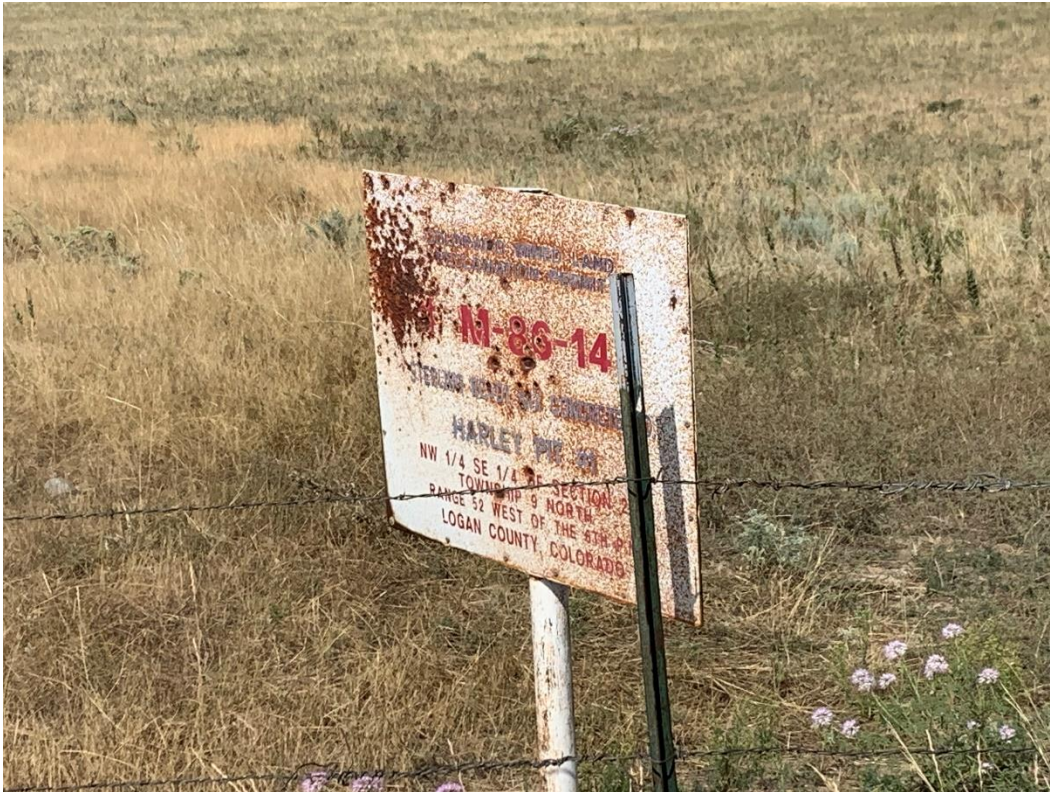
The mine entrance sign was in place facing CR 40 (photo 1). The permit boundary markers were in place.

Photo 1 – Mine entrance sign facing CR 40

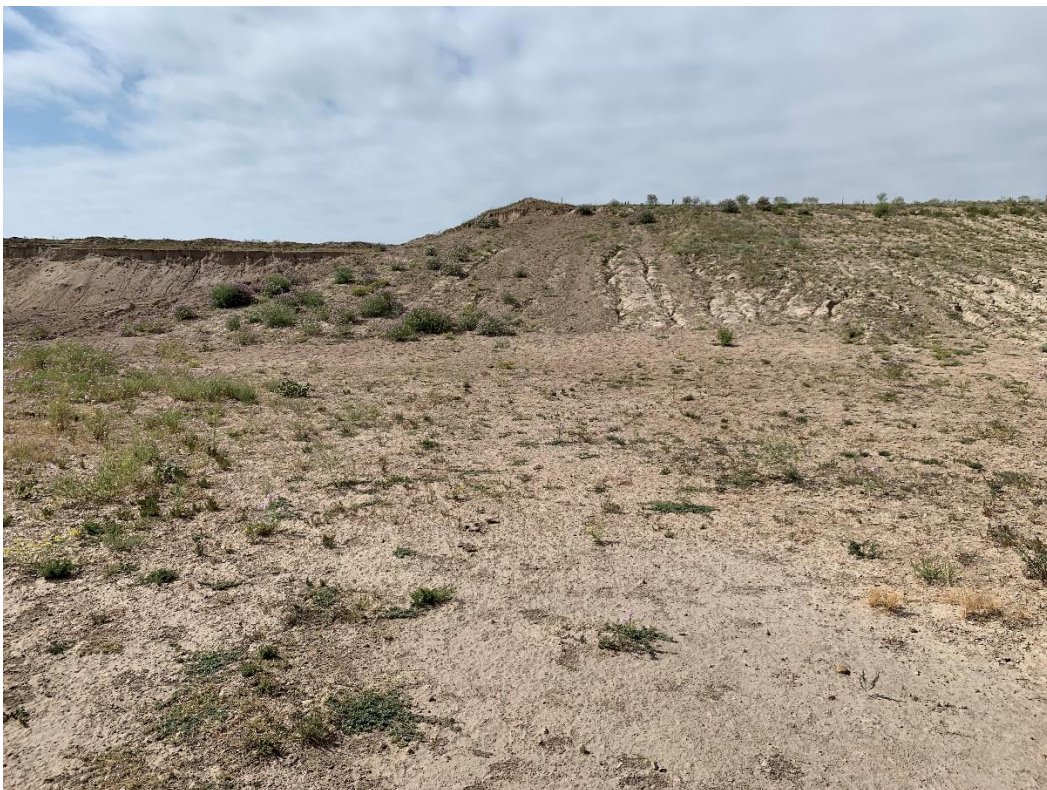
The two highwalls were noted in the current excavation. The main highwall is on the southern side of the pit and is following along the access road. The western section of this highwall that was noted in the last inspection report (12/19/2016) as getting close to the fence has been backfilled and graded to approximately 3h:1v slopes (photo 2). This section of the pit and the rest of the western section has been reclaimed. The remaining highwall is about 1,900 feet long and 25 feet high (photo 3).

Photo 2 – Area below fence that was backfilled

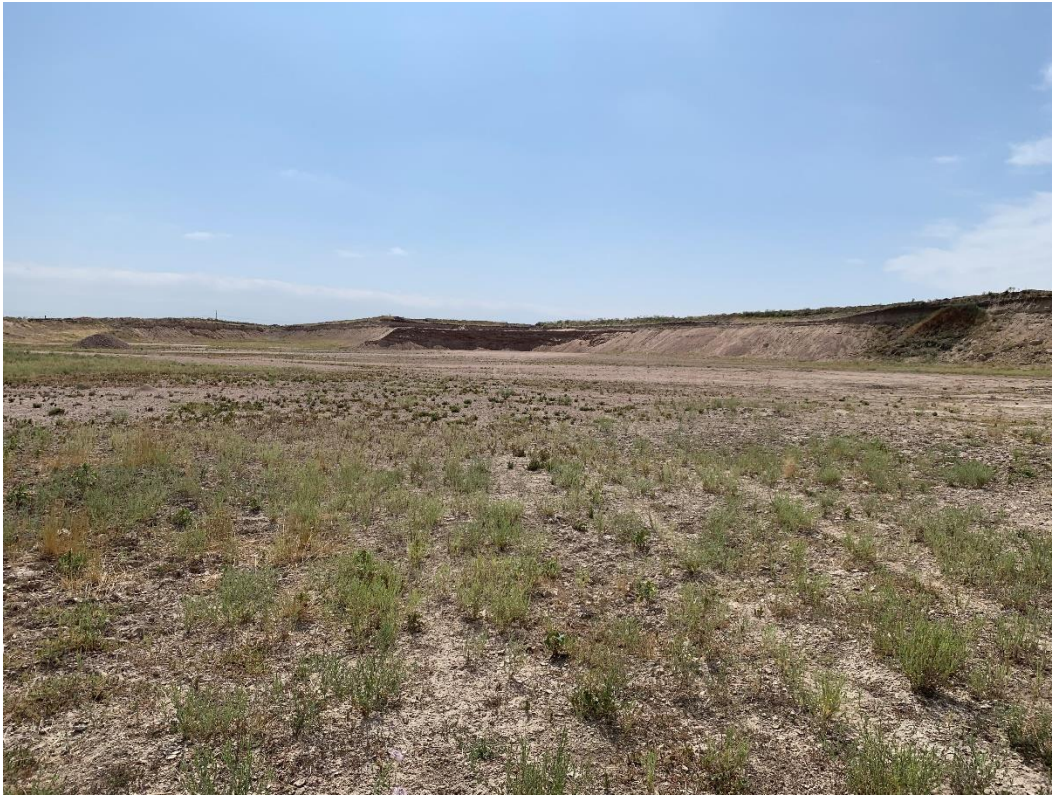
Photo 3 – Southern highwall
