MINERALS PROGRAM INSPECTION REPORT
PHONE: (303) 866-3567

MINE NAME: Bollish Pit #2	MINE/PROSPECTING ID#: M-2007-013	MINERAL: Sand, gravel and bor for construction	COUNTY: Logan
INSPECTION TYPE: Monitoring	INSPECTOR(S): Brock Bowles	INSP. DATE: August 25, 2021	INSP. TIME: 11:00
OPERATOR: McAtee Construction Company	OPERATOR REPRESENTATIVE: Jeff Harms	TYPE OF OPERATION: 112c - Construction Regular Operation

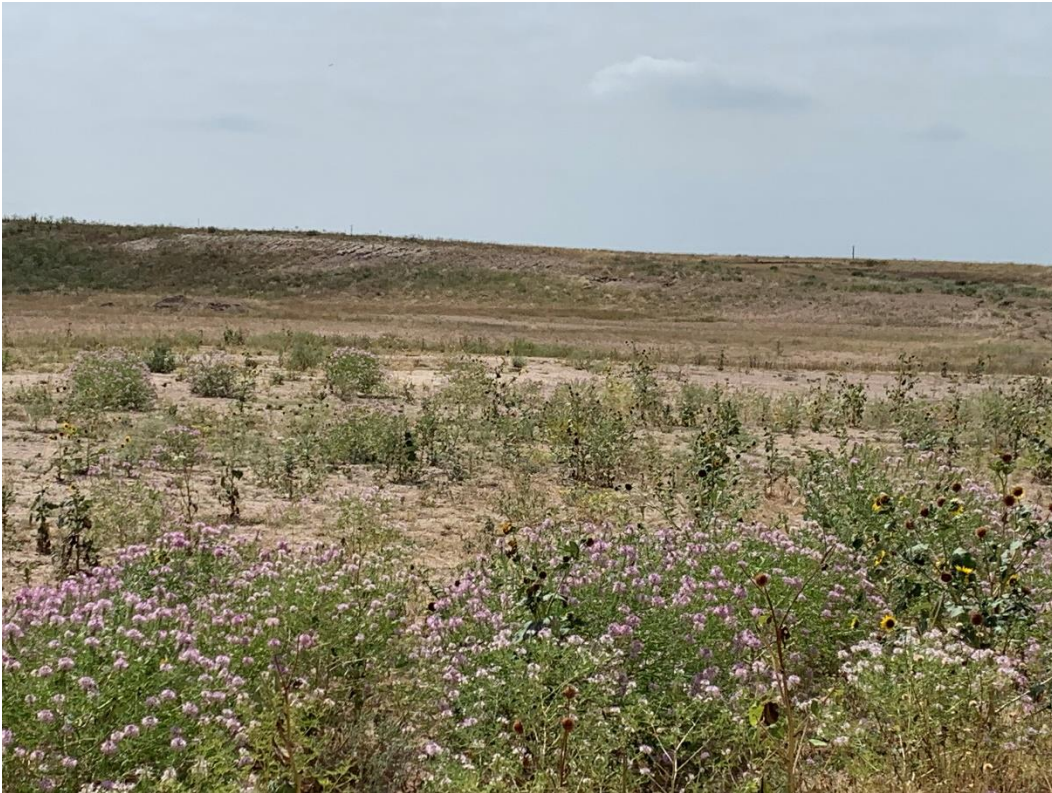
The pit bottom is graded flat and the pit walls were graded to approximately 3h:1v (photo 1). A small section of the pit was not graded in the north east corner of the pit (photo 2). This is the borrow area approved to remain as a borrow pit for the landowner in TR2.

Photo 1 – Pit area facing south

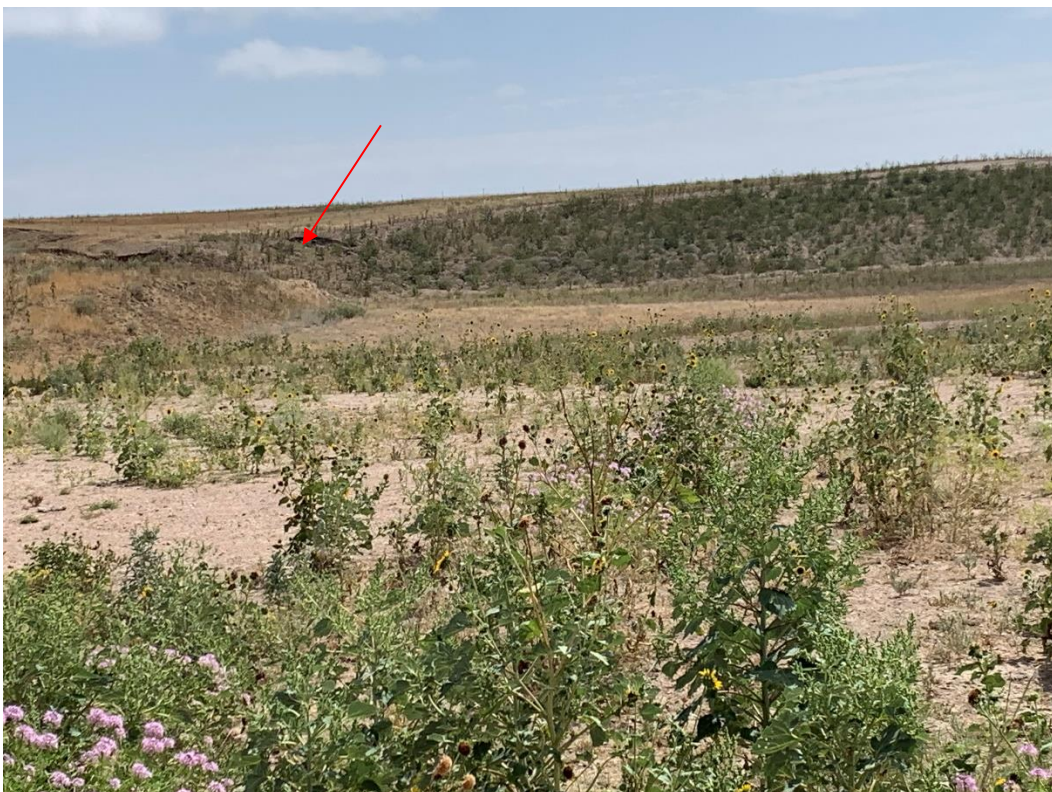
Photo 2 – Northeast corner of pit left as borrow pit for landowner.

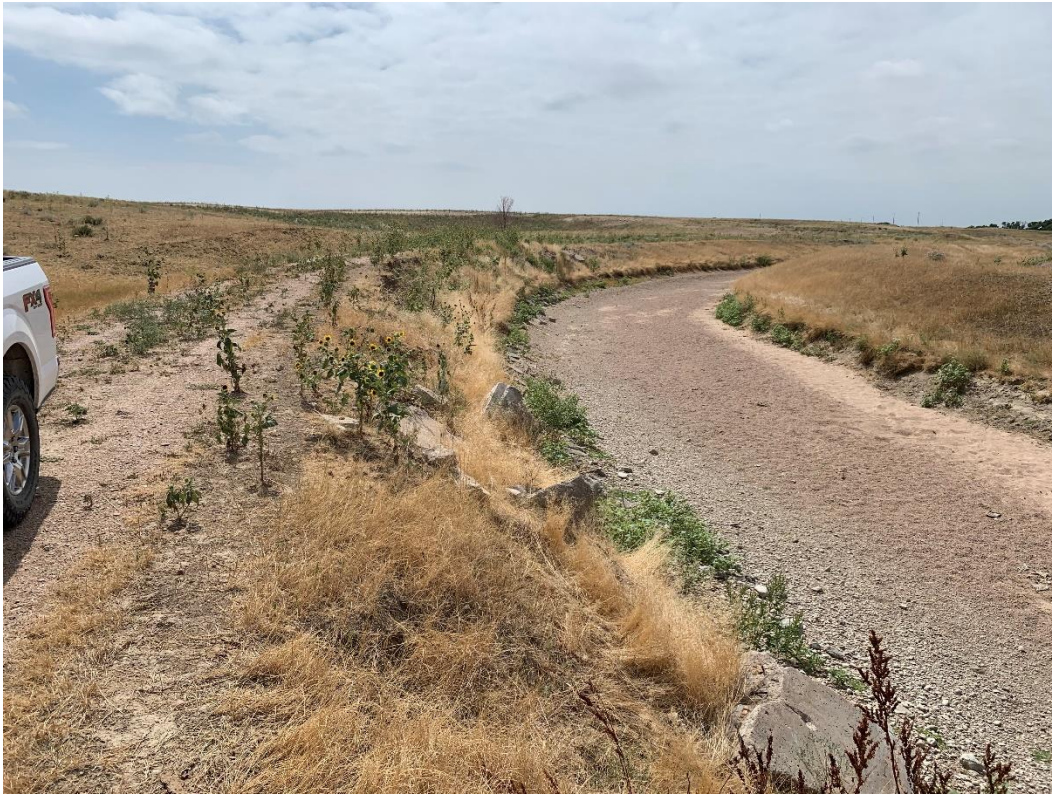
The western embankment between the pit and the ditch appeared to be stable (photo 3).

Photo 3 – Embankment between pit and ditch, facing south
