**MINERALS PROGRAM INSPECTION REPORT**  
**PHONE: (303) 866-3567**

<b>MINE NAME:</b> Krehmeyer Pit	<b>MINE/PROSPECTING ID#:</b> M-2005-070	<b>MINERAL:</b> Gravel and sand	<b>COUNTY:</b> Phillips
<b>INSPECTION TYPE:</b> Monitoring	<b>INSPECTOR(S):</b> Brock Bowles	<b>INSP. DATE:</b> July 1, 2021	<b>INSP. TIME:</b> 12:30
<b>OPERATOR:</b> Ritchey's Redi-Mix Concrete, Inc.	<b>OPERATOR REPRESENTATIVE:</b> Jerry Ritchie	<b>TYPE OF OPERATION:</b> 112c - Construction Regular Operation	
<b>REASON FOR INSPECTION:</b> Normal I&E Program	<b>BOND CALCULATION TYPE:</b> None	<b>BOND AMOUNT:</b> \$7,400.00	
<b>DATE OF COMPLAINT:</b> NA	<b>POST INSP. CONTACTS:</b> None	<b>JOINT INSP. AGENCY:</b> None	
<b>WEATHER:</b> Cloudy	<b>INSPECTOR'S SIGNATURE:</b>

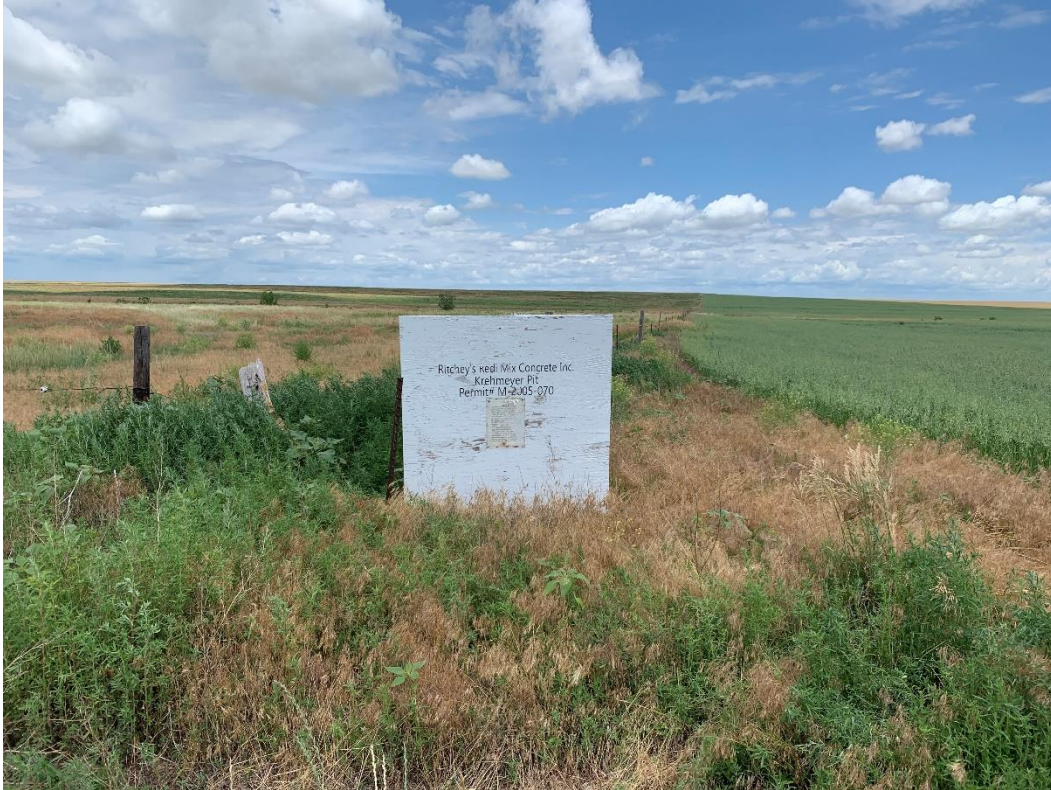
The permit identification sign was in place at the mine entrance and legible (photo 1). The permit boundary markers were in place (photo 2). Mining was not taking place at the time of the inspection. The last excavation date according to the 2021 Annual Report was March 2014. The mine is in its final reclamation phase.

Photo 1 – Mine entrance sign facing

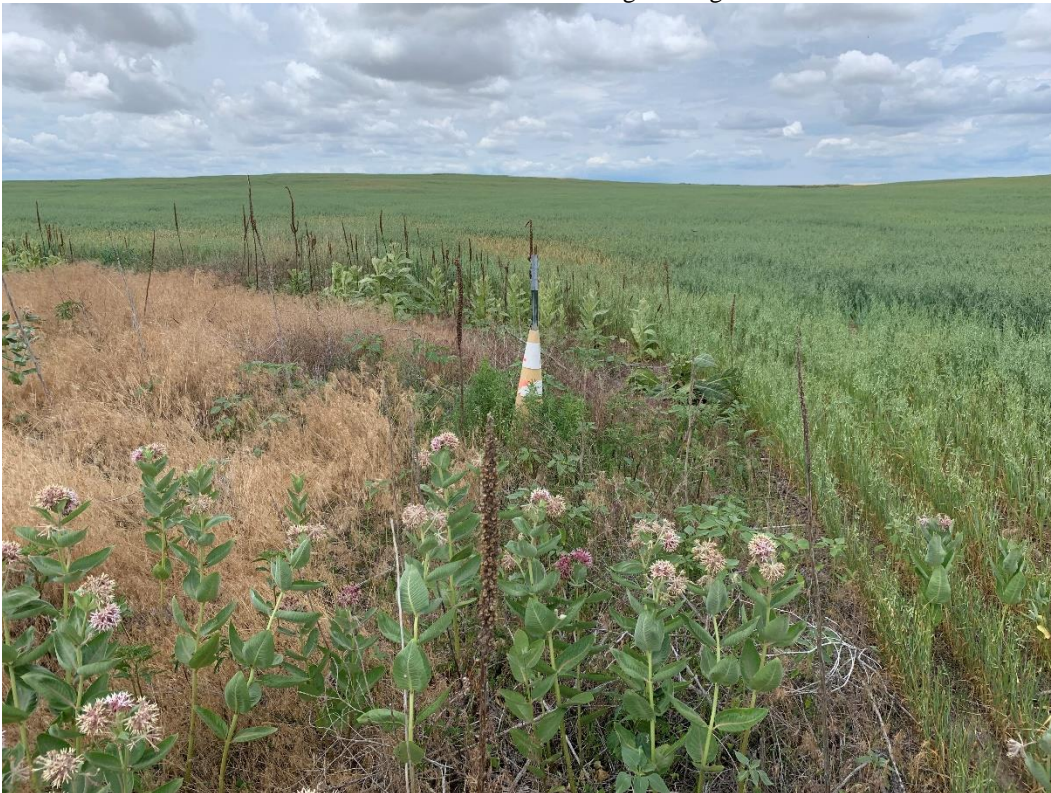
Photo 2 – Northeastern boundary marker

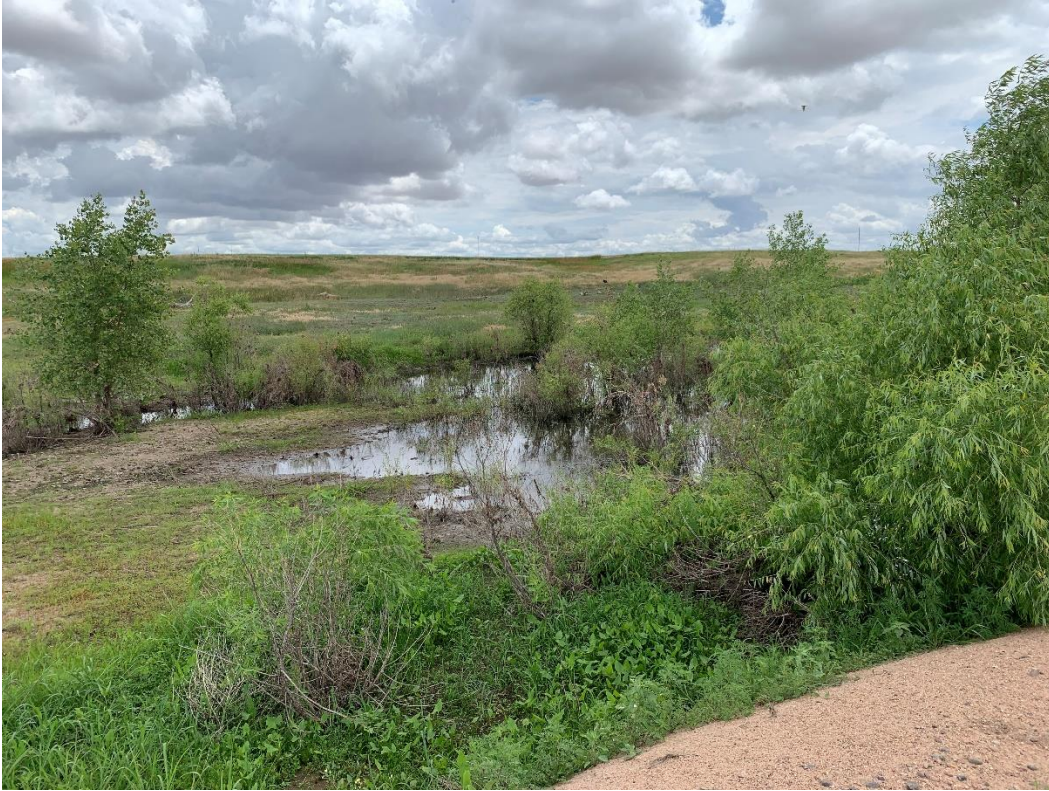
Sandy Creek had some water in the bottom of the creek (photo 3). Jerry Ritchie said that there has been several large rain events in the last few months and it had rained the previous night. As a reminder, the Div. of Water Resources requires any storm water runoff intercepted by this operation must infiltrate into the ground or be release to the creek system within 72 hours.

Photo 3 – Water in Sandy Creek

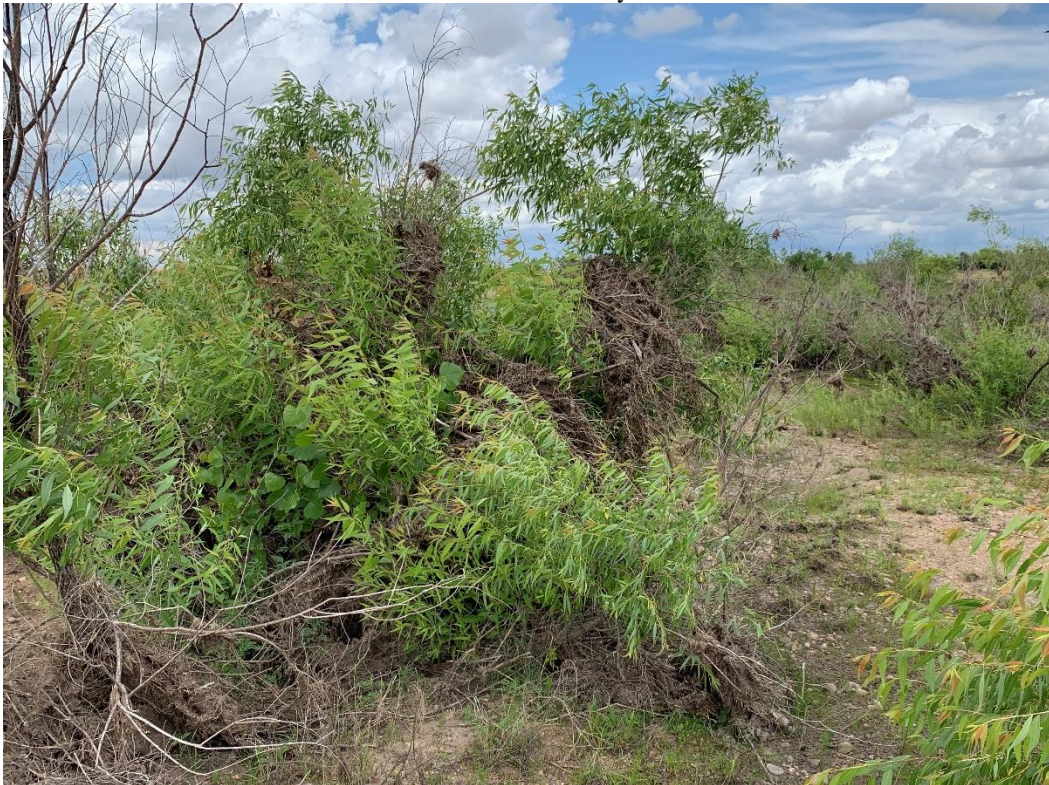
The water level in Sandy Creek got really high as can be seen by the debris caught in the trees. It is estimated that the water was 5-6 feet deep (photo 4). The speed of the water was also significant enough to remove soil from around the roots of small plants exposing about 2 inches of the roots. The flow of the water also pushed the plant over (photo 5).

Photo 4 – Debris in trees shows how deep the water was during a recent rain event

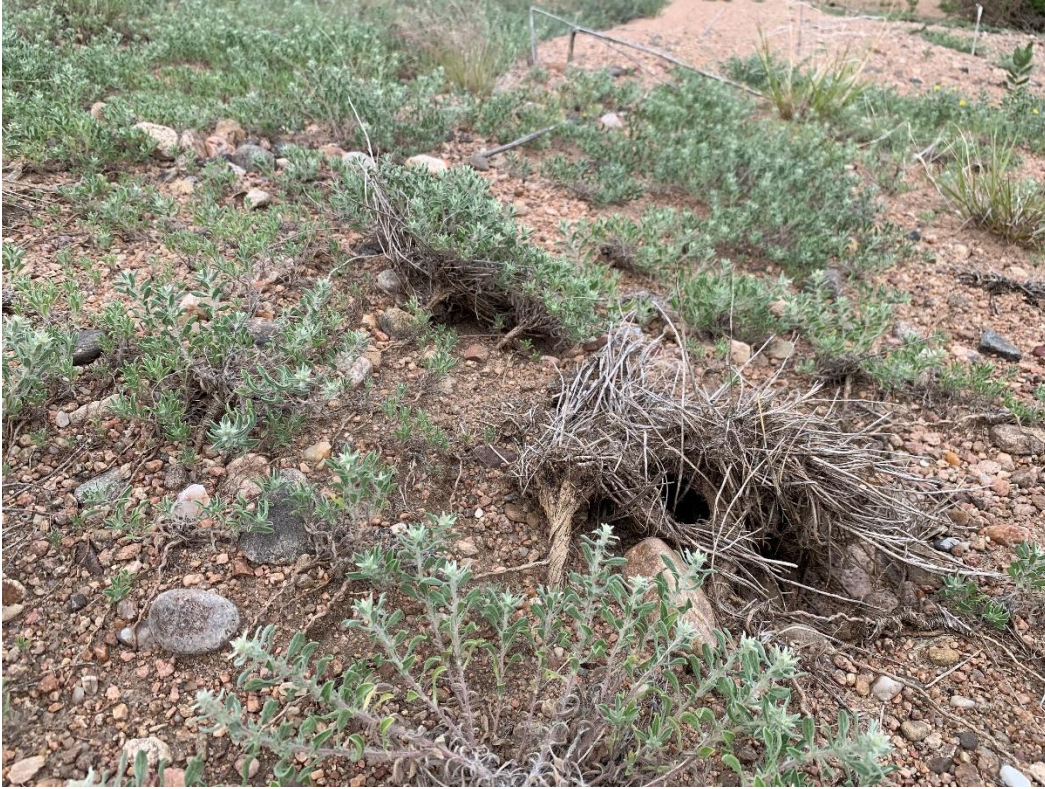
Photo 5 – Soil eroded from around roots of some small plants.

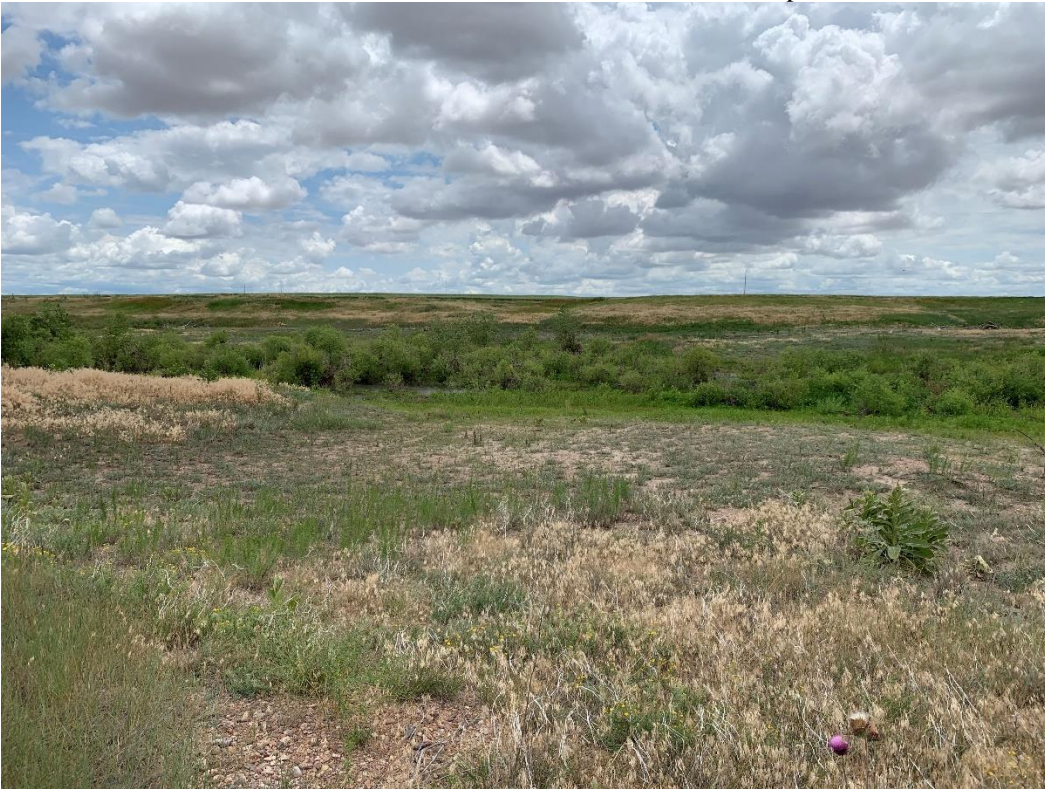
The water rose to a level that exceed the creek bank on the north side. The water flowed beyond the north permit boundary and onto the adjacent cropland. The water flowed east through the crop field then flowed back onto the permitted area and then back into the creek. The mine is in reclamation and the creek channel is not obstructed by any mining related objects such as stockpiles or diversions. The creek bottom is fairly dense with small trees, shrubs and grasses which is the most likely reason why the water level exceeded the bank (photo 6).

Photo 6 – Dense vegetation in the creek bottom.

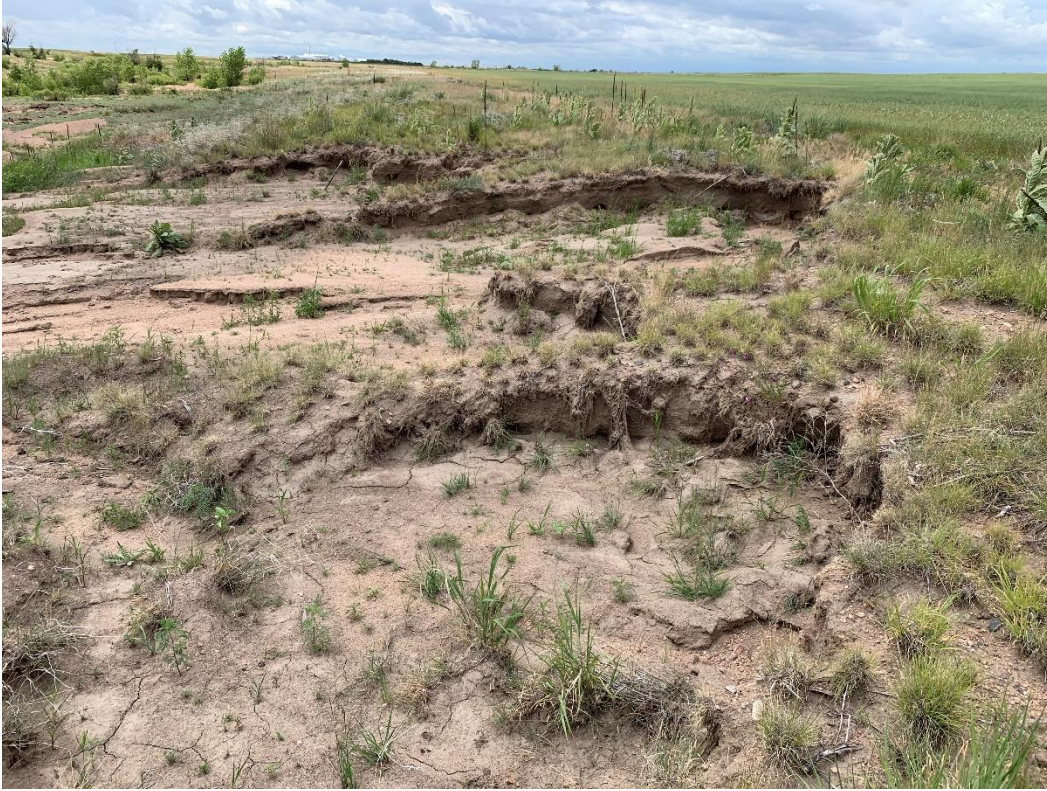
The location where the water flowed from the crop field back into the creek had significant erosion (photo 7). The crop debris on the edge of the field shows where the water flowed from the crop field back into the permit area and then into the creek (photo 8). The erosion damaged an area about 750 ft<sup>2</sup> and 18 inches deep. The side of the pit in this area was graded to about 3h:1v or less as required by the permit. There isn't a natural channel or drainage in this area that would indicate special attention or a structure is warranted. Mr. Ritchie will repair the damaged area after the oats crop has been harvested to prevent damage to the crop. Harvest is expected within the next month.

Photo 7 – Erosion from where water flowed back into Sandy Creek

When the erosion repairs are completed, photos of the repair need to be submitted to DRMS. Once the photos are reviewed verifying the repairs, a final surety release (SL) application can be submitted. If the surety release application is received by the division within 30 days of this report, this inspection can be used for the purposes of the surety release.

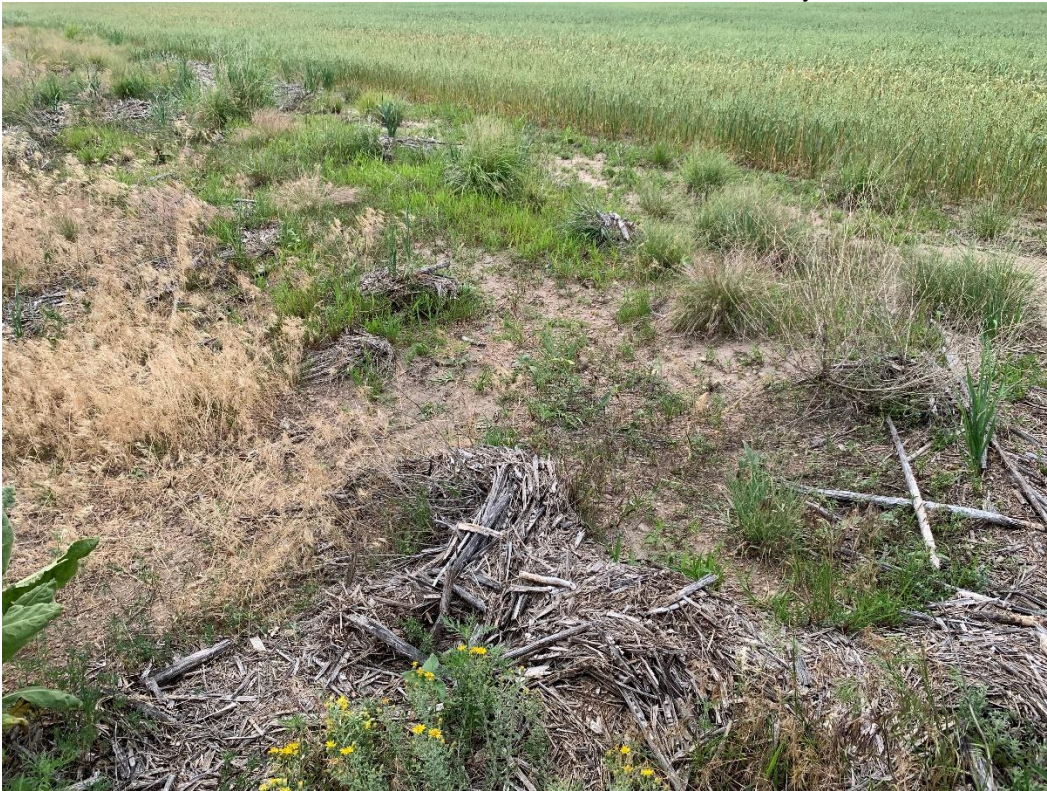
Photo 8 - Crop debris shows where water flowed from the field.
