MINERALS PROGRAM INSPECTION REPORT
PHONE: (303) 866-3567

MINE NAME: Von Doose Mine	MINE/PROSPECTING ID#: M-2019-031	MINERAL: Silver	COUNTY: Ouray
INSPECTION TYPE: Monitoring	INSPECTOR(S): Lucas West	INSP. DATE: August 23, 2021	INSP. TIME: 09:30
OPERATOR: Atlas Mining & Reclamation, LLC	OPERATOR REPRESENTATIVE: Eli Doose	TYPE OF OPERATION: 110(1) - Hard Rock Limited Impact	
REASON FOR INSPECTION: Normal I&E Program	BOND CALCULATION TYPE: Partial Bond	BOND AMOUNT: \$37,319.00	
DATE OF COMPLAINT: NA	POST INSP. CONTACTS: None	JOINT INSP. AGENCY: None	
WEATHER: Clear	INSPECTOR'S SIGNATURE:

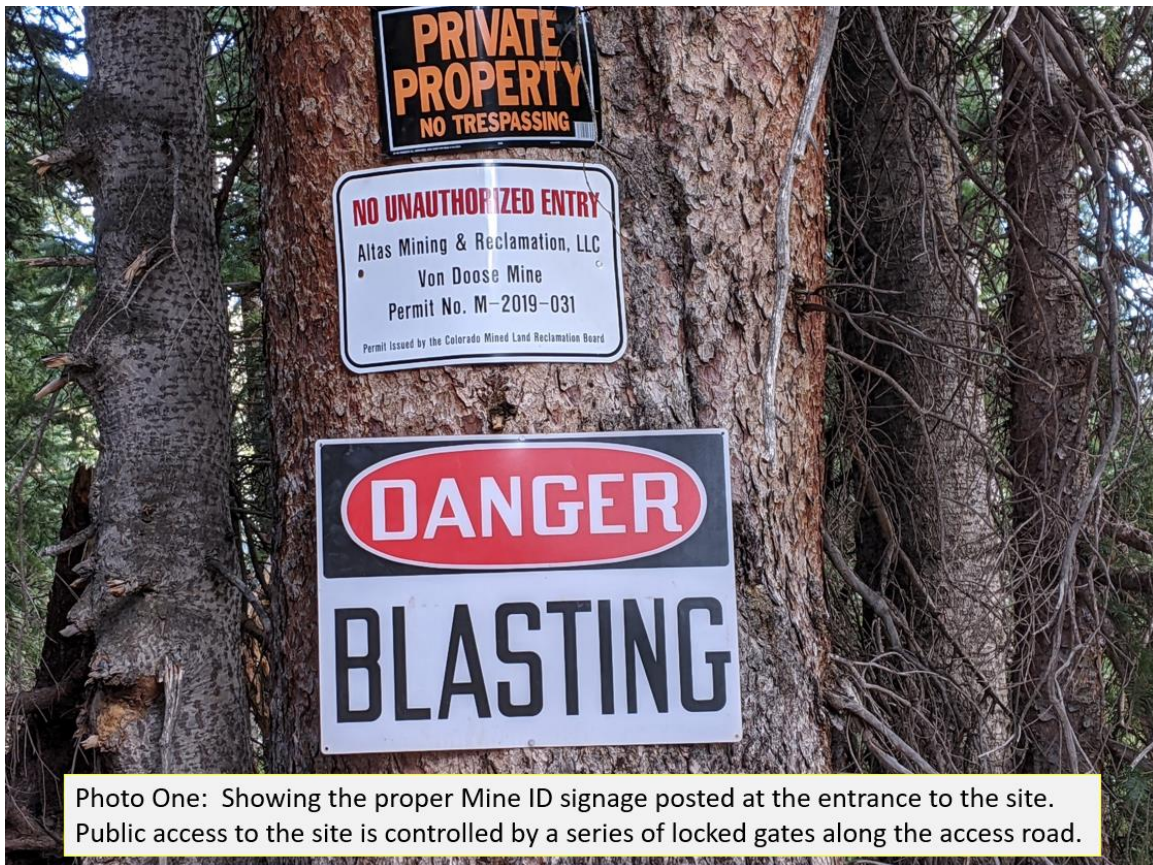
The site was not active at the time of the inspection, as the Operator is conducting mining operations unaccompanied and was participating in the inspection. Proper mine identification signage and permit boundary markers were observed on site seen in Photo One. The access road leading from the county road to the permit area are in excellent condition and well maintained. No erosion or sedimentation of the access road was noted. The mining operations are confined to the portal area and waste rock dump with a small pad constructed as a lay down and storage yard utilized to support the operation. The lay down yard has been constructed nearly exactly as the permit application materials had depicted, though is slightly smaller at this time leaving room for future expansion. The lay down yard can be seen in Photos Two and Three. Materials stored on the lay down yard included various construction supplies, small equipment used in the mining operations along with explosives and primer magazines. All materials stored on the pad are neat, orderly and in good working order. The explosives magazines contain explosive materials and were verified to be secure at the time of the inspection. The access road leading from the lay down yard to the main portal and waste rock dump is also in excellent condition and well maintained.

Photo One: Showing the proper Mine ID signage posted at the entrance to the site. Public access to the site is controlled by a series of locked gates along the access road.

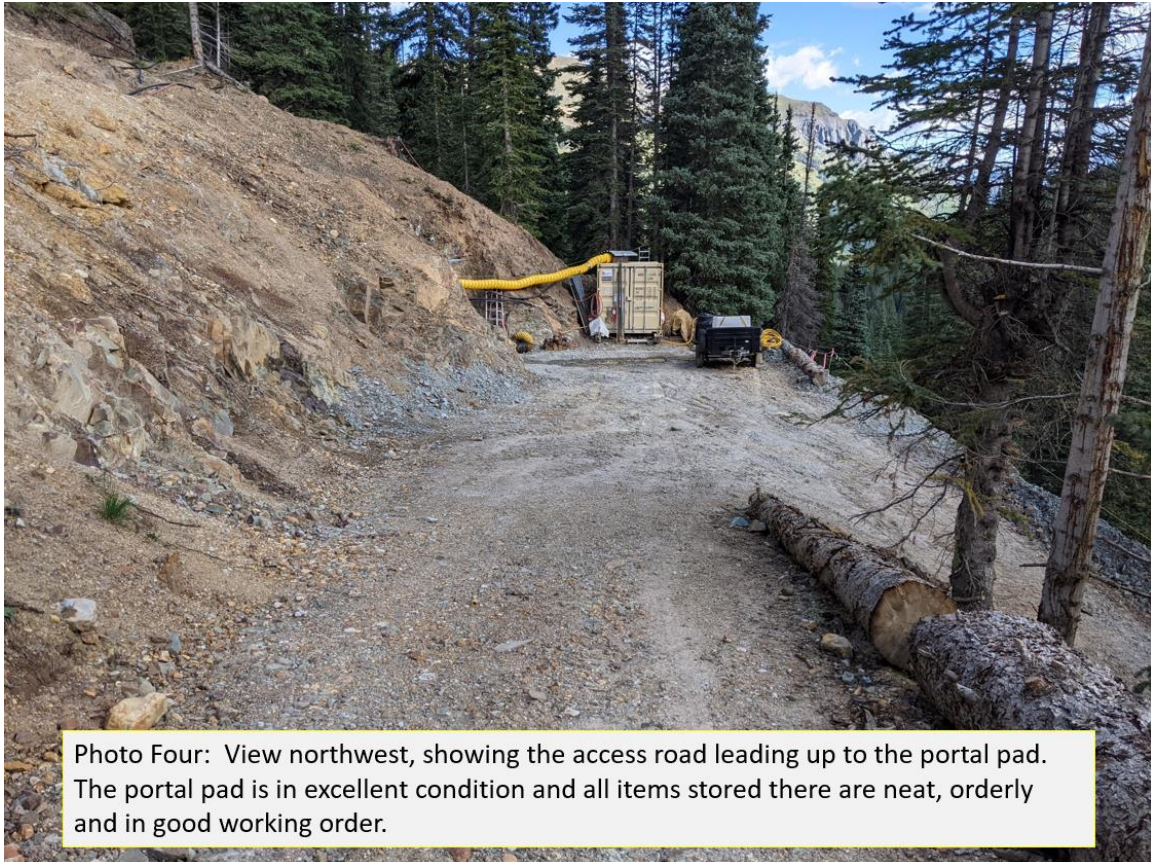
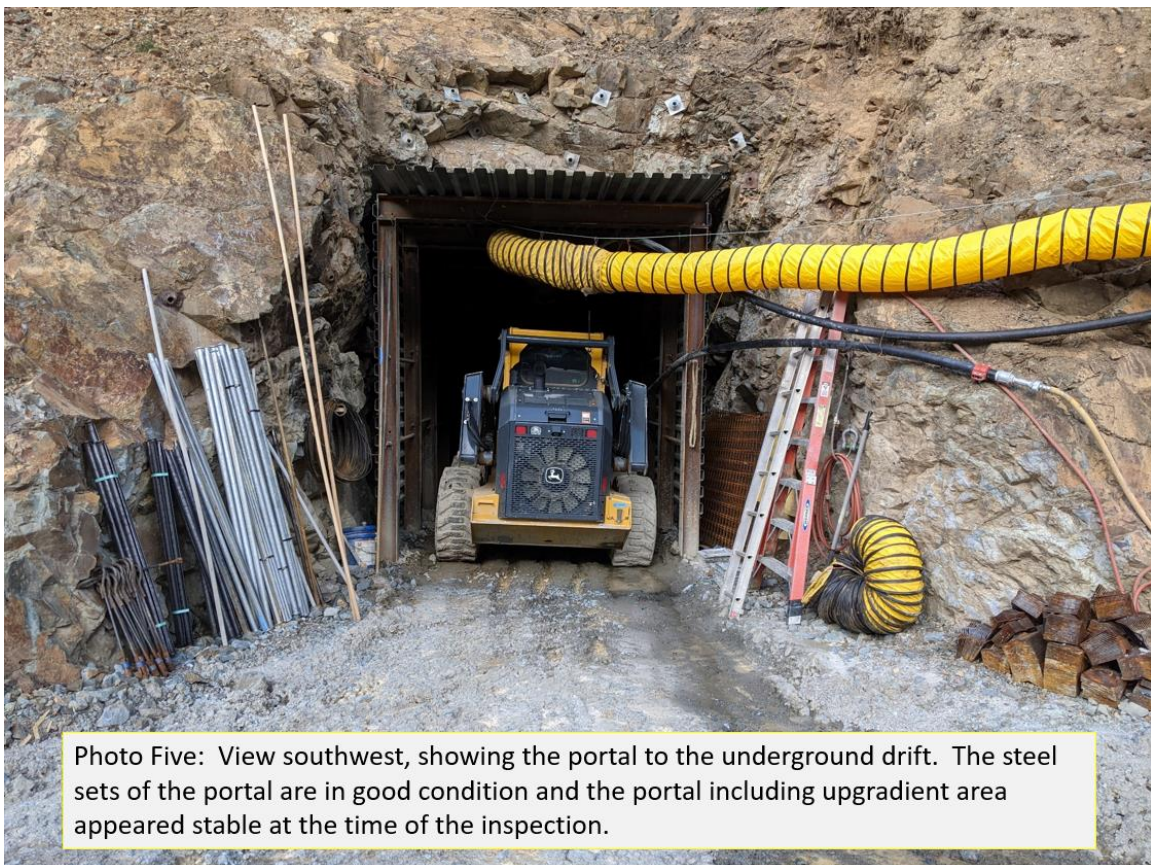
The main portal area can be seen in Photos Four and Five. The area consists of a portal pad and work area as well as the portal providing access to the underground drift. The pad and work area has been graded to create positive drainage and no impounded surface water was identified. The portal is dry and does not discharge, leaving the work area dry and accessible. Materials stored on the pad area is neat, orderly and in good condition. The portal has been secured with rock bolts and steel sets, no evidence of settling, slumping or instability was noted. The area above the portal including upland diversions for storm water were also in excellent working order. Adjacent to the portal area is the waste rock dump complete with rock catchment berms, storm water control structures and topsoil stockpile. The waste rock dump consist of large angular material that has been blasted as the underground drift advances and can be seen in Photo Six. All waste rock appears stable and is following the natural contours of the ground beneath it. The catchment berms are constructed earthen berms utilized to prevent dumped waste rock from leaving it's intended placement location. The berms appear to be functioning exactly how they were designed and can be seen in Photo Seven. The lowest catchment berm also serves as a storm water control structure leading to a sediment trap. The berm showed evidence of recent flow and the sediment trap contained minimal standing water, with evidence of recent containment. The catchment can be seen in Photo Eight.
