Aerial for Bowie #2 September inspection

PERMIT INFORMATION

Permit Number: C-1996-083 Mine Name: Bowie No. 2 Mine Operator: Bowie Resources, LLC Operator Address: Mr. Basil Bear P.O. Box 1488 Paonia, CO 81428	County: Delta Operation Type: Underground Permit Status: Active Ownership: Private
	Operator Representative Present: None
Operator Representative Signature: (Field Issuance Only)

Inspection Start Date: September 8, 2021 Inspection Start Time: 10:25 Inspection End Date: September 8, 2021 Inspection End Time: 10:35		Inspection Type: Aerial Inspection Inspection Reason: Normal I&E Program Weather: Clear	
Joint Inspection Agency: None		Joint Inspection Contacts: 	
Post Inspection Agency: None		Post Inspection Contacts: 	
Inspector(s): Robert Zuber, P.E. Brock Bowles	Inspector's Signature: <i>Robert D. Zuber</i>		Signature Date: 9/9/2021

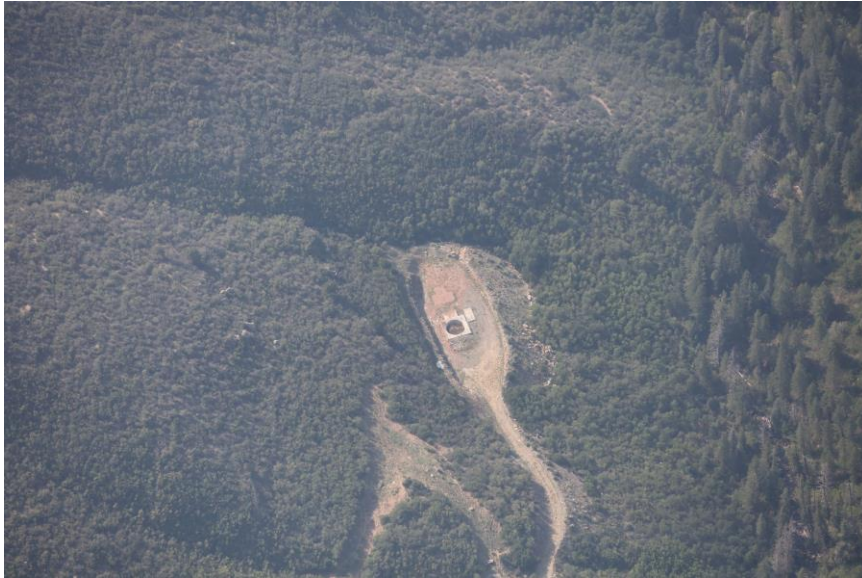
Pad for Terror Creek Vent Shaft

The pad for the Terror Creek Vent Shaft was inspected. No problems were identified. Also, no problems were seen at the pads for GVB-B17A, GVB-B17B, GVB-B17C, or GVB-B17D.

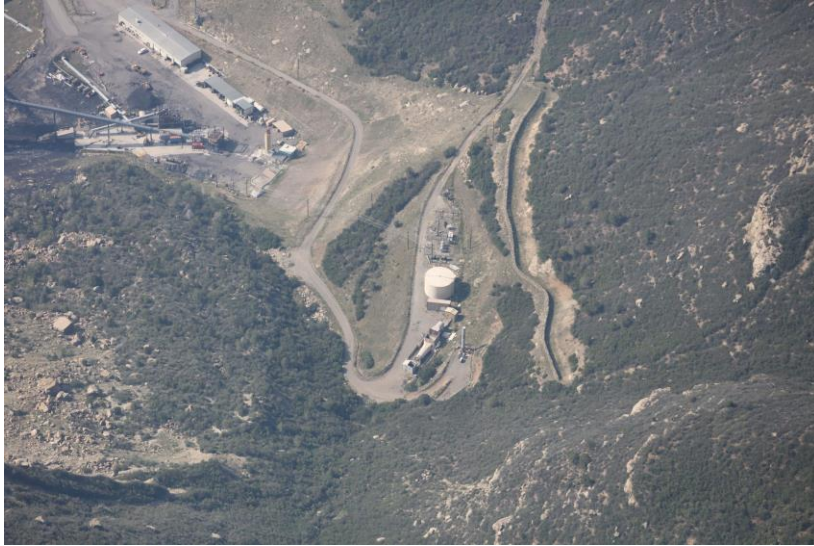
Utility Bench with rock fall protection berm

No problems were identified with any facility areas, including the following: the Utility Bench, the D Portal Bench, the B Portal Bench, the Material Storage Area by Curve #4, the Conveyor Corridor, the Coal Stockpile Pad, the office, the Preparation Plant area, the storage area and buildings near Pond D, the Pump House and Filter Building, the train loadout area.

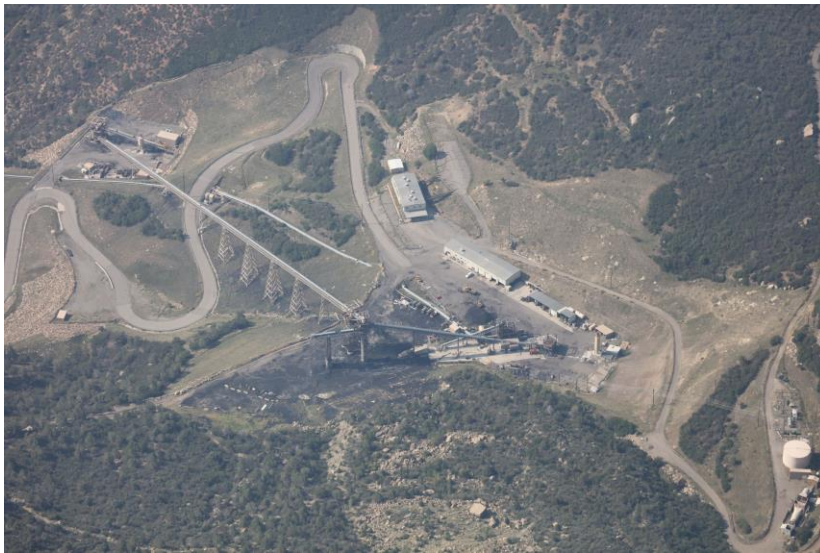
Benches for Portals B and D and upper part of access road

The slumps above the B Portal Bench and at Curve 11 have not worsened in recent weeks.

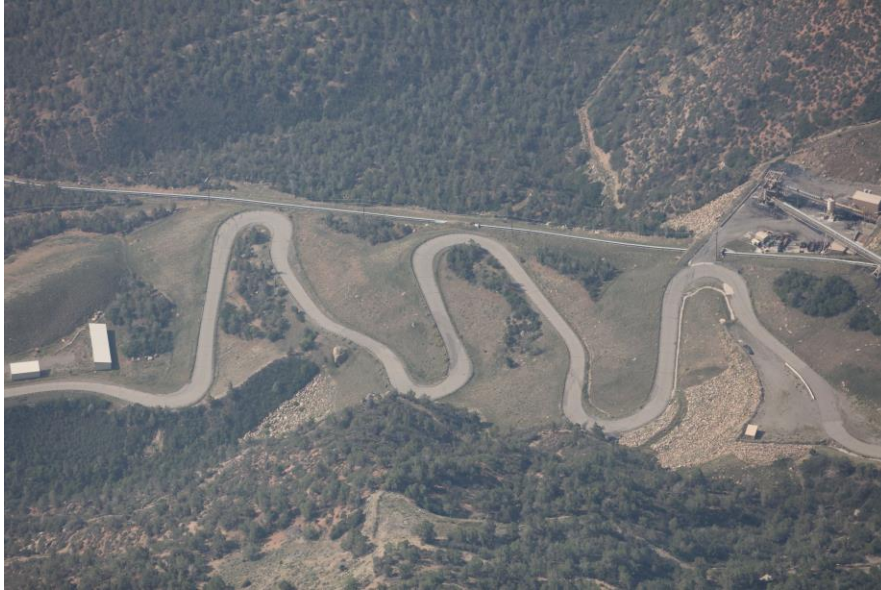
Road to portal benches

No problems were seen with any roads.

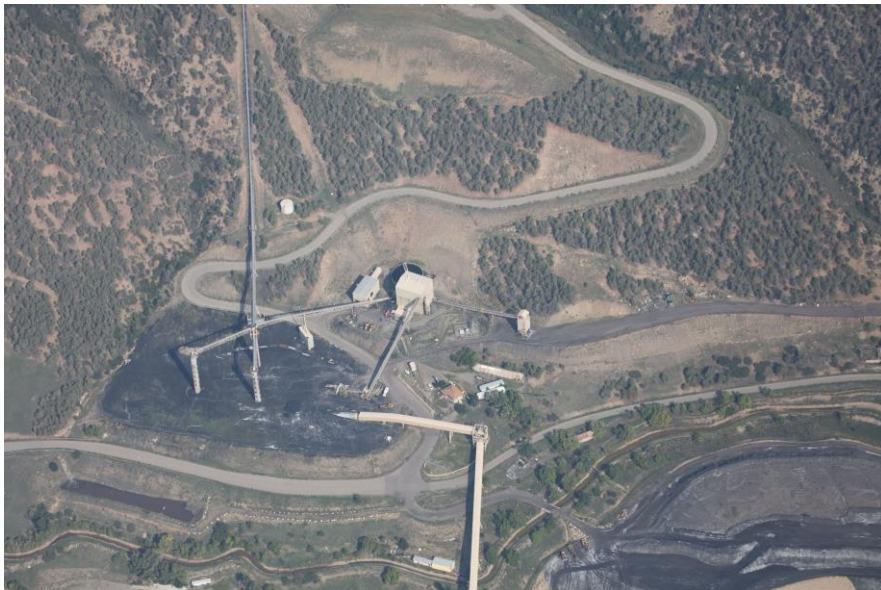
Facilities and Pond B

The following ponds were inspected: B, C, D, F, J, and K. All of these ponds appeared to contain water. No problems were identified with embankments or other features of the ponds.

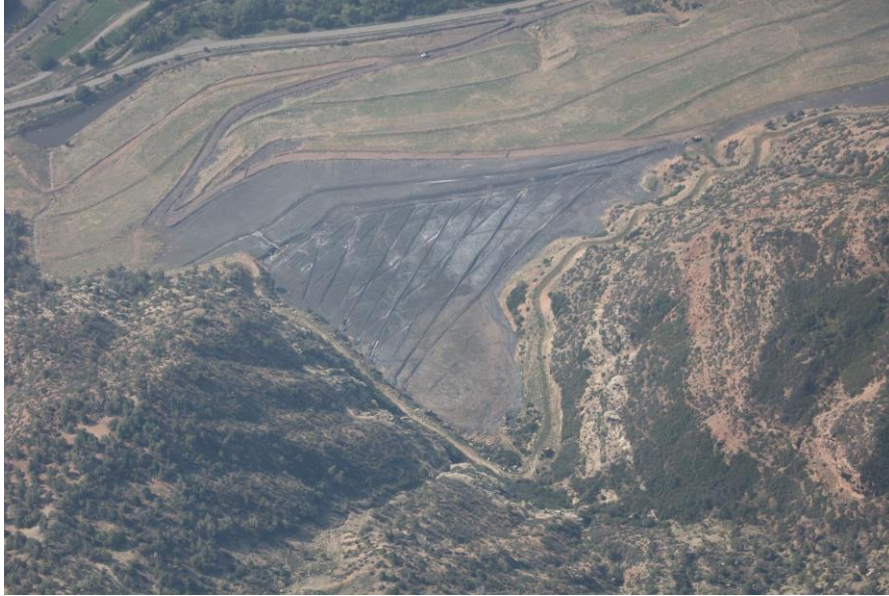
Minor erosion on Gob Pile #2 and Gob Pile #3 does not appear to be a problem, and there is no sign of significant coal waste in the ditch below Gob Pile #3 (Ditch J3).

Gob Pile #1, Gob Pile #4, and the reclaimed portion of Gob Pile #2 all appear to be in adequate condition with minimal areas that are bare. The hillsides along the access road to the mine portals and Utility Bench appear to be in good condition. No signs of erosion can be seen in the photographs.

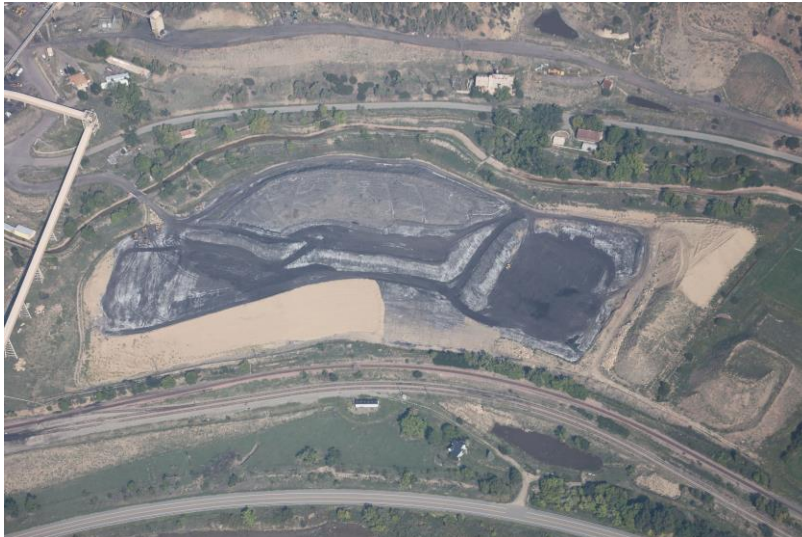
Gob Pile #3, soil piles, and Pond J

No erosion or other issues were identified at soil piles.
