COLORADO
Division of Reclamation,
Mining and Safety
Department of Natural Resources

Permit Number: C-1981-038 Mine Name: Bowie No. 1 Mine Operator: Bowie Resources, LLC Operator Address: Mr. Basil R Bear P.O. Box 1488 Paonia, CO 81428	County: Delta Operation Type: Underground Permit Status: Active Ownership: Private
	Operator Representative Present: None
Operator Representative Signature: (Field Issuance Only)

Inspection Start Date: September 8, 2021 Inspection Start Time: 10:15 Inspection End Date: September 8, 2021 Inspection End Time: 10:25		Inspection Type: Aerial Inspection Inspection Reason: Normal I&E Program Weather: Clear	
Joint Inspection Agency: None		Joint Inspection Contacts:	
Post Inspection Agency: None		Post Inspection Contacts:	
Inspector(s): Robert Zuber, P.E. Brock Bowles	Inspector's Signature:

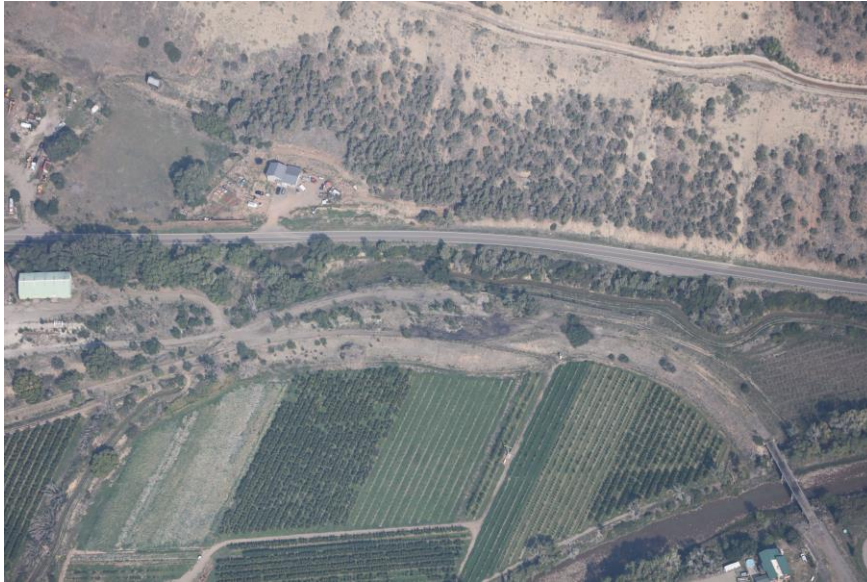
The ponds at the West Mine were completely dry. No problems were seen with the embankments or other portions of these ponds. The pond at the loadout also appeared to have no problems.

No erosion or other problems were identified at the loadout. This includes the eastern portion, along the UPRR tracks and adjacent to Grange Road and Black Bridge Road.

Loadout – pond and ends of 600' culvert

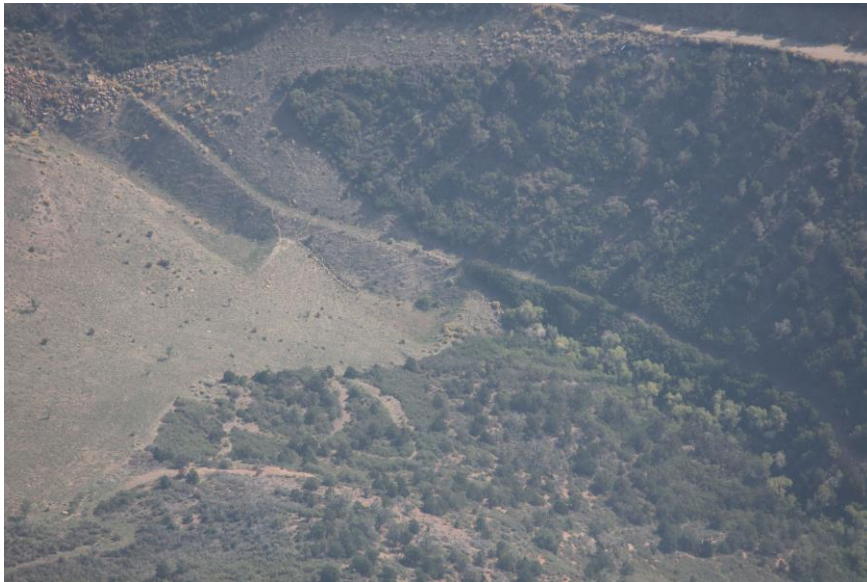
The West Mine was inspected, especially the ponds and other areas near the creek. No erosion problems were identified.

West Mine ponds
