MINERALS PROGRAM INSPECTION REPORT
PHONE: (303) 866-3567

MINE NAME: Sunny Dale Farm Pit	MINE/PROSPECTING ID#: M-1998-059	MINERAL: Gravel	COUNTY: Phillips
INSPECTION TYPE: Surety Release Inspection	INSPECTOR(S): Brock Bowles	INSP. DATE: August 25, 2021	INSP. TIME: 13:00
OPERATOR: L & L Ready Mix	OPERATOR REPRESENTATIVE: Mike Koellner	TYPE OF OPERATION: 112c - Construction Regular Operation	
REASON FOR INSPECTION: Surety Release Requested	BOND CALCULATION TYPE: None	BOND AMOUNT: \$30,000.00	
DATE OF COMPLAINT: NA	POST INSP. CONTACTS: None	JOINT INSP. AGENCY: None	
WEATHER: Clear	INSPECTOR'S SIGNATURE:

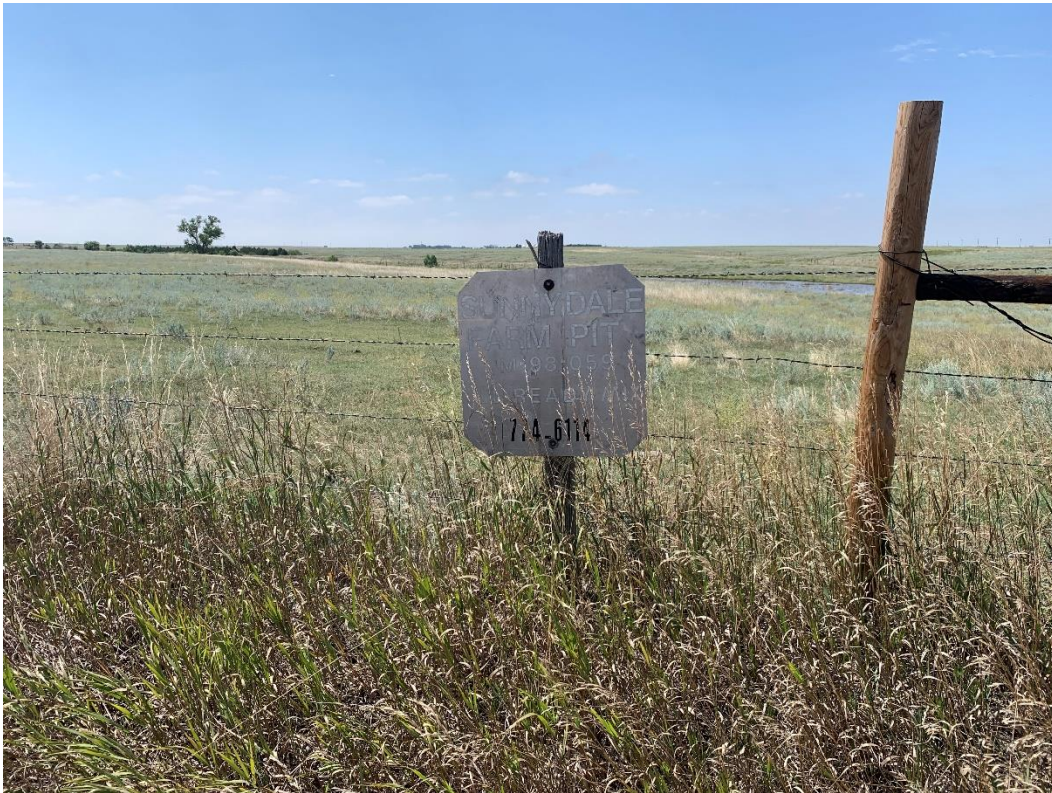
The permit identification sign was in place at the mine entrance and legible (photo 1). No mining activity was being conducted and no equipment was on site. The entrance gate was locked upon arrival and several bulls were in the pasture where the mine site is located.

Photo 1 – Mine entrance sign facing CR 23

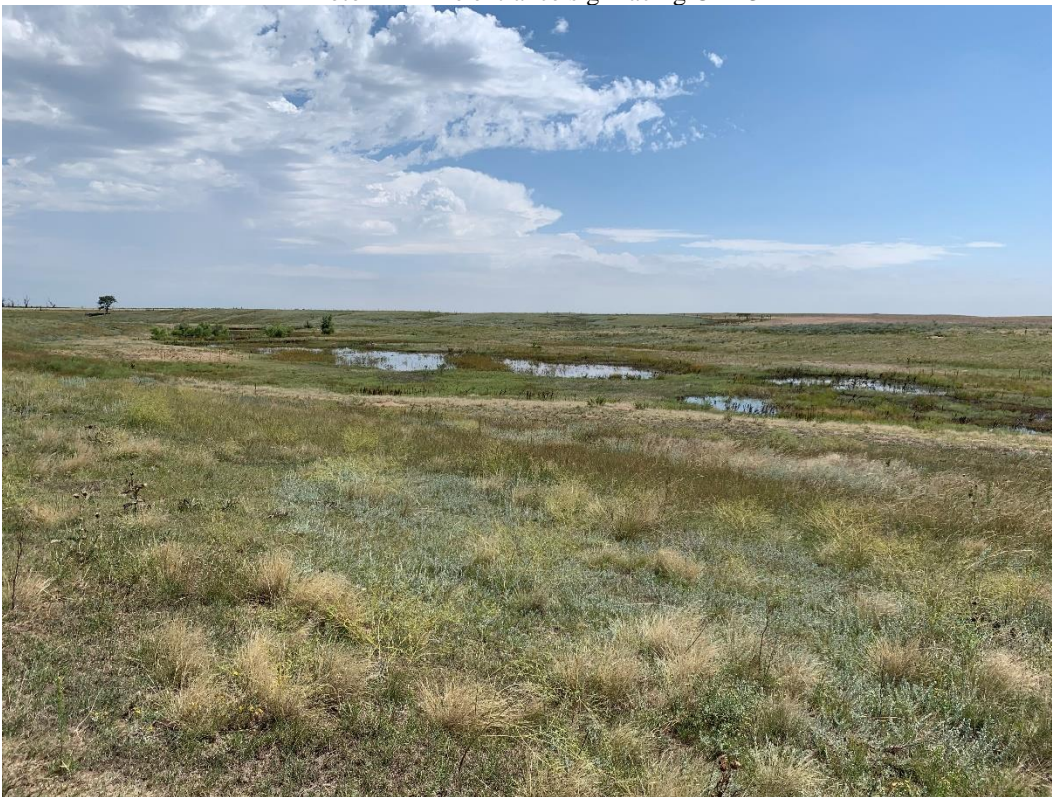
The site is located in the south fork of Frenchman Creek. Frenchman Creek is an ephemeral creek that had some standing water in it at during this inspection (photo 2). The area had gotten several inches of rain within the last two days. According to Mr. Koellner the area received about 4 inches. Areas outside the mining permit were also heavily impacted by the recent rain event indicating it was a significant event. It was noted that an adjacent farmer's field had significant erosion, a culvert under the road was damaged and two plowed fields had standing water.

Photo 2 – Some standing water in Frenchman Creek

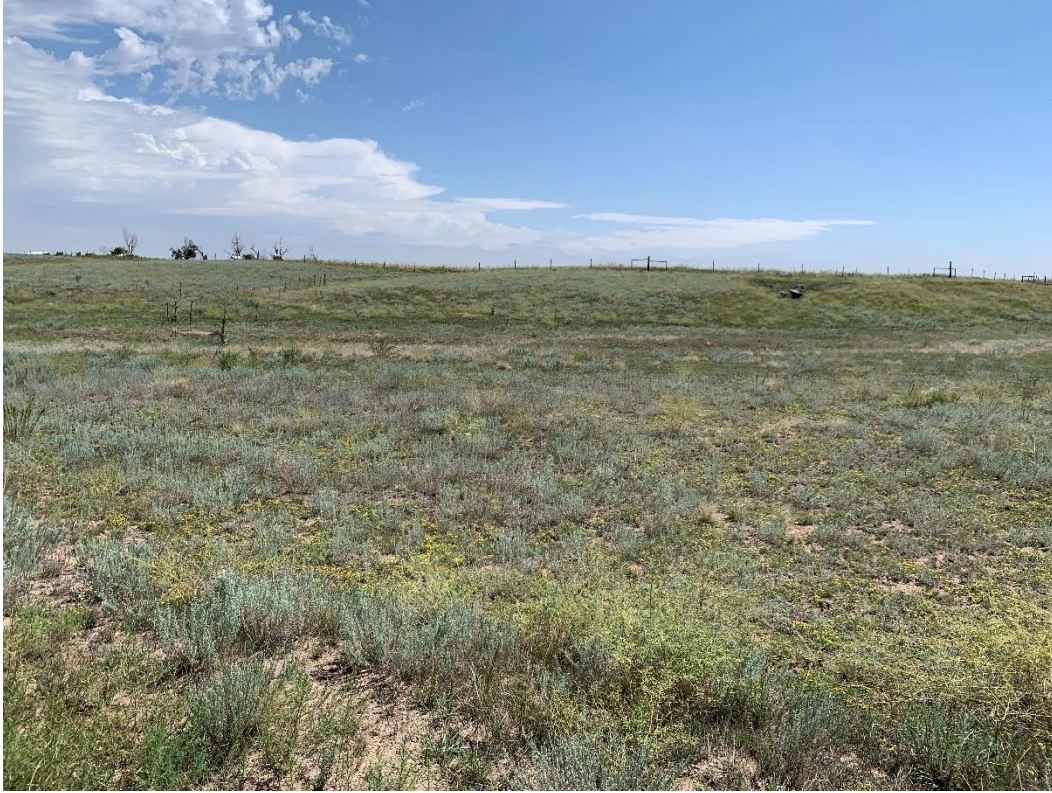
The creek banks of the mined area were graded to 3h:1v, blended in well with the surrounding landscapes and appeared to be stable. There were no signs of erosion. The vegetation was well established on the creek bottom, banks and was consistent with the surrounding areas (Rule 3.1.10(1)) (photos 3 & 4). A couple of musk thistles and mullein plants were seen. These plants are List B and C (respectively) Colorado Noxious weeds and should be treated. The population of both plants was very sparse.

Photo 3 – Frenchman Creek bottom and banks- east side

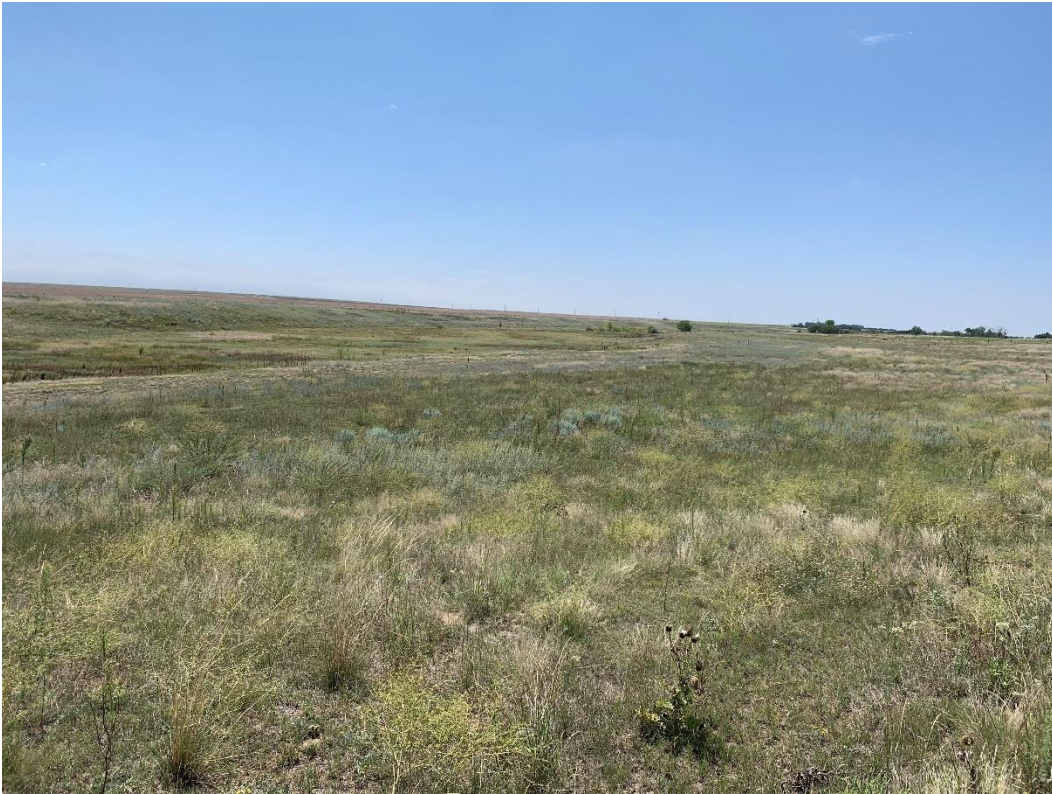
Photo 4 – Frenchman Creek, west end of mine
