MINERALS PROGRAM INSPECTION REPORT
PHONE: (303) 866-3567

MINE NAME: Baculite Mesa Pit	MINE/PROSPECTING ID#: M-1997-011	MINERAL: Sand and Gravel	COUNTY: Pueblo
INSPECTION TYPE: Monitoring	INSPECTOR(S): Patrick Lennberg	INSP. DATE: August 26, 2021	INSP. TIME: 09:00
OPERATOR: Baculite Mesa, LLC	OPERATOR REPRESENTATIVE: Steve O'Brian	TYPE OF OPERATION: 112c - Construction Regular Operation	
REASON FOR INSPECTION: Normal I&E Program	BOND CALCULATION TYPE: Complete Bond	BOND AMOUNT: \$60,000.00	
DATE OF COMPLAINT: NA	POST INSP. CONTACTS: None	JOINT INSP. AGENCY: None	
WEATHER: Clear	INSPECTOR'S SIGNATURE:

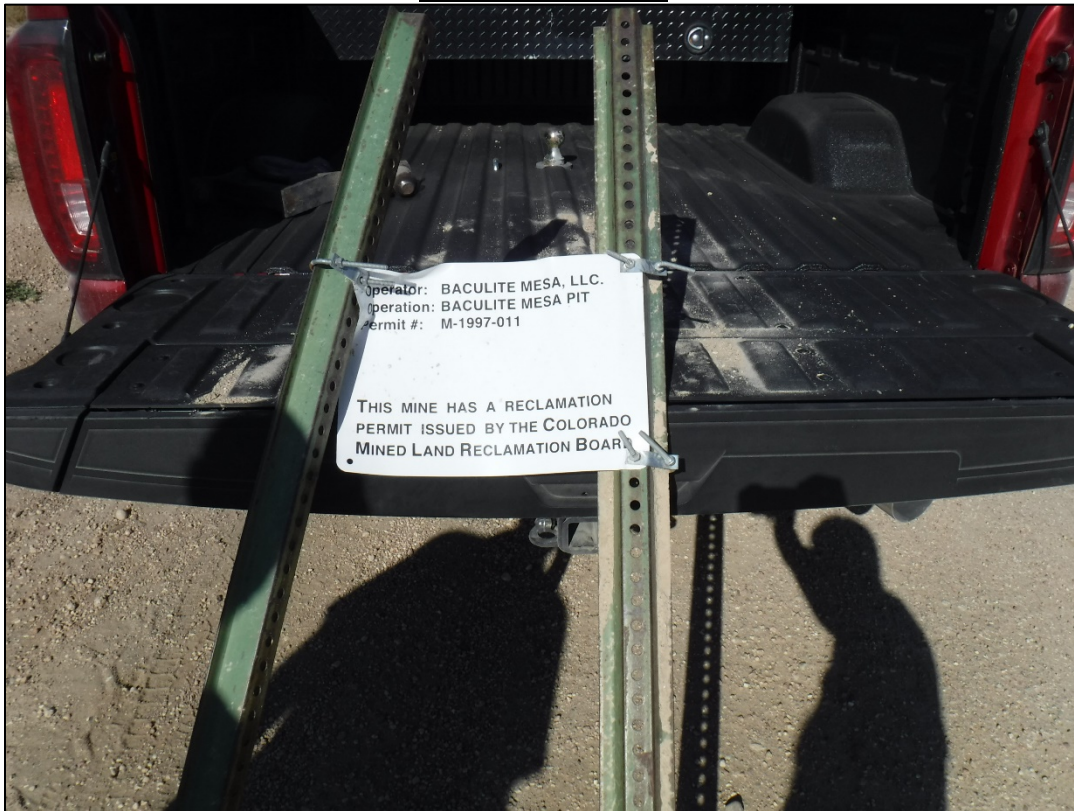
The Baculite Mesa Pit is a Construction Materials 112c Operation and is permitted at 1,970 acres, with all those acres identified as affected land and only 40 acres are approved to be disturbed at any one time. The pit is located on land owned by Baculite Mesa, LLC. The site is located approximately 3 miles northeast of Pueblo in Pueblo County and the mine entrance is on the east side of Baculite Mesa Road. Affected lands will be reclaimed to support a post-mining land use of rangeland. A mine sign was not posted at the mine entrance because it was in the process of being relocated but the mine sign was viewed.

Photo 1: Mine sign to be placed at entrance to mine site

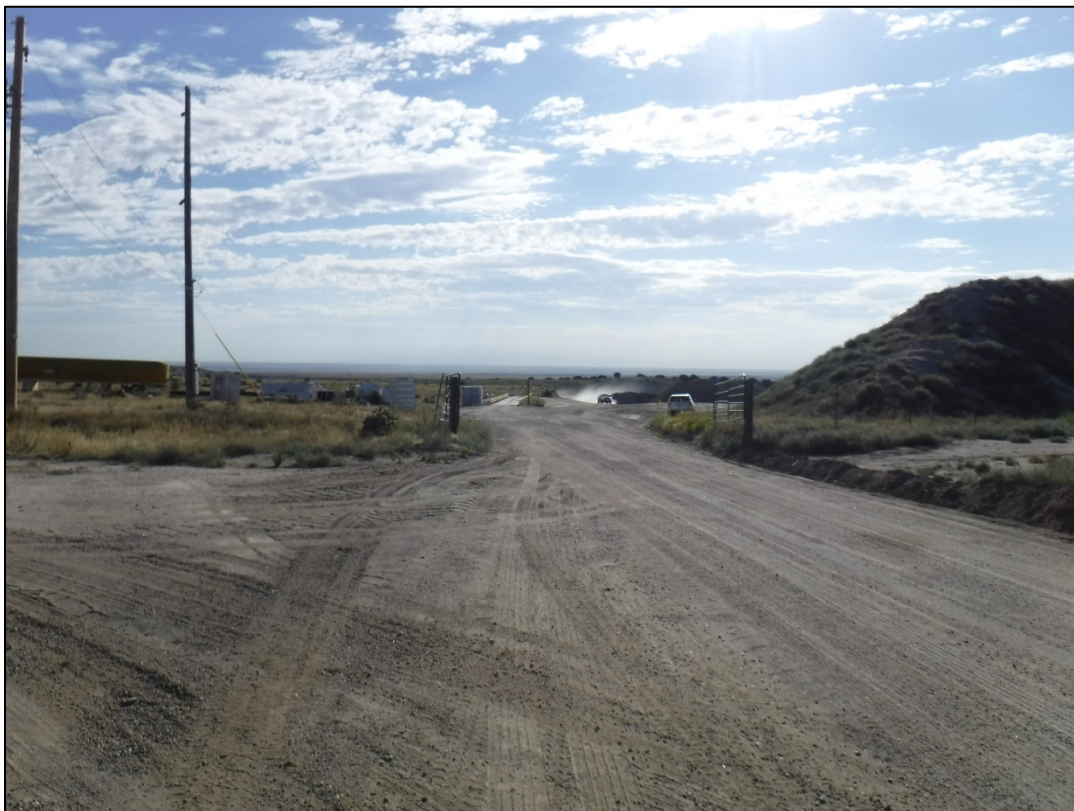
Photo 2: Primary mine entrance

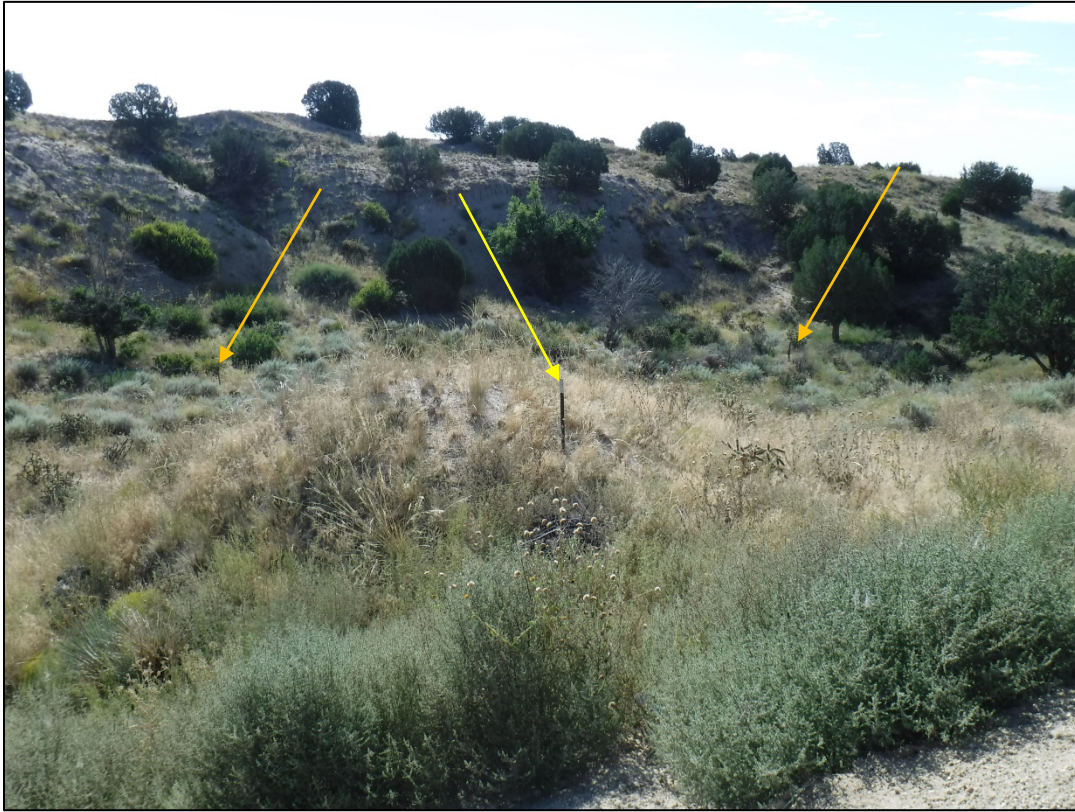
The site was not actively being mined at the time of inspection, however, there was a front end loader loading various haul trucks with stockpiled material. The permit boundary was delineated around the active portion of the site with metal tee posts, marking the 30 foot offset, and property fence lines marking the permit boundary.

Photo 3: Typical boundary markers, orange arrows are property/permit markers, yellow arrow is 30' offset

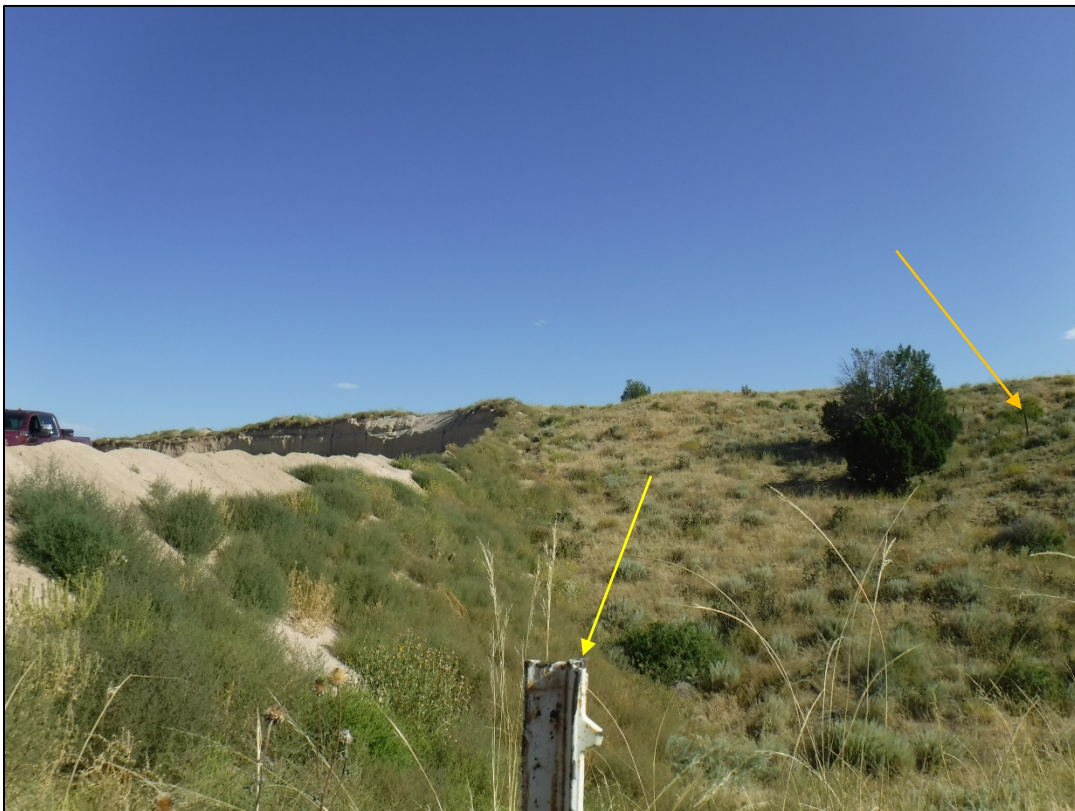
Photo 4: Salvaged growth medium/topsoil left portion of picture, orange arrow property/permit marker, yellow arrow is 30' offset boundary

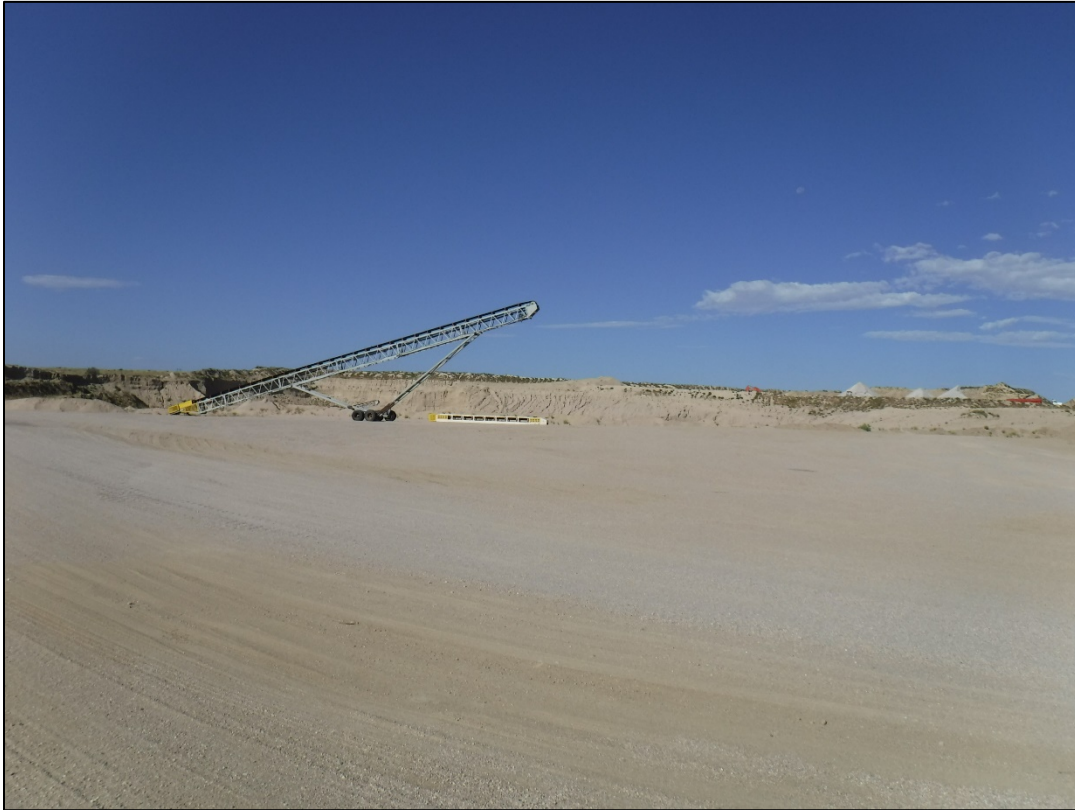
Photo 5: Looking west from the east side of the pit area

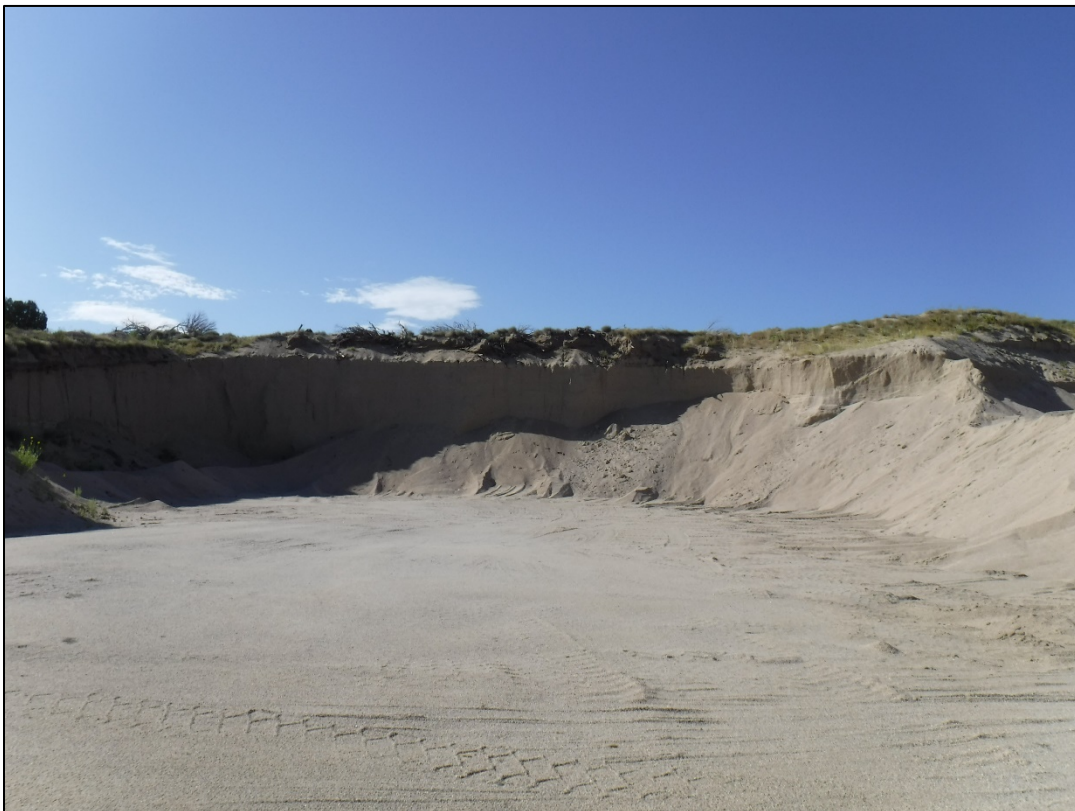
The disturbed area is approximately 38.9 acres according to the July 2021 annual report and map. The disturbed area consists of a single pit, approximately 30 to 40 feet deep. The permit is approved to have a highwall up to 1,500 feet long. The Division estimates the highwall to be near this length but not as a continuous highwall but several segments. Other side slopes of the pit have been graded to approximately 2H:1V or flatter. Various stockpiles of product are located at the toe of the western pit slope. Topsoil, approximately 28,500 cubic yards, has been stripped and is stockpiled along the western and southern sides of the pit.

Photo 6: Typical highwall configuration

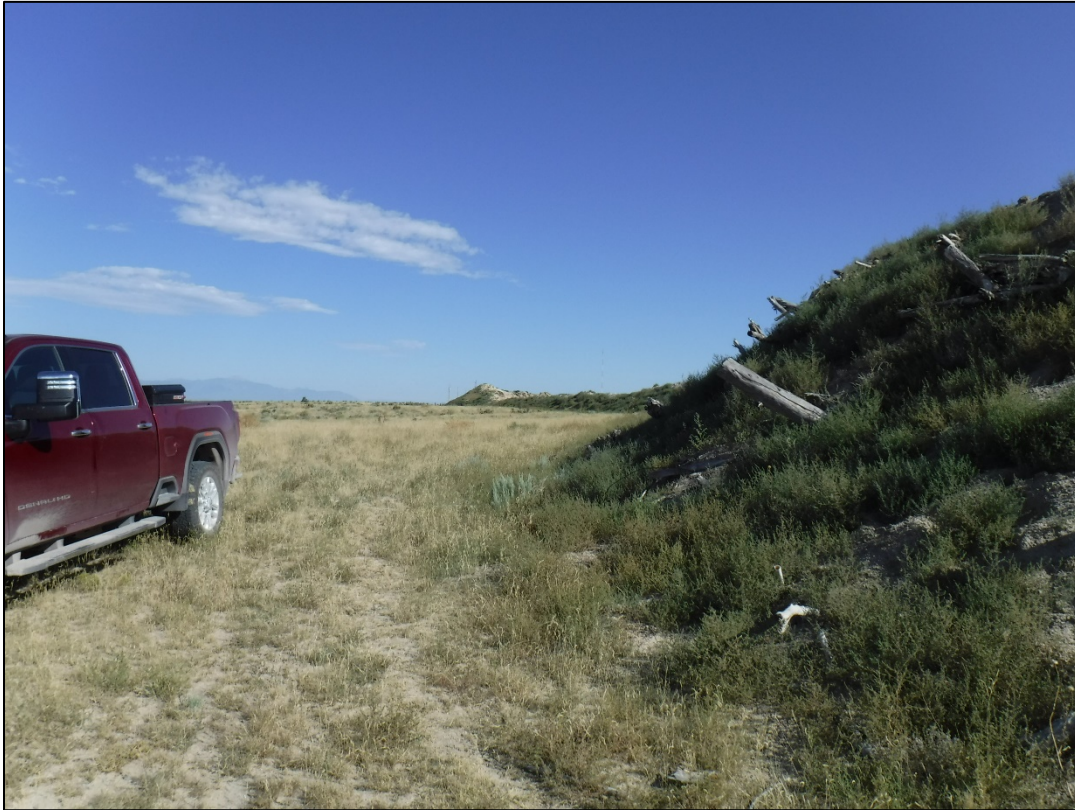
Photo 7: Growth medium/topsoil along the west side of pit area

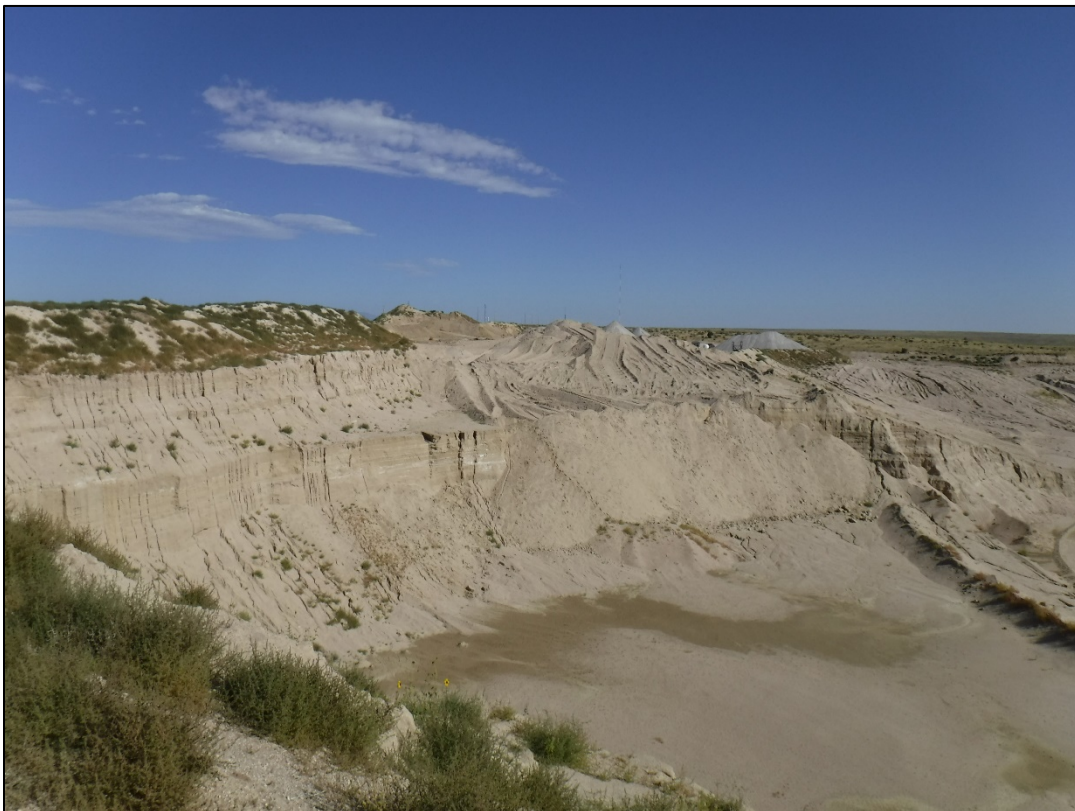
Photo 8: Highwall configuration near the southwestern corner of disturbed area, center background and right of picture the highwalls have been grade to 2V:1H or shallower

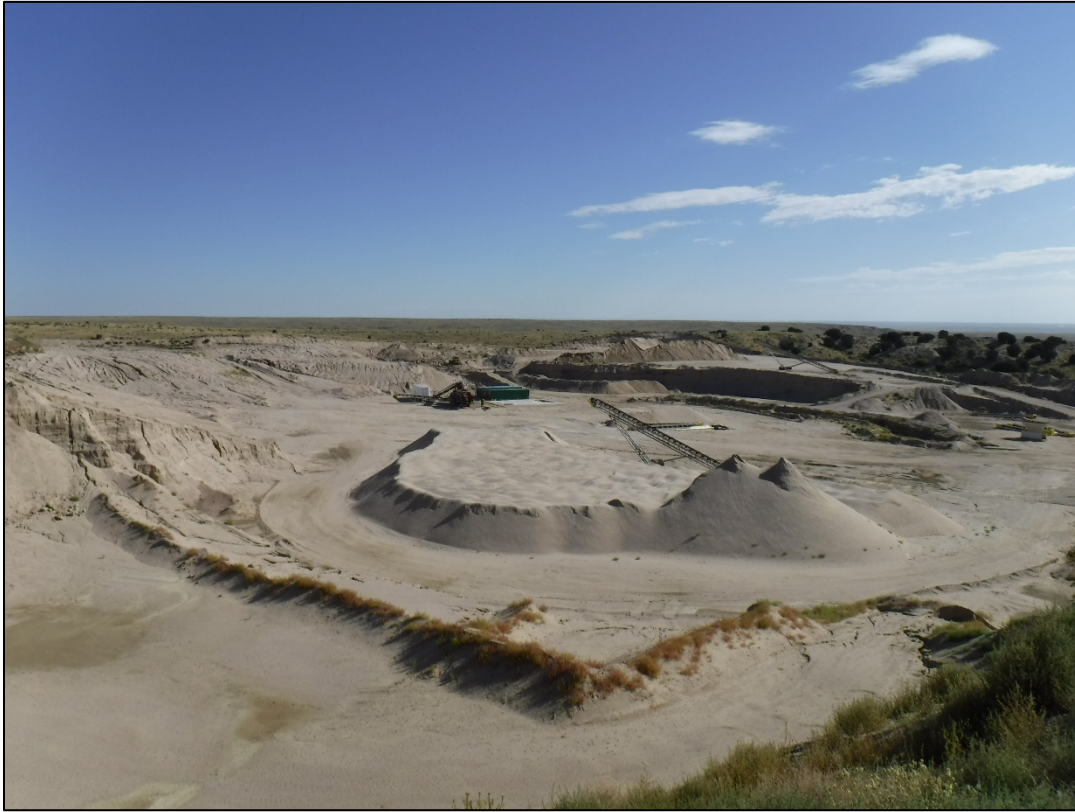
Photo 9: Looking northeast across the main pit area

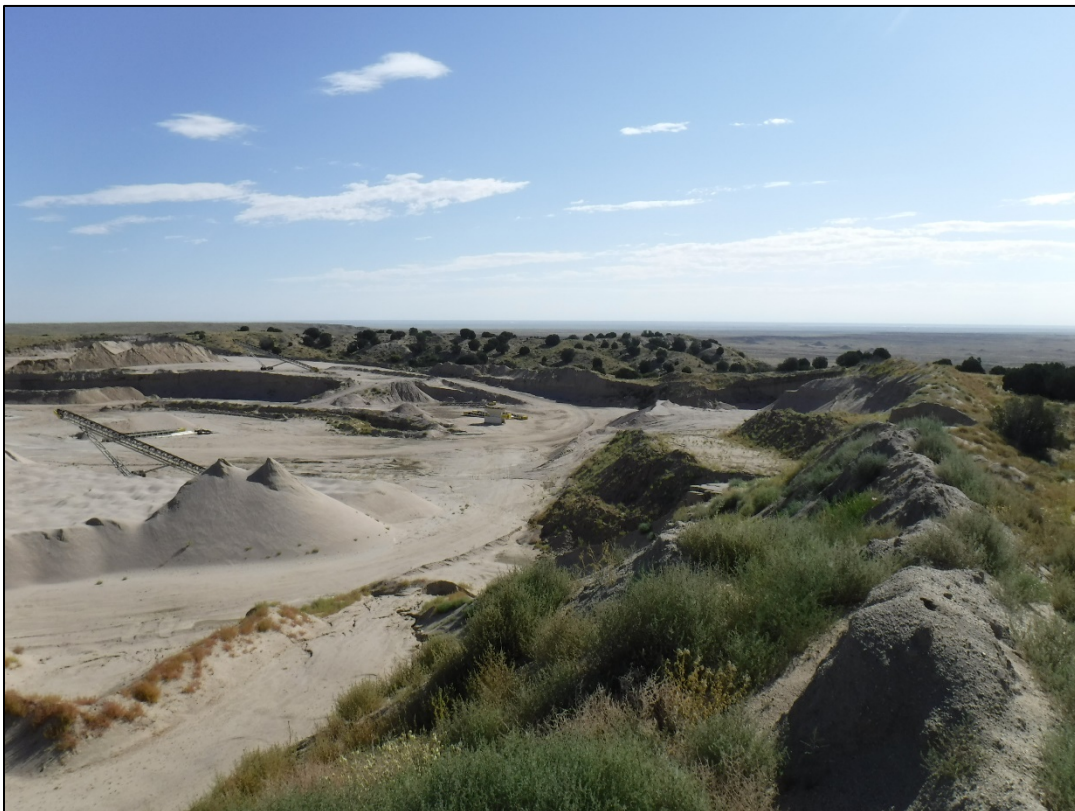
Photo 10: Looking east across the southern pit area

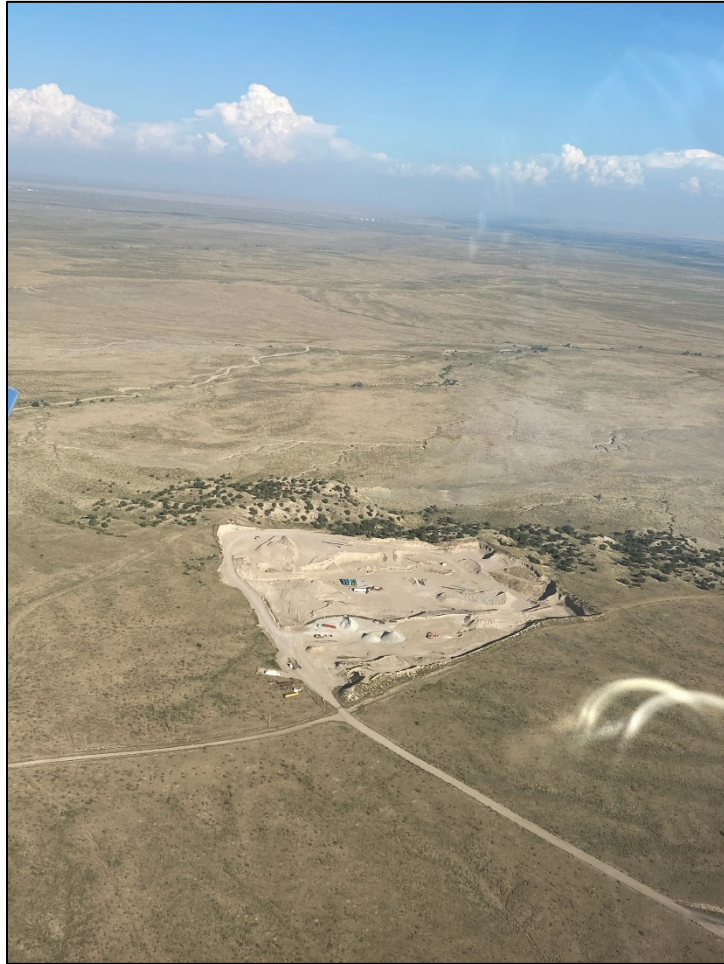
Photo 11: Aerial photo of mine site provided by operator, photo was taken a week prior to inspection

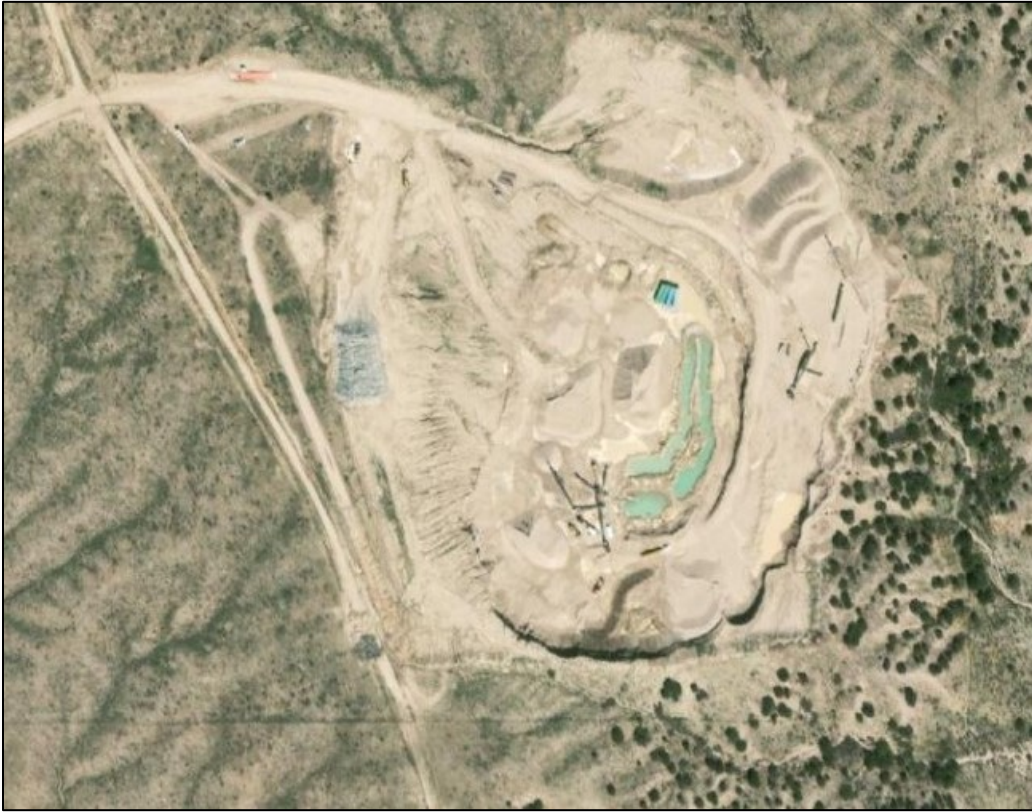
Photo 12: Aerial photo of mine site from the Pueblo County Assesor's website
