MINERALS PROGRAM INSPECTION REPORT
PHONE: (303) 866-3567

MINE NAME: Rancho Rosado	MINE/PROSPECTING ID#: M-1985-085	MINERAL: Sand and gravel	COUNTY: Saguache
INSPECTION TYPE: Monitoring	INSPECTOR(S): Dustin Czapl	INSP. DATE: August 17, 2021	INSP. TIME: 18:55
OPERATOR: Skoglund Excavating Inc.	OPERATOR REPRESENTATIVE: None	TYPE OF OPERATION: 112c - Construction Regular Operation	
REASON FOR INSPECTION: Normal I&E Program		BOND CALCULATION TYPE: None	
DATE OF COMPLAINT: NA		BOND AMOUNT: \$15,001.00	
POST INSP. CONTACTS: None		JOINT INSP. AGENCY: None	
WEATHER: Clear	INSPECTOR'S SIGNATURE:

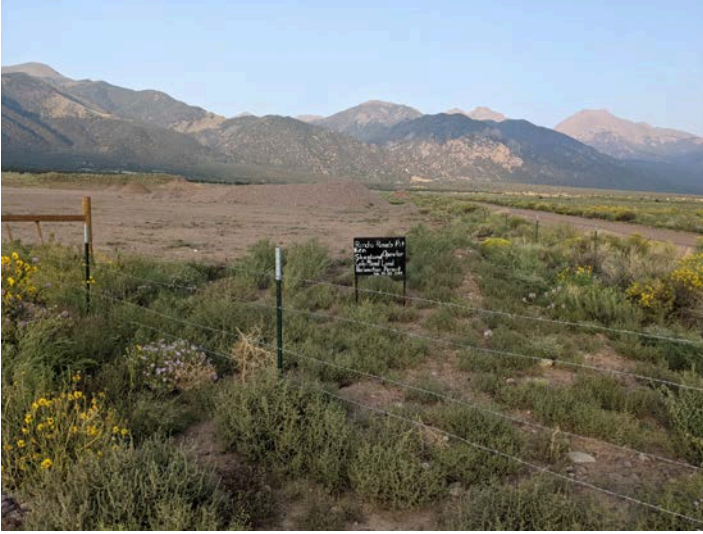
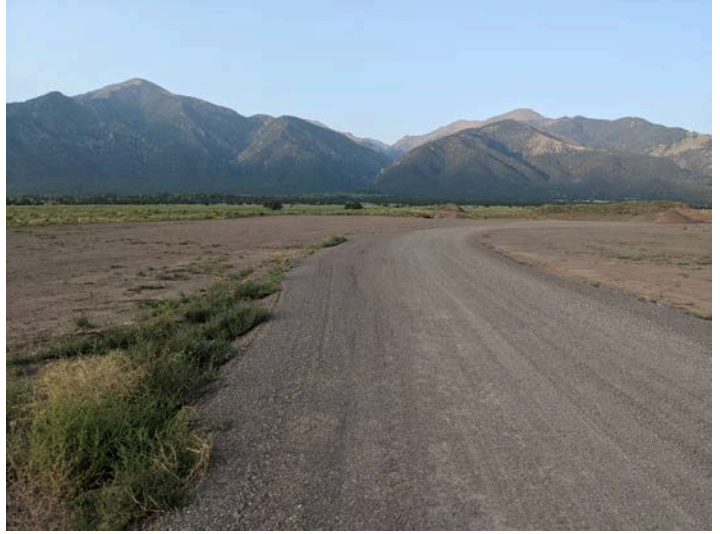
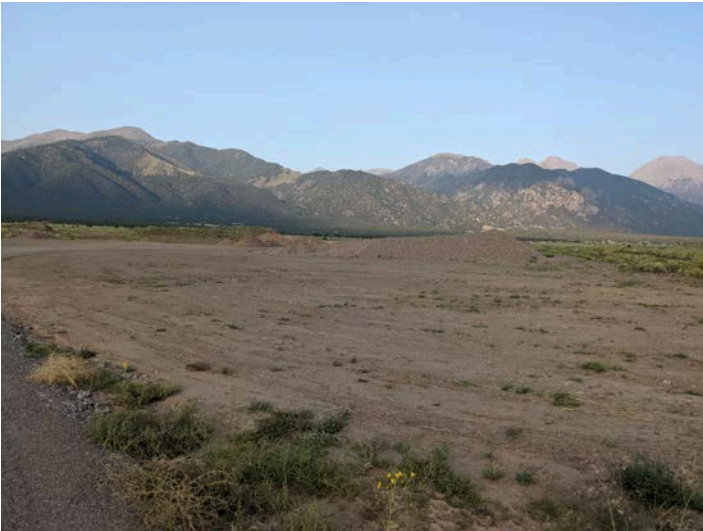
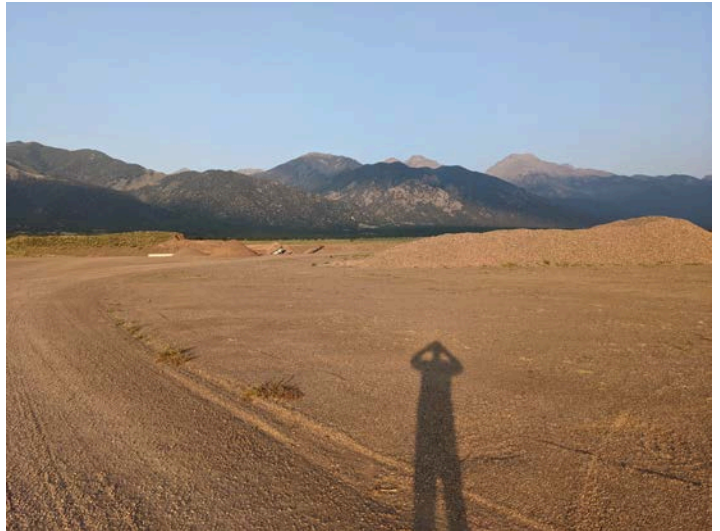
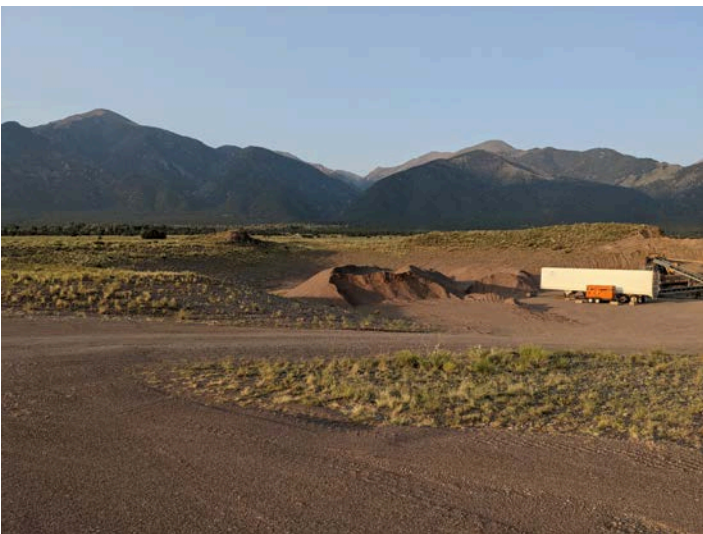
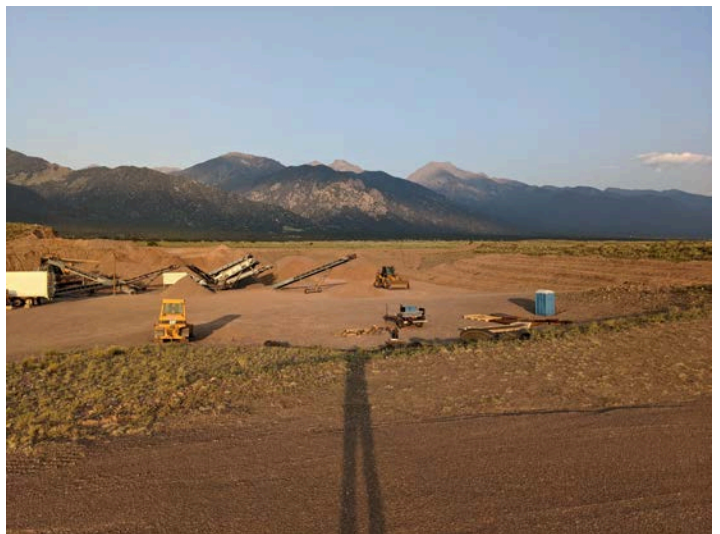
Approximately 8 acres are currently disturbed at the site. The pit has been excavated to a depth of approximately 20 feet. Slopes around the pit are graded to approximately 3H:1V. Materials stockpiles are located in the pit area. Crushing/processing equipment are located in the pit. Overall the site is orderly.
