MINERALS PROGRAM INSPECTION REPORT
PHONE: (303) 866-3567

MINE NAME: Swede Corners Pit	MINE/PROSPECTING ID#: M-1988-087	MINERAL: Sand and gravel	COUNTY: Saguache
INSPECTION TYPE: Monitoring	INSPECTOR(S): Dustin Czapl	INSP. DATE: August 18, 2021	INSP. TIME: 13:00
OPERATOR: Southway Construction Company, Inc.	OPERATOR REPRESENTATIVE: None	TYPE OF OPERATION: 110c - Construction Limited Impact	
REASON FOR INSPECTION: Normal I&E Program	BOND CALCULATION TYPE: Complete Bond	BOND AMOUNT: \$11,270.00	
DATE OF COMPLAINT: NA	POST INSP. CONTACTS: None	JOINT INSP. AGENCY: None	
WEATHER: Clear	INSPECTOR'S SIGNATURE:

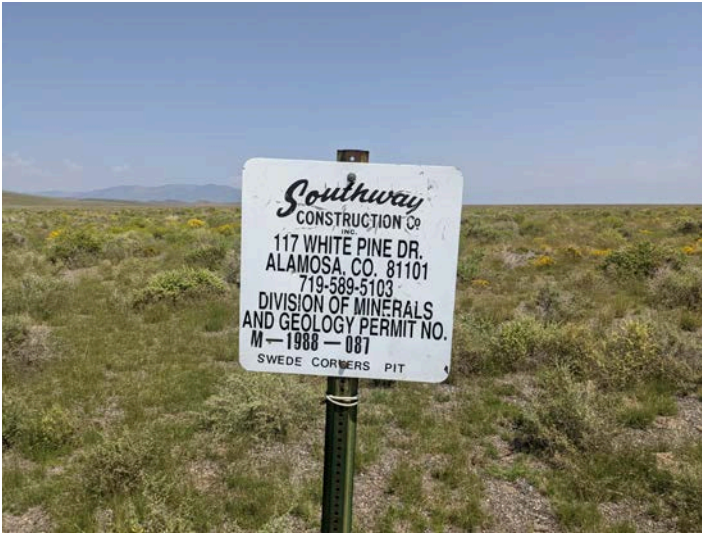
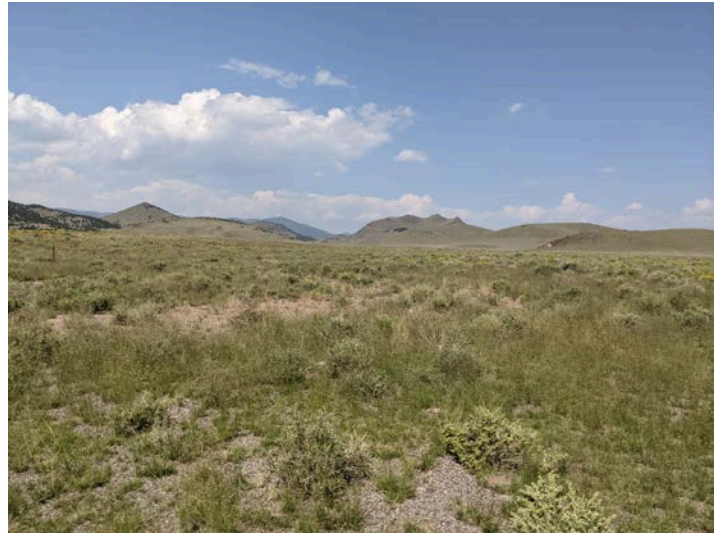
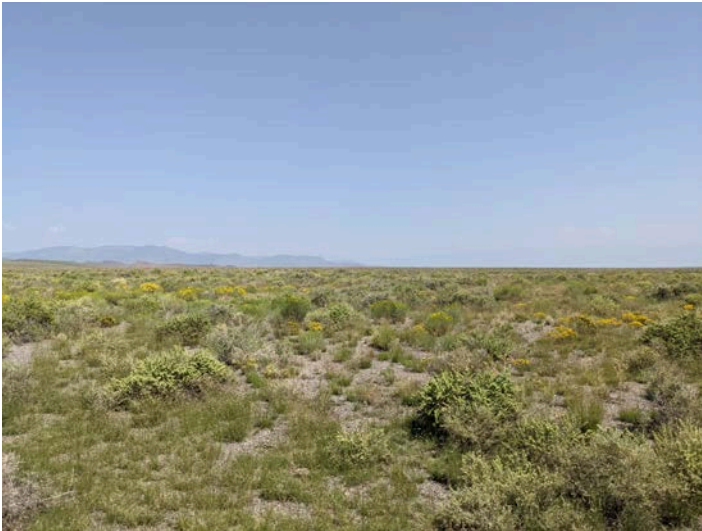
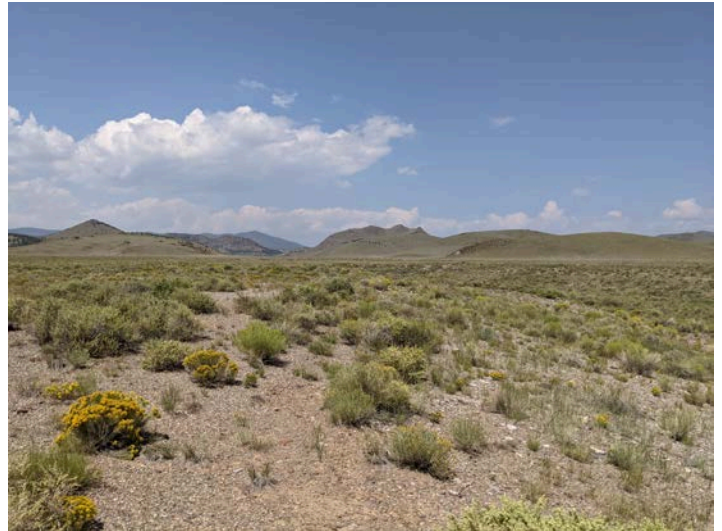
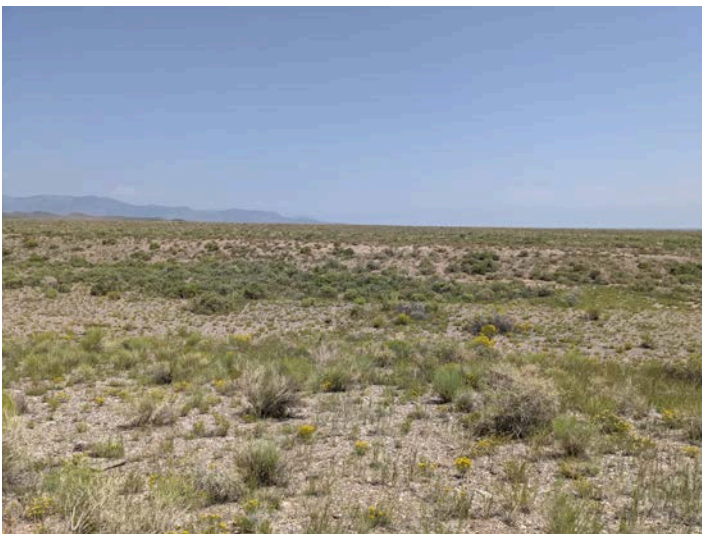
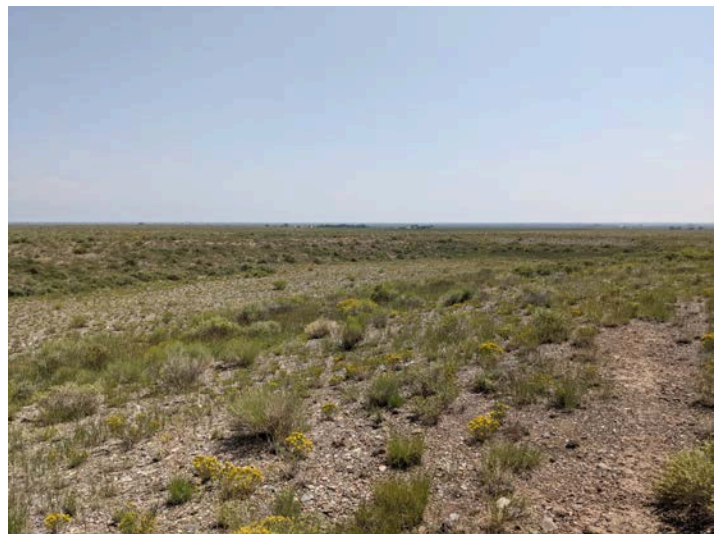
The site is in final reclamation. All but 0.60 acres of the 9.90 acre permit area was released from further reclamation responsibility on January 9, 2017 through approval of AR-01. Observations made during this inspection determined that vegetation is well established over the affected area and that coverage appears equal in extent to that of the surrounding area.
