MINERALS PROGRAM INSPECTION REPORT
PHONE: (303) 866-3567

MINE NAME: Clayton Sand and Gravel	MINE/PROSPECTING ID#: M-1999-022	MINERAL: Sand and gravel	COUNTY: Saguache
INSPECTION TYPE: Monitoring	INSPECTOR(S): Dustin Czaplá	INSP. DATE: August 18, 2021	INSP. TIME: 10:45
OPERATOR: Eddie Clayton	OPERATOR REPRESENTATIVE: None	TYPE OF OPERATION: 110c - Construction Limited Impact	
REASON FOR INSPECTION: Normal I&E Program	BOND CALCULATION TYPE: Complete Bond	BOND AMOUNT: \$7,900.00	
DATE OF COMPLAINT: NA	POST INSP. CONTACTS: None	JOINT INSP. AGENCY: None	
WEATHER: Clear	INSPECTOR'S SIGNATURE:

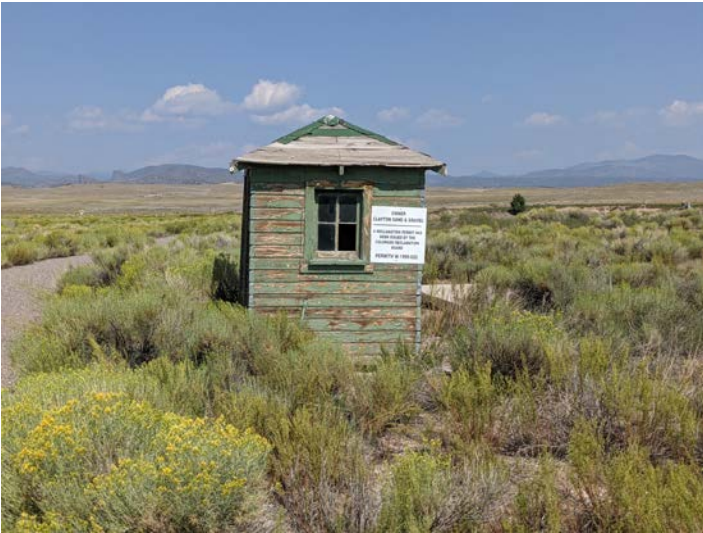
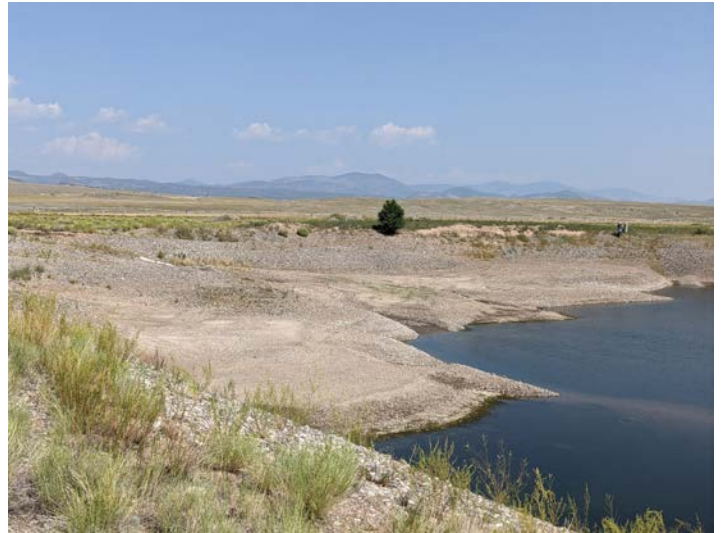
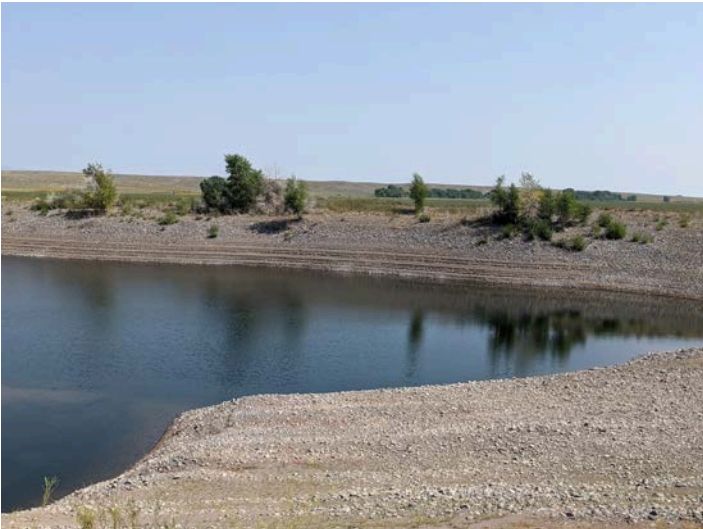
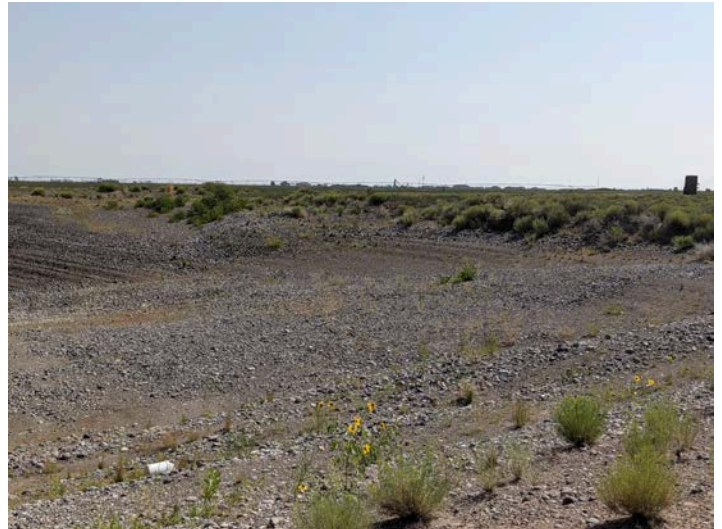
Adequate mine identification signage was noted at the entrance to the site.

Mining disturbance appears to be contained within the approved permit area boundary.

The pit slopes appear stable and have been graded to approximately 3H:1V. The slopes have not yet received topsoil or seeding. Native vegetation in disturbed areas around the pit perimeter is well established.
