MINERALS PROGRAM INSPECTION REPORT
PHONE: (303) 866-3567

MINE NAME: Hooper Pit	MINE/PROSPECTING ID#: M-2020-024	MINERAL: Sand and gravel	COUNTY: Saguache
INSPECTION TYPE: Monitoring	INSPECTOR(S): Dustin Czaplá	INSP. DATE: August 18, 2021	INSP. TIME: 09:50
OPERATOR: APC Southern Construction Co., LLC	OPERATOR REPRESENTATIVE: None	TYPE OF OPERATION: 111 - Construction by Government Agency	
REASON FOR INSPECTION: Normal I&E Program	BOND CALCULATION TYPE: Complete Bond	BOND AMOUNT: \$20,000.00	
DATE OF COMPLAINT: NA	POST INSP. CONTACTS: None	JOINT INSP. AGENCY: None	
WEATHER: Clear	INSPECTOR'S SIGNATURE:

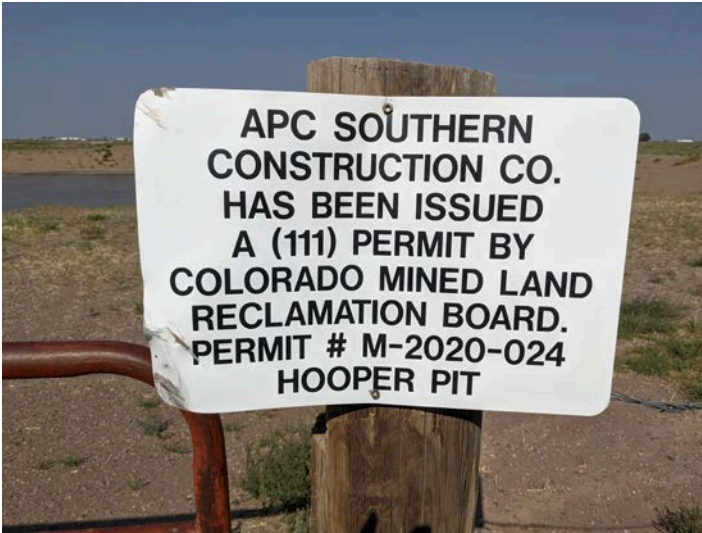
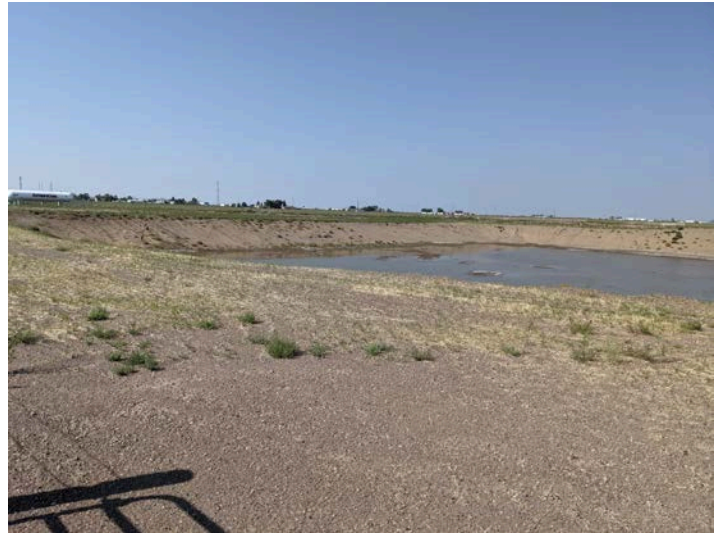
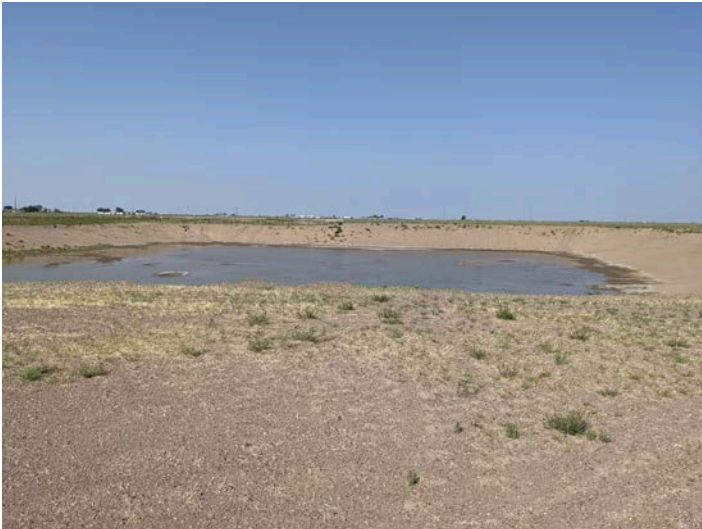
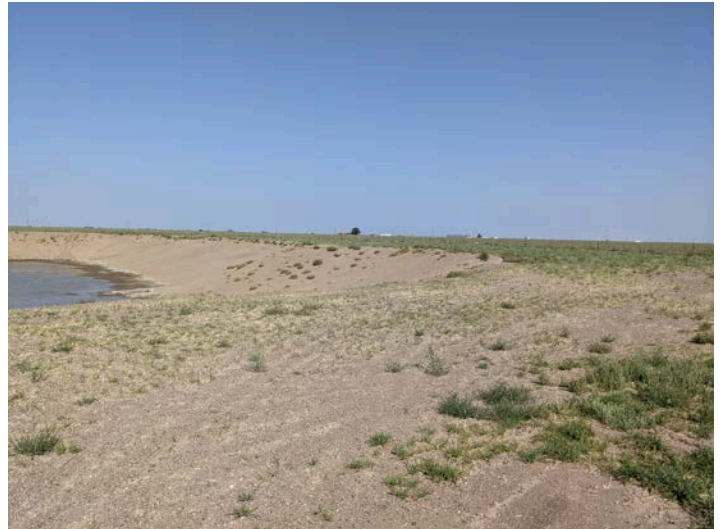
Adequate mine identification signage was noted at the entrance to the site.

The affected area was marked by fencing that was clearly visible and adequate to delineate the affected area boundary.

Mining is complete at the site. Reclamation grading has occurred and the pit slopes are graded to approximately 3H:1V. It appeared that seeding had occurred but the disturbed area is not well vegetated yet. Standing water was observed in the pit floor. It is unclear at this time whether the mining has exposed groundwater, or if this is irrigation water from adjacent fields. This is something that will need to be monitored by the operator in order to determine if groundwater has been exposed. If so, backfilling the pit to an elevation two feet above the static groundwater level will be required.
