**MINERALS PROGRAM INSPECTION REPORT**  
**PHONE: (303) 866-3567**

<b>MINE NAME:</b> Hollenbeck Pit	<b>MINE/PROSPECTING ID#:</b> M-1985-023	<b>MINERAL:</b> Sand and gravel	<b>COUNTY:</b> Gunnison
<b>INSPECTION TYPE:</b> Monitoring	<b>INSPECTOR(S):</b> Dustin Czapla	<b>INSP. DATE:</b> August 17, 2021	<b>INSP. TIME:</b> 12:30
<b>OPERATOR:</b> Duane E. Hollenbeck	<b>OPERATOR REPRESENTATIVE:</b>	<b>TYPE OF OPERATION:</b> 110c - Construction Limited Impact

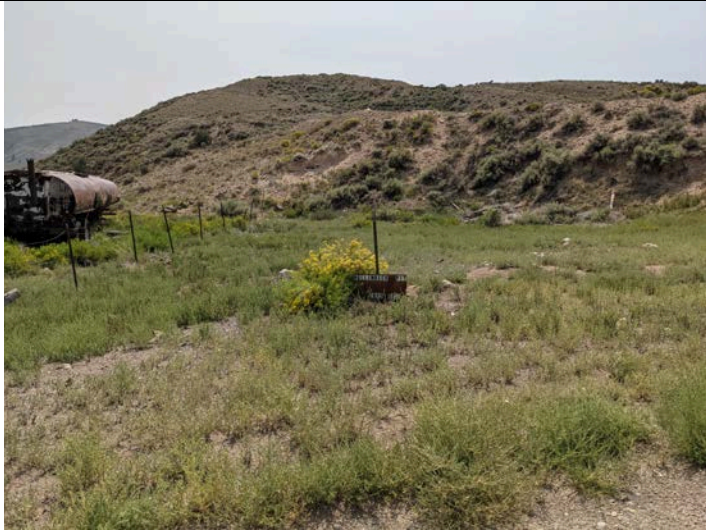
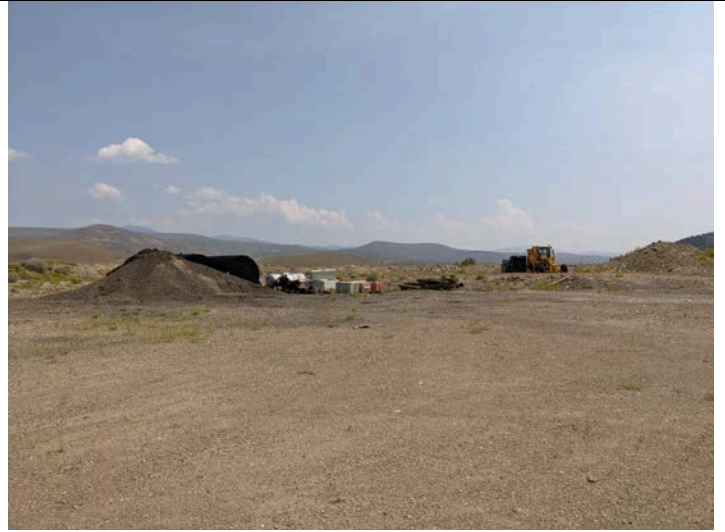
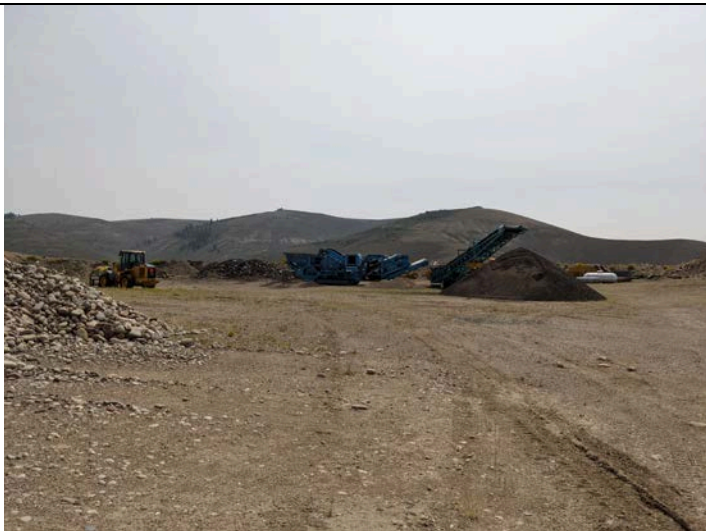
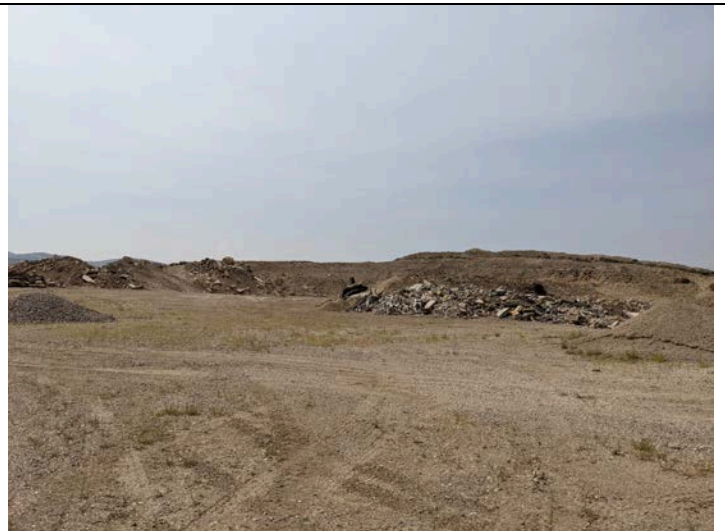
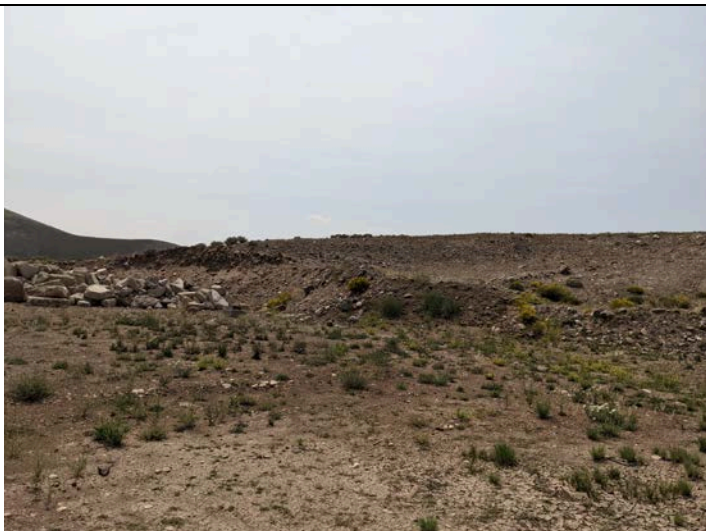
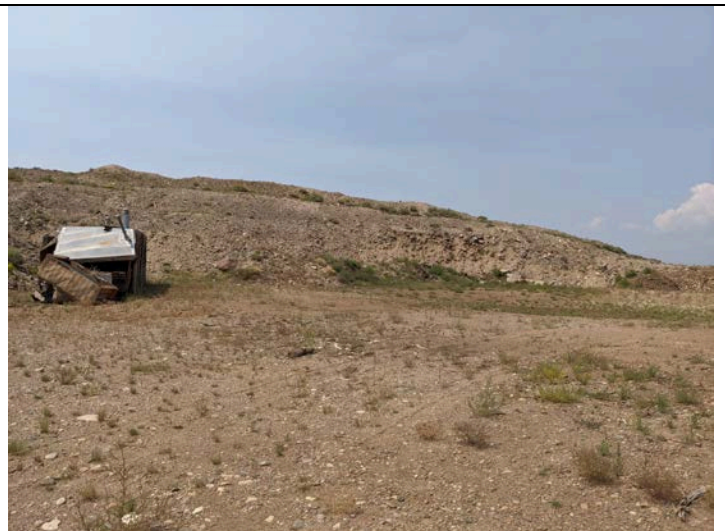
Adequate mine identification signage was noted at the entrance to the site.

The affected area was marked by t-posts that were clearly visible and adequate to delineate the affected area boundary.

The site sees minimal mining activity. Mining equipment is stored on site. Various materials stockpiles, gravel, soil, recycled concrete and asphalt, are located on the pit floor. Much of the highwall is backfilled to 2-3H:1V.
