**MINERALS PROGRAM INSPECTION REPORT**  
**PHONE: (303) 866-3567**

<b>MINE NAME:</b> Cotton Creek Pit	<b>MINE/PROSPECTING ID#:</b> M-2013-054	<b>MINERAL:</b> Sand and gravel	<b>COUNTY:</b> Saguache
<b>INSPECTION TYPE:</b> Monitoring	<b>INSPECTOR(S):</b> Dustin Czapla	<b>INSP. DATE:</b> August 17, 2021	<b>INSP. TIME:</b> 18:00
<b>OPERATOR:</b> Cotton Creek Gravel, LLC	<b>OPERATOR REPRESENTATIVE:</b> None	<b>TYPE OF OPERATION:</b> 110c - Construction Limited Impact

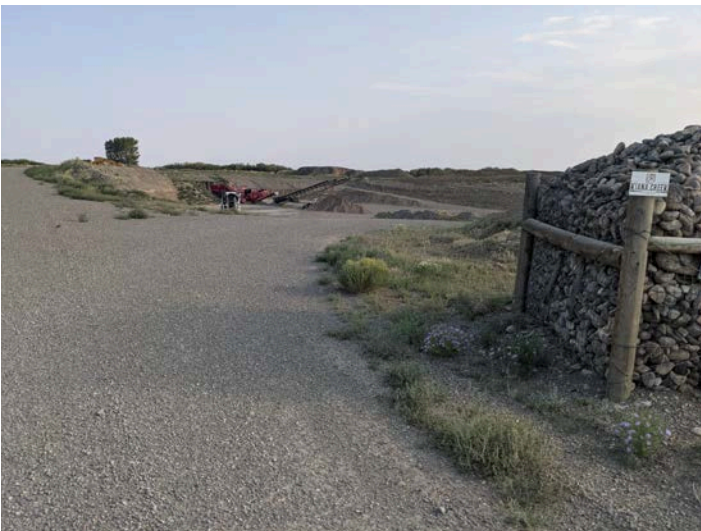
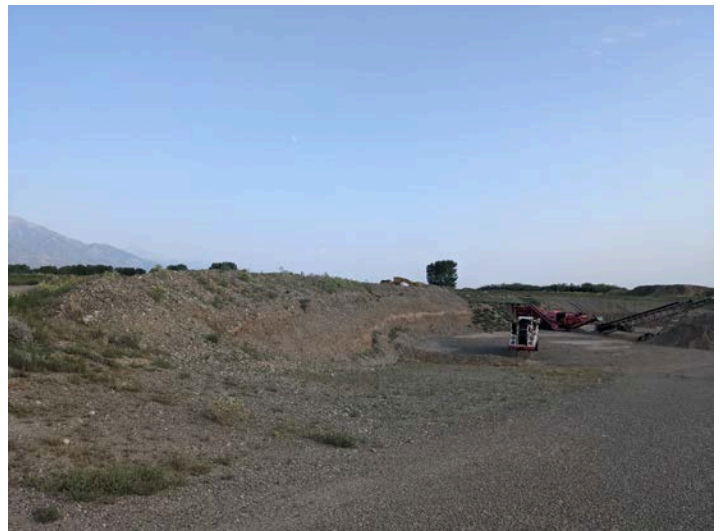
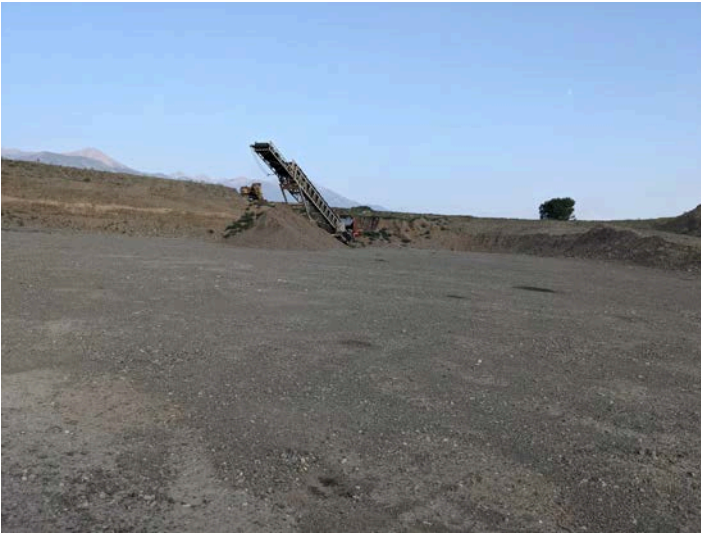
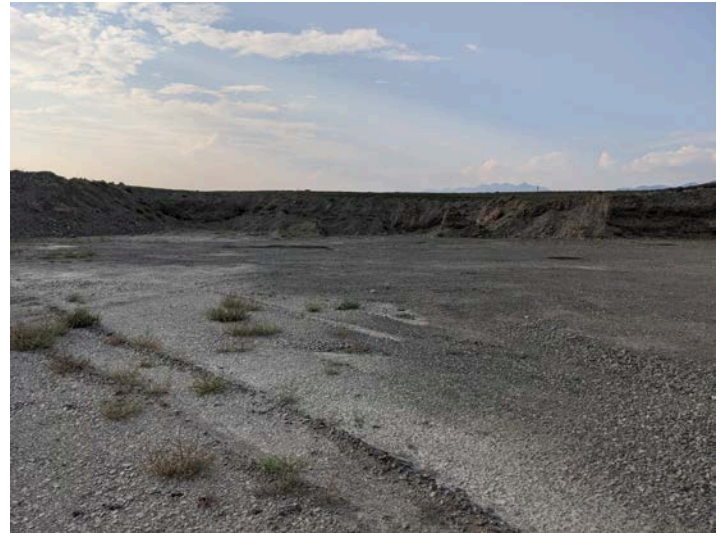
Adequate mine identification signage was not observed at the entrance to the site. This has been noted as a problem.

The pit has been excavated to a depth of approximately 20-25 feet. Slope regrading has commenced on the west, north and south highwall areas. Slopes have been graded to approximately 3H:1V. A near vertical highwall remains on the east side of the pit. Materials stockpiles are located in the pit area. Crushing equipment was in place on the pit floor. Fuel storage was not observed on site. Overall, the site is orderly.
