**MINERALS PROGRAM INSPECTION REPORT**  
**PHONE: (303) 866-3567**

<b>MINE NAME:</b> Ruby Trust Mine	<b>MINE/PROSPECTING ID#:</b> M-1979-181	<b>MINERAL:</b> Gold and silver	<b>COUNTY:</b> Ouray
<b>INSPECTION TYPE:</b> Monitoring	<b>INSPECTOR(S):</b> Lucas West	<b>INSP. DATE:</b> August 23, 2021	<b>INSP. TIME:</b> 11:23
<b>OPERATOR:</b> Walker Ruby Mining Company, Inc.	<b>OPERATOR REPRESENTATIVE:</b> Bob Larson	<b>TYPE OF OPERATION:</b> 110(2) - Hard Rock Limited Impact	
<b>REASON FOR INSPECTION:</b> Normal I&E Program	<b>BOND CALCULATION TYPE:</b> Complete Bond	<b>BOND AMOUNT:</b> \$18,738.00	
<b>DATE OF COMPLAINT:</b> NA	<b>POST INSP. CONTACTS:</b> None	<b>JOINT INSP. AGENCY:</b> None	
<b>WEATHER:</b> Clear	<b>INSPECTOR'S SIGNATURE:</b>

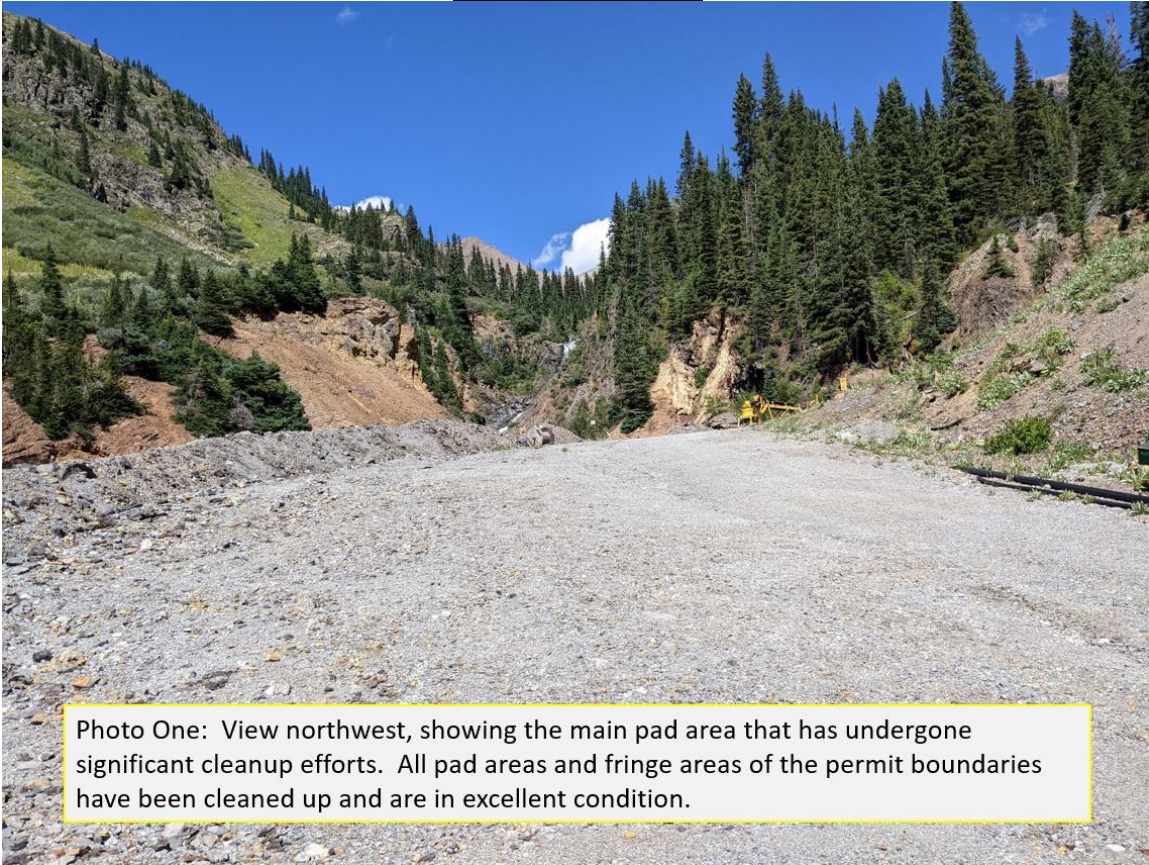
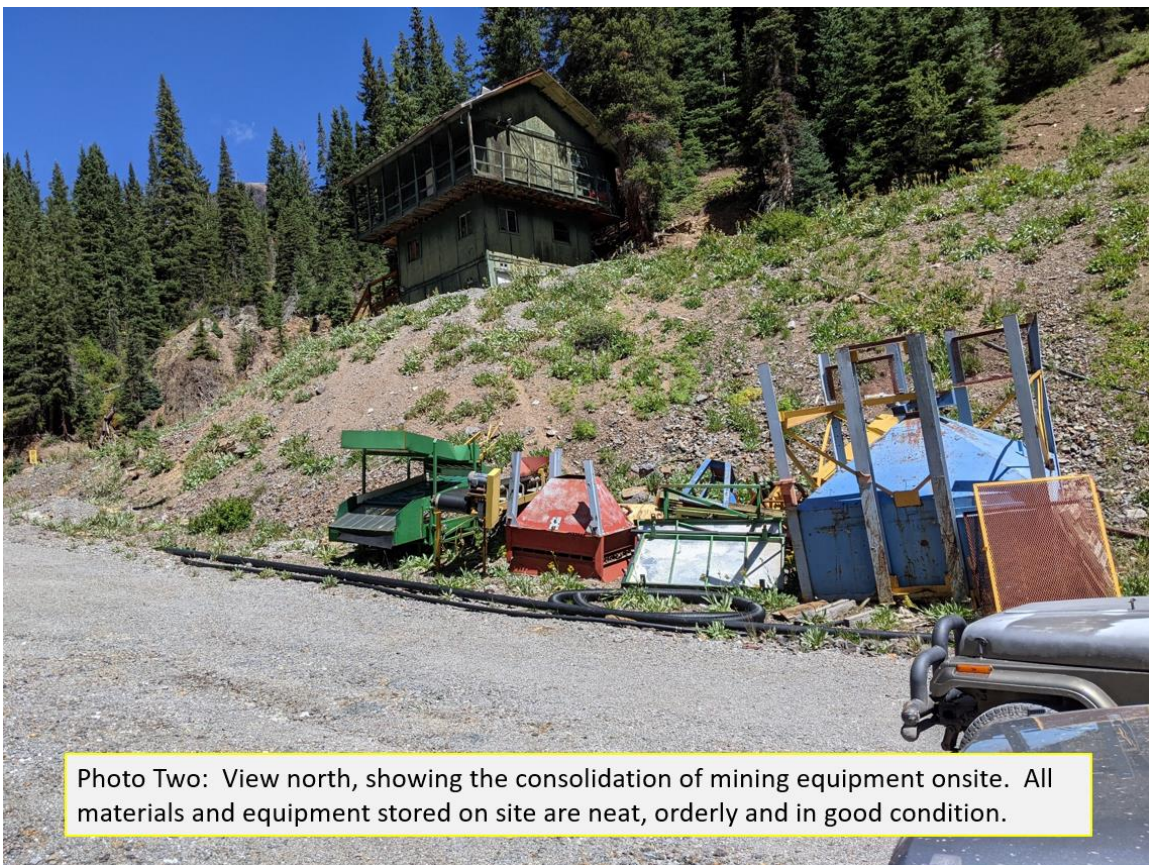
The proper mine identification signage was posted at the entrance to the site. Mining activities were not occurring at the time of the inspection. Since the Division's previous inspection significant cleanup efforts have been taken on the site. All historic mining debris along Sneffles creek as well as miscellaneous items within the permit area have been removed. All remaining equipment is stored on the pad area in a neat and orderly fashion. The pad area as well as the stored equipment can be seen in Photos One and Two.

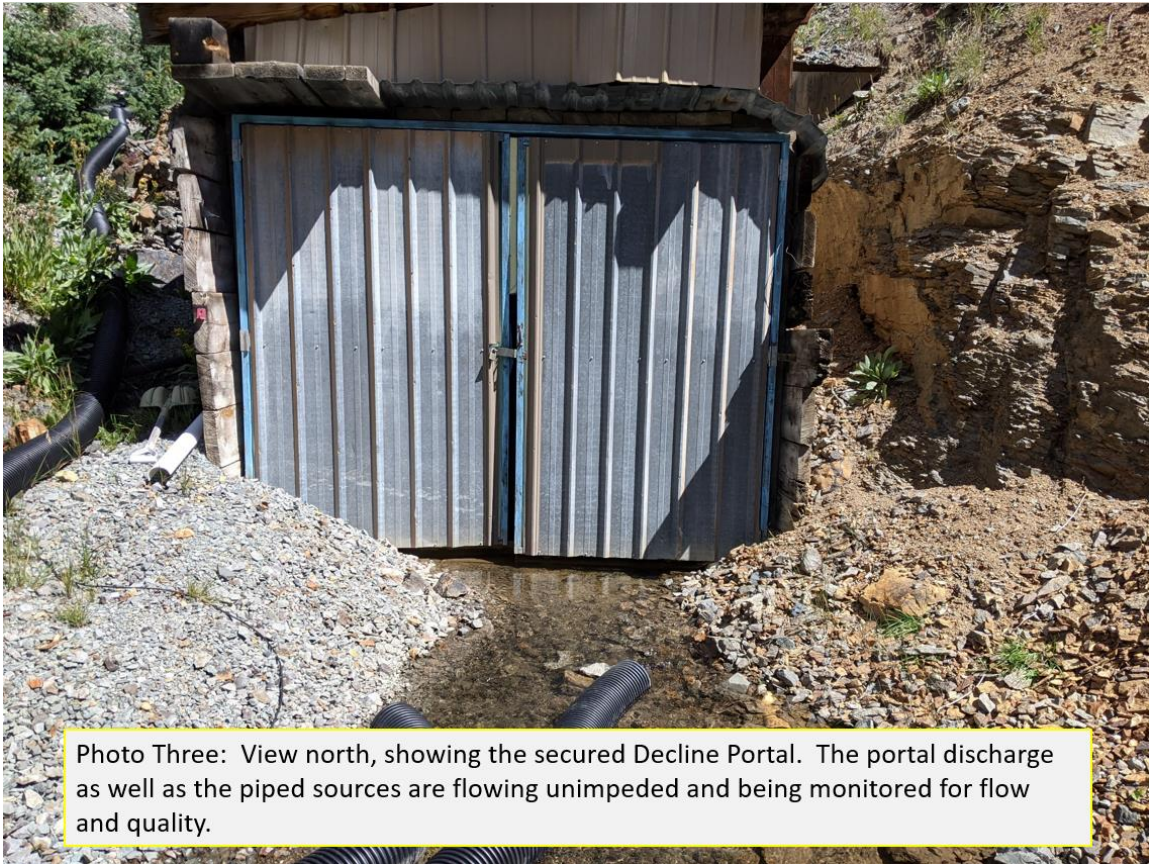
Photo Three: View north, showing the secured Decline Portal. The portal discharge as well as the piped sources are flowing unimpeded and being monitored for flow and quality.

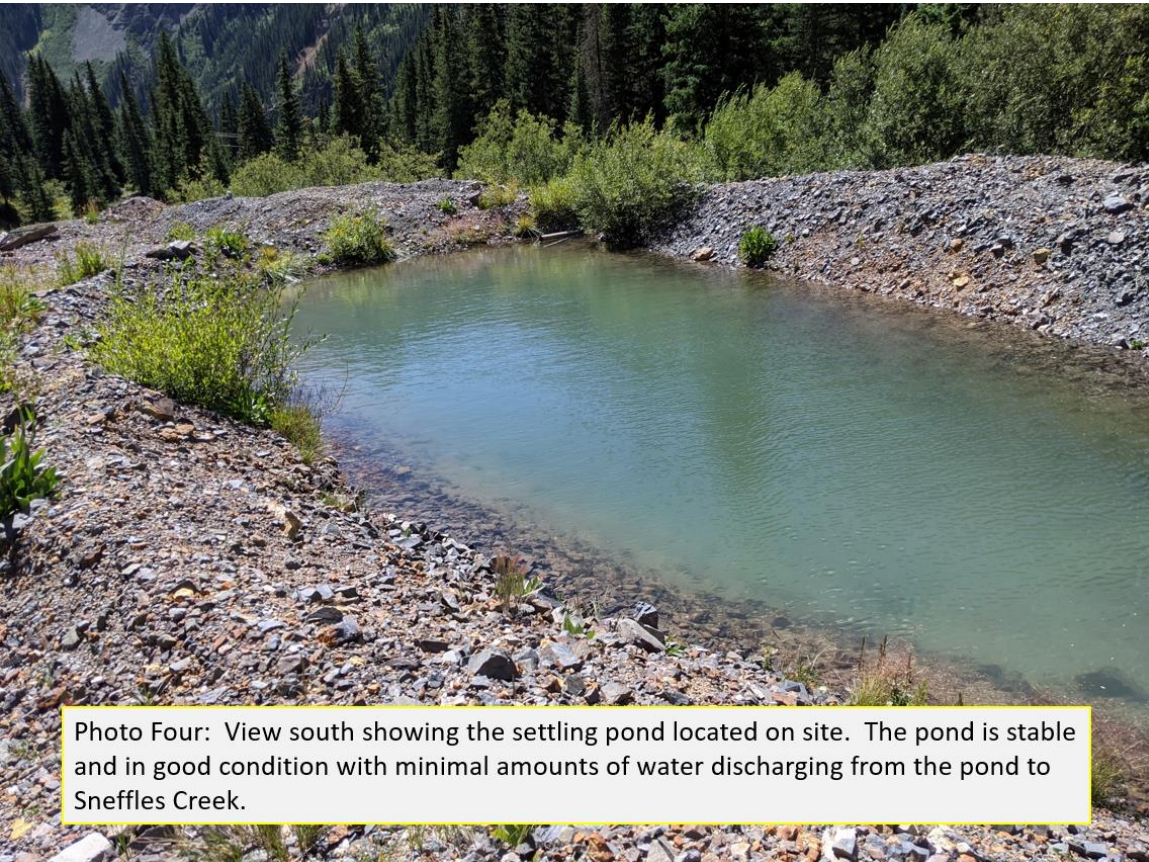
Photo Four: View south showing the settling pond located on site. The pond is stable and in good condition with minimal amounts of water discharging from the pond to Sneffles Creek.

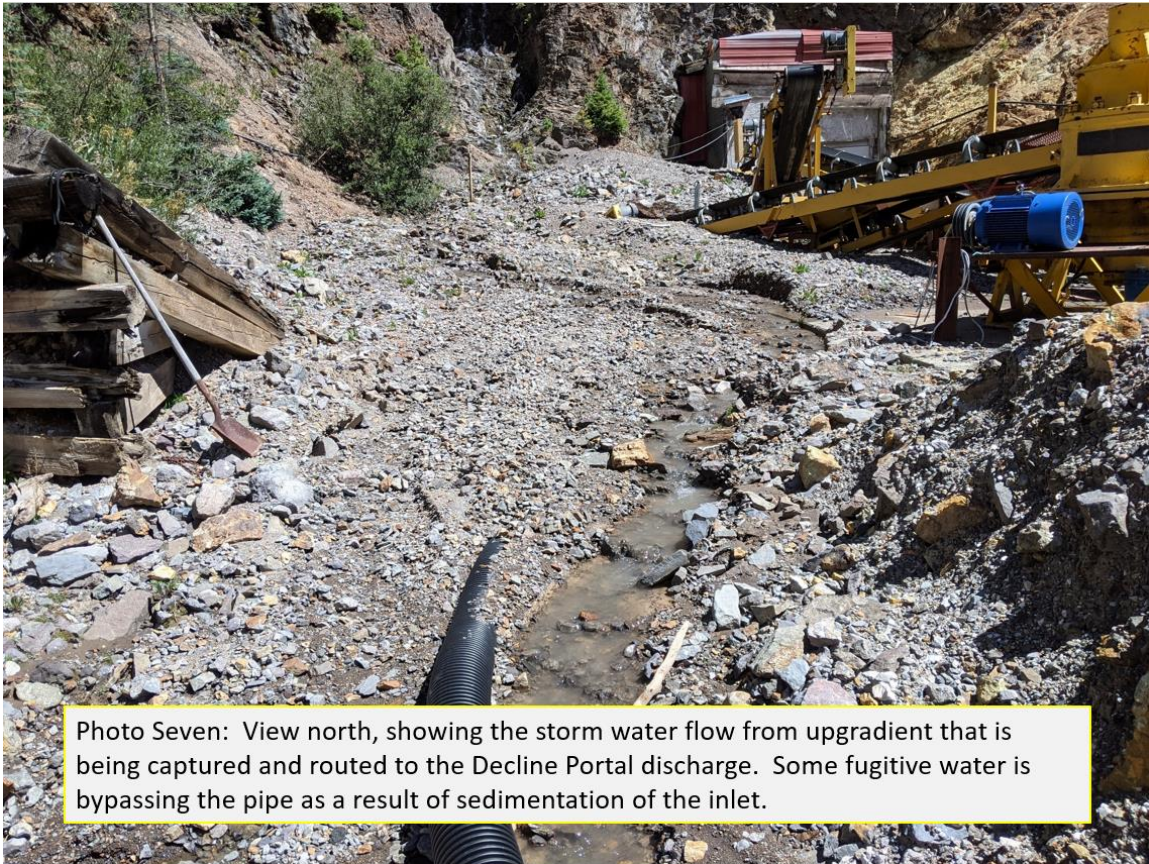
Photo Seven: View north, showing the storm water flow from upgradient that is being captured and routed to the Decline Portal discharge. Some fugitive water is bypassing the pipe as a result of sedimentation of the inlet.
