COLORADO
Division of Reclamation,
Mining and Safety
Department of Natural Resources

Permit Number: C-1980-004 Mine Name: McClane Canyon Mine Operator: ARC McClane Canyon, LLC Operator Address: Jim E Stover 2352 N 7th Street, Unit C Grand Junction , CO 81501	County: Garfield Operation Type: Underground Permit Status: Temporary Cessation Ownership: Private
	Operator Representative Present: Chuck Selingo
Operator Representative Signature: (Field Issuance Only)

Inspection Start Date: September 2, 2021 Inspection Start Time: 09:05 Inspection End Date: September 2, 2021 Inspection End Time: 09:50		Inspection Type: Coal Complete Inspection Inspection Reason: Normal I&E Program Weather: Clear	
Joint Inspection Agency: None		Joint Inspection Contacts: None	
Post Inspection Agency: None		Post Inspection Contacts: None	
Inspector(s): Clayton Wein	Inspector's Signature: <i>Clayton Wein</i>		Signature Date: 9/10/2021

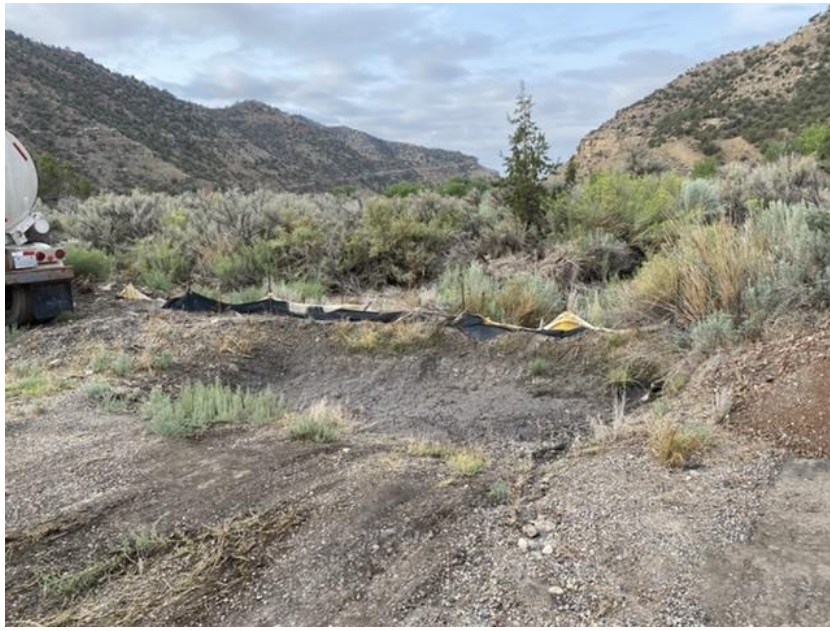
The day prior to the inspection the site received precipitation. Water was observed in sediment traps and the impoundment. Two sediment traps are located to the west of the mine office. The one on the north side of the haul road was dry. The silt fence at the outlet was intact. There were no off site impacts observed. The sediment trap located on the south side of the haul road was also dry. **The sediment fence was observed to be falling over (Photo 1).** No off site impacts were observed. Mr. Selingo informed the Division that the sediment traps were scheduled to be cleaned and the silt fence on the south sediment trap will be replaced. The sediment pond was impounding water during the inspection. The level of water impounded in the pond was not at the level of the discharge outlet (Photo 2). The outlet was clear of debris. The embankment of the pond was vegetated and stable. There were no indications of erosional features. Once the pond becomes dry and the mud at the bottom dries, Mr. Selingo stated that the pond could be cleaned. The level of sediment in the pond has not reached its maximum capacity. The sumps along the haul road are above gradient to the sediment pond. Only the lower sump was impounding water. There was no water discharging from the sump. Mr. Selingo stated that once the sump is dry, it will be cleaned out. The sumps farther upgradient were observed to be dry. There was debris and sediment in

Photo 1: The sump south of the haul road near the mine office. The silt fence has fallen over and partly filled with sediment.

1. Clean the sediment traps to the south of the mine office. Replace the silt fence for the sediment trap on the south side of the haul road.
2. Clean all sumps along the haul road.
3. When accessible, clean the sediment pond
4. Clean the eastern sump at the portals area as soon as possible.

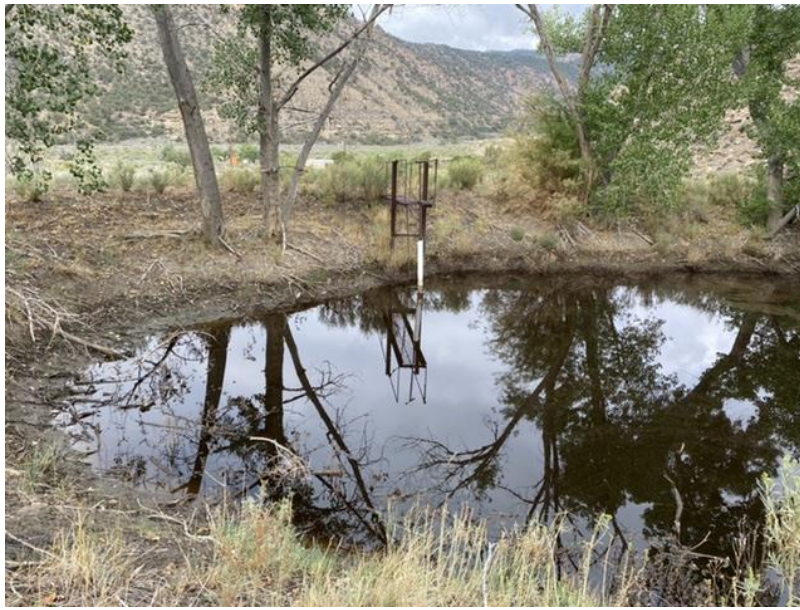
Photo 2: The sediment pond with impounded water. The water level was below the PVC riser for the outlet.

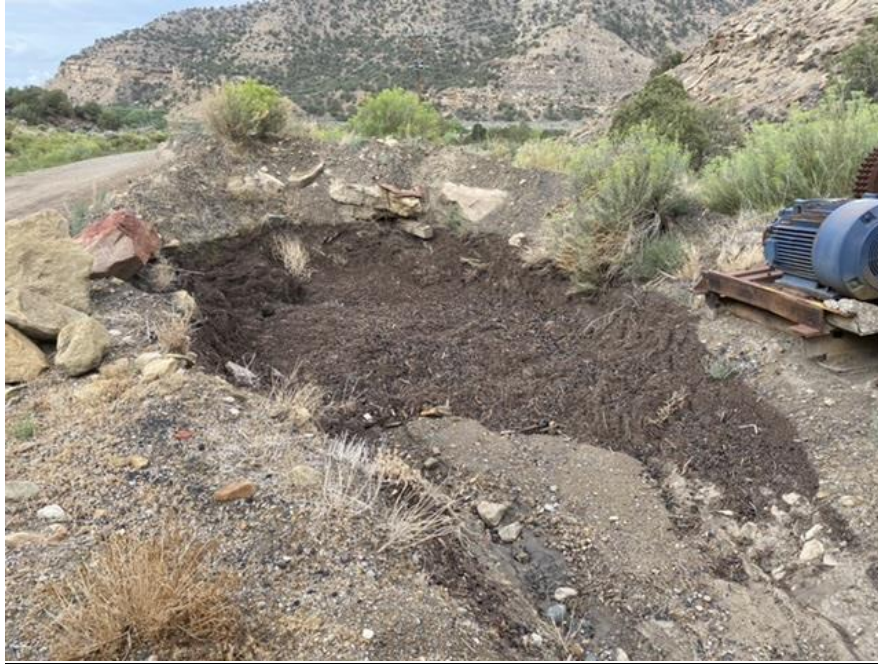
the bottom of the sumps (Photo 3). **The sumps require cleaning.** Mr. Selingo has included the sumps in the maintenance list. Two sumps are located at the portals area. The sump to the north of the portals was impounding a small amount of water. There was no discharge from the sump. The outlet of the sump was clear of debris. **The sump located to the east of the portals bench was completely overtopped with sediment (Photo 4).** Due to a large scale forest fire in 2020, the drainage above the eastern sump has been mostly burned. **Large amounts of sediment are transported during precipitation events. The east sump needs to be cleaned as soon as possible.** Mr. Selingo stated that he has equipment rented for September 7th to complete maintenance at the site. **The sump's discharge outlet is buried in sediment several feet deep. The embankment of the sump was also buried in sediment.**

Photo 3: One of the sumps along the haul road upgradient of the sediment pond. The sump has filled with debris and sediment. The outlet to the sump was still clear.

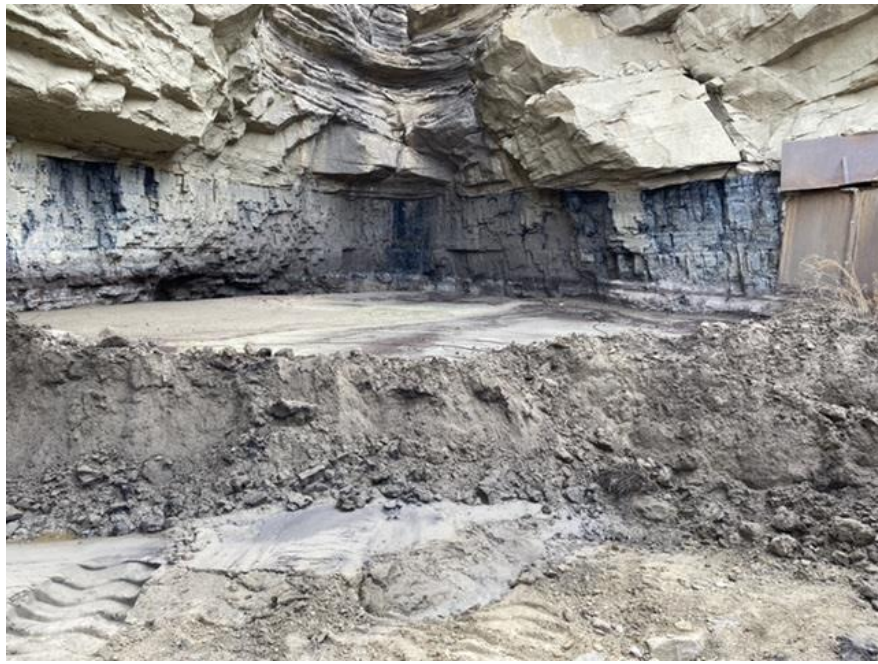
Photo 4: The eastern sump near the portals bench. The sump has filled and been overtopped by sediment from the areas upstream burned by a forest fire.

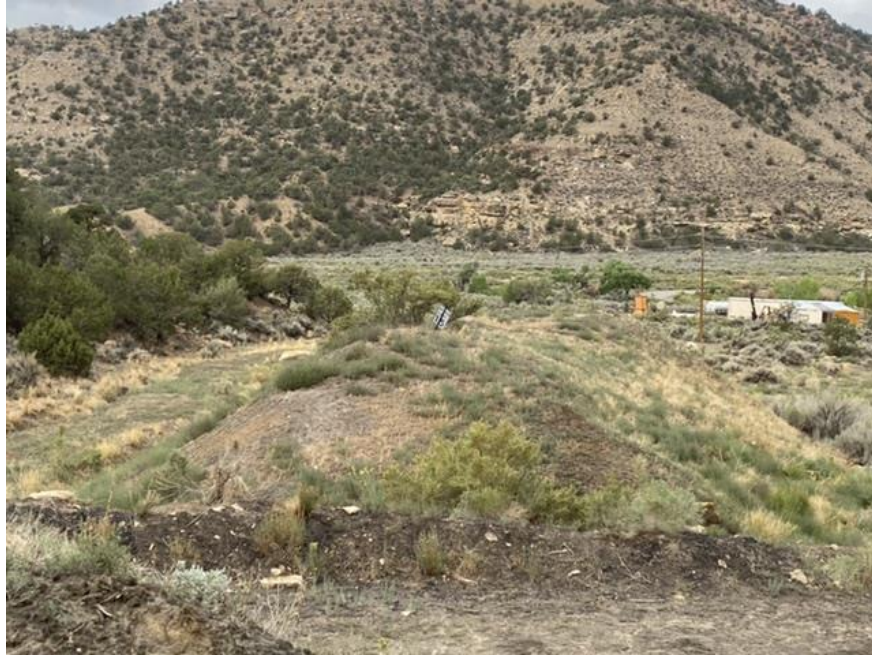
The topsoil pile is located to the south of the sediment pond. The pile was stable with vegetative cover (Photo 5). There were no erosional issues noted. The topsoil marker was identified on top of the pile. The perimeter ditch was dry and stable. No off site impacts were observed.

Photo 5: The topsoil Pile.
