MINERALS PROGRAM INSPECTION REPORT
PHONE: (303) 866-3567

MINE NAME: Borrow Site for Bennett Crossing Filing 2 (Parcel 1)	MINE/PROSPECTING ID#: M-2019-029	MINERAL: Borrow material for construction	COUNTY: Adams
INSPECTION TYPE: Surety-Related Inspection	INSPECTOR(S): Patrick Lennberg	INSP. DATE: August 27, 2021	INSP. TIME: 09:00
OPERATOR: LGI Homes - Colorado, LLC	OPERATOR REPRESENTATIVE: Kacy Flemmons LGI, and Rick Mitchell landowner	TYPE OF OPERATION: 111(1)(b) - Special One-Time Incidental	
REASON FOR INSPECTION: Surety Release Requested	BOND CALCULATION TYPE: None	BOND AMOUNT: \$75,000.00	
DATE OF COMPLAINT: NA	POST INSP. CONTACTS: None	JOINT INSP. AGENCY: None	
WEATHER: Clear	INSPECTOR'S SIGNATURE:

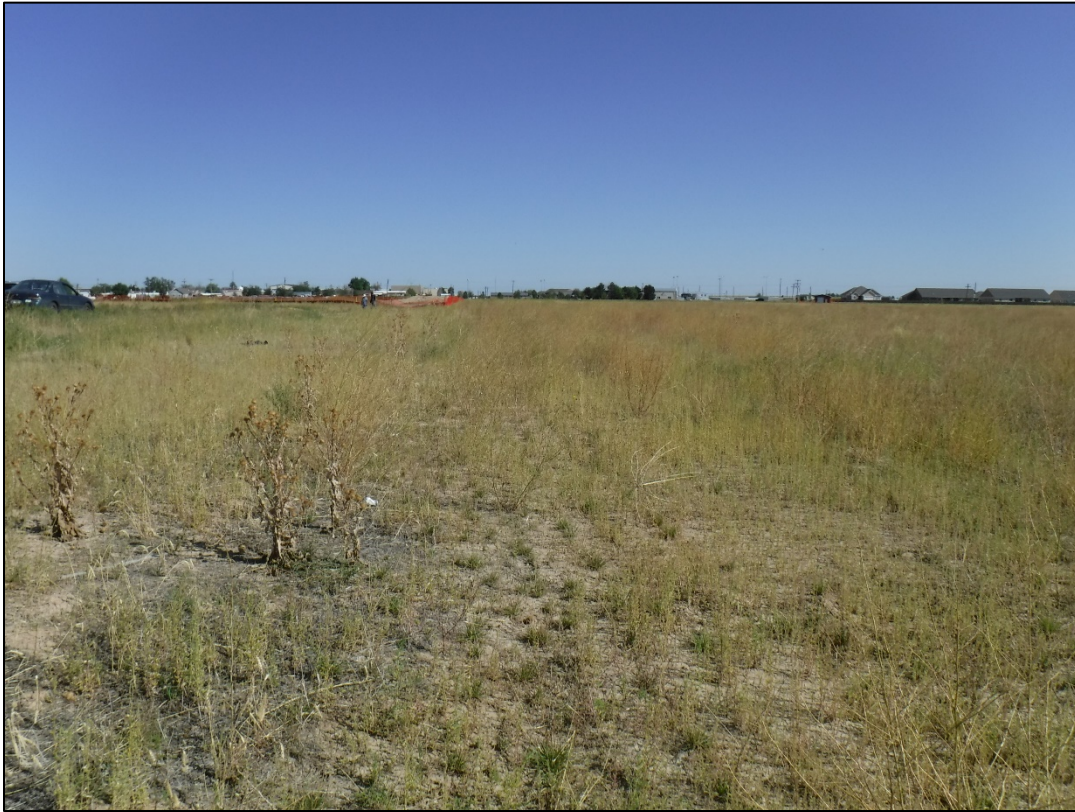
Photo 1: Growth in the south end of permit area looking north, orange fence is the edge of construction activities encroaching unaffected land of permit boundary

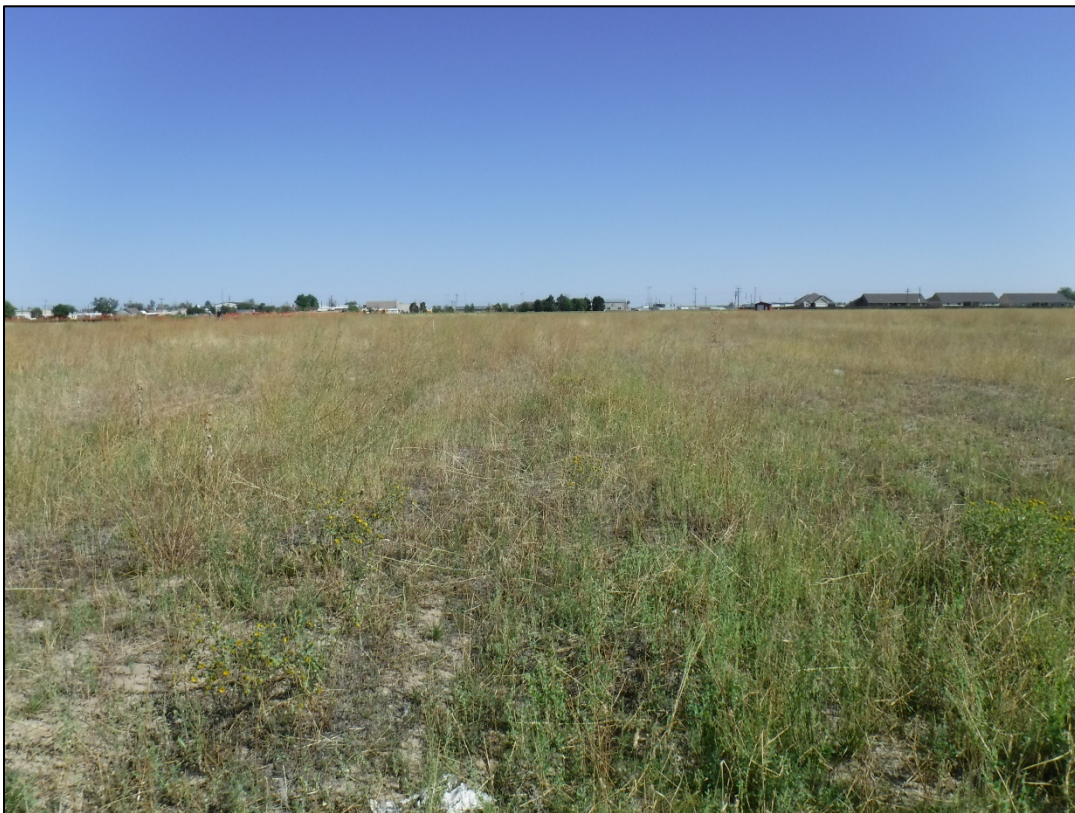
Photo 2: Typical growth in the south are looking north

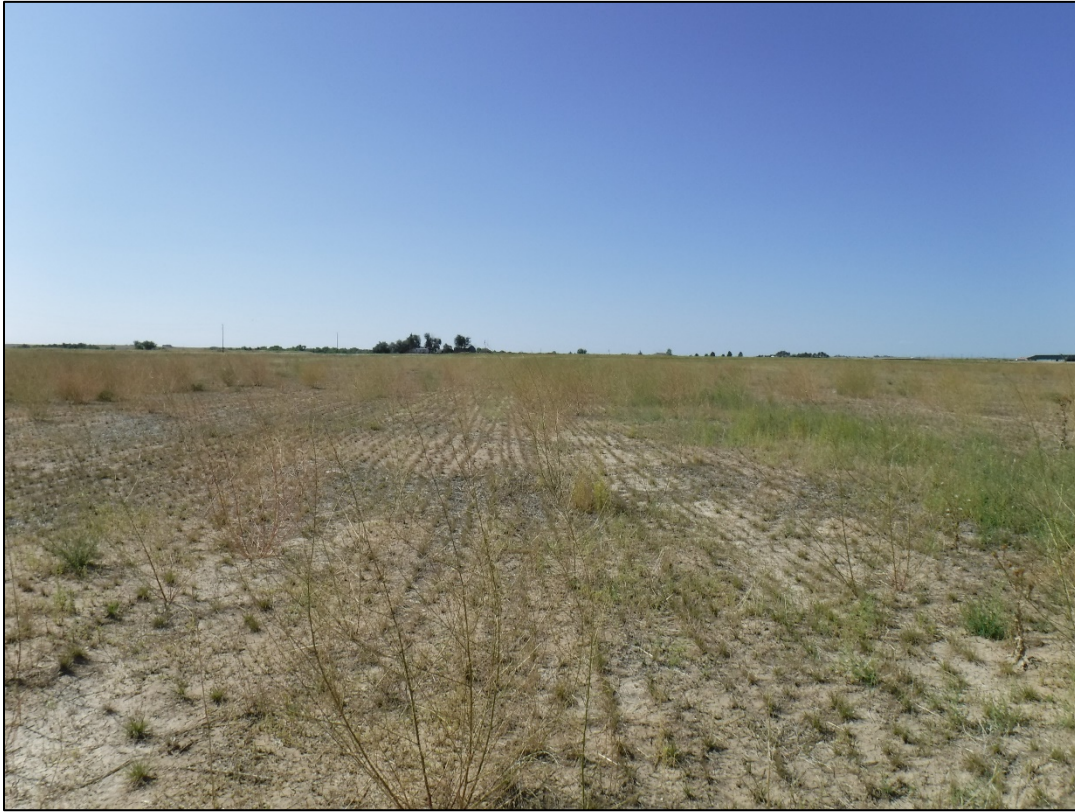
The site was mulched and seeded in Fall 2019. Vegetation appears to be growing as expected for most of the area and with the wet Spring/Summer the vegetation has become well established throughout most of the permit boundary. There were some weeds volunteering into the site but it is not acting a source to the surrounding properties. Although the post-mining land use industrial/commercial the approved reclamation plan states that the parcel will be revegetated to meet the criteria as defined in Rule 3.1.10(1). The Town of Bennett has also begun a development project next to the northwest corner of the permit boundary. Construction at the site was on hold, at the time of inspection, until suitable water was available but the project is encroaching on the permit boundary and looks like it will cross the boundary in the near future. There is an area, a couple acres in size, in the north central portion of the permit where vegetation has not established as well as other revegetated areas. It is not immediately clear why vegetation in the area is lagging behind other areas.

Photo 3: Growth in the area where vegetation is not growing similar to other areas of permit, looking south

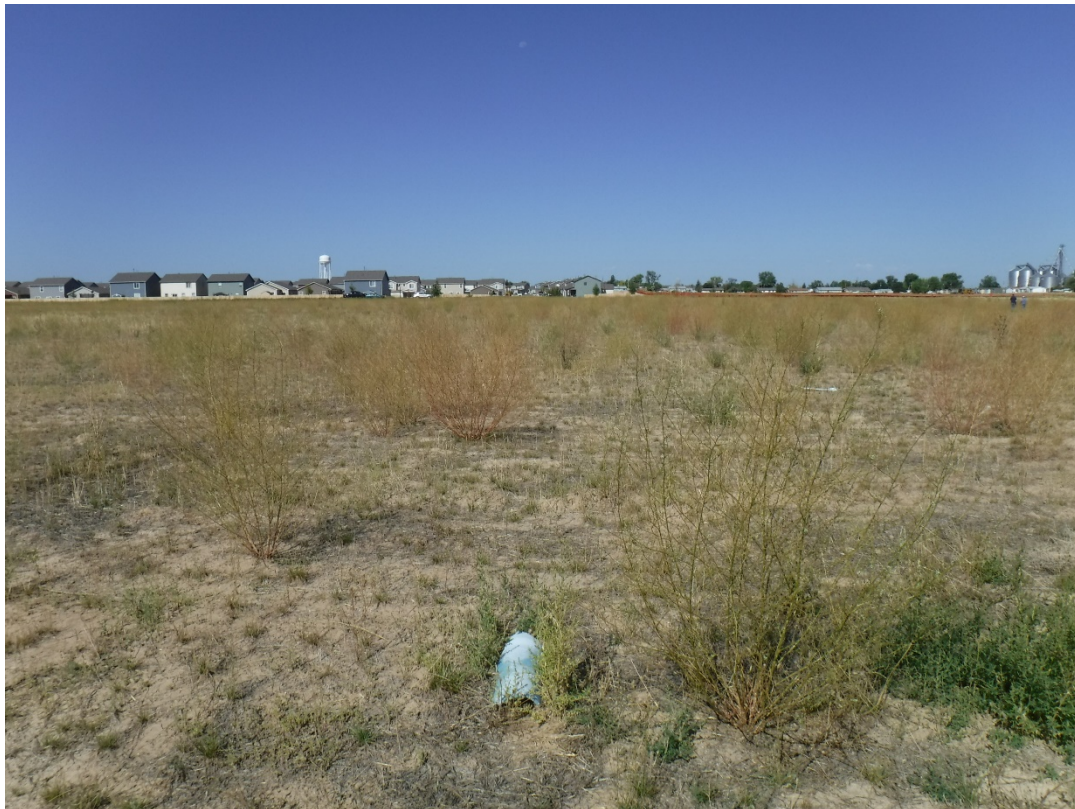
Photo 4: Growth in the area where vegetation is not growing similar to other areas of permit, looking west

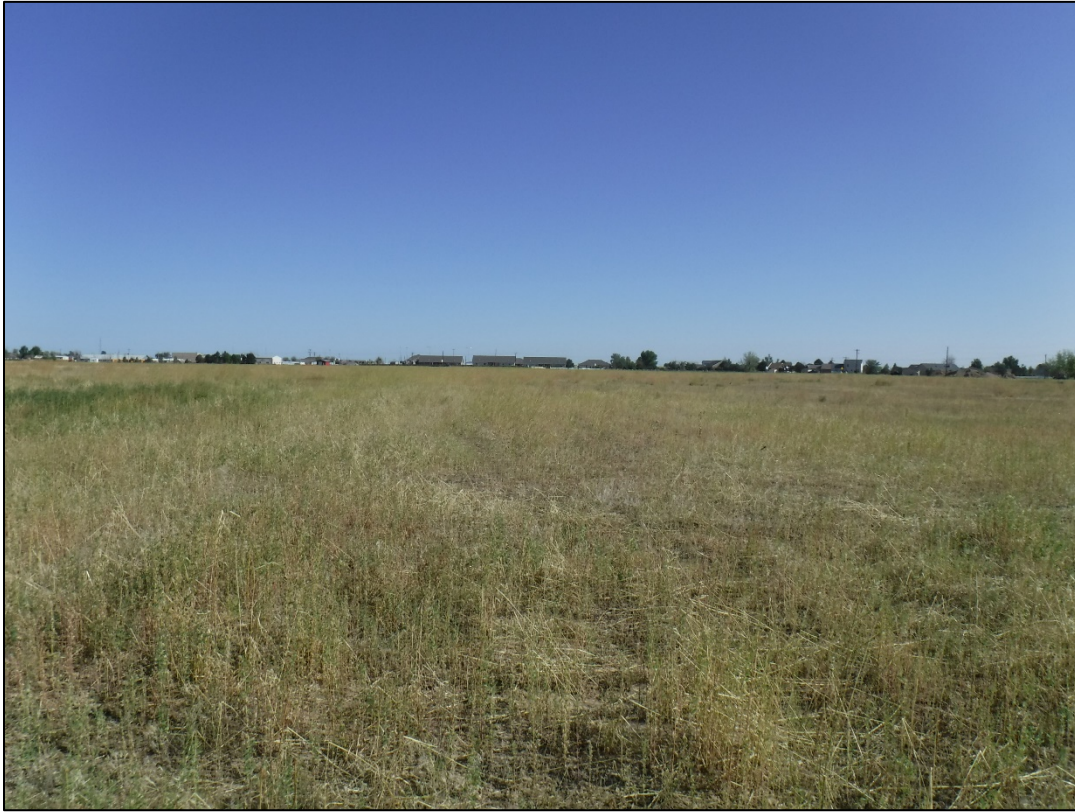
Photo 5: Looking north across the central portion of permit area

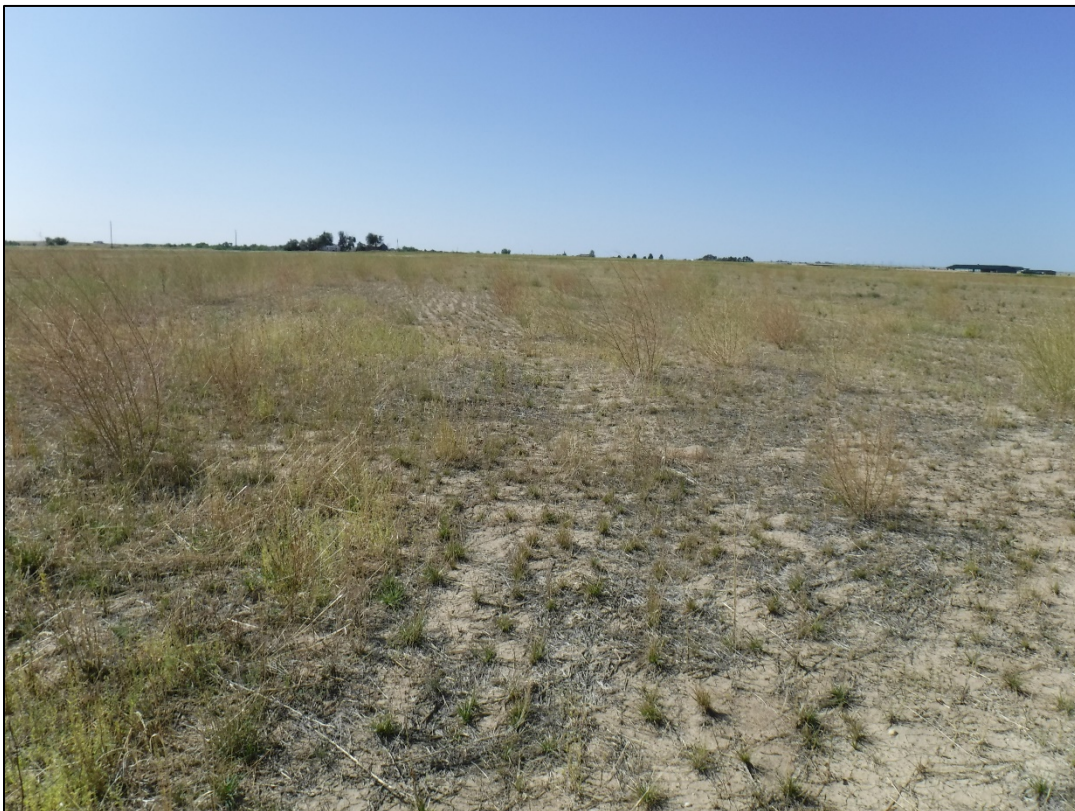
Photo 6: Looking south near the border where the vegetation begins to thin
