**MINERALS PROGRAM INSPECTION REPORT**  
**PHONE: (303) 866-3567**

<b>MINE NAME:</b> Borrow Site for Bennett Crossing Filing 2 (Parcel 2)	<b>MINE/PROSPECTING ID#:</b> M-2019-030	<b>MINERAL:</b> Borrow Material	<b>COUNTY:</b> Adams
<b>INSPECTION TYPE:</b> Surety Release Inspection	<b>INSPECTOR(S):</b> Patrick Lennberg	<b>INSP. DATE:</b> August 27, 2021	<b>INSP. TIME:</b> 09:00
<b>OPERATOR:</b> LGI Homes - Colorado, LLC	<b>OPERATOR REPRESENTATIVE:</b> Kacy Flemmons, LGI and Rick Mitchell, Landowner	<b>TYPE OF OPERATION:</b> 111(1)(b) - Special One-Time Incidental	
<b>REASON FOR INSPECTION:</b> Surety Release Requested	<b>BOND CALCULATION TYPE:</b> None	<b>BOND AMOUNT:</b> \$75,000.00	
<b>DATE OF COMPLAINT:</b> NA	<b>POST INSP. CONTACTS:</b> None	<b>JOINT INSP. AGENCY:</b> None	
<b>WEATHER:</b> Clear	<b>INSPECTOR'S SIGNATURE:</b>

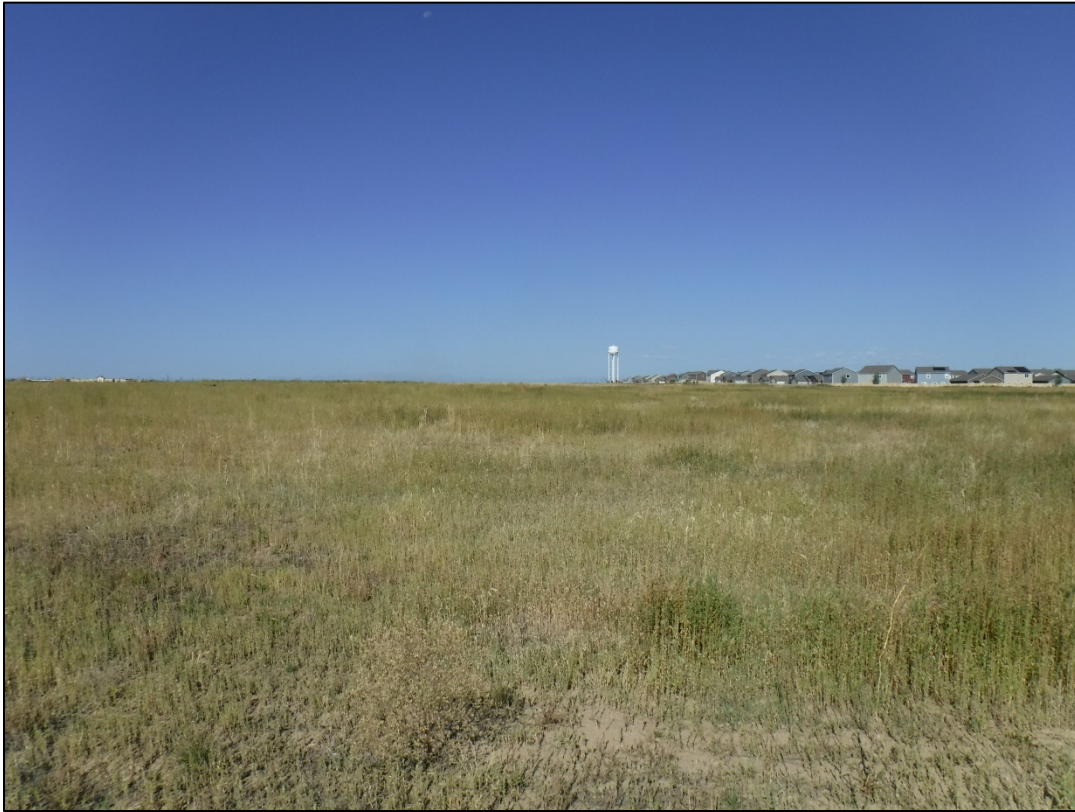
**Photo 1:** Typical growth in the south end looking west

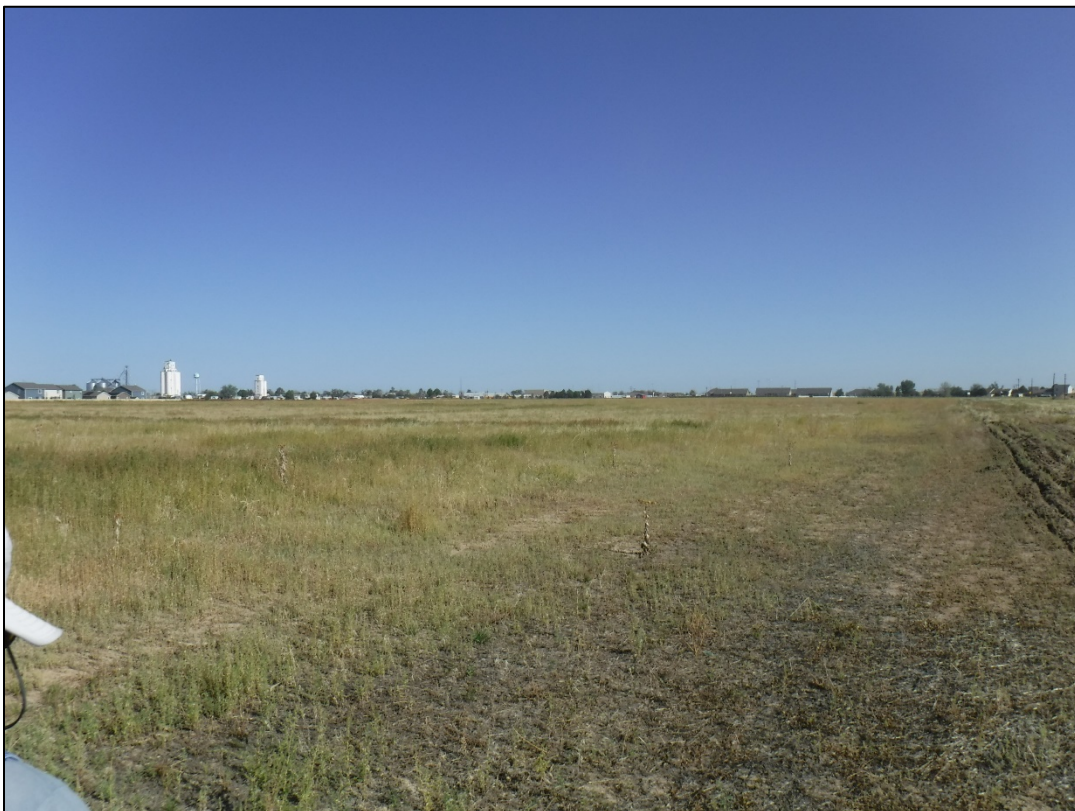
**Photo 2:** Typical growth looking northwest from the southeastern corner

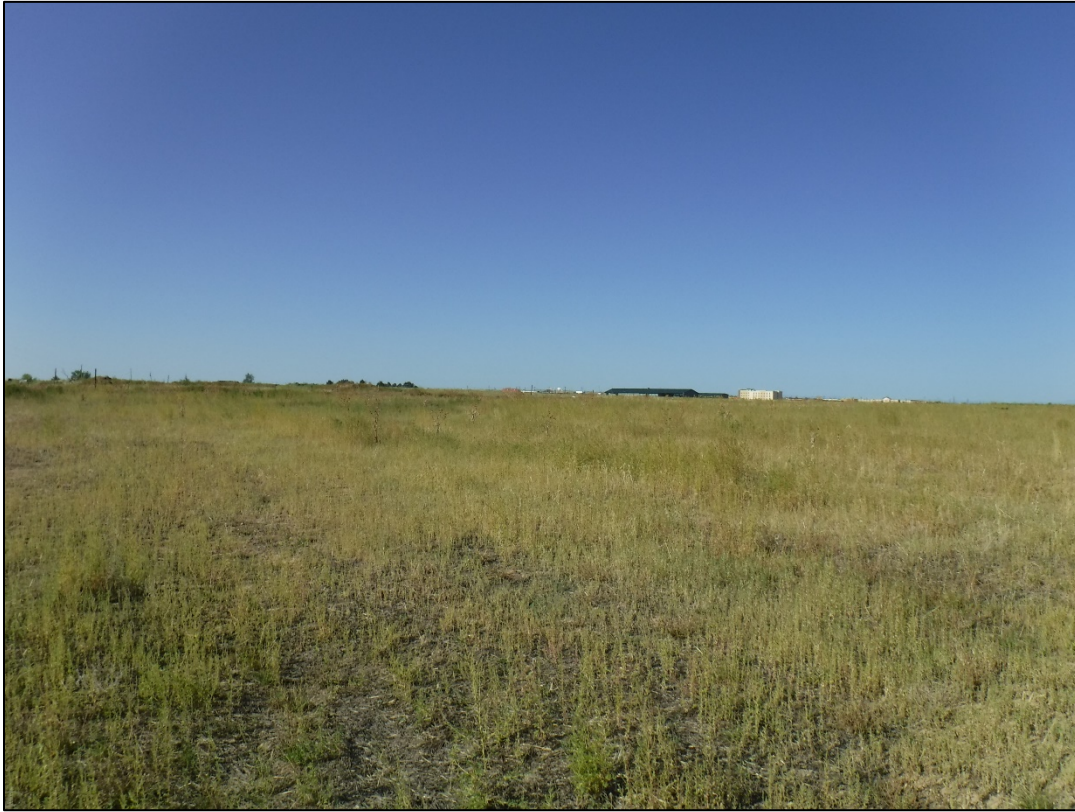
**Photo 3:** Typical growth looking south from the southeastern corner

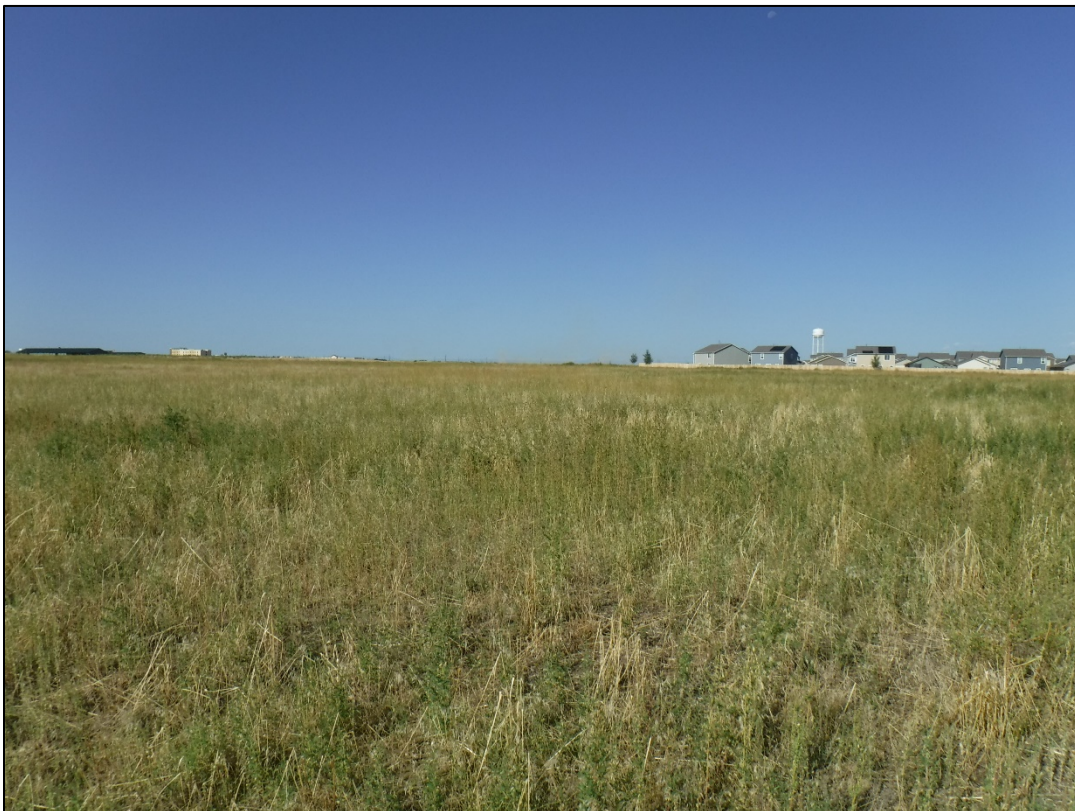
**Photo 4:** Typical growth looking south from the north central area of permit

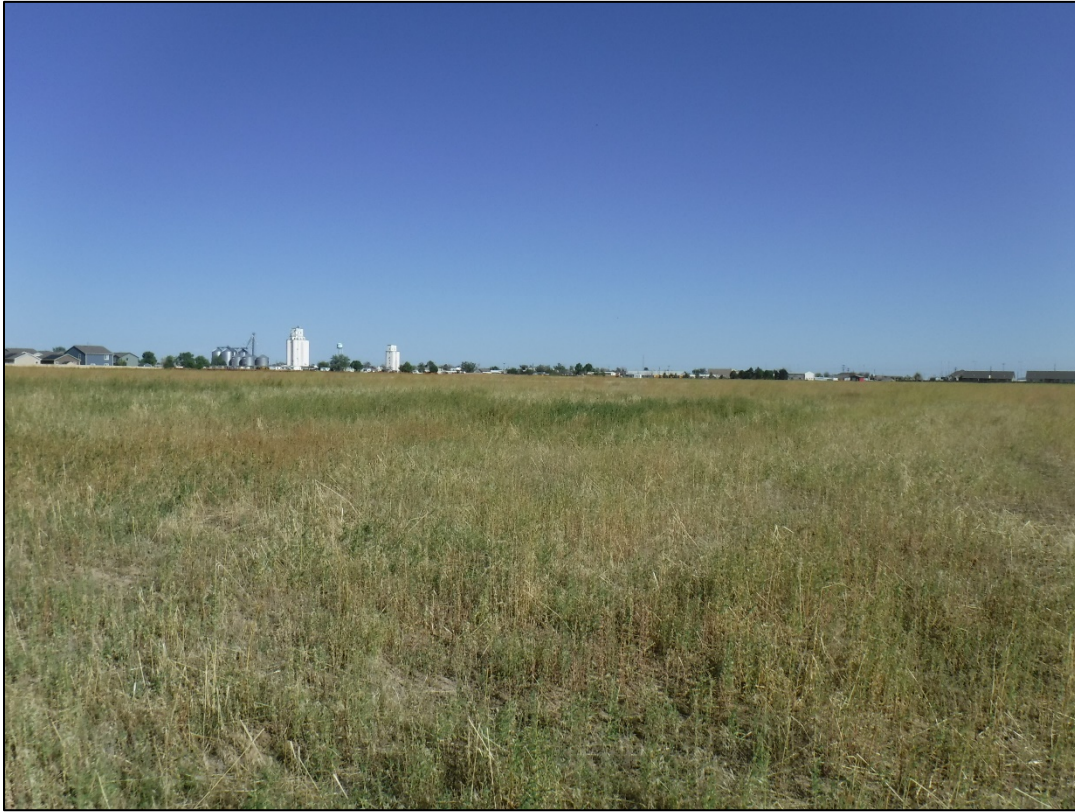
**Photo 5:** Typical growth looking north from the north central area of permit

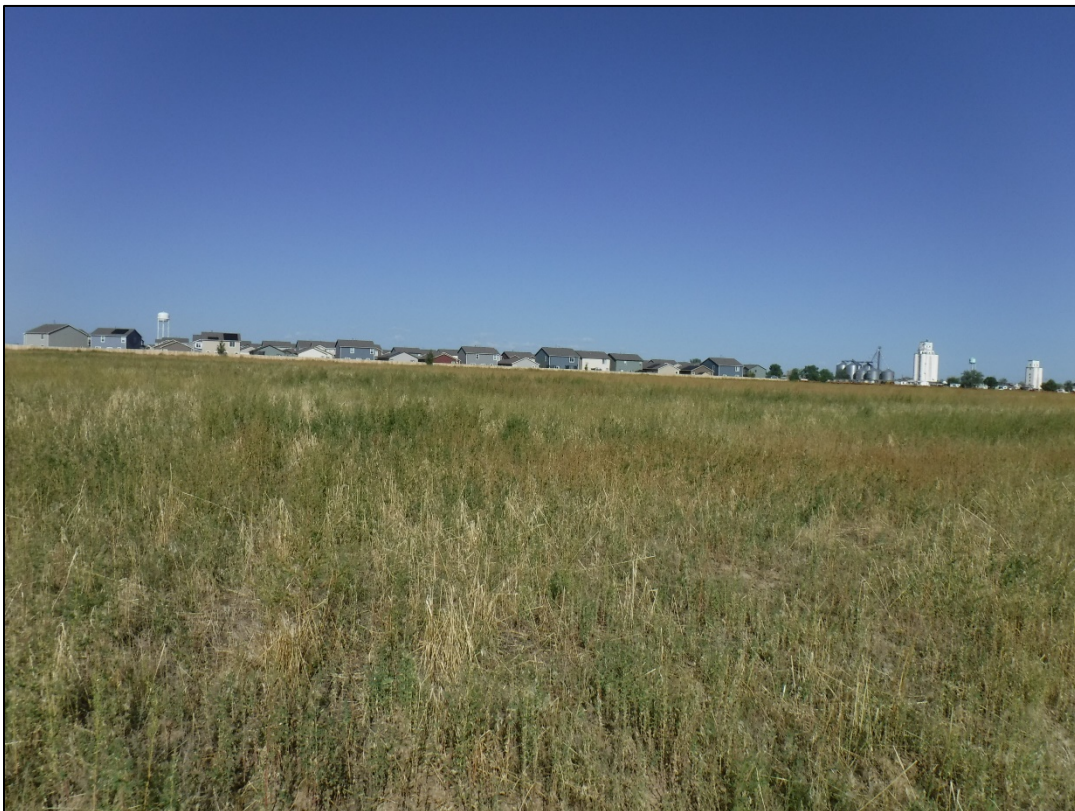
**Photo 6:** Typical growth looking east from the north central area of permit
