**MINERALS PROGRAM INSPECTION REPORT**  
**PHONE: (303) 866-3567**

| <b>MINE NAME:</b><br>Cresson Project | <b>MINE/PROSPECTING ID#:</b><br>M-1980-244 | <b>MINERAL:</b><br>Gold | <b>COUNTY:</b><br>Teller |
| <b>INSPECTION TYPE:</b><br>Monitoring | <b>INSPECTOR(S):</b><br>Brock Bowles | <b>INSP. DATE:</b><br>July 28, 2021 | <b>INSP. TIME:</b><br>09:00 |

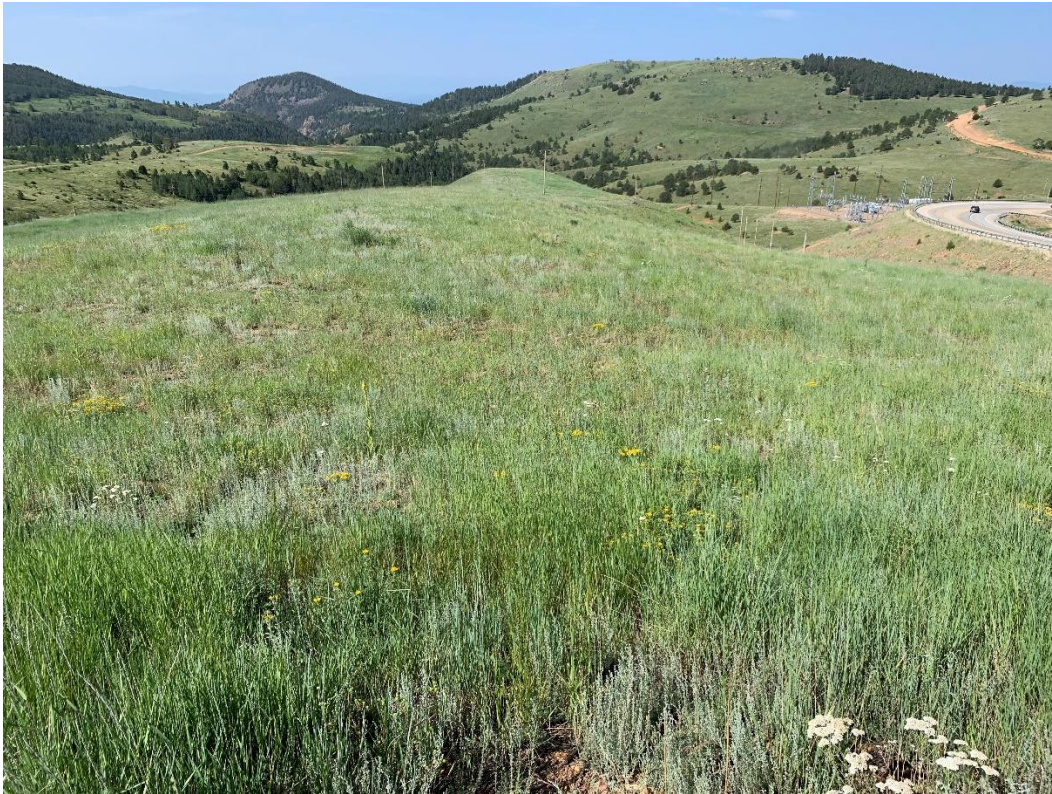
- GM 19 – Location: south of ADR 1. The pile had a dense vegetation cover of grasses and wildflower and overall looked really good (photo 1). There were a couple of small patches of Canada thistle that need to be treated as part of the regular treatment regimen. A gully had formed along the northeast access road and needs to be repaired (photo 2). This was the only erosion feature noted and the rest of the pile appeared to be stable.

Photo 1 – Growth Medium Pile 19

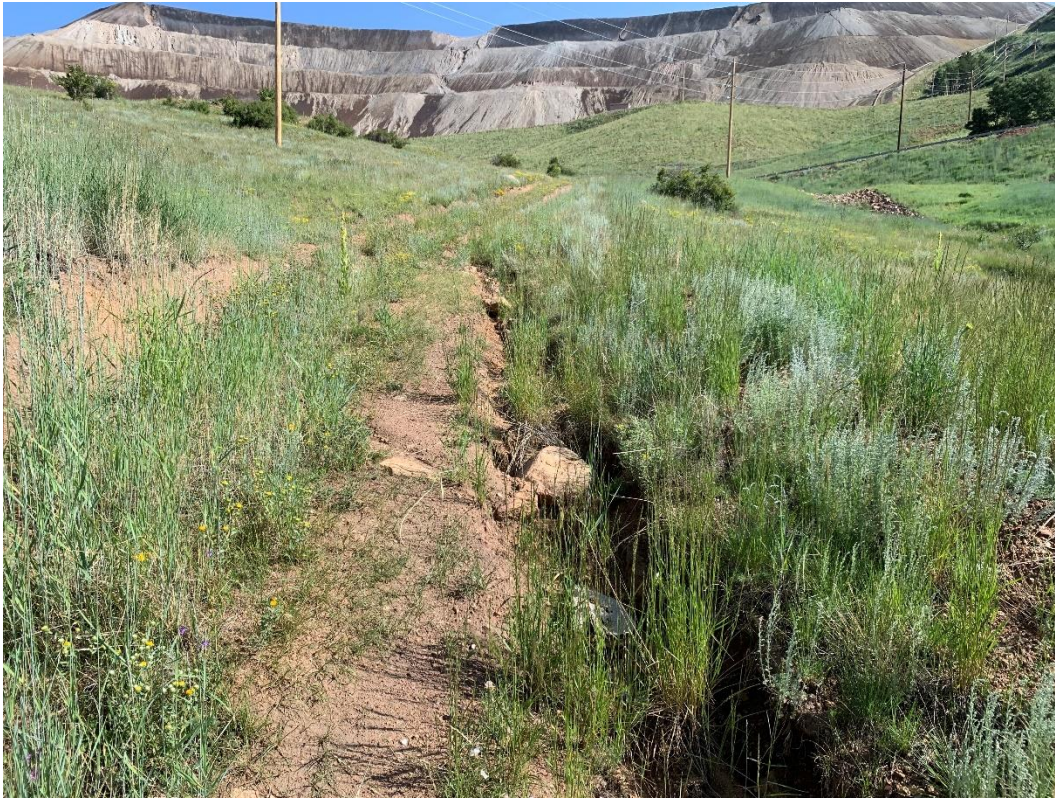
Photo 2 – Gully on GM-19 on northeast access road

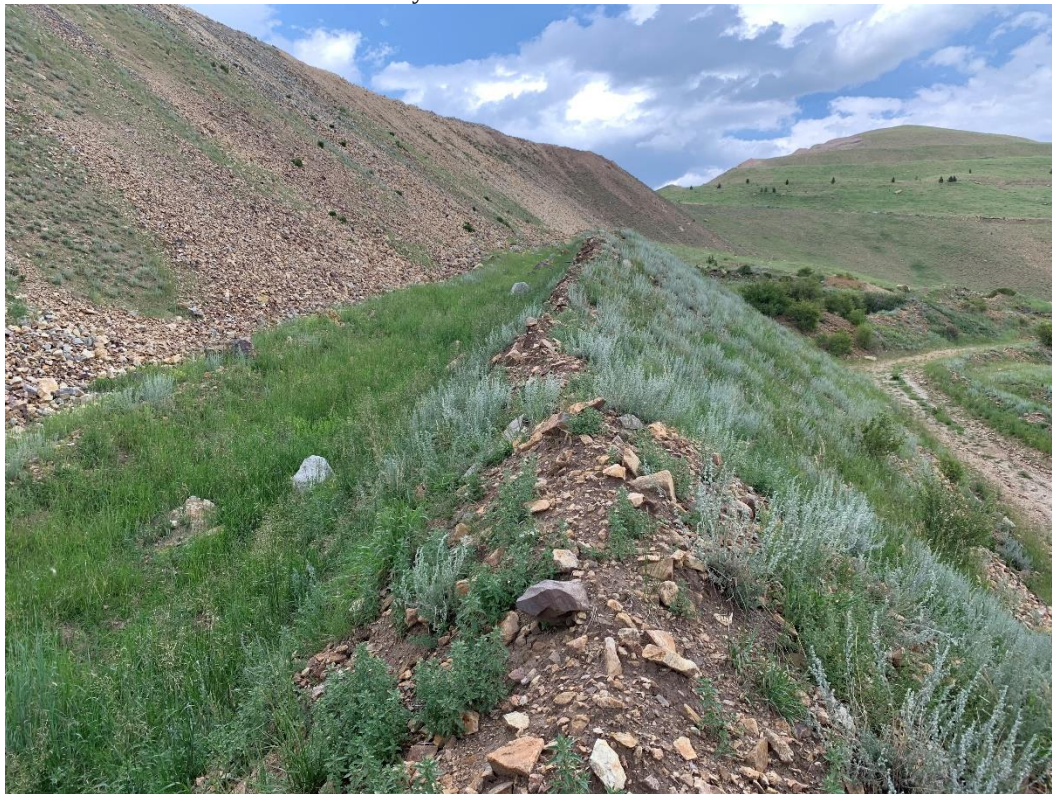
- GM 33 – Location: NE of crusher. This pile is almost gone. It is being reapplied to the ECOSA reclamation.
- GM 37 – Location: east of the main Cresson Pit. The pile had a dense vegetation cover and appeared to be stable (photo 3). There were a few thistles (Canada and musk) that need to be treated as part of the regular treatment regimen.

Photo 3 – GM-37, facing north

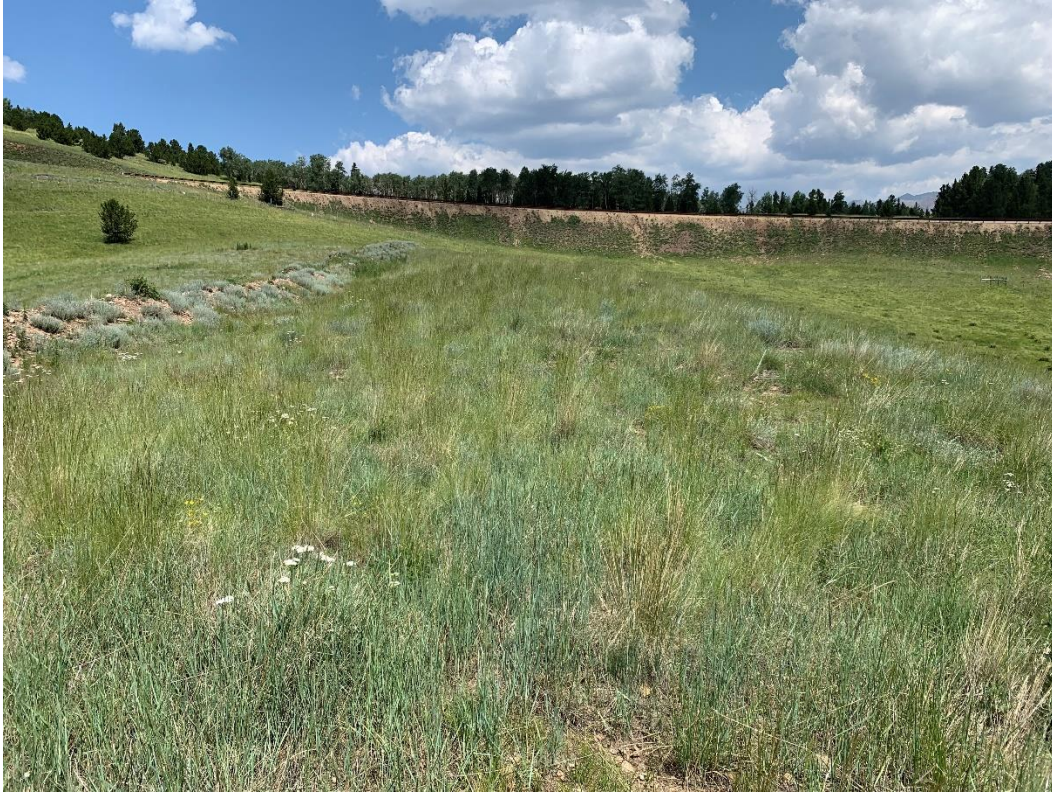
- GM 38 – Location: East of WHEX pit. The pile had a dense vegetation cover of grasses and wildflower and overall looked really good (photo 4). There were a couple of small patches of Canada thistle that need to be treated as part of the regular treatment regimen.

Photo 4 – GM-38, facing north

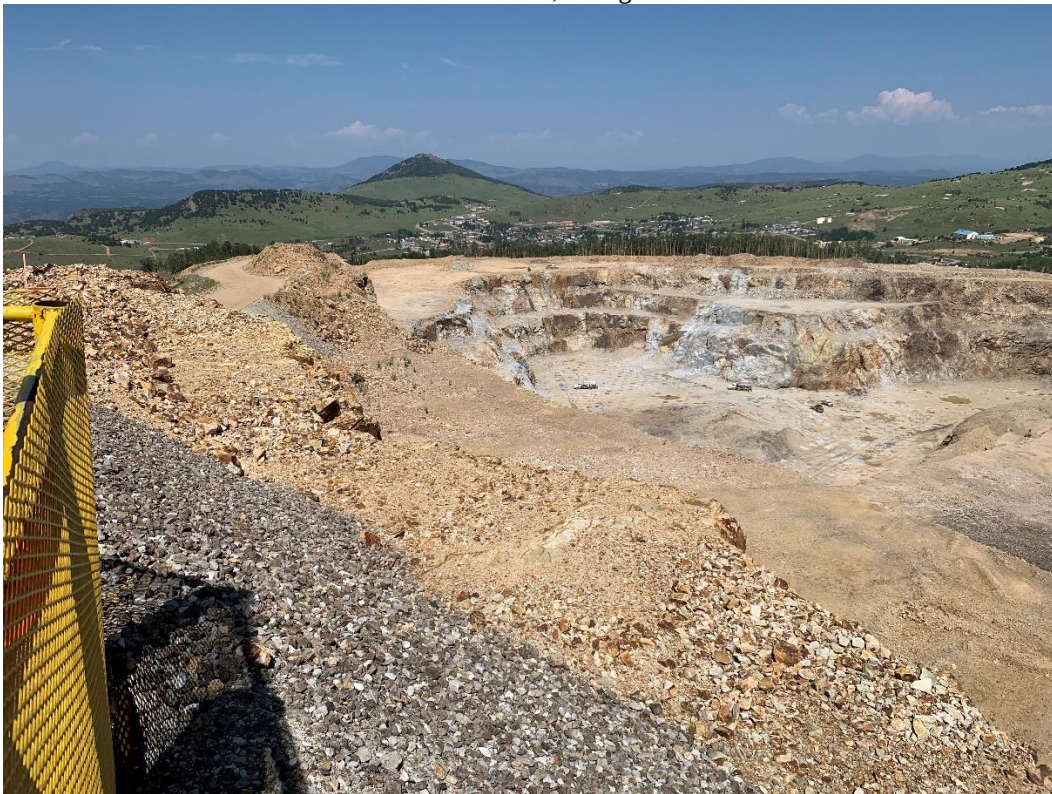
The Schist Island area was still being mined. A blast occurred in the bottom of the pit earlier in the day (photo 5) and another blast is expected tomorrow morning. Backfilling is expected to start later in August.

Photo 5 – Schist Island overlook, facing west

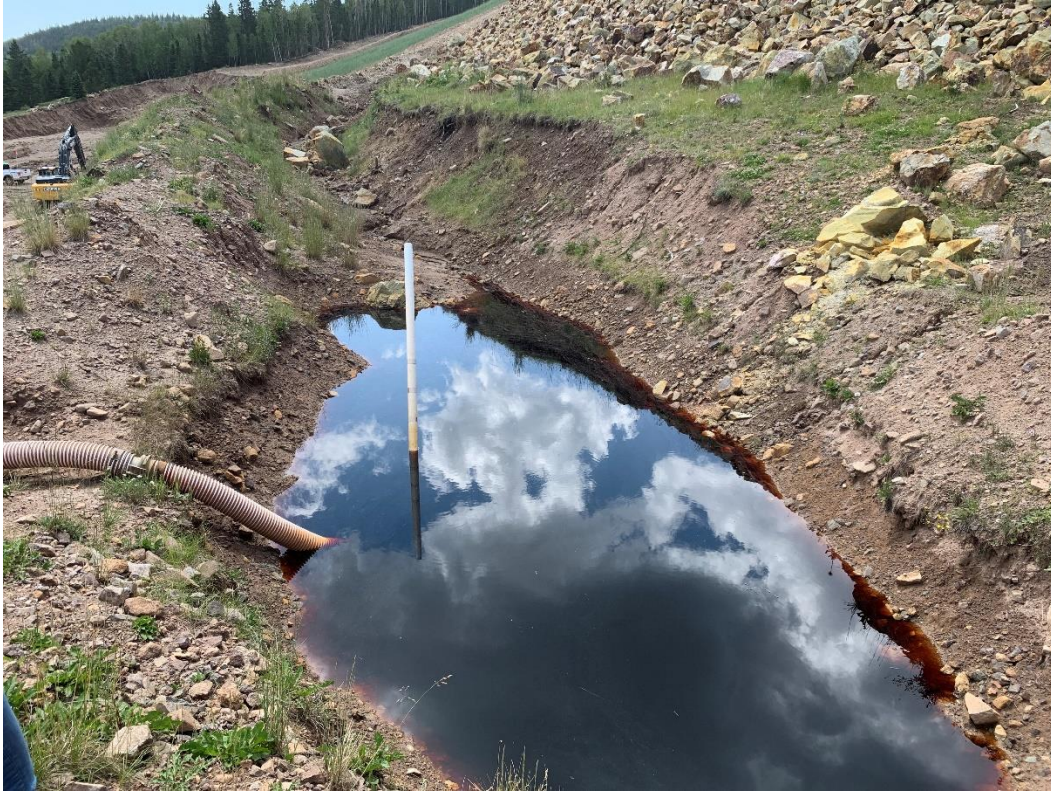
Water was seeping from under the ECOSA and flowing into the catch pond (photo 6). The water had a very dark brown/red color. No water was discharging from the pond. The pump was set up to drain the pond but was

not running at the time.

Photo 6 – ECOSA seep catch pond

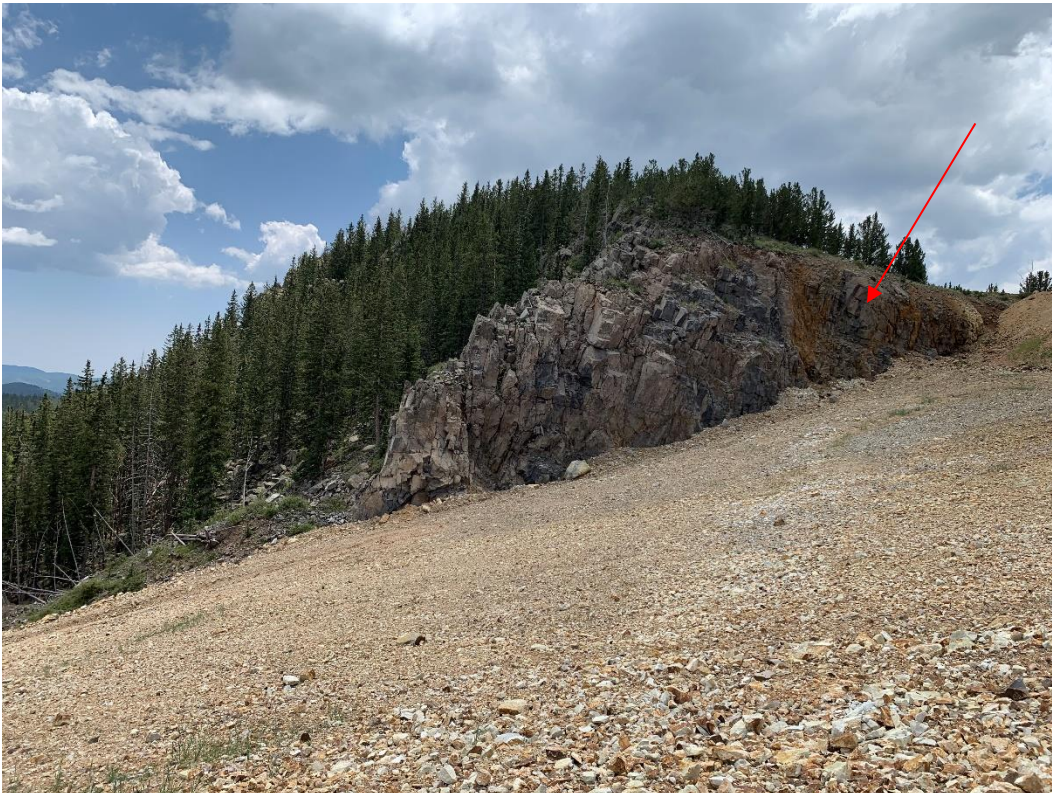
The west side of the Bull Cliffs area is mostly backfilled, but it appears about a 35-40 foot high section of the highwall has not been backfilled (photo 7). The Operator is reminded that a fence is required to be placed above all remaining highwalls at final reclamation as required by AM13.

Photo 7 – Highwall area that has not been backfilled and needs a fence.

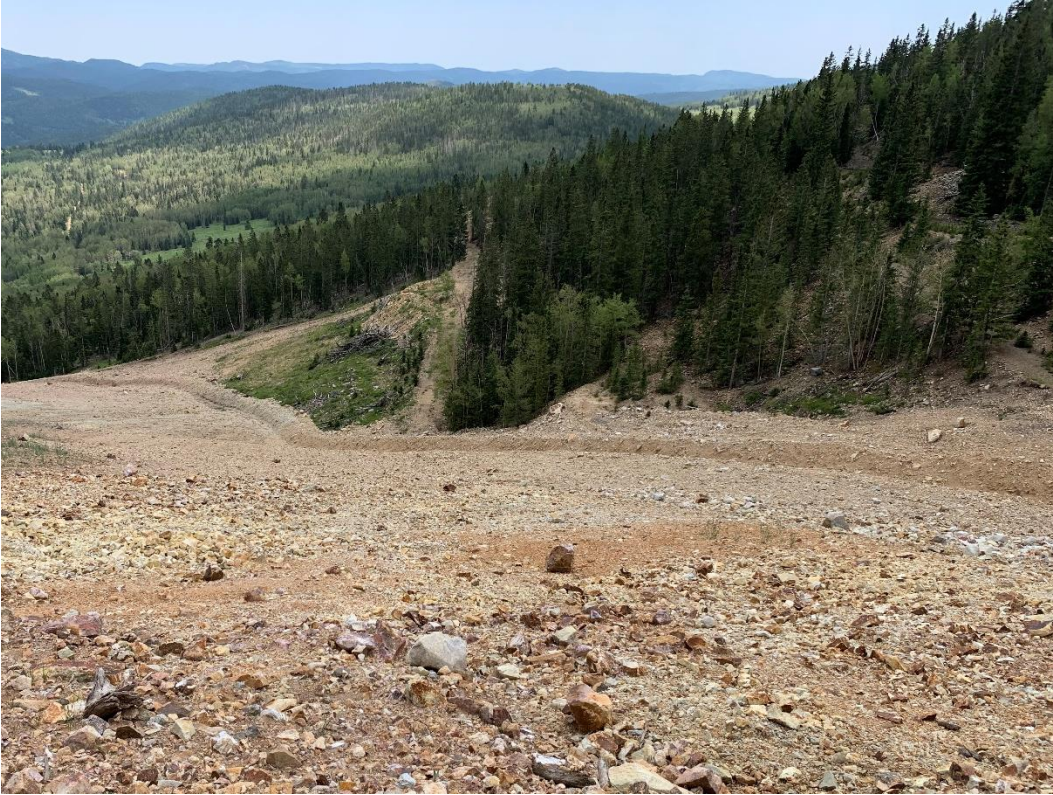
The south side of the ECOSA area was graded and seeded last year. A perimeter ditch was installed on the south side of the ECOSA next to the undisturbed hillside (photo 8). This ditch directs runoff water to the toe of the ECOSA into the area that is being mined for clay for the VLF2. Two contour ditches were installed on the reclaimed area to direct runoff to the south perimeter ditch. The upper contour ditch does not connect to the perimeter ditch. Water flows to the end of the upper ditch, then down the face of the backfilled material where a gully has formed (photo 9).

Photo 8 – Perimeter ditch on southern end of ECOSA

The ditches installed on the ECOSA have not been reviewed by the Division, are incomplete in construction, the contour ditches are blocked and excessive erosion gullies have formed. For these reasons, a stormwater management plan needs to be developed and implemented to better control runoff with the goal of controlling erosion and the loss of growth medium. A maintenance plan also needs to be developed and implemented to routinely inspect and clean ditches to ensure their continued proper operation. Additionally, the rills and gullies will need to be repaired and reseeded.

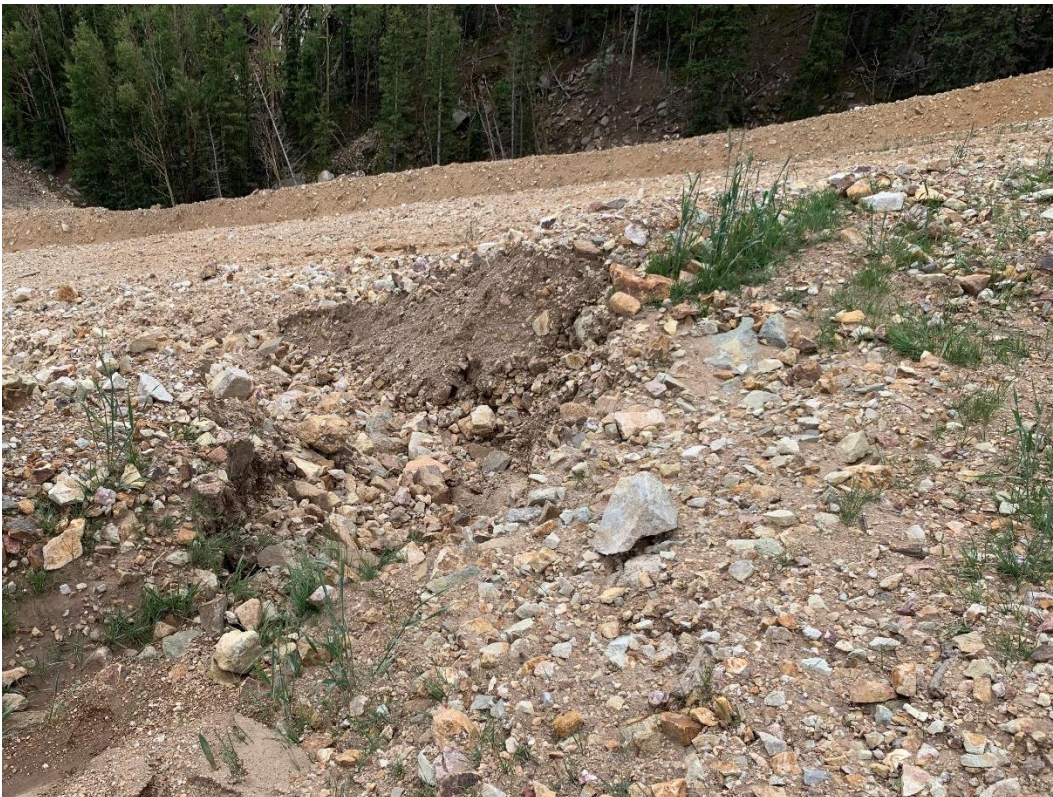
Photo 9 – Gully at the end of the upper contour ditch, perimeter ditch in background

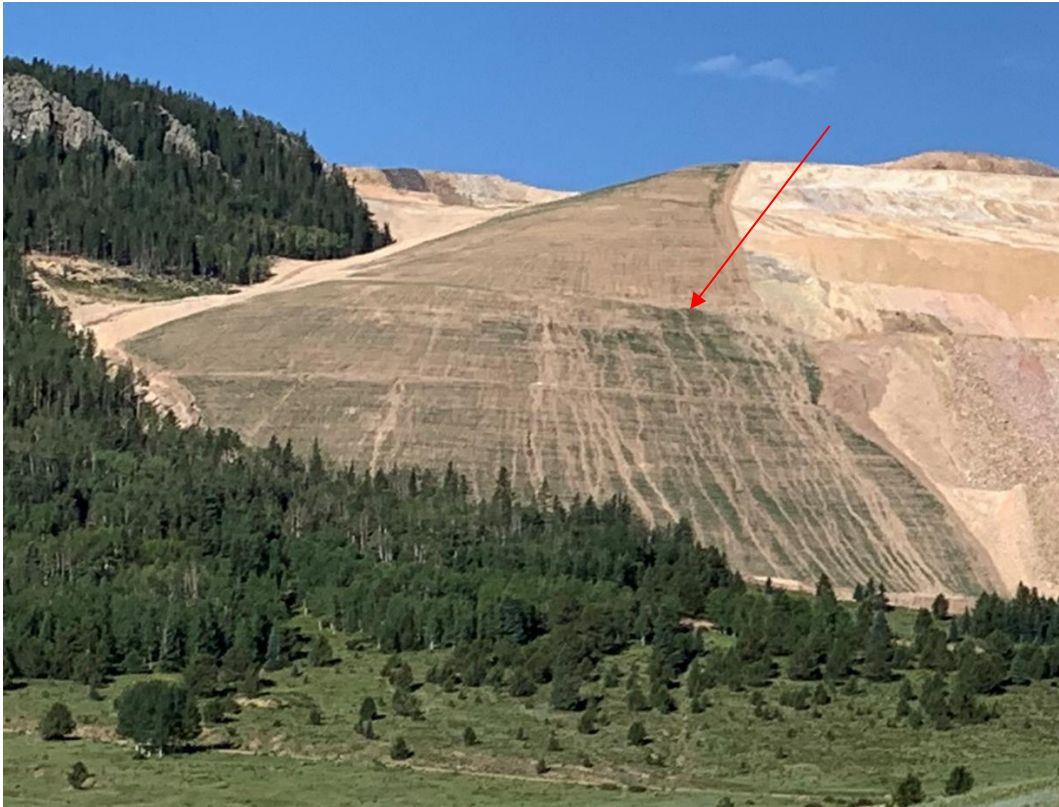
A significant number of rills and gullies have formed on the reclaimed area (photo 10). The rills originate at the upper contour ditch indicating that the ditch is blocked, forcing water out of the ditch. The rills/gullies continue down the reclamation through the lower contour ditch to the bottom of the ECOSA (photo 11).

The formation of rills and gullies is contributing to growth medium loss. The water flowing through the rills transports and deposits the growth medium at the toe of the ECOSA, which is the same area being mined for clay for the VLF2 liner. The growth medium budget for the reclamation of the entire Cresson Project is tight. Growth medium needs to be protected better as per Rule 3.1.9(5).

Photo 10 – South ECOAS, rills originate at contour ditches

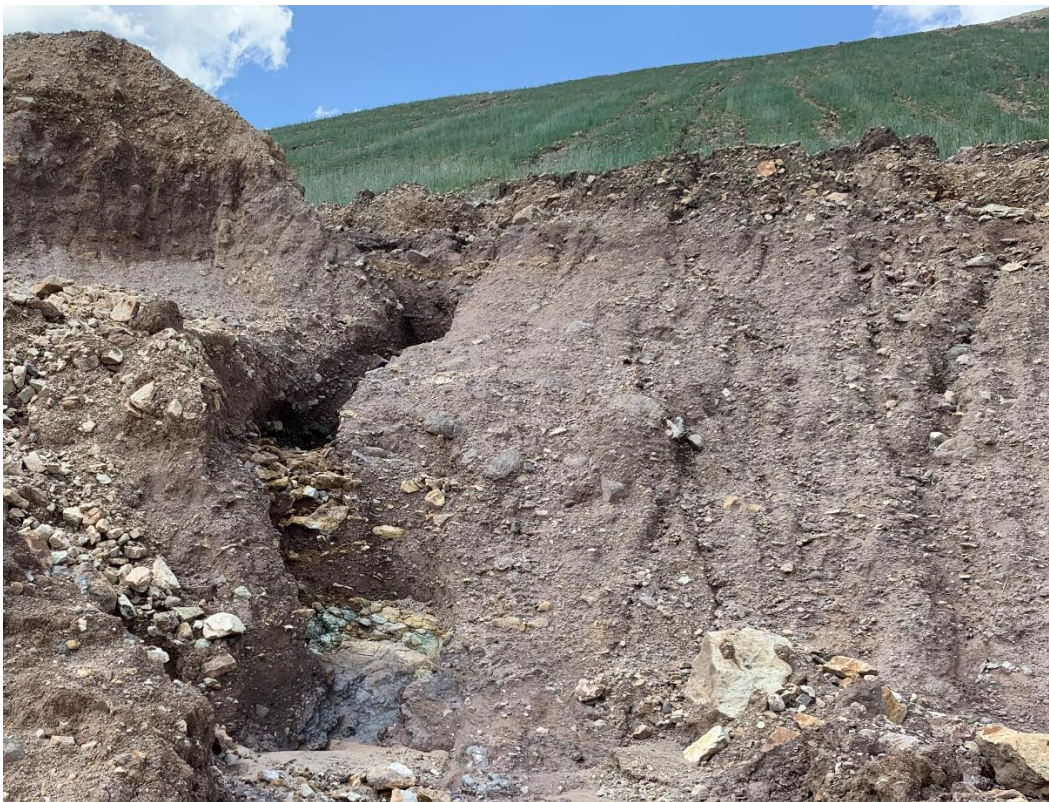
Photo 11 – Rills at toe of ECOSA

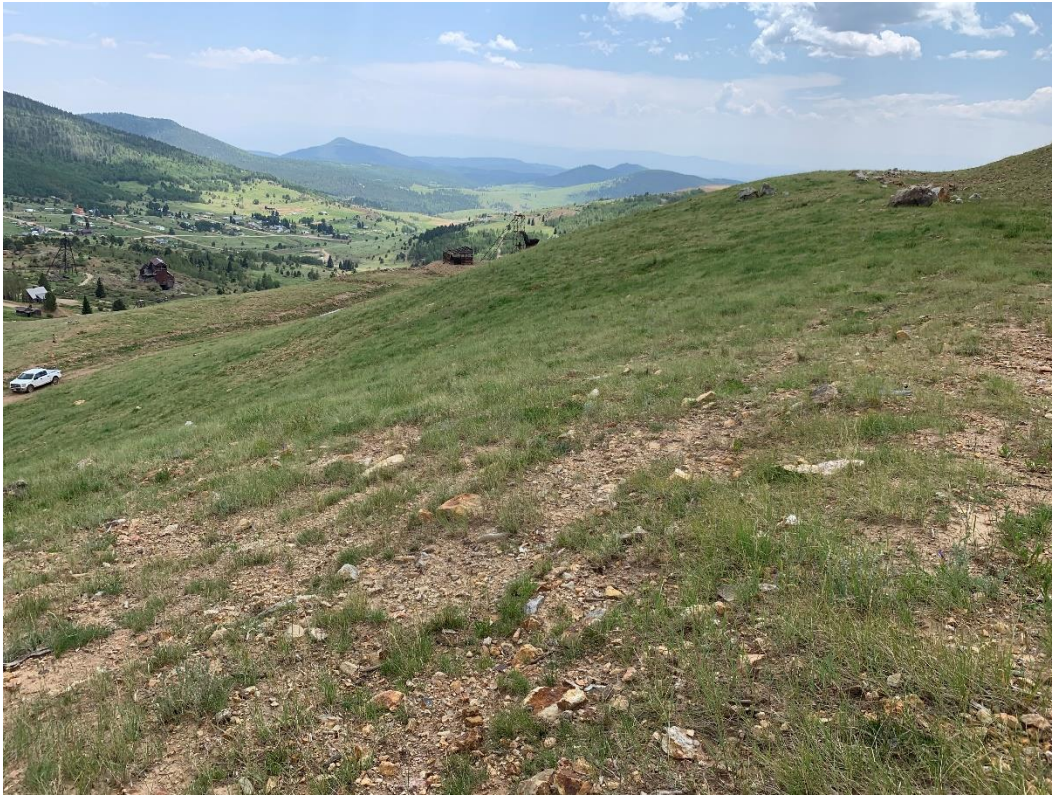
The vegetation on most of the backfilled areas was well established and appeared to be stable (photo 12).

Photo 12 – Vegetation on the Altman Backfill

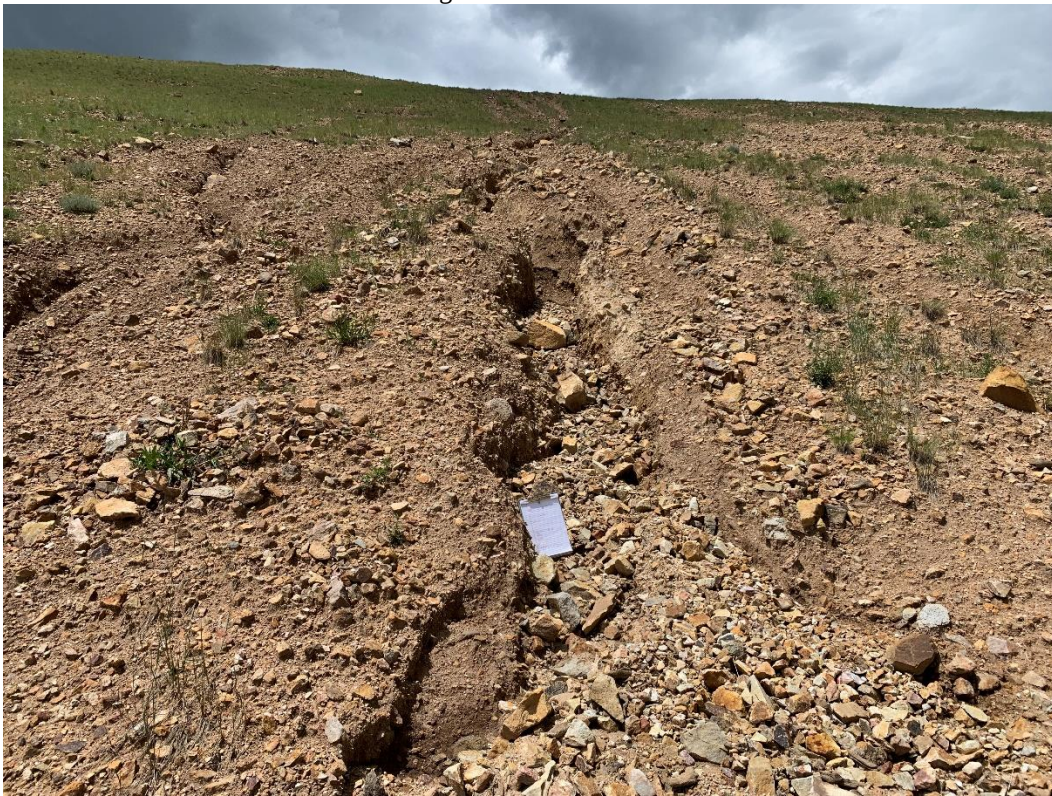
Several rills and gullies have formed on the east side of the reclamation of the Altman Backfill (photo 13). Growth medium and subsoil have eroded off the reclamation and has been deposited in the contour ditch effectively blocking the water flow in the ditch. The water is forced out of the ditch and flows down reclamation below the ditch where small rills have started to form.

Photo 13 – Erosion and gullies on the east side of the Altman Backfill

A stormwater management plan needs to be developed and implemented to better control runoff with the goal of controlling erosion and the loss of growth medium. A maintenance plan also needs to be developed and implemented to routinely inspect and clean ditches to ensure their continued proper operation. Additionally, the rills and gullies will need to be repaired and reseeded.

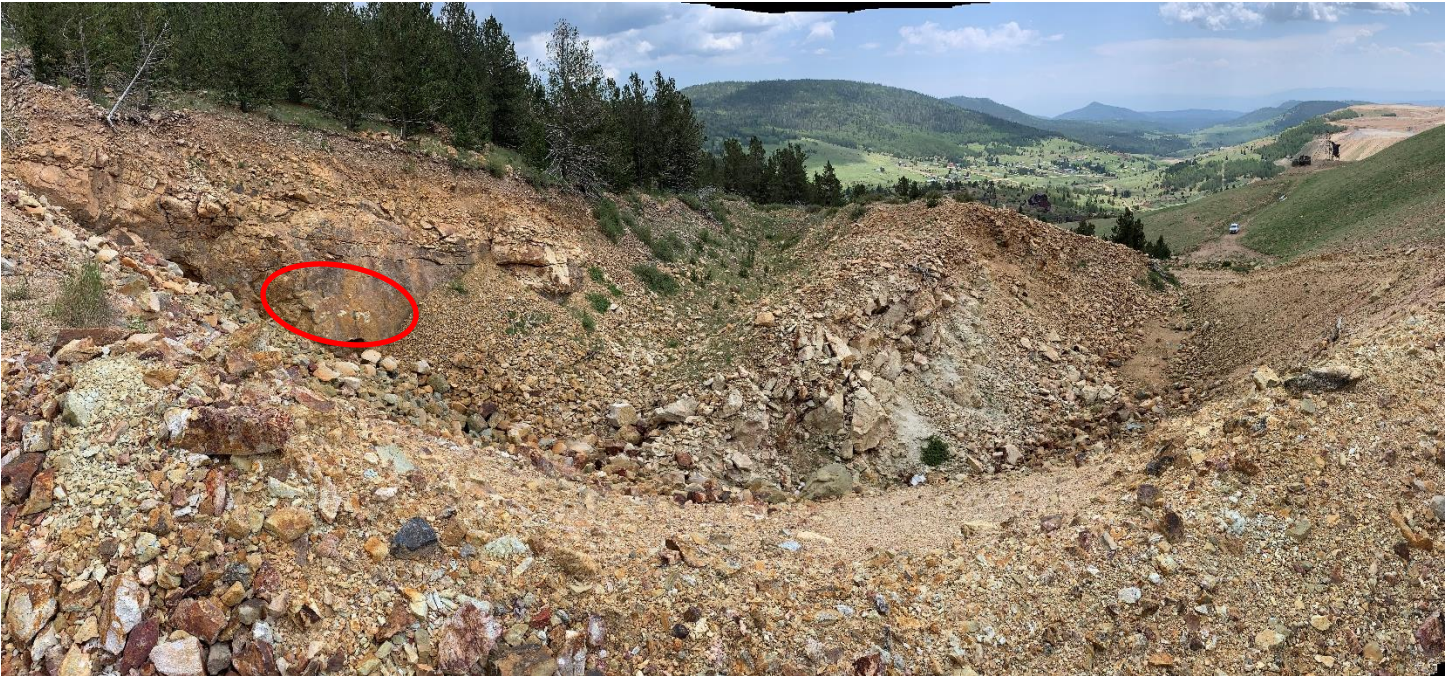
On the east side of the Altman Backfill, there is a large hole that has not been reclaimed (photo 14), although

the area around the hole has been reclaimed. Blast holes can be seen in the east wall of the hole indicating it is a mine related disturbance. Volunteer vegetation is growing in the hole indicating that this area has not been disturbed in a long time. CC&V staff did not know why it was not backfilled/reclaimed, if there is a possible future use or if it is scheduled to be reclaimed. The hole did not contained water and appeared to be stable in its present state, however, the Operator will ultimately need to backfill and reclaim this hole.

Photo 14 – Altman Backfill hole facing south, with blast holes
