**MINERALS PROGRAM INSPECTION REPORT**  
**PHONE: (303) 866-3567**

<b>MINE NAME:</b> Upper Mountain Top	<b>MINE/PROSPECTING ID#:</b> P-2011-003	<b>MINERAL:</b> Silver	<b>COUNTY:</b> Ouray
<b>INSPECTION TYPE:</b> Monitoring	<b>INSPECTOR(S):</b> Lucas West	<b>INSP. DATE:</b> August 23, 2021	<b>INSP. TIME:</b> 14:56
<b>OPERATOR:</b> Ken Orvis, The Mining Company Inc.	<b>OPERATOR REPRESENTATIVE:</b> None	<b>TYPE OF OPERATION:</b> MP - Mineral Prospecting

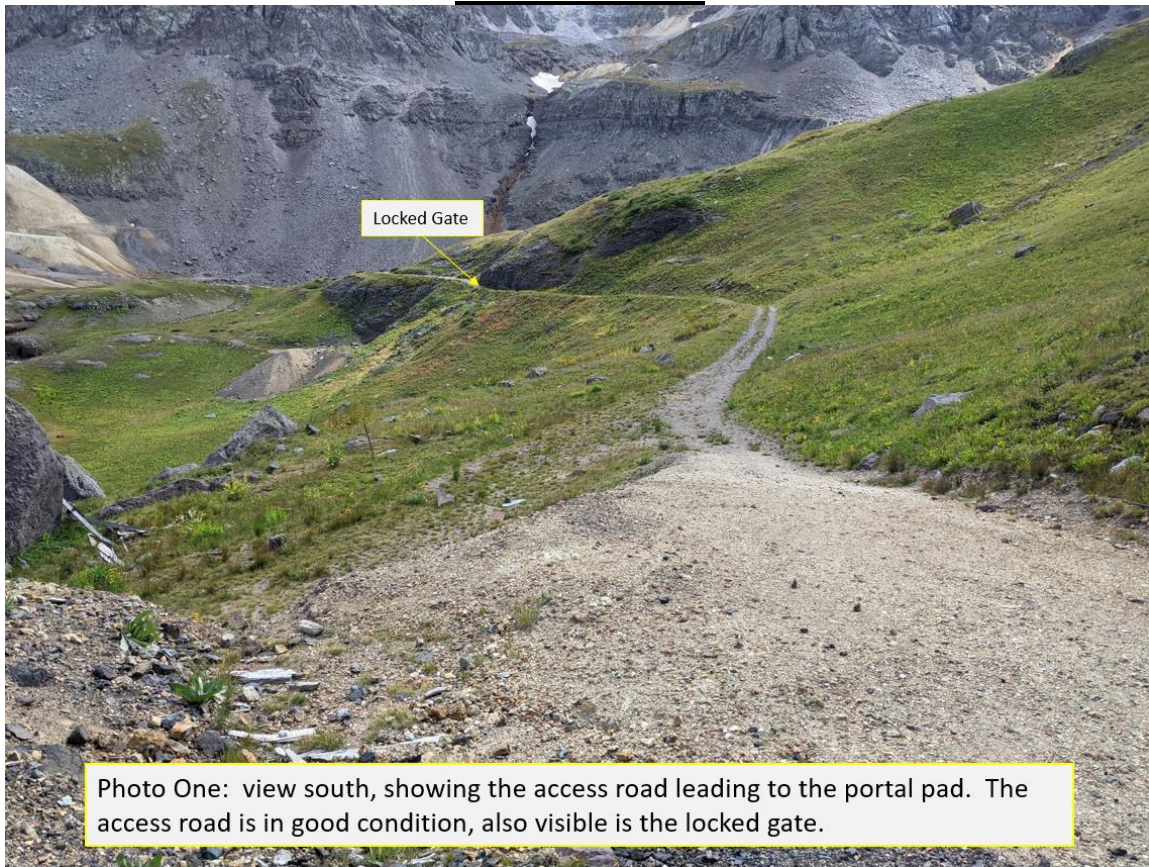
The access road is an existing claim road that branches off of Forest Service Road 853.1C, the locked gate lies along the access road near the boundary of the claim. No identification sign was posted on site at the time of the inspection. Due to the high volume of recreational travel in the area and the likelihood of theft the lack of identification signage is not considered a problem at this time. The access road is in good condition and no signs of settling, slumping or erosion of the road was noted. The access road can be seen in Photo One. At the end of the access road is the portal pad, waste rock dump and portal. The portal was observed and secured with a locking metal gate, no evidence of vandalism or attempted unauthorized entry was noted. The portal was discharging at the time of the inspection and was visually estimated to be flowing at a rate of 20-25 Gallons Per Minute. The flow was following a preferential flow path and showed no visual signs of impaired water quality. The portal and it's discharge can be seen in Photo Two. Leading away from the portal is a historic mine rail spur leading to the edge of the waste rock dump. The dump itself is in good condition and appeared stable at the time of the inspection.

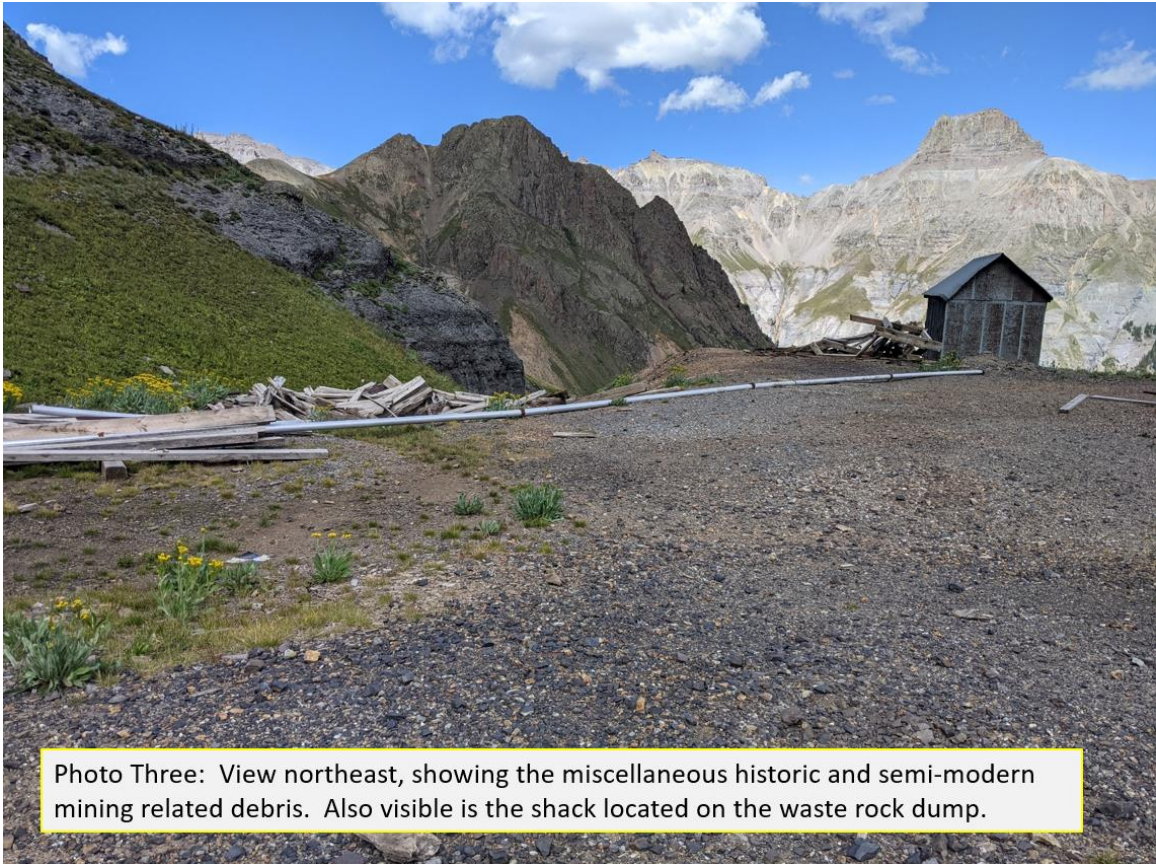
Across the portal pad, a mixture of historic and semi-modern mining related debris is scattered. The debris appears to be being stored for potential future use and is somewhat neat and orderly. Adjacent to the stored materials is a small shack that was in good condition. The shack was secured and no signs of attempted unauthorized entry or vandalism was noted. The shack and various debris can be seen in Photo Three.
