**MINERALS PROGRAM INSPECTION REPORT**  
**PHONE: (303) 866-3567**

<b>MINE NAME:</b> Camp Bird Mine	<b>MINE/PROSPECTING ID#:</b> M-1982-090	<b>MINERAL:</b> Gold, silver, lead, zinc	<b>COUNTY:</b> Ouray
<b>INSPECTION TYPE:</b> Monitoring	<b>INSPECTOR(S):</b> Lucas West	<b>INSP. DATE:</b> August 23, 2021	<b>INSP. TIME:</b> 16:00
<b>OPERATOR:</b> Caldera Mineral Resources, LLC	<b>OPERATOR REPRESENTATIVE:</b> None	<b>TYPE OF OPERATION:</b> 112 - Hard Rock Regular Operation	
<b>REASON FOR INSPECTION:</b> Normal I&E Program	<b>BOND CALCULATION TYPE:</b> None	<b>BOND AMOUNT:</b> \$157,680.00	
<b>DATE OF COMPLAINT:</b> NA	<b>POST INSP. CONTACTS:</b> None	<b>JOINT INSP. AGENCY:</b> None	
<b>WEATHER:</b> Clear	<b>INSPECTOR'S SIGNATURE:</b>

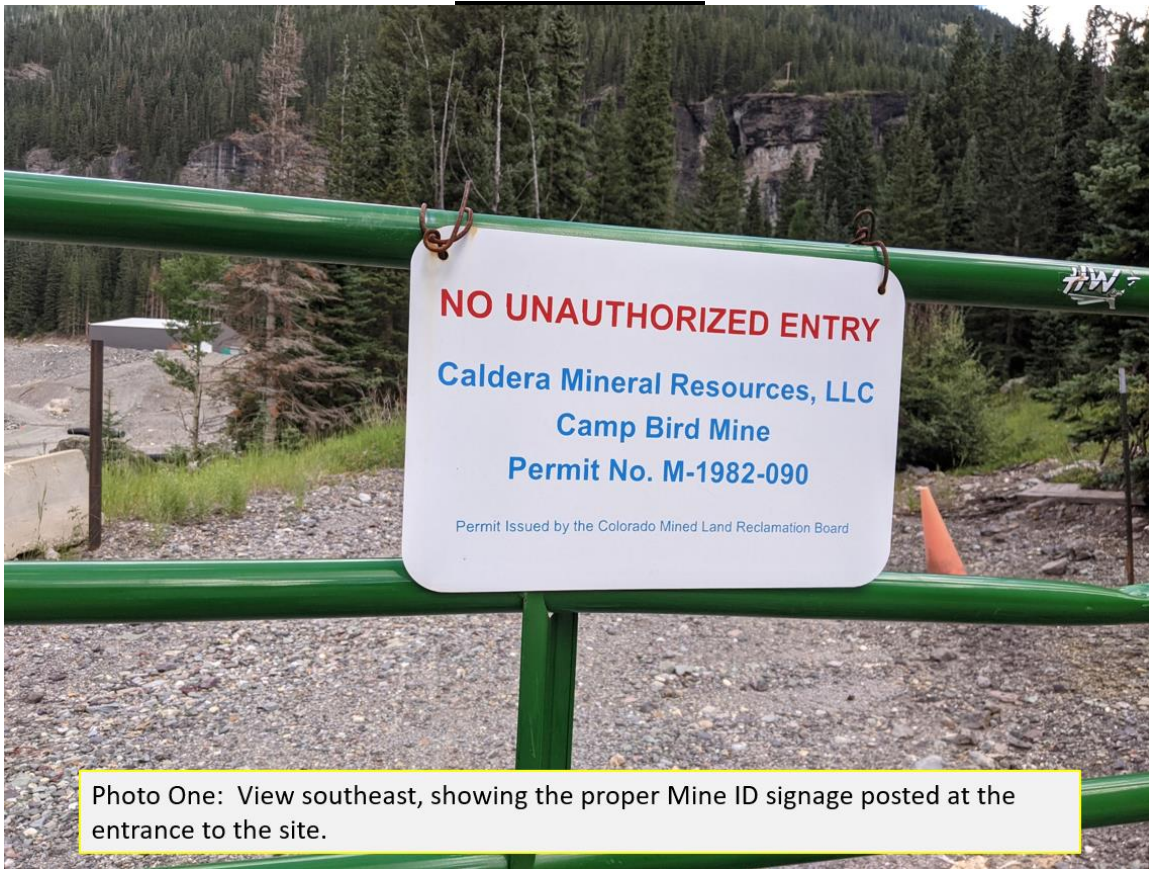
The proper mine identification signage was posted at the entrance to the site, seen in Photo One, and the permit area is clearly defined within the pre-law disturbed areas. The main portal area consists of a large shop structure, portal, storage and storage area. The portal is secured with a locking steel gated closure which can be seen in Photo Two. The closure is in good condition and shows no signs of attempted unauthorized entry. Adjacent to the portal is the large shop structure which is in good condition. Surrounding the shop are various storage areas containing items such as large shipping containers, timbers, rail line and other various mining related materials. An example of the items can be seen in Photo Three. All items being stored in the permit area are in a neat and orderly fashion and not considered a problem at this time. Several stockpiles of material are located adjacent to the storage area. The stockpiles were stable at the time of the inspection and in good condition.

Photo One: View southeast, showing the proper Mine ID signage posted at the entrance to the site.

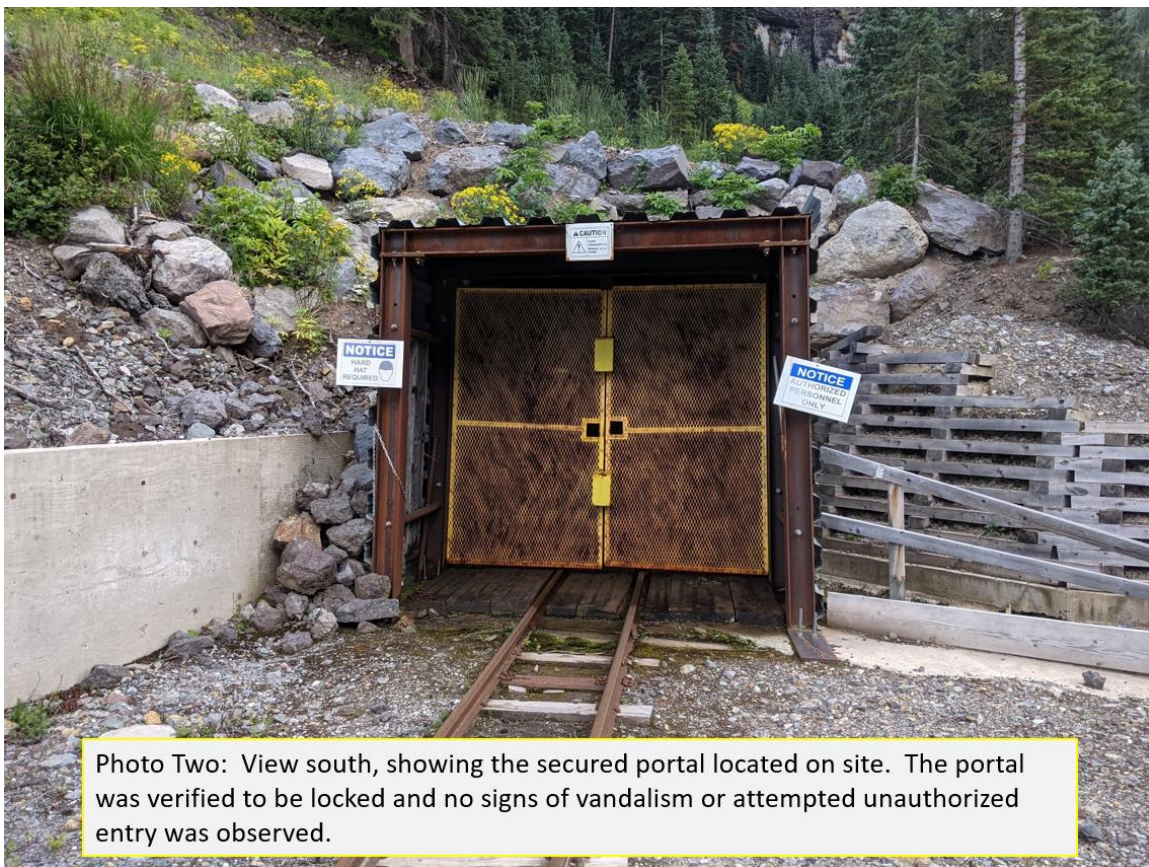
Photo Two: View south, showing the secured portal located on site. The portal was verified to be locked and no signs of vandalism or attempted unauthorized entry was observed.

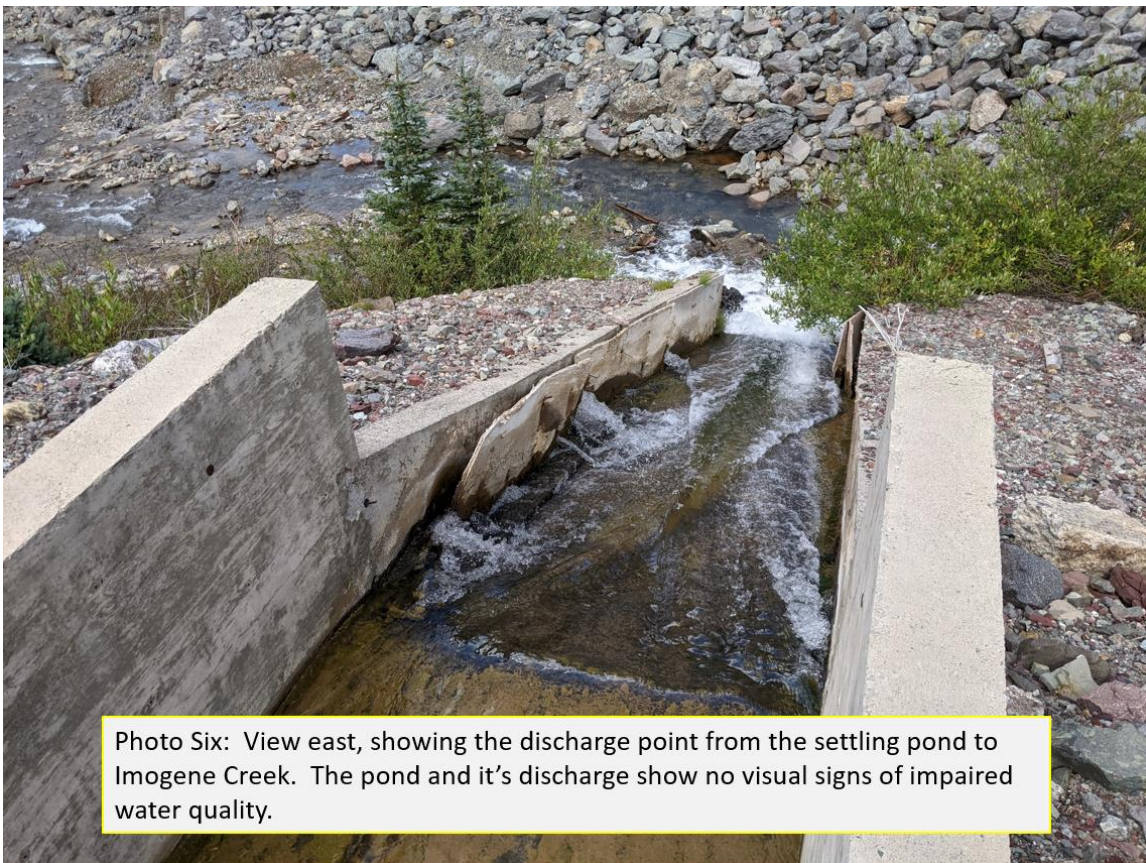
The portal has an associated discharge that is routed through pipes and conveyances to the west side of Imogene creek. The flow then reports to a large settling pond before discharging into Imogene Creek. All conveyances and discharge points appeared to be functioning as designed. The discharge into Imogene Creek can be seen in Photo Six. No visual evidence of impaired water quality was noted throughout the system.

Photo Six: View east, showing the discharge point from the settling pond to Imogene Creek. The pond and its discharge show no visual signs of impaired water quality.
