**COLORADO**  
Division of Reclamation,  
Mining and Safety  
Department of Natural Resources

<b>Permit Number:</b> C-1981-041 <b>Mine Name:</b> Roadside Portals <b>Operator:</b> Snowcap Coal Company, Inc. <b>Operator Address:</b> MS Tonya Hammond P.O. Box 1430 Palisade, CO 81526	<b>County:</b> Mesa <b>Operation Type:</b> Underground <b>Permit Status:</b> Active <b>Ownership:</b> Private
	<b>Operator Representative Present:</b>  NA
<b>Operator Representative Signature:</b> (Field Issuance Only)

<b>Inspection Start Date:</b> September 8, 2021 <b>Inspection Start Time:</b> 10:00 <b>Inspection End Date:</b> September 8, 2021 <b>Inspection End Time:</b> 10:05		<b>Inspection Type:</b> Aerial Inspection <b>Inspection Reason:</b> Normal I&E Program <b>Weather:</b> Clear	
<b>Joint Inspection Agency:</b>  None		<b>Joint Inspection Contacts:</b>  None	
<b>Post Inspection Agency:</b>  None		<b>Post Inspection Contacts:</b>  None	
<b>Inspector(s):</b>  Clayton Wein  Brock Bowles	<b>Inspector's Signature:</b>  <i>Clayton Wein</i>		<b>Signature Date:</b>  9/13/2021

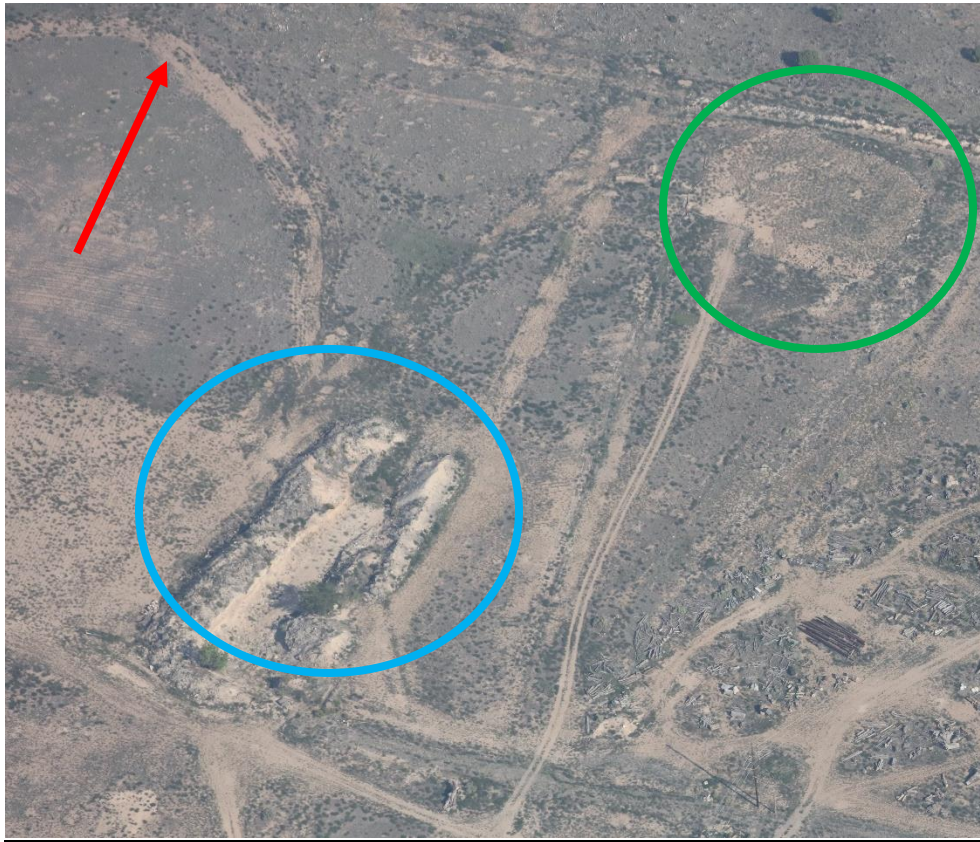
The Carey Pit was dry during the inspection (Photo 1). The pit is located to the southwest off the TR-69 repair area, on Tract 71. There was no evidence of recent water application to the pit. The land owner's middle field is located to the southeast of the TR-69 repair area (Photo 2). There was no evidence of recent water application to the area. The trenches on top of the Tract 70 Mesa were observed to be dry (Photo 3). There were no indications of recent water application in the trenches.

**Photo 1:** The Carey Pit is outlined in the Photo above by the blue circle. The TR-69 repair area is outlined by the green circle.

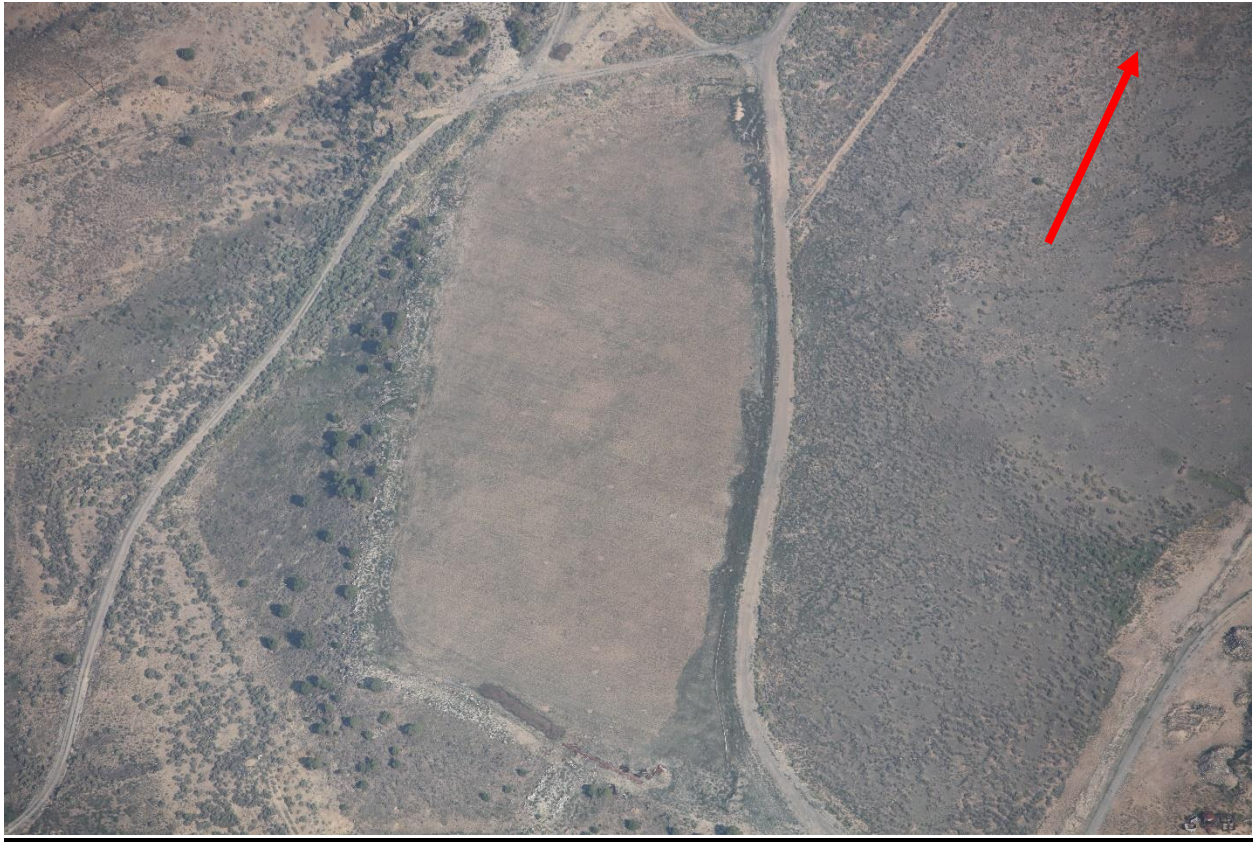
**Photo 2:** The landowner's middle field was dry during the inspection.

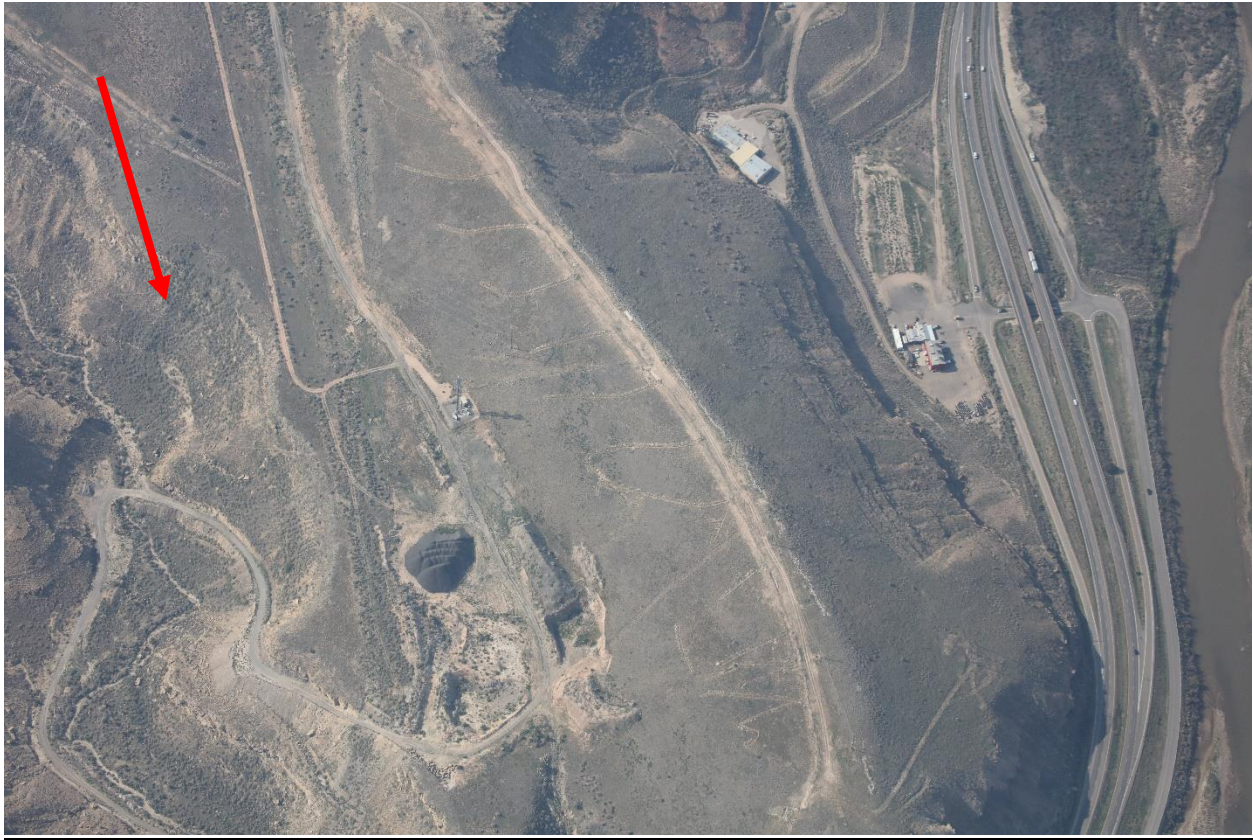
**Photo 3:** The trenches located on top of the Tract 70 Mesa can be seen running through the middle of the photograph above.

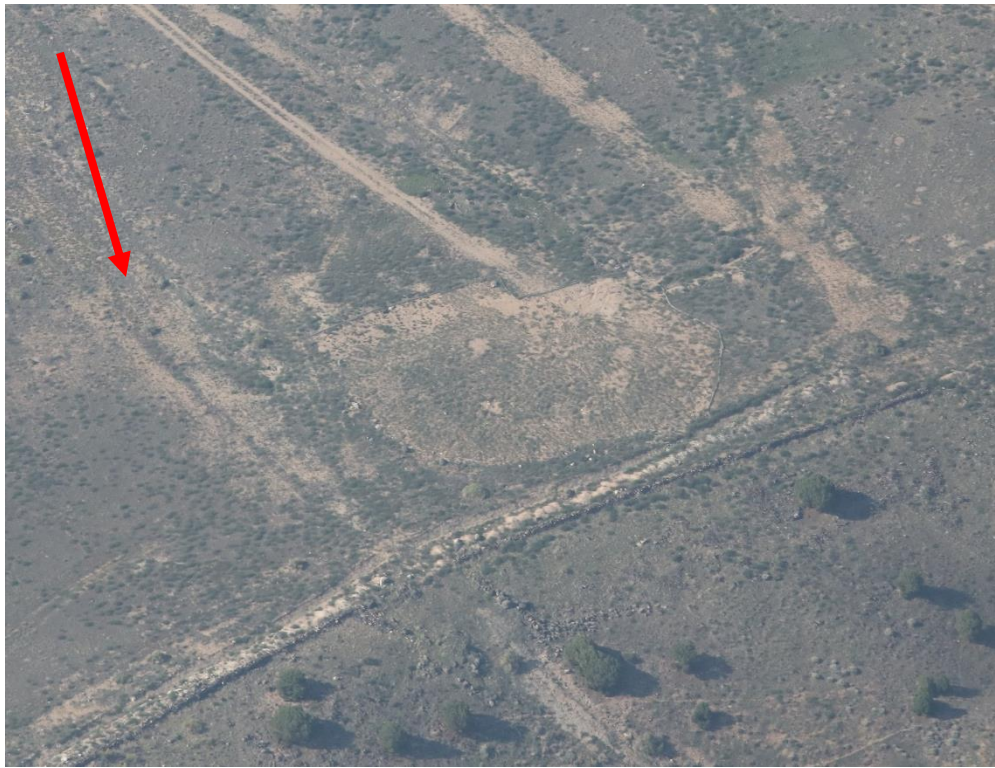
The TR-69 repair area was stable with vegetative cover (Photo 4). There were no indications of erosional features or off-site impacts. The sediment logs were intact and in the correct positions at the site. The site had no indications of surface settling.

**Photo 4:** The TR-69 repair area is located in the center in the photo above. For a more general location of the TR-69 repair area, please reference Photo 1.
