MINERALS PROGRAM INSPECTION REPORT
PHONE: (303) 866-3567

MINE NAME: Climax Mine	MINE/PROSPECTING ID#: M-1977-493	MINERAL: Molybdenum	COUNTY: Lake, Summit
INSPECTION TYPE: Monitoring	INSPECTOR(S): Lucas West	INSP. DATE: August 24, 2021	INSP. TIME: 08:47
OPERATOR: Climax Molybdenum Company	OPERATOR REPRESENTATIVE: Alex Ungers	TYPE OF OPERATION: 112d-3 - Designated Mining Operation	
REASON FOR INSPECTION: Normal I&E Program	BOND CALCULATION TYPE: None	BOND AMOUNT: \$91,011,850.00	
DATE OF COMPLAINT: NA	POST INSP. CONTACTS: None	JOINT INSP. AGENCY: None	
WEATHER: Clear	INSPECTOR'S SIGNATURE:

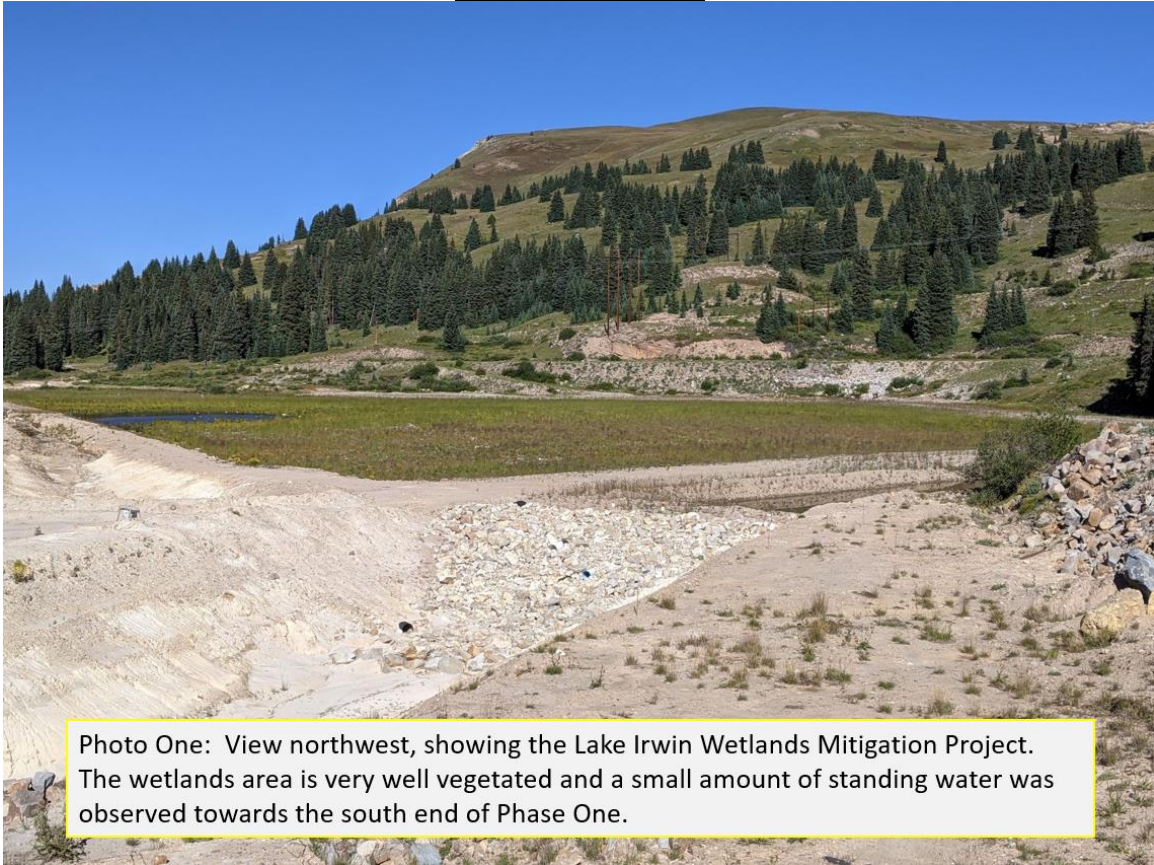
The Lake Irwin wetlands mitigation project was observed to be in excellent condition and can be seen in Photo One. The vegetation in phase one is dense, diverse and thriving. Small amounts of standing water was observed towards the south end of the phase. Conversations with the Operator indicate that vegetation monitoring and weed maintenance are on-going. No problems were noted in this area.

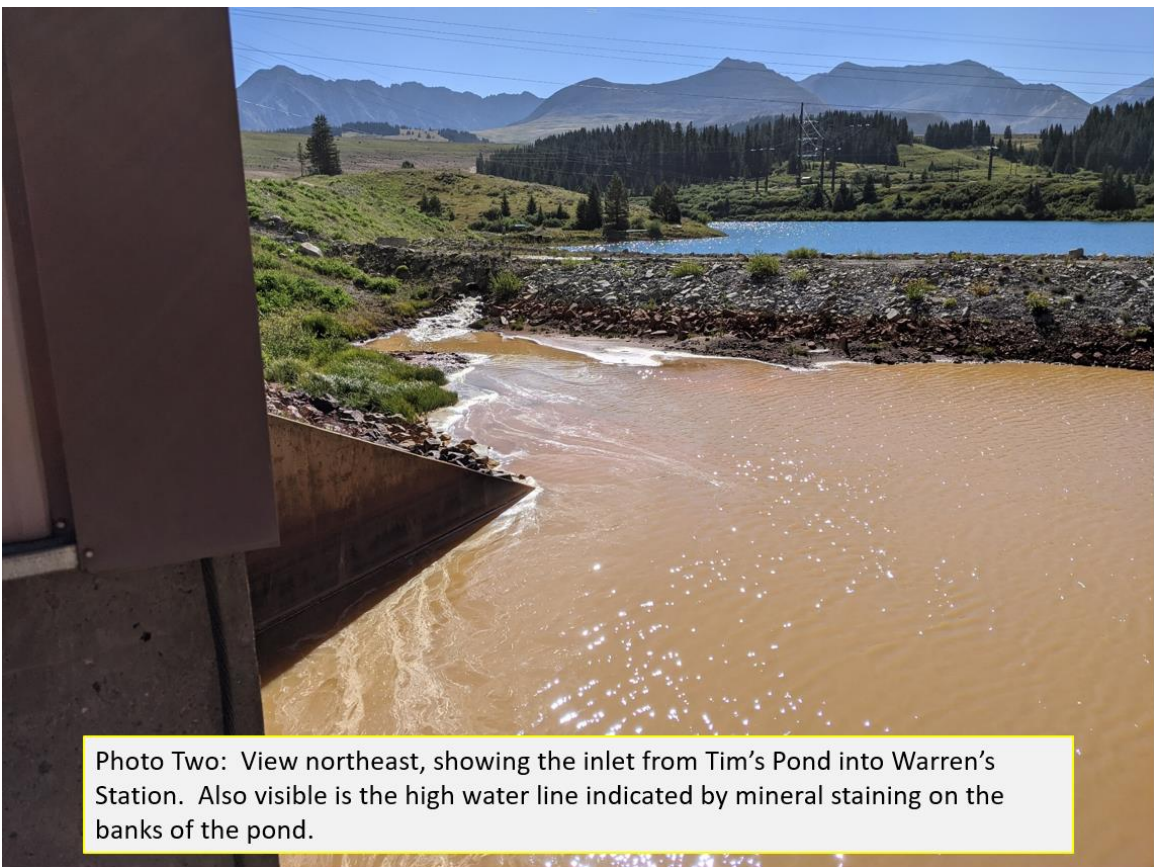
The pond referred to as Warren's Station collects flow from Tim's Pond as well as 1 dam seepage water to be settled and pumped to the Sludge Densification Plant. The pond can be seen in Photo Two. The flow entering the pond was observed and was flowing unobstructed at the time of the inspection. Recently the inlet from Tim's Pond suffered a pipe failure which was caught and repaired by the Operator. The pond banks and separation dam appeared to be stable at the time of the inspection and in good condition. A high water line was observed indicating the increased available capacity of the pond. The pump station was also observed and visually all equipment associated with the pump system was in good working order. The overall condition of the pond is good and no problems were noted.

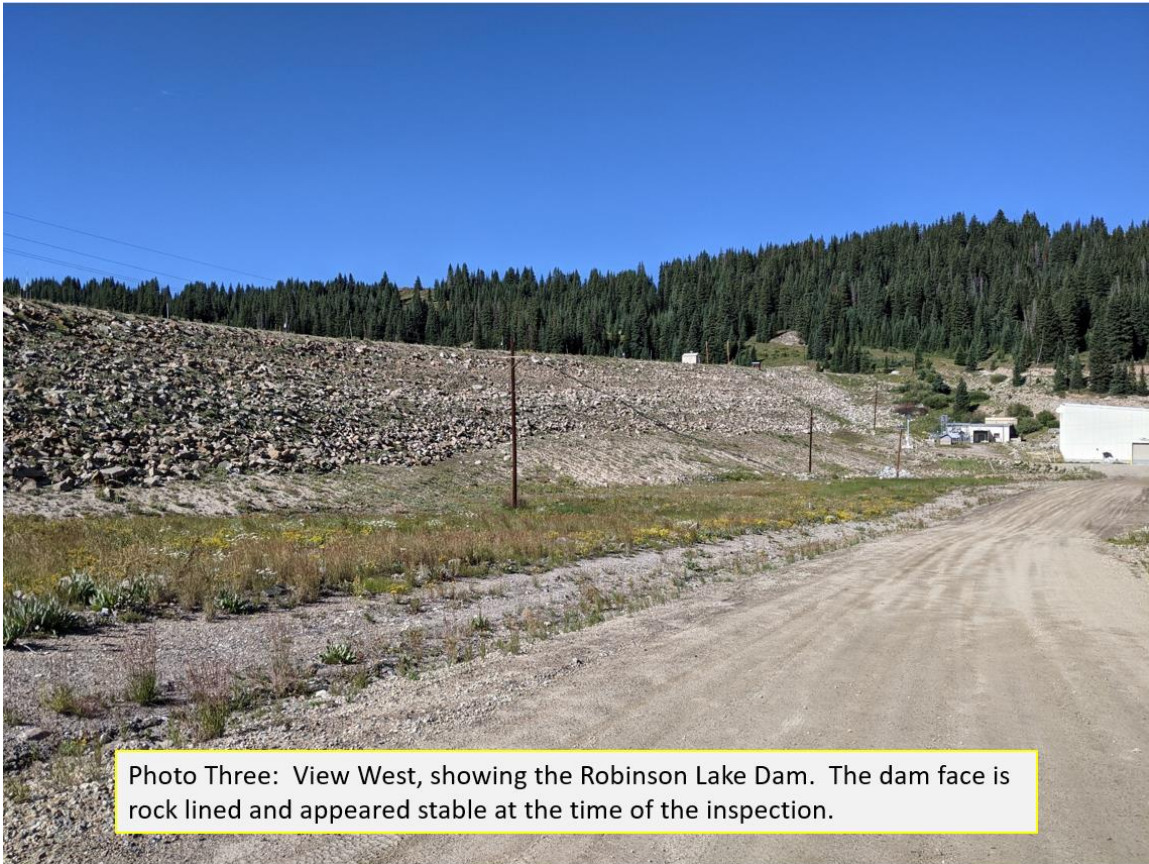
Adjacent to Warren's Station lies the Robinson Lake with associated dam and Seepwater system. The lake itself is in good condition from all observed vantage points. The dam was observed and can be seen in Photo Three. The dam face is rock lined and sparsely vegetated. No evidence of settling, slumping or erosion was noted and the dam appeared to be stable at the time of the inspection. The Seepwater collection pond and pump system were also observed. The pond is well vegetated and stable and can be seen in Photo Four. The pump system appeared to be in good working order and was not actively pumping at the time of the inspection. The pump system and pond are in good condition and no problems were noted.

Photo Three: View West, showing the Robinson Lake Dam. The dam face is rock lined and appeared stable at the time of the inspection.

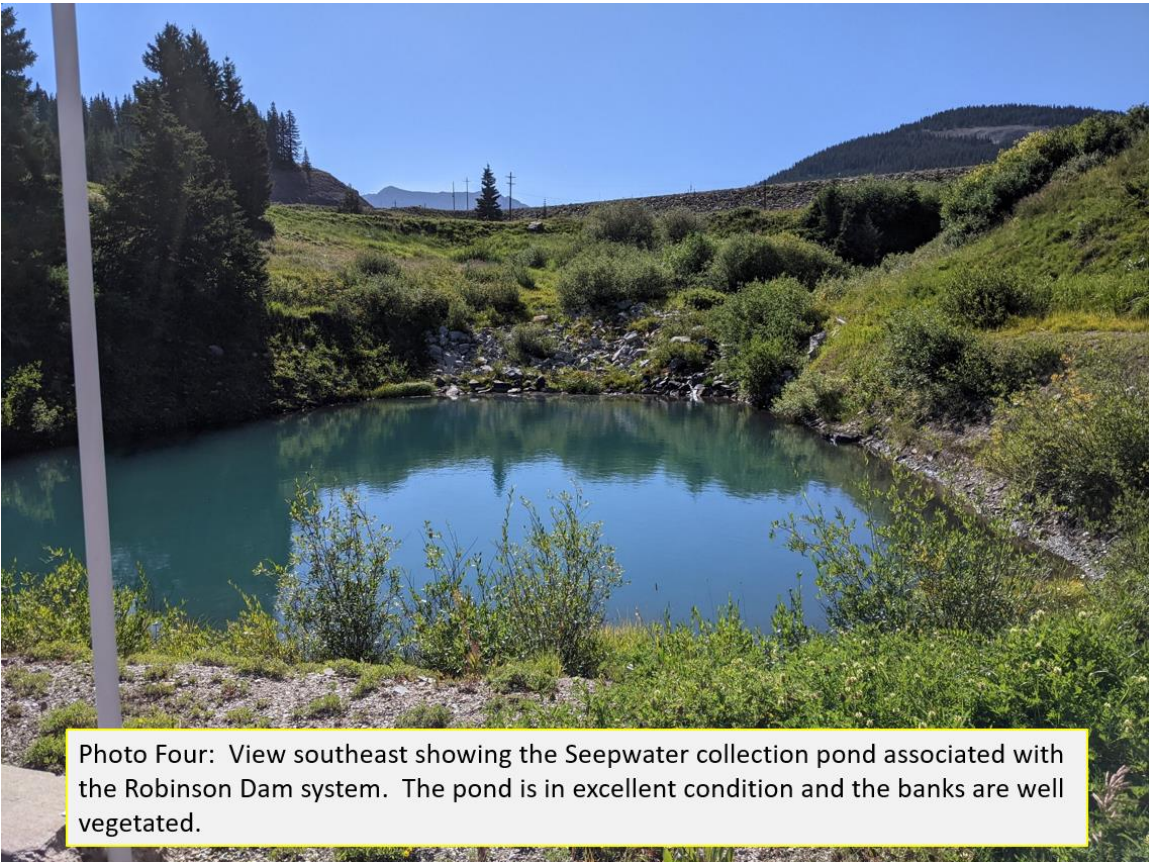
Photo Four: View southeast showing the Seepwater collection pond associated with the Robinson Dam system. The pond is in excellent condition and the banks are well vegetated.

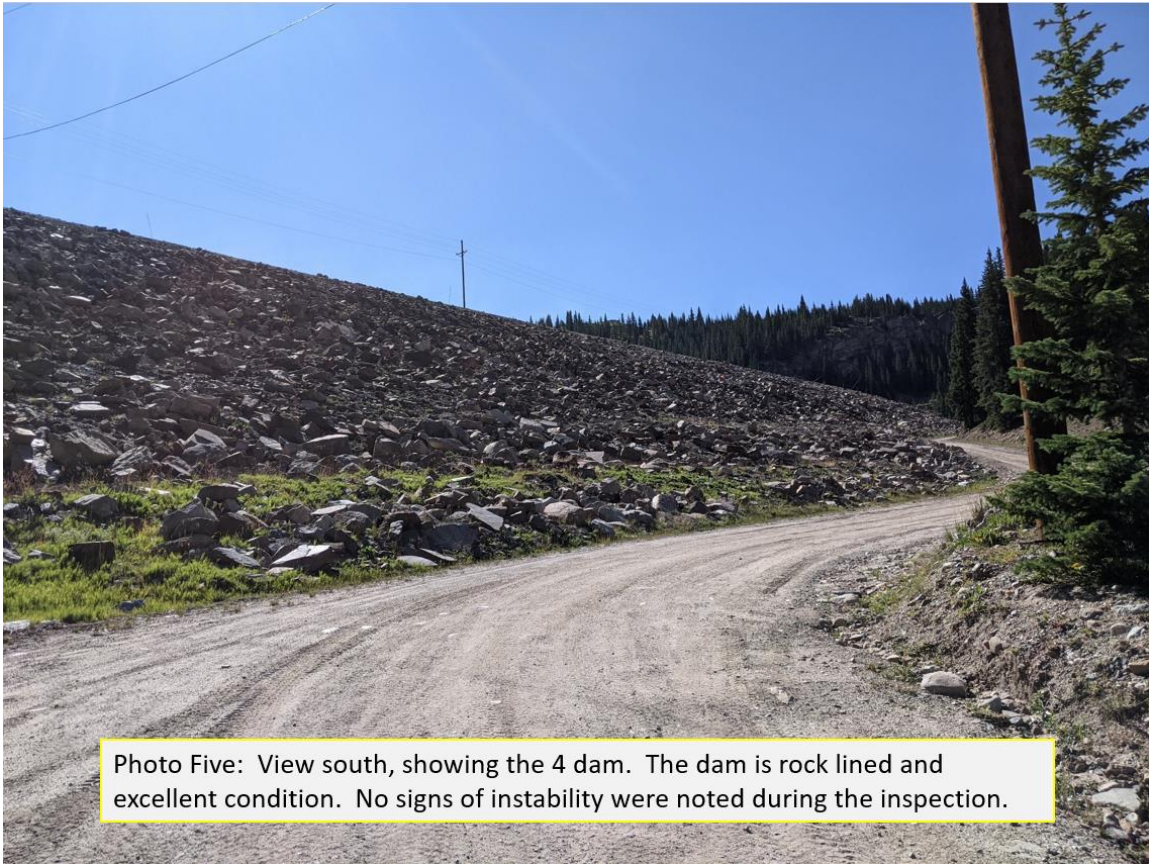
The 4 dam is part of the Eagle Park Reservoir system located in the western reaches of the permit area. The dam face is rock lined and was observed to be in good condition. No signs of settling, slumping or instability were noted, and the dam can be seen in Photo Five. Immediately down gradient from the dam is the 4 dam

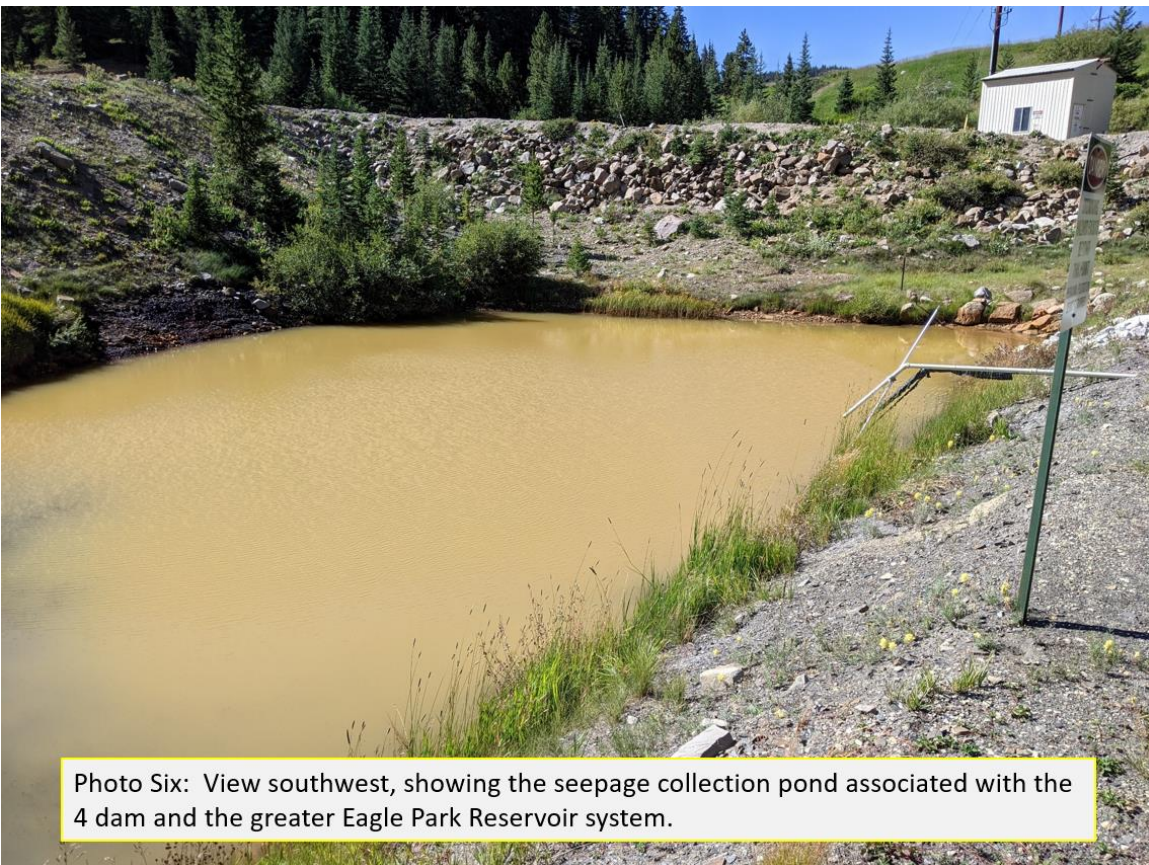
Seepwater collection pond and pump system. The pond can be seen in Photo Six. The water level in the pond was below the observed maximum capacity and the banks of the pond are in good condition and well vegetated. The small dam associated with the pond was also observed complete with emergency spill way. As part of the system, a containment wall was constructed to collect any seepage that may come from the dam, to be recirculated into the system. This collection area is referred to as the "seep seep". Minimal standing water was observed in the seep seep. The Eagle Park Reservoir discharge was observed and is flowing unimpeded. All storm water control structures in the area were in good condition and functioning as designed.
