MINERALS PROGRAM INSPECTION REPORT PHONE: (303) 866-3567

MINE NAME:	MINE/PROSPECTING ID#:	MINERAL:	COUNTY:
Cross Gold Mine	M-1977-410	Gold, copper, silver, zinc and lead	Boulder
INSPECTION TYPE:	INSPECTOR(S):	INSP. DATE:	INSP. TIME:
Preoperation Inspection	Amy Eschberger, Peter Hays	June 24, 2021	10:00
OPERATOR:	OPERATOR REPRESENTATIVE(S):	TYPE OF OPERATION:	
Grand Island Resources LLC	Richard Mittasch, Daniel Pollock	110(2) - Hard Rock Limited Impact

PERMIT #: M-1977-410 INSPECTOR'S INITIALS: AME INSPECTION DATE: June 24, 2021

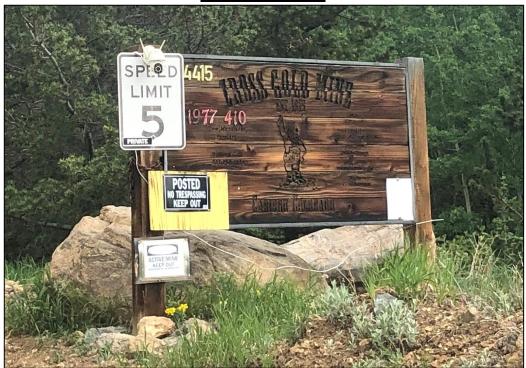
Photo 1. View of permit sign posted at Cross Mine entrance. This sign includes the site name and permit number as required by Rule 3.1.12(1), but should also include the operator name and a statement that a reclamation permit for the operation has been issued by the CO Mined Land Reclamation Board.

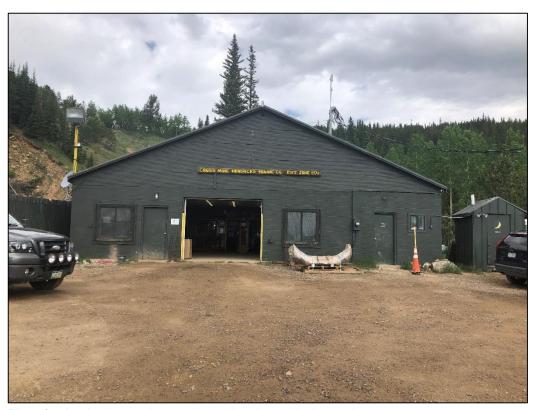
Photo 2. View looking northwest at Cross Shop located in Cross Mine area.

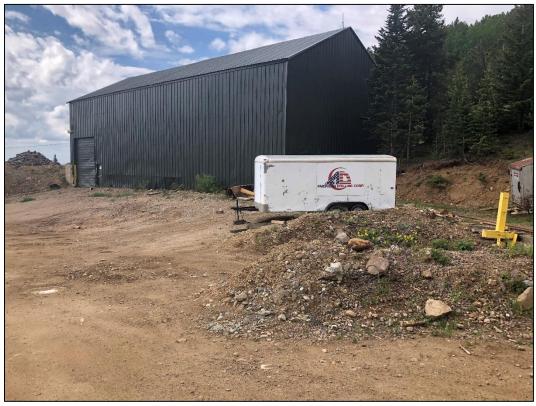
Photo 3. View looking south at Cross Warehouse/Ore Storage Building located in Cross Mine area.

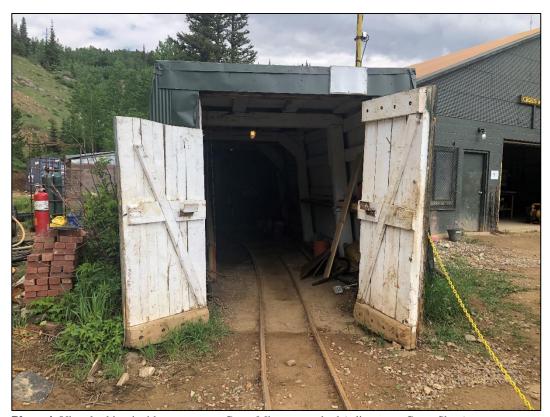
Photo 4. View looking inside entrance to Cross Mine snow shed (adjacent to Cross Shop).

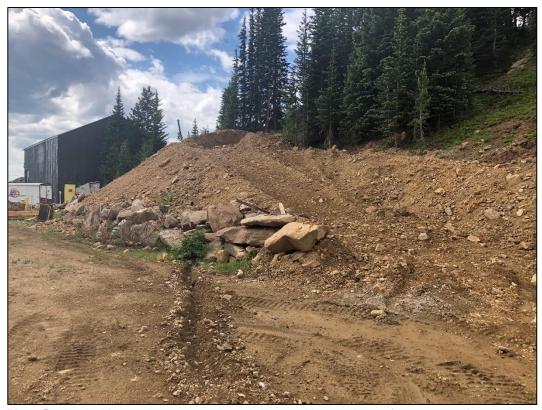
Photo 5. View looking south at waste rock stockpile stored just southeast of New Cross Mine Decline Portal in Cross Mine area.

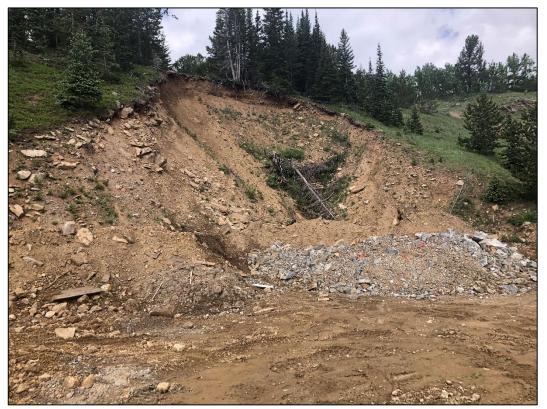
Photo 6. View looking west at New Cross Mine Decline Portal in Cross Mine area. Development of this portal was discontinued, leaving a partially excavated hillside with steep slopes.

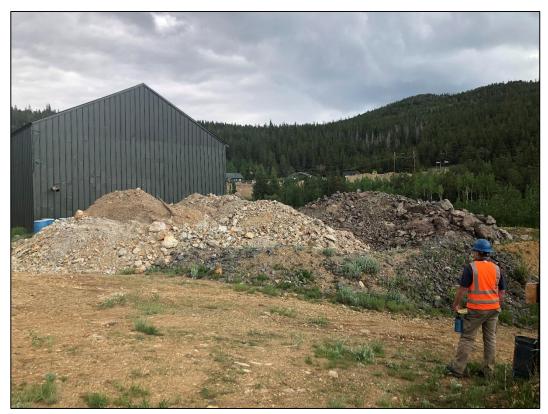
Photo 7. View looking northwest at waste rock stockpile stored just southeast of Cross Warehouse/Ore Storage Building in Cross Mine area.

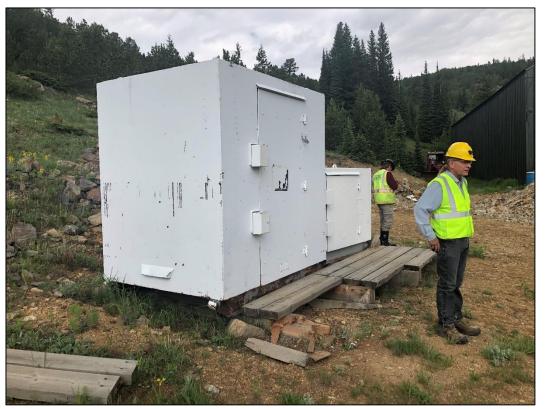
Photo 8. View looking northwest at explosives storage area located southeast of Cross Warehouse/Ore Storage Building in Cross Mine area, where two magazines are secured with padlocks and lock boxes.

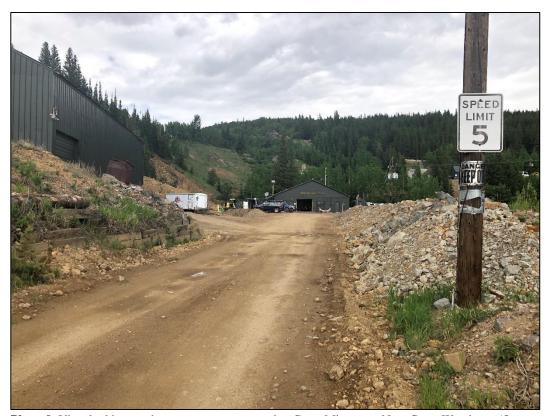
Photo 9. View looking northwest across access road to Cross Mine area. Note Cross Warehouse/Ore Storage Building (at left) and Cross Shop (at center).

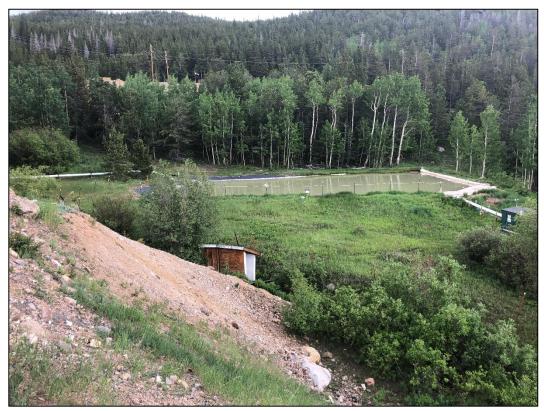
Photo 10. View looking north across valley between Cross and Caribou Mines, showing Pond 2 in which water from each mine is combined prior to being discharged to Coon Track Creek under NPDES permit.

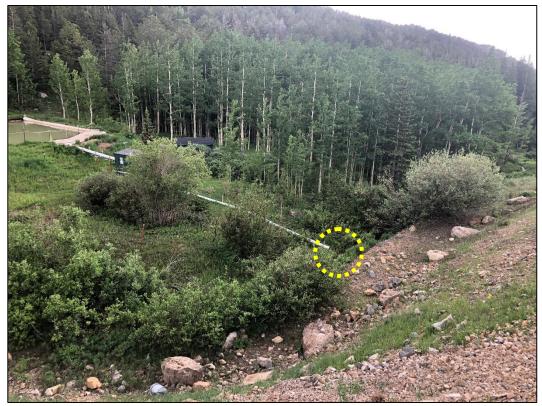
Photo 11. View looking east across valley between Cross and Caribou Mines, showing approximate location (circled) of discharge point from Pond 2 to Coon Track Creek under NPDES permit.

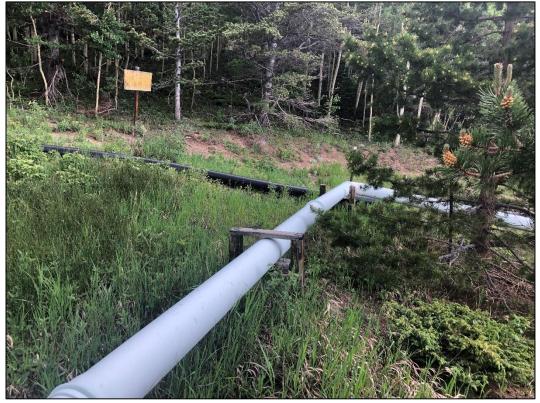
Photo 12. View looking northeast at expansion area proposed in AM-2 for pond water pipelines, located directly north of Pond 2. Note white pipeline which conveys water from Pond 1 (at Cross Mine) and black pipeline which conveys water from Ponds 3A-3C (at Caribou Mine).

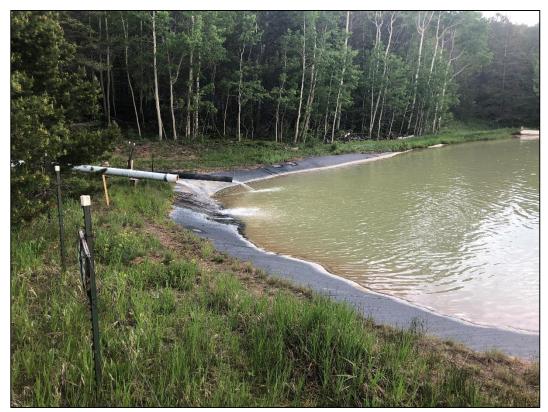
Photo 13. View looking east across northern corner of Pond 2, showing discharge into pond from Pond 1 (Cross Mine; white pipeline) and Ponds 3A-3C (Caribou Mine; black pipeline). The proposed expansion area in AM-2 would include the northern edge of this pond with the discharge pipelines.

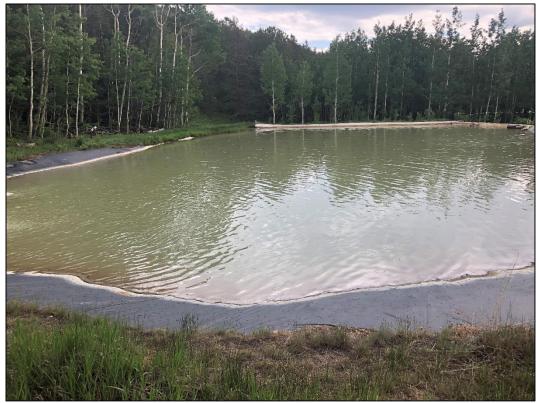
Photo 14. View looking southeast across Pond 2 in which water from each mine is combined prior to being discharged to Coon Track Creek under NPDES permit. Operator should remove any sediment or vegetation from pond liner to maintain adequate freeboard and protect liner integrity.

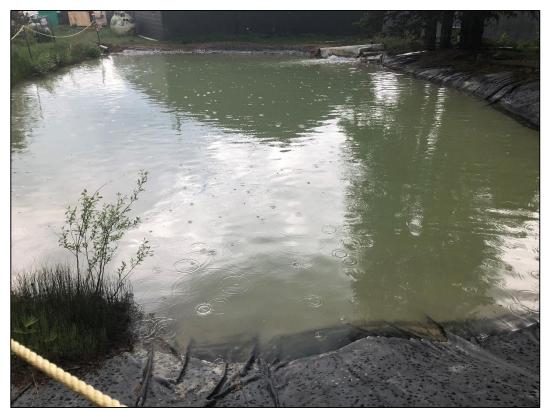
Photo 15. View looking southeast across Pond 1, in which Cross Mine water is discharged and treated with lime daily. Water from this pond gravity drains to Pond 2. Operator should remove any sediment or vegetation from pond liner to maintain adequate freeboard and protect liner integrity.

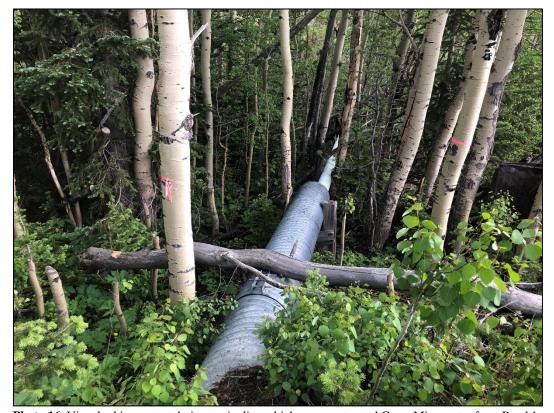
Photo 16. View looking east at drainage pipeline which conveys treated Cross Mine water from Pond 1 to Pond 2.

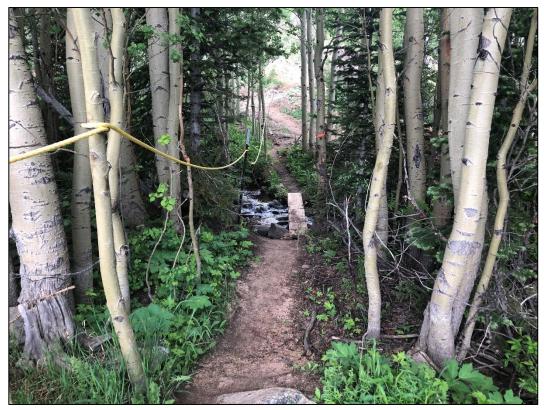
Photo 17. View looking north at existing footpath which allows access from Pond 1 at Cross Mine to Ponds 3A-3C at Caribou Mine.

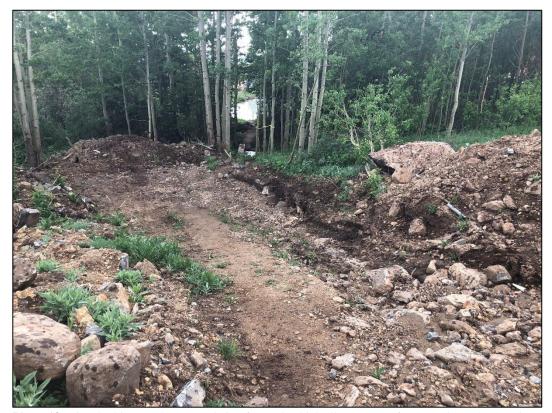
Photo 18. View looking southeast at existing footpath which allows access from Pond 1 at Cross Mine to Ponds 3A-3C at Caribou Mine.

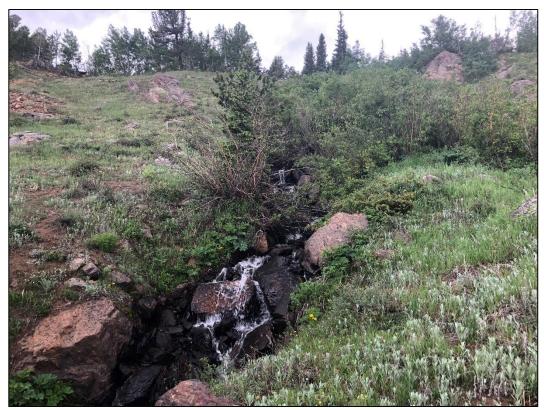
Photo 19. View looking west at expansion area proposed in AM-2 along western edge of current permit area, for Ponds 3A-3C and new road construction. Note Coon Track Creek (at center) which will be routed beneath the new road via a culvert.

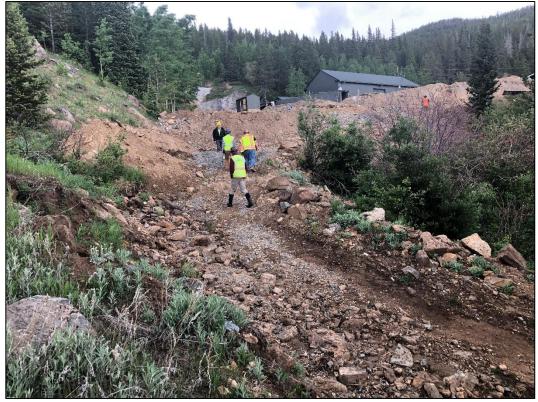
Photo 20. View looking north at existing footpath which allows access from Pond 1 at Cross Mine to Ponds 3A-3C at Caribou Mine. The new road proposed in AM-2 may align at least partially with this portion of the existing footpath.

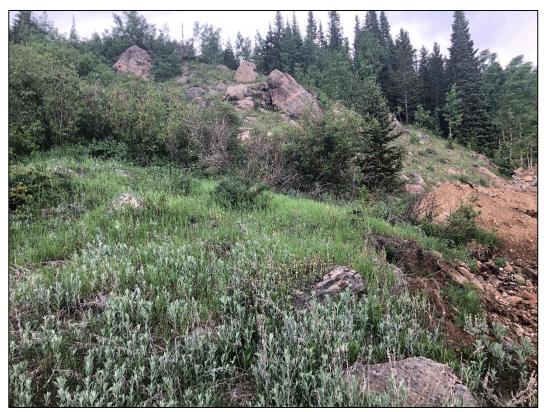
Photo 21. View looking northwest at expansion area proposed in AM-2 along western edge of current permit area, for Ponds 3A-3C and new road construction.

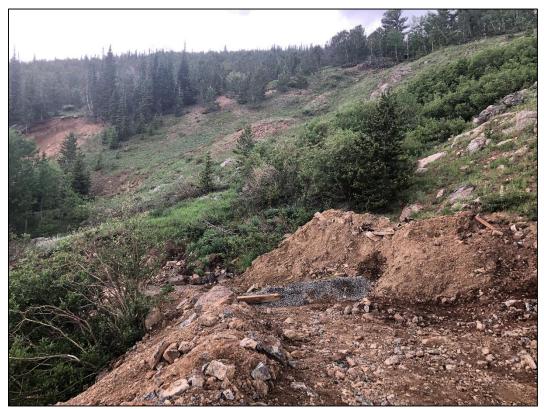
Photo 22. View looking south/southwest (from southern edge of Pond 3C) at expansion area proposed in AM-2 along western edge of current permit area, for Ponds 3A-3C and new road construction.

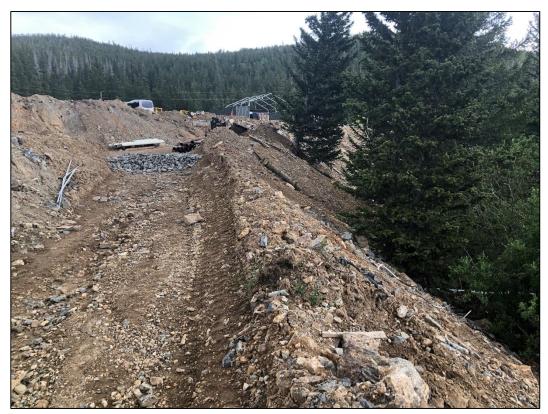
Photo 23. View looking east/northeast at existing footpath below Ponds 3A-3C. The new road proposed in AM-2 appears to align with this portion of the existing footpath.

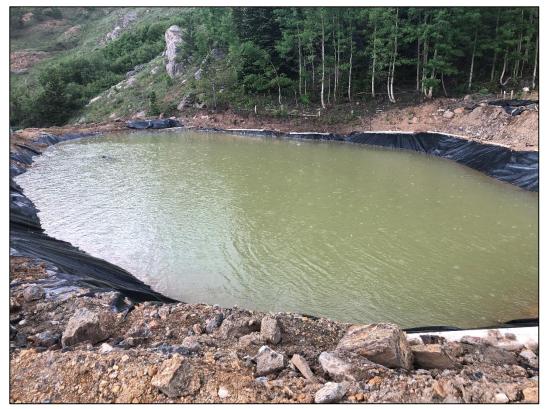
Photo 24. View looking southwest across Pond 3C (in Caribou Mine area) which was rehabilitated per TR-8. This is the largest and most downgradient of the three settling ponds.

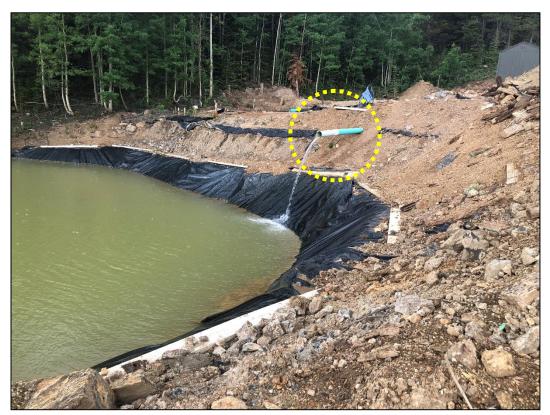
Photo 25. View looking west across northern edge of Pond 3C (in Caribou Mine area) which was rehabilitated per TR-8, showing inlet pipe from Pond 3B (circled) discharging into pond.

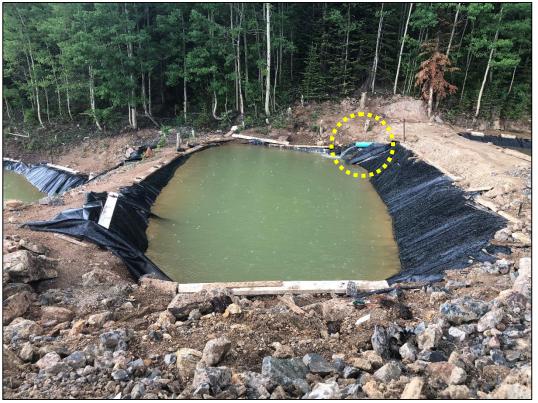
Photo 26. View looking southwest across Pond 3B (in Caribou Mine area) which was rehabilitated per TR-8. This is the middle of the three settling ponds. Note inlet pipe from Pond 3A (circled) discharging into pond.

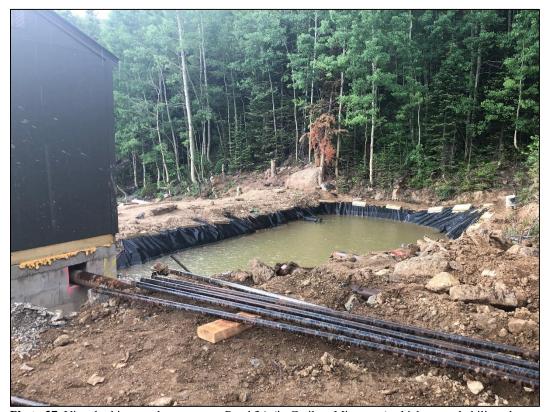
Photo 27. View looking southwest across Pond 3A (in Caribou Mine area) which was rehabilitated per TR-8. This is the most upgradient of the three settling ponds.

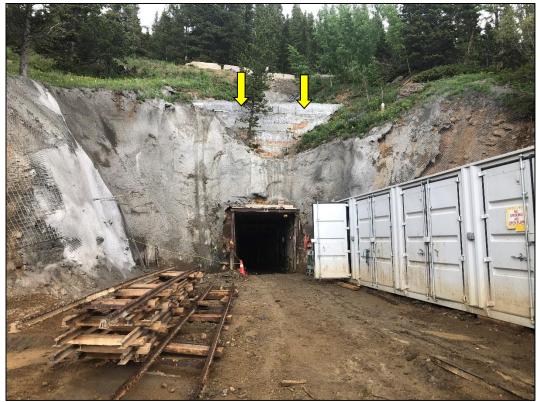
Photo 28. View looking northwest at expansion area proposed in AM-2 with Idaho Tunnel portal (in Caribou Mine area). Note surrounding slope face stabilized with shotcrete and small "glory hole" created by tunnel collapse (location indicated) stabilized with pervious cellular concrete per TR-5.

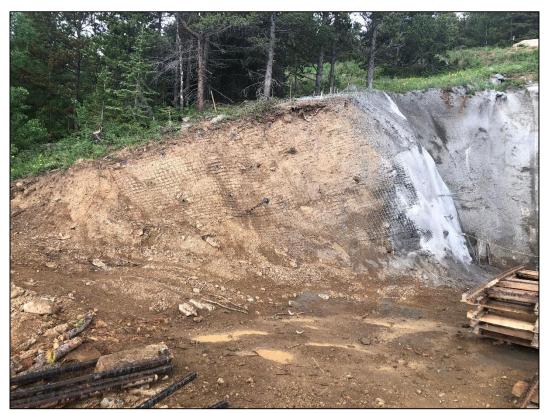
Photo 29. View looking northwest at excavated hillside just west/southwest of Idaho Tunnel Portal (in Caribou Mine area) which is part of expansion area proposed in AM-2. This slope face is stabilized partially with shotcrete and partially with wire mesh anchored into the slope.

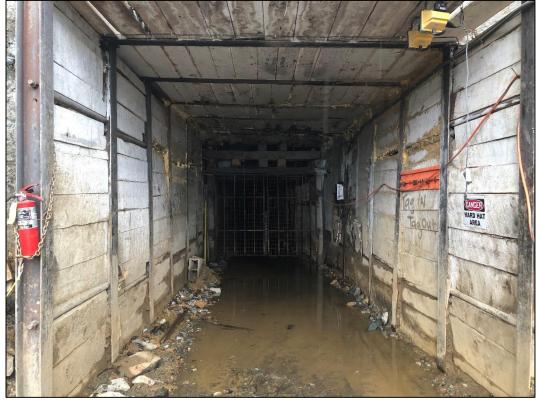
Photo 30. View looking inside Idaho Tunnel portal (in Caribou Mine area) which is secured by a locked gate. Note water draining from mine opening. This portal has been rehabilitated for safe entry per TR-5.

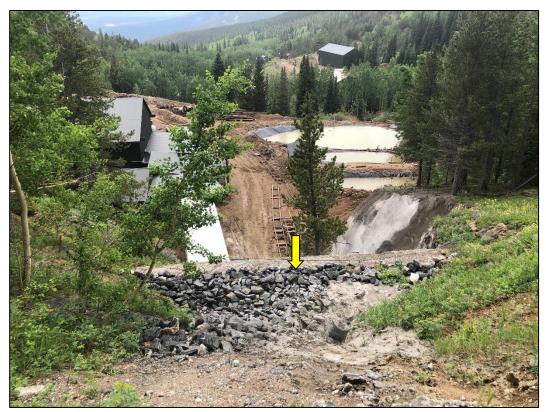
Photo 31. View looking southeast from Caribou Road across slope above Idaho Tunnel Portal where small "glory hole" created by tunnel collapse (location indicated) was stabilized with pervious cellular concrete per TR-5. This disturbed slope is part of the expansion area proposed in AM-2.

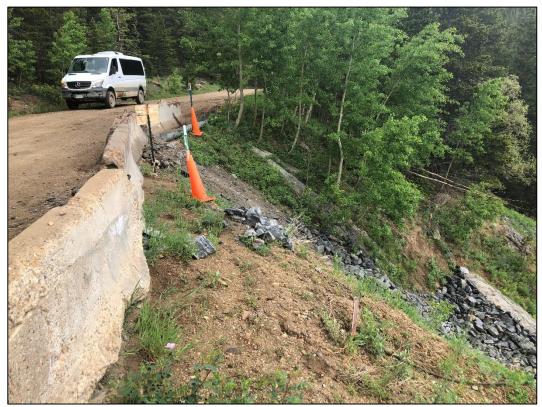
Photo 32. View looking northeast across slope between Caribou Road (at left) and area above Idaho Tunnel Portal (at right) where small "glory hole" was stabilized with pervious cellular concrete per TR-5. This disturbed slope is part of the expansion area proposed in AM-2. The new northern permit boundary in this area would align with the edge of Caribou Road.

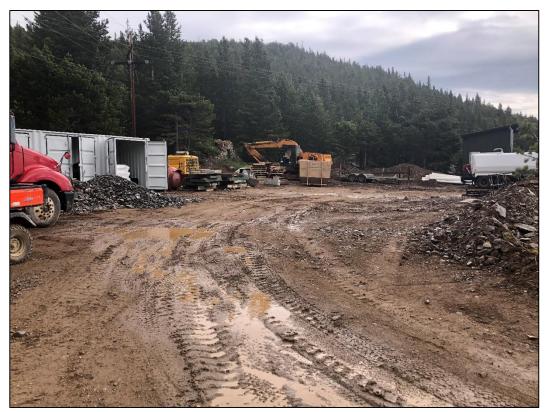
Photo 33. View looking east at expansion area proposed in AM-2 for oil shed and equipment storage (in Caribou mine area).

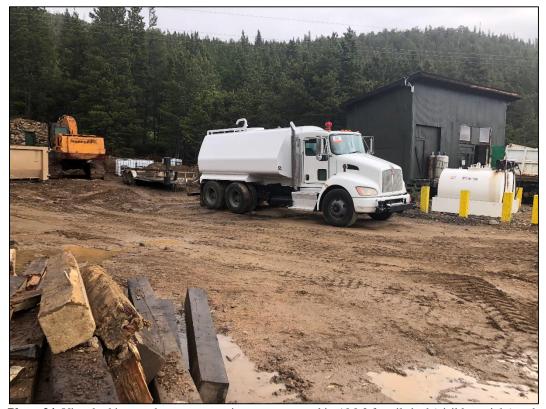
Photo 34. View looking northeast at expansion area proposed in AM-2 for oil shed (visible at right) and equipment storage (in Caribou Mine area).

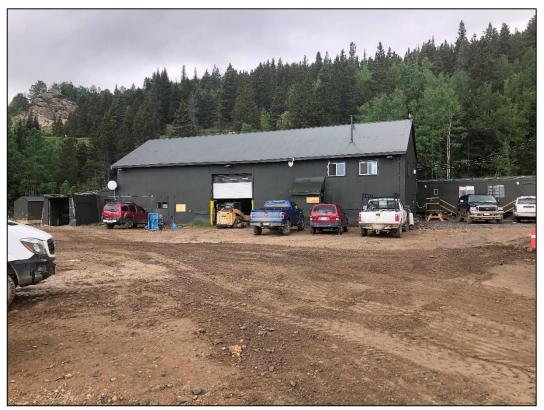
Photo 35. View looking northwest at Caribou Office and Dryroom Building located in Caribou Mine area.

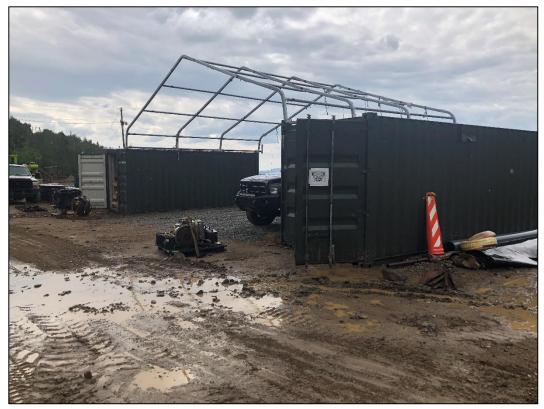
Photo 36. View looking southeast at new work area constructed with conex boxes in Caribou Mine area.

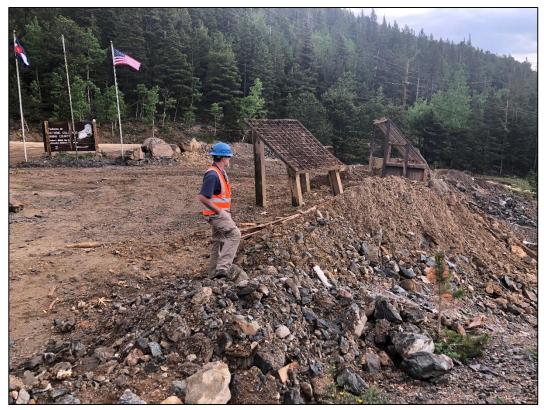
Photo 37. View looking northeast across top of historic waste rock pile located in Caribou Mine area. Rock screens were present in this area during inspection. Operator is not authorized to conduct any processing activities on site beyond screening/sizing waste rock for aggregate use.

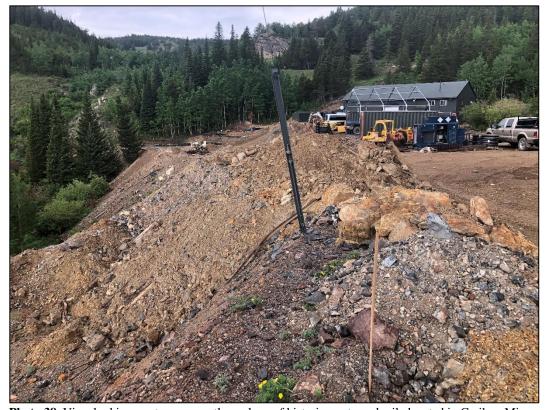
Photo 38. View looking west across southern slope of historic waste rock pile located in Caribou Mine area, with slope gradients of approximately 1H:1V.

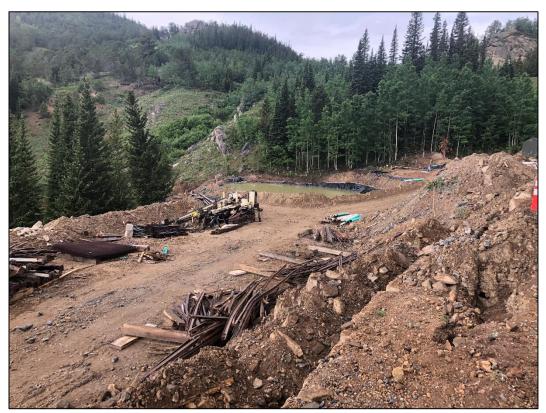
Photo 39. View looking west across existing road from Caribou Mine access road to Ponds 3A-3C (partially visible in background). The new road proposed in AM-2 may align at least partially with this existing road.

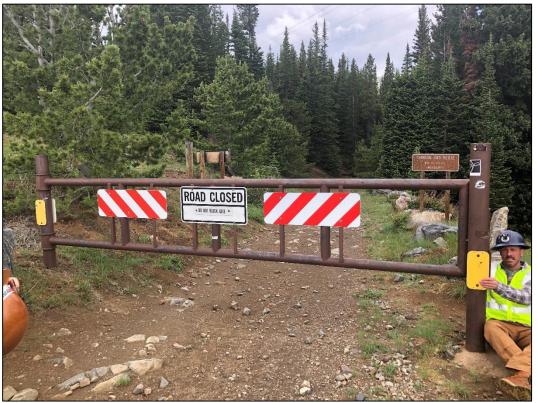
Photo 40. View of locked gate at entrance to Forest Service Road used to access Caribou Level 300 Portal permit area proposed in AM-2. The proposed site is located approximately 1,900 feet down the road from the entrance gate.

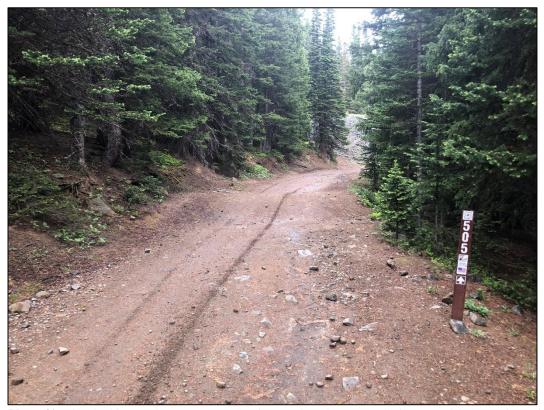
Photo 41. View looking northwest at Forest Service Road used to access Caribou Level 300 Portal permit area proposed in AM-2. Note sign at right indicating road is FS 505.

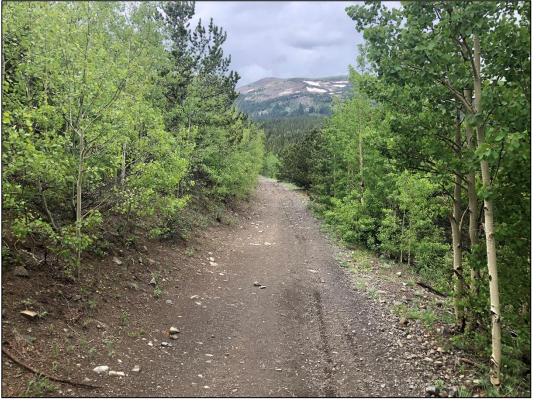
Photo 42. View looking west/northwest at Forest Service Road used to access Caribou Level 300 Portal permit area proposed in AM-2.

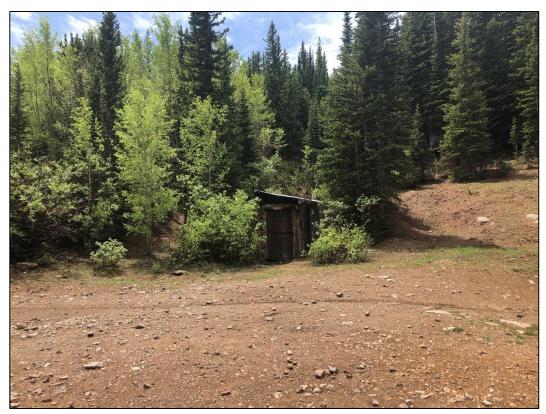
Photo 43. View looking south (across Forest Service Road) at Caribou Level 300 Portal permit area proposed in AM-2. Note entrance to snow shed (in background) located approximately 10-15 feet off road. The proposed permit area will need to be delineated with markers.

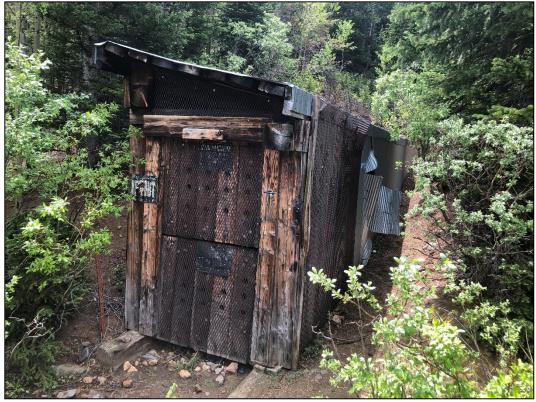
Photo 44. Closer view of entrance to snow shed for Caribou Level 300 Portal proposed in AM-2. The proposed permit area will need to be delineated with markers.

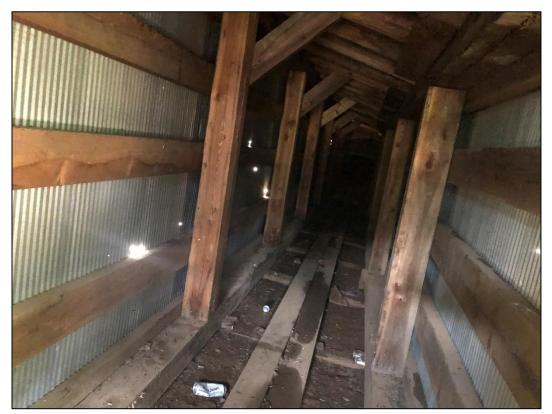
Photo 45. View inside snow shed for Caribou Level 300 Portal proposed in AM-2 (from hole in west side of shed). Some trash was present inside, indicating this shed is accessible by the public (at least to some extent).

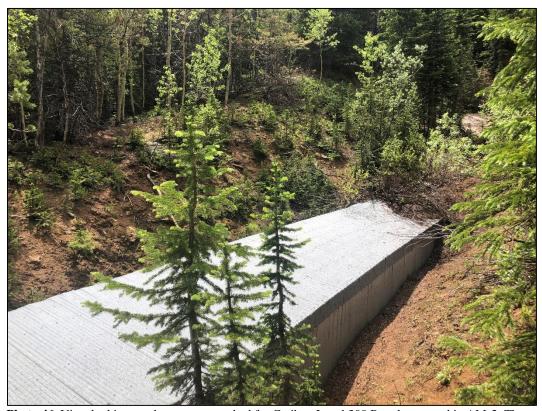
Photo 46. View looking south across snow shed for Caribou Level 300 Portal proposed in AM-2. The permit area will need to be delineated with markers.

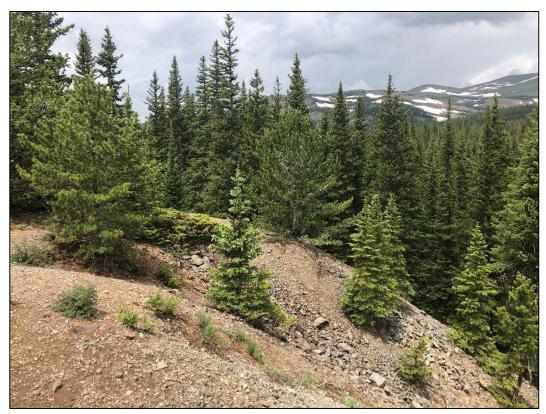
Photo 47. View looking northwest across edge of historic waste rock pile located north of proposed Caribou Level 300 Portal permit area, on north side of Forest Service Road. This pile is not included in the proposed permit area.

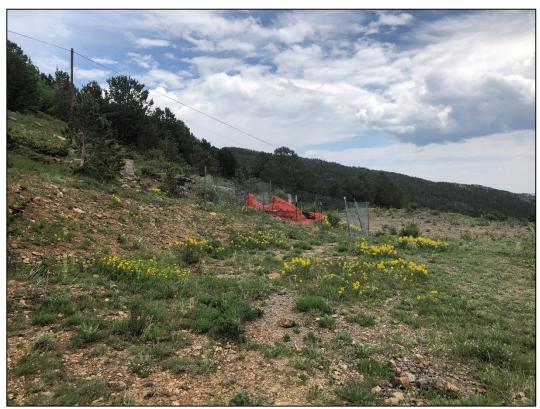
Photo 48. View looking east/northeast at Potosi Shaft permit area proposed in AM-2, located approximately 100 feet north of Caribou Road. The proposed permit area will need to be delineated with markers.

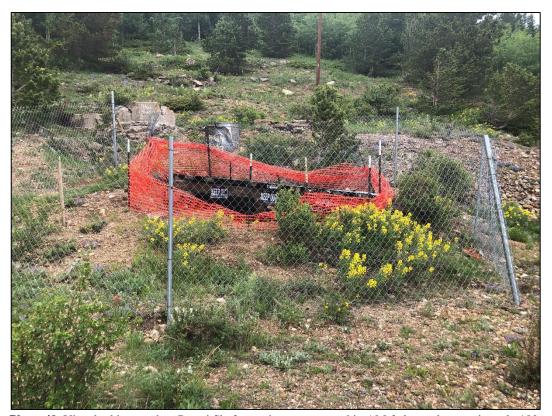
Photo 49. View looking north at Potosi Shaft permit area proposed in AM-2, located approximately 100 feet north of Caribou Road. The shaft is currently enclosed by chainlink fencing. The proposed permit area will need to be delineated with markers.

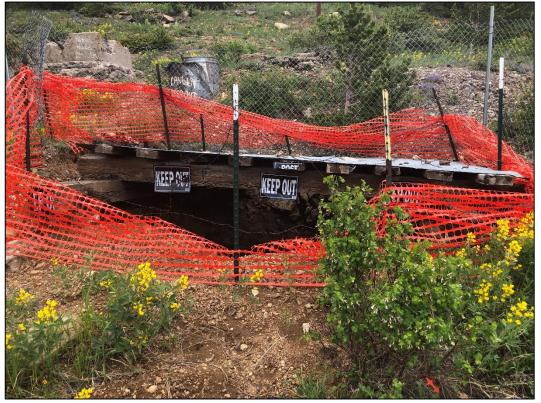
Photo 50. Closer view of Potosi Shaft proposed in AM-2, showing "Keep Out" signs posted and barbed wire fencing immediately surrounding shaft (within chainlink fence enclosure).

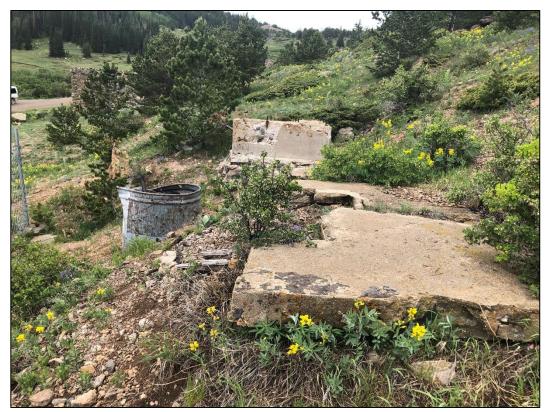
Photo 51. View looking west at historic structures located directly behind Potosi Shaft. These structures need to be addressed in AM-2. Since the proposed permit area was not delineated, the Division is uncertain whether these structures are included in the proposed permit area.

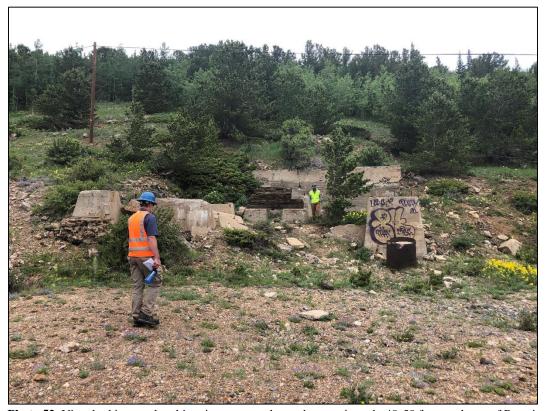
Photo 52. View looking north at historic structures located approximately 40-50 feet northeast of Potosi Shaft. These structures need to be addressed in AM-2.

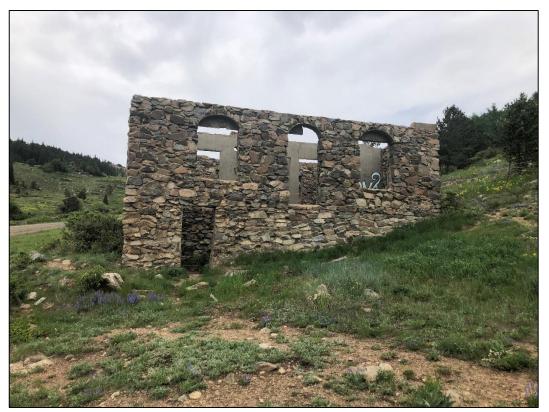
Photo 53. View looking west at historic structure (remnants of stone building) located approximately 130 feet west of Potosi Shaft. This structure needs to be addressed in AM-2.

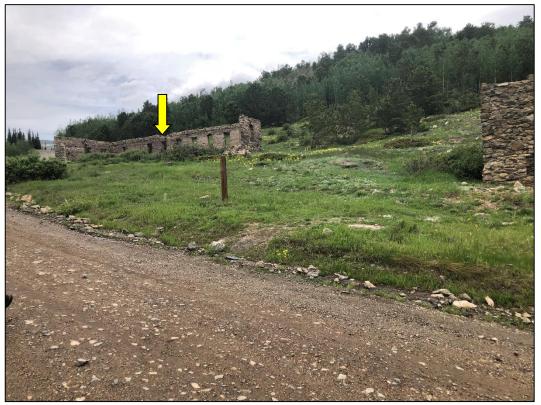
Photo 54. View looking northwest at historic structure (remnants of stone building; indicated) located approximately 230 feet west of Potosi Shaft. Since the proposed permit area was not delineated, the Division is uncertain whether this structure is located within 200 feet. If so, it must be addressed in AM-2. Caribou Road is visible in the foreground.
