New Elk Mine, C-1981-012, Inspection Report

PERMIT INFORMATION

INSPECTION INFORMATION

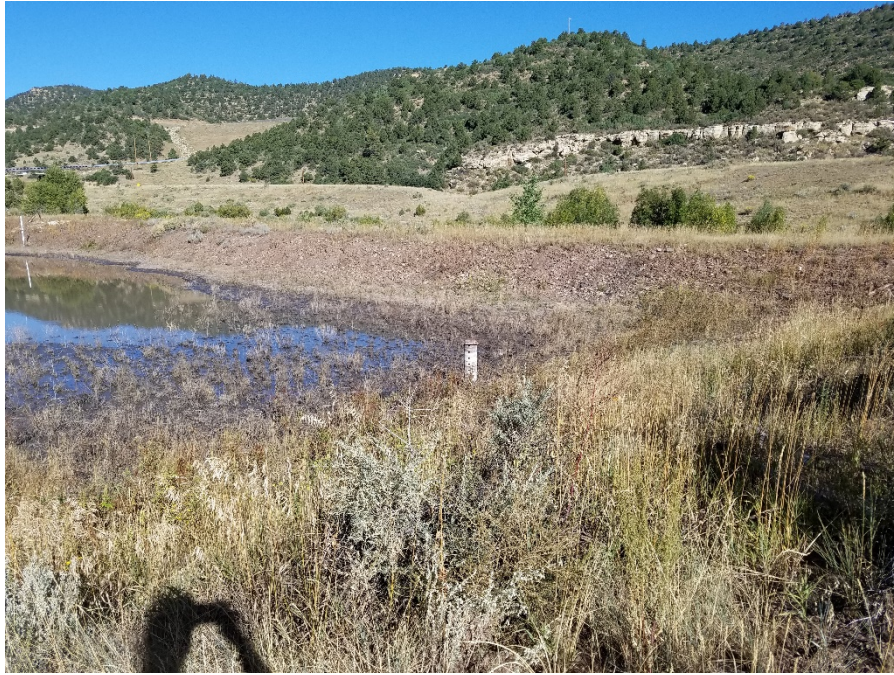
The Small Area Exemption located adjacent to Pond 007a to the south is being used as an equipment storage yard. Some debris was observed in the drainage ditch surrounding this area. NECC will need to keep this area clear of debris in accordance with Rule 4.11.4.

Figure 1. Pond 007a, from the east end looking west.

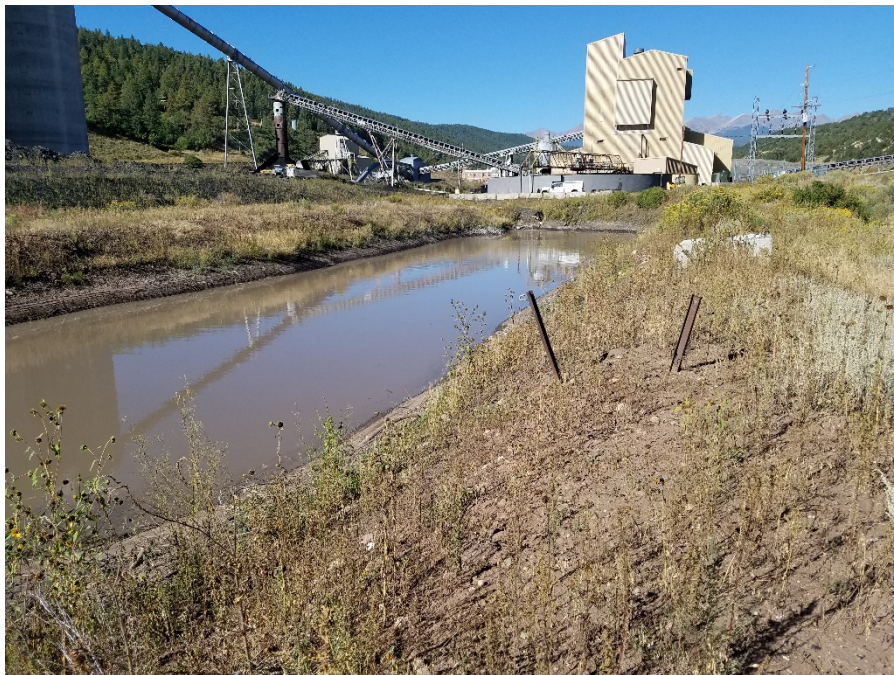
Pond 006 was receiving water. The embankment was stable and vegetated.

Figure 2. Pond 006 from the east end looking west.

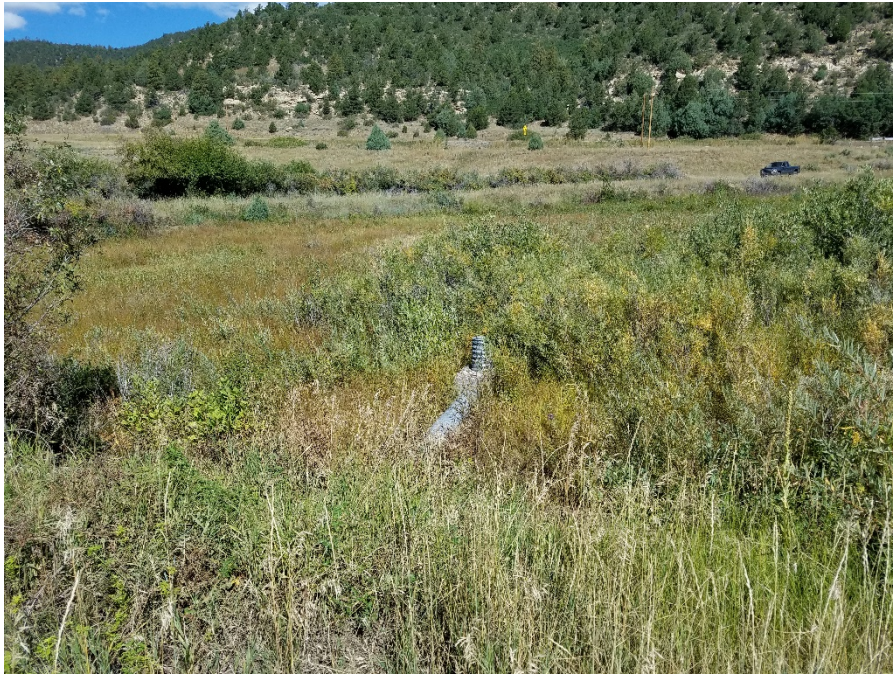
Pond 004 was overall dry and not discharging. Vegetation has established in the pond. According to Nick Mason, NECC may begin to pump water from the other ponds within the facilities area to this pond. **Prior to this activity, NECC will need to clear the significant amount of shrubby vegetation that has established in the pond so the capacity of the pond will not be impacted as well as the functioning of the discharge pipe.**

Figure 3. Pond 004, shrubby vegetation established in the pond.

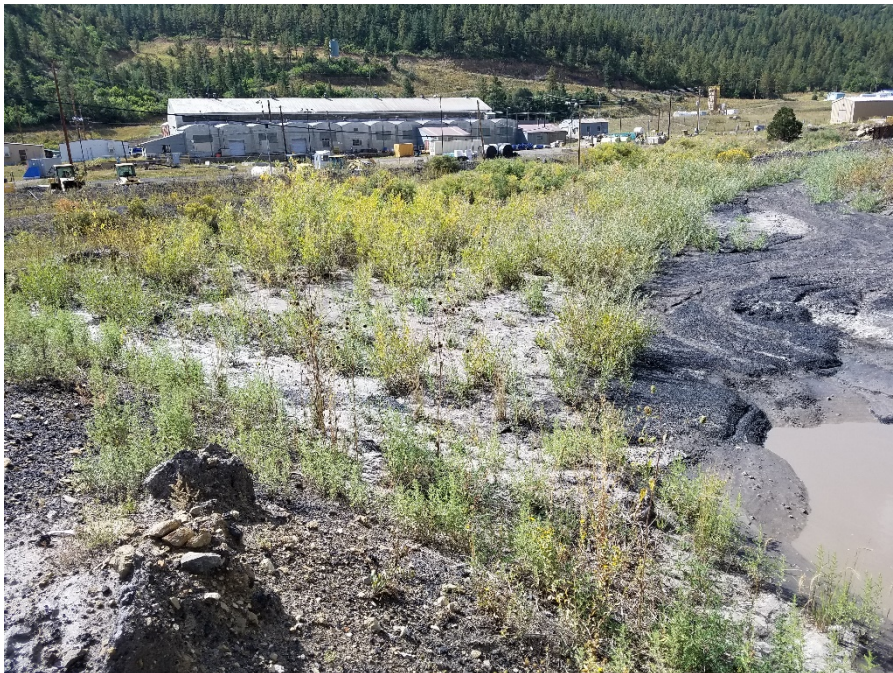
The drainage from Development Waste Disposal Area #2 (DWDA #2) is managed by ditches D12 and D14 which direct water to Culvert C13 which further directs water to ditches that carry the water to Pond 007. A small sump where ditch D14 and D12 meet at Culvert C13 is silted in fairly substantially and willow shrubs have begun to establish in this area. It appears the berm directing water into culvert C13 is breached likely due to the recent precipitation. **NECC must reestablish this berm and clean up the sump so runoff from the DWDA #2 flows into culvert C13.**

Figure 4. DWDA #2, southeast corner. Sump where D14 and D12 meet at culver C13. This area needs to be cleaned out.

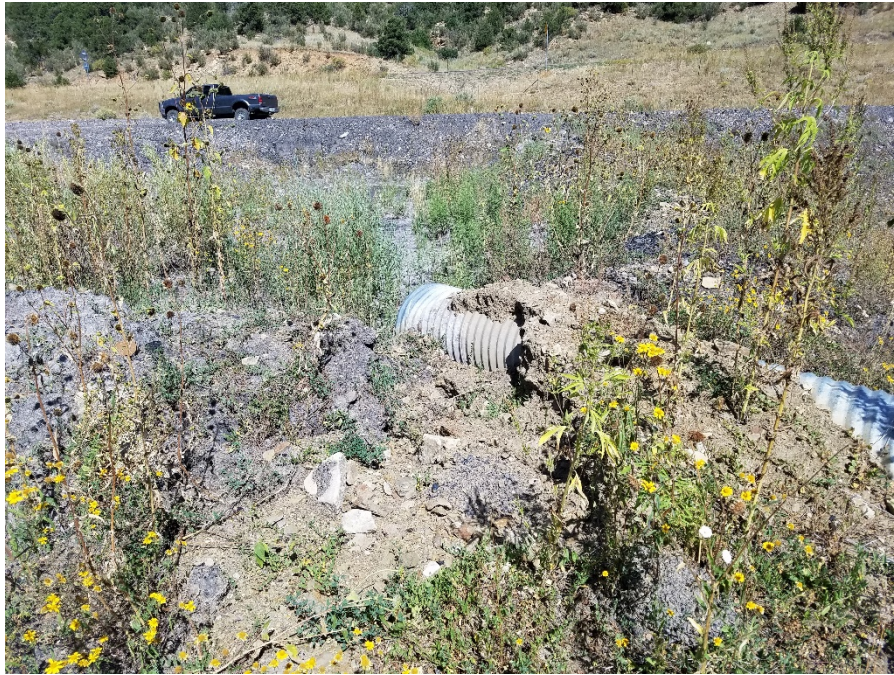
Figure 5. Berm directing flow to culver C-13 breached and needs repair.

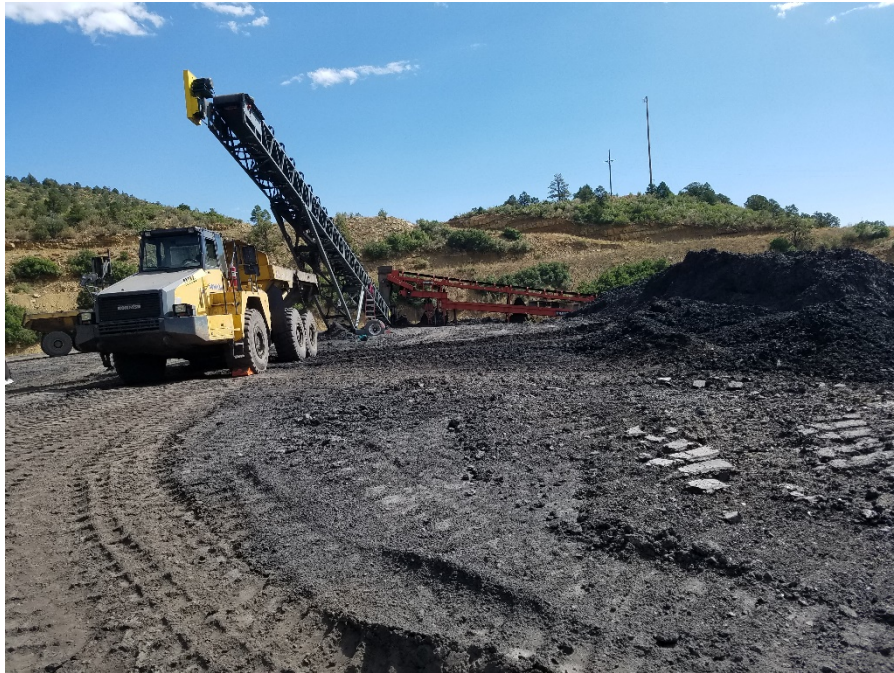
The conveyor from the wash plant was not running at the time the RDA was observed during the inspection. However, it does appear waste was recently transported to the RDA. A large pile of waste was observed adjacent to the end of the conveyor. Two articulated trucks and a dozer were observed on top of the RDA. Recently dumped waste was observed on the northwest upper end of the RDA. The first four RDA bench faces were observed. These areas were vegetated and stable. The side drains on the west and east side of the RDA were clear and functional.

Figure 6. Waste piled on top of the RDA where conveyor ends.

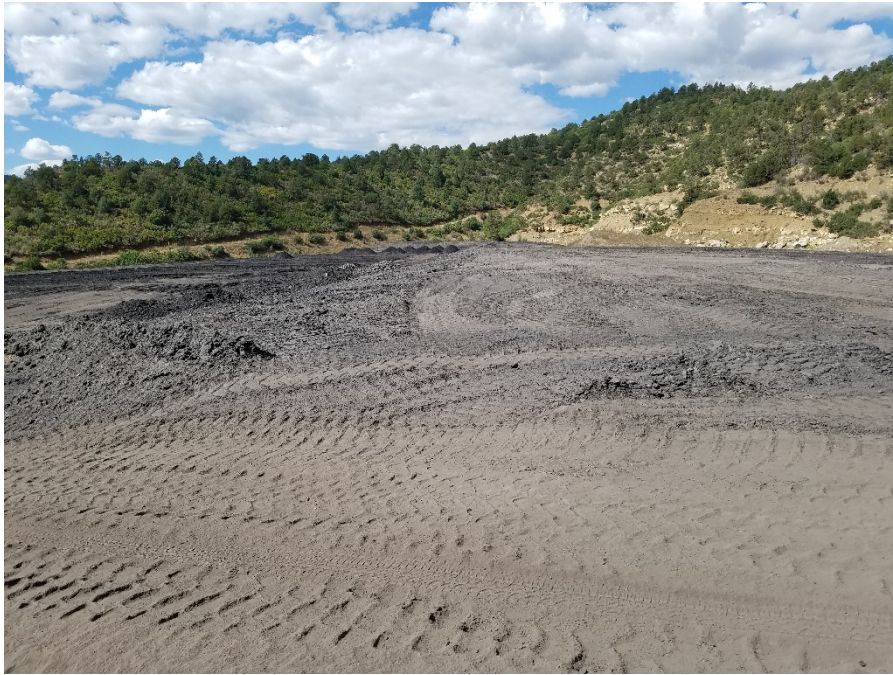
Figure 7. From the east end of the top of the RDA looking west.

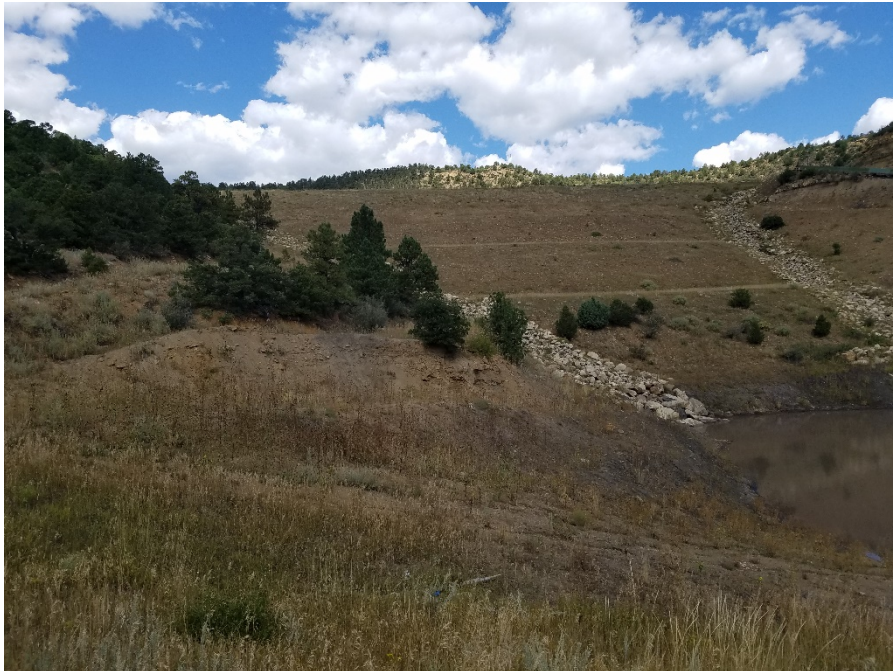
Figure 8. From the south end of the RDA looking north at the reclaimed benches.

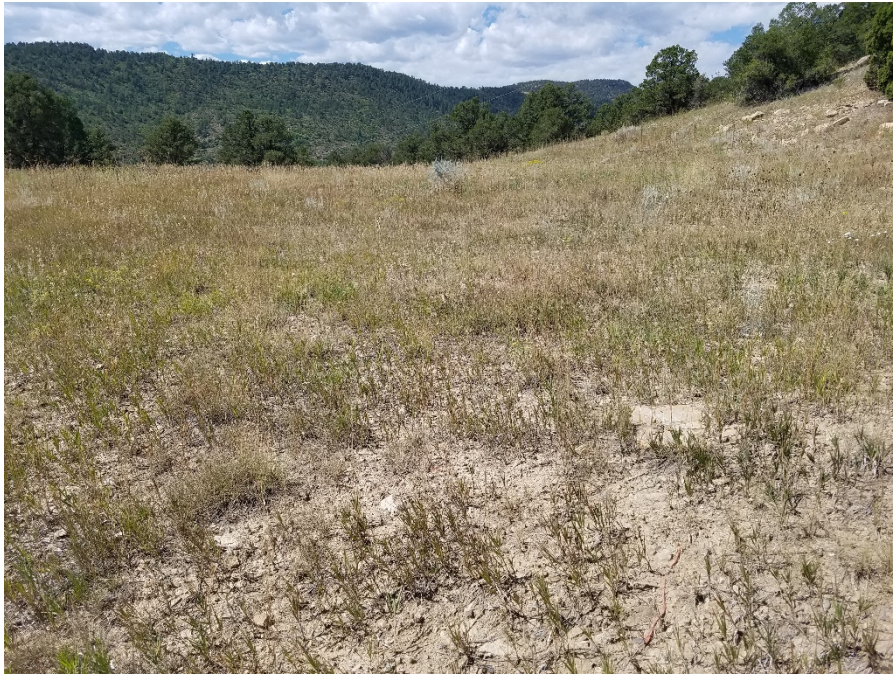
The former Golden Eagle Fan Site was observed. The area is stable and vegetated.

Figure 9. Golden Eagle Fan Site.

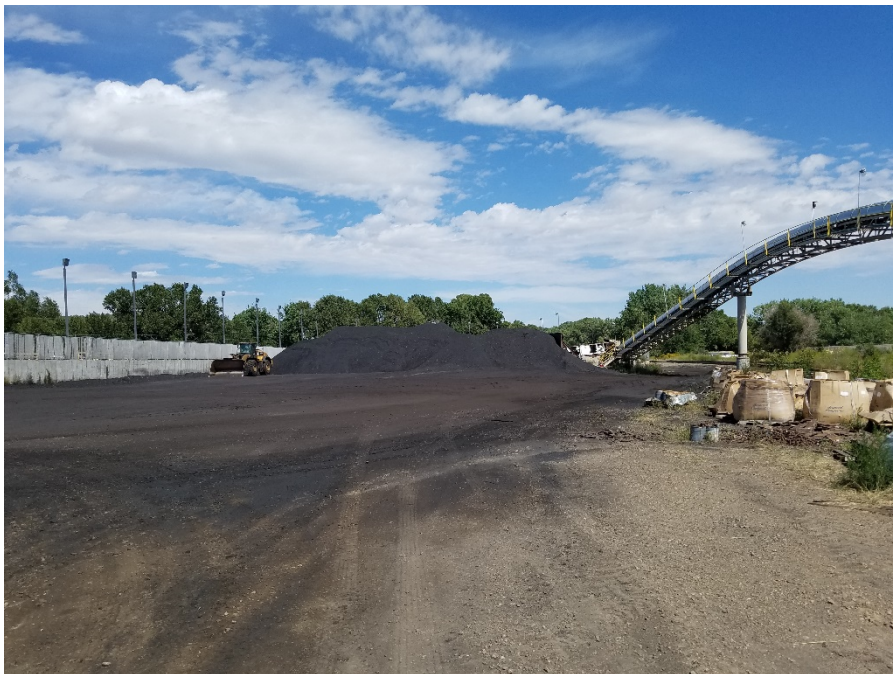
The Jansen Loadout area was observed. No problems were noted.

Figure 10. Coal stockpiled at the Jansen Loadout.
