COLORADO
Division of Reclamation,
Mining and Safety
Department of Natural Resources

Permit Number: C-1981-015 Mine Name: Fruita No 1 & 2 Operator: Dorchester Coal Company Operator Address: Greg Lewicki 9054 South Forrest Drive Highlands Ranch, CO 80126	County: Mesa Operation Type: Underground Permit Status: Revoked Ownership: Private
	Operator Representative Present: NA
Operator Representative Signature: (Field Issuance Only)

Inspection Start Date: September 16, 2021 Inspection Start Time: 09:25 Inspection End Date: September 16, 2021 Inspection End Time: 10:30		Inspection Type: Coal Complete Inspection Inspection Reason: Normal I&E Program Weather: Clear	
Joint Inspection Agency: None		Joint Inspection Contacts: None	
Post Inspection Agency: None		Post Inspection Contacts: None	
Inspector(s): Clayton Wein	Inspector's Signature: <i>Clayton Wein</i>		Signature Date: 9/17/2021

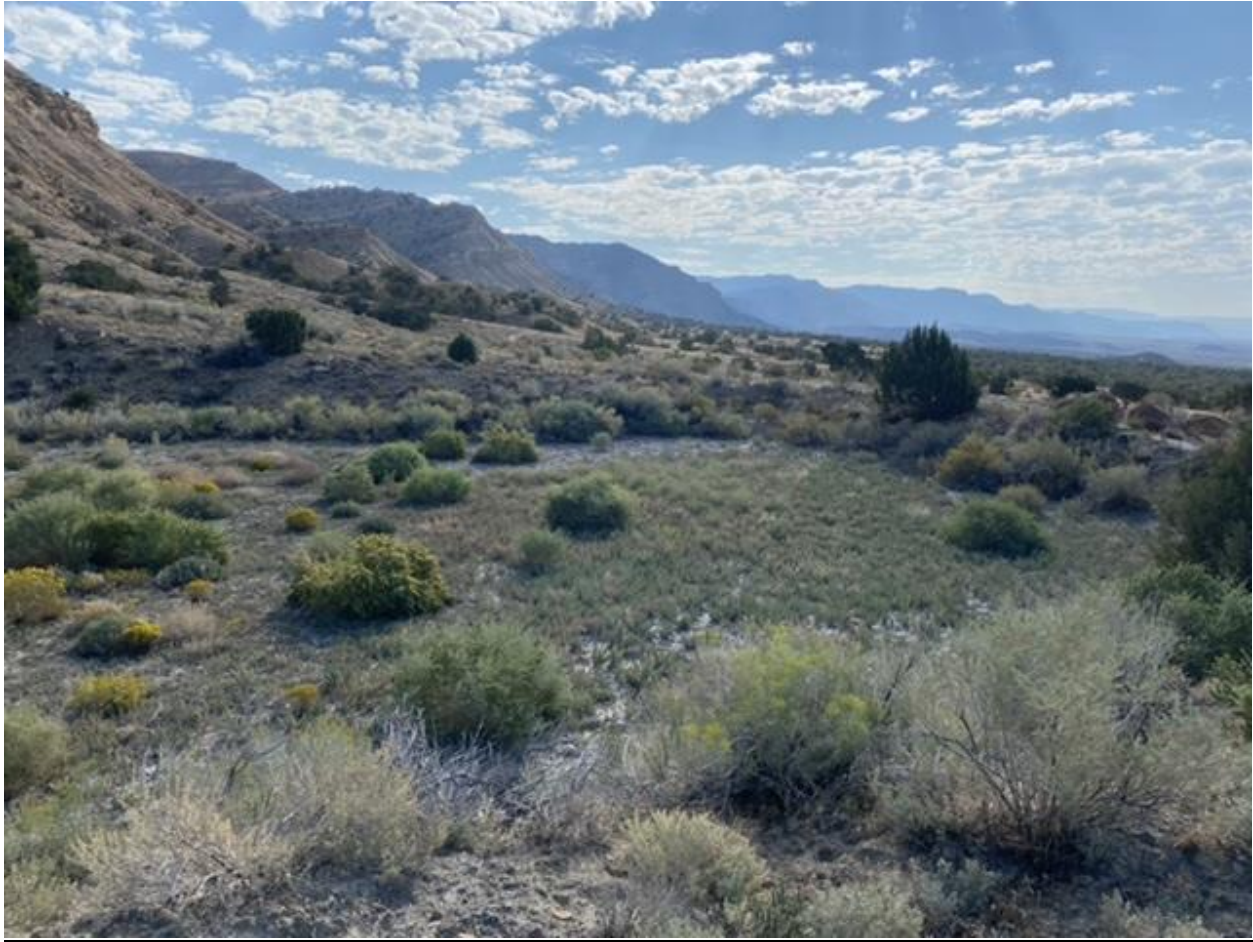
During the inspection the sediment pond, located at the southern portion of the permit boundary, was dry (Photo 1). The embankments for the pond were stable with vegetative cover. There were no indications of erosional features. The outlet for the pond was stable with riprap lining. No obstructions were observed.

Photo 1: The southern portion of the sediment pond.

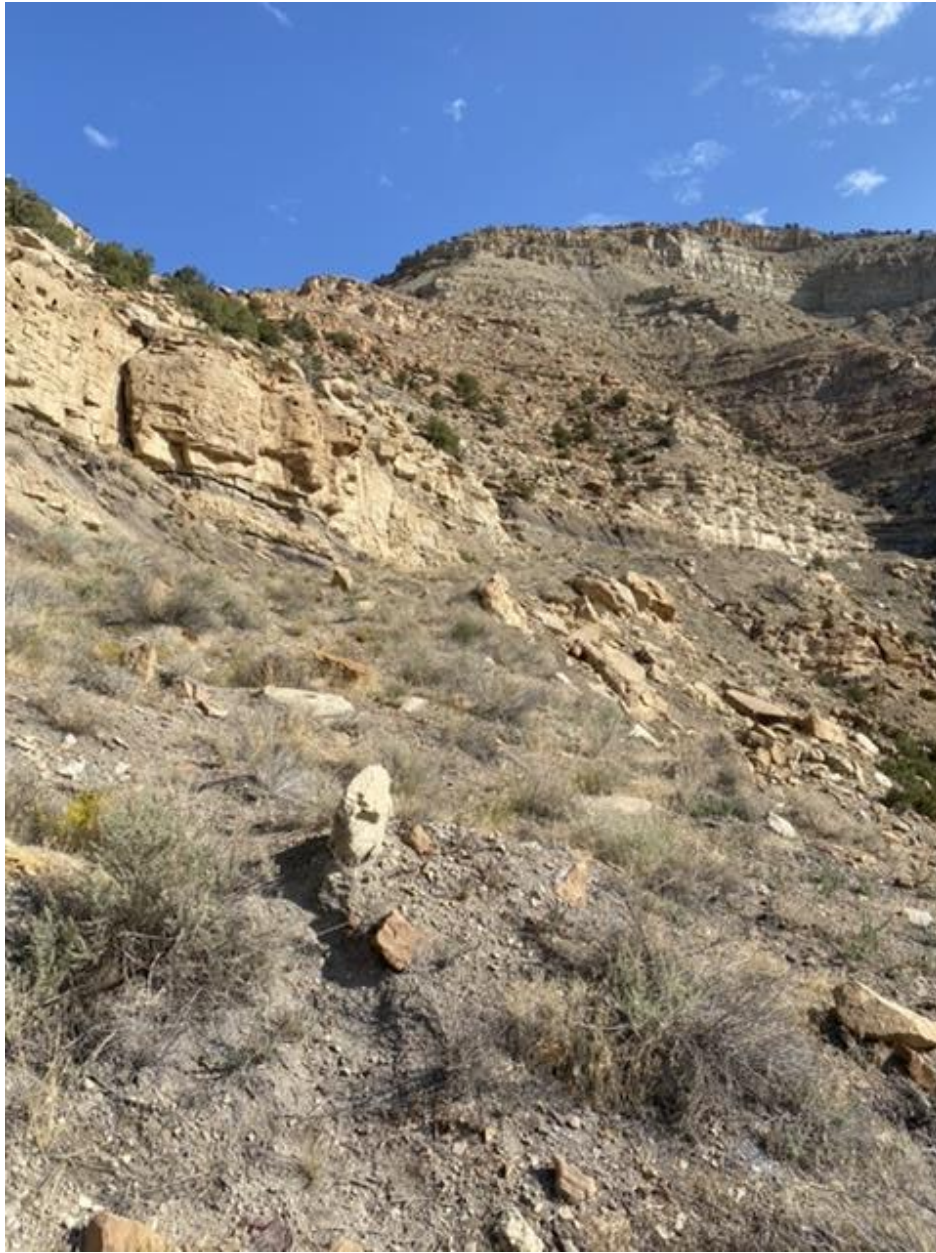
The riprap channel extending down the reclaimed bench to the drainage into the sediment pond was stable (Photo 2). There were no indications of down cutting or erosion.

The reclaimed haul road was stable with vegetation (Photos 2 and 3). The cut and fill slopes of the road remain intact and there were no indications of sloughing. The reclaimed bench was also stable with vegetative cover. The slope of the bench was stable with no erosional concerns. Vegetation on the bench's slope is sparse as noted in previous Division inspections. The backfilled portals were stable with no erosional issues identified (Photo 4).

Photo 2: The lower portion of the reclaimed haul road.

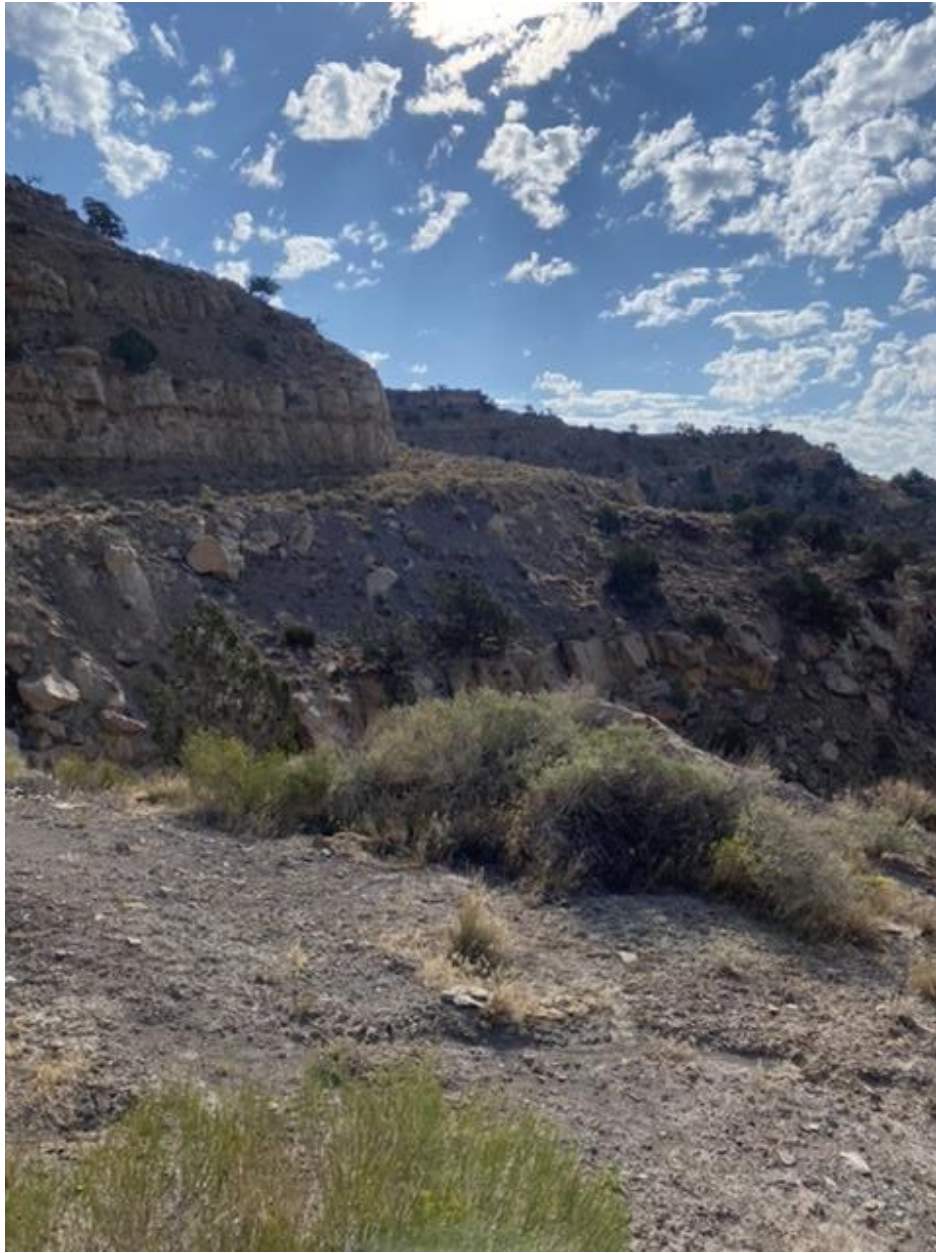
Photo 3: The upper portion of the reclaimed haul road.

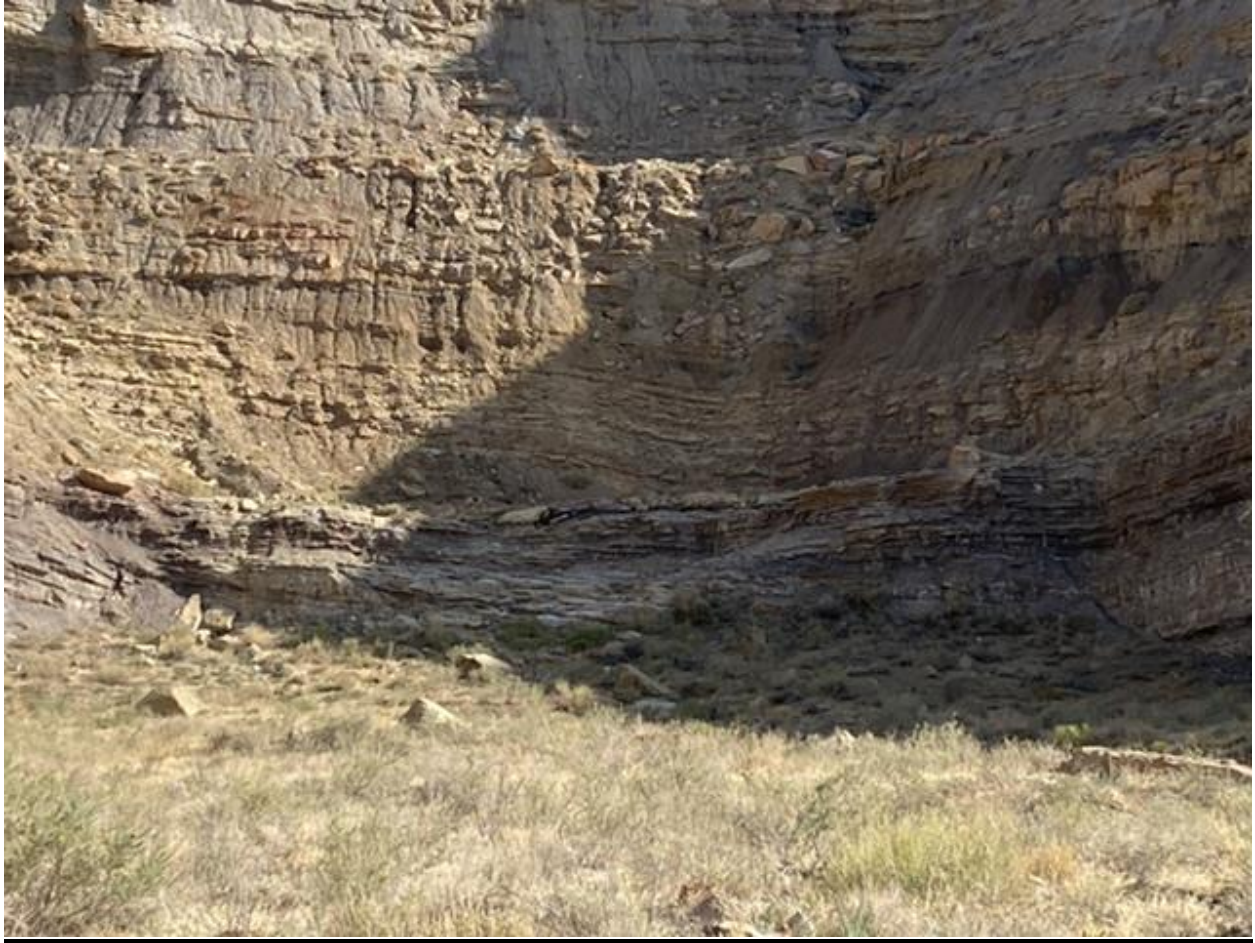
Photo 4: The northern portion of the reclaimed bench and the backfilled portals.
