# Spring 2021 Subsidence and Geologic Field Observations

## Southern Panels Mining Areas

Mountain Coal Company, LLC  
West Elk Mine

September 2021

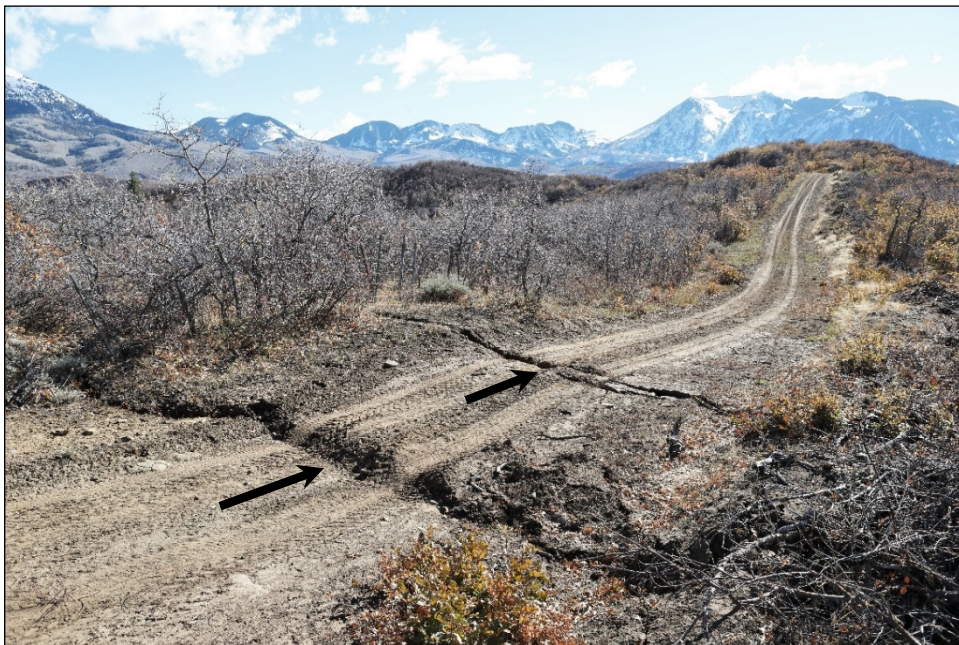
Two parallel subsidence cracks were observed approximately 300 feet south of the E7-12 MVB pad during WWE's fall 2018 field work (Figure 1). These cracks had a N60°W orientation and an offset of about 13 feet. Observational evidence at that time (i.e., sharpness of crack edges) suggested that the cracks had not formed at the same time. The northern crack had rounded edges while the southern crack had sharp edges. E-seam overburden thickness at this location is about 800 feet.

Figure 1. Southeastward view during the fall 2018 field visit of two parallel subsidence cracks that appeared as a result of recent longwall mining beneath the area. The closer crack showed more rounded edges than the distant crack, suggesting the latter was more recently formed.

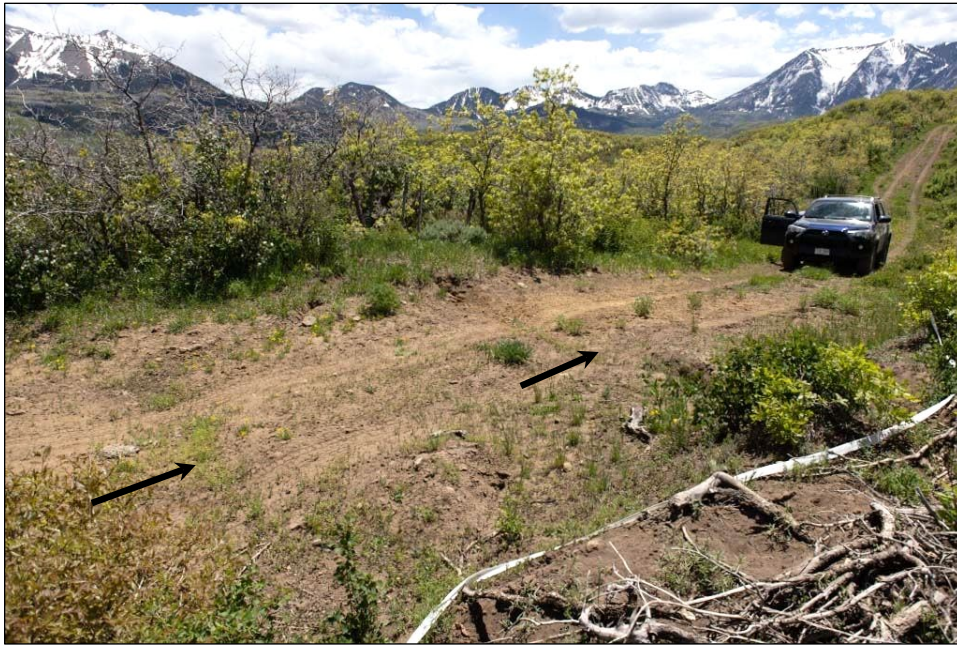
Observations made during the spring 2021 field visit found that the northern crack was nearly completely filled while the southern crack still had a measurable width and depth, particularly at the edges of the road. Both cracks showed signs of healing and weathering (Figure 2) since the previous field visit.

Figure 2. Southeastward view during the spring 2021 field visit of the same area shown in Figure 1.

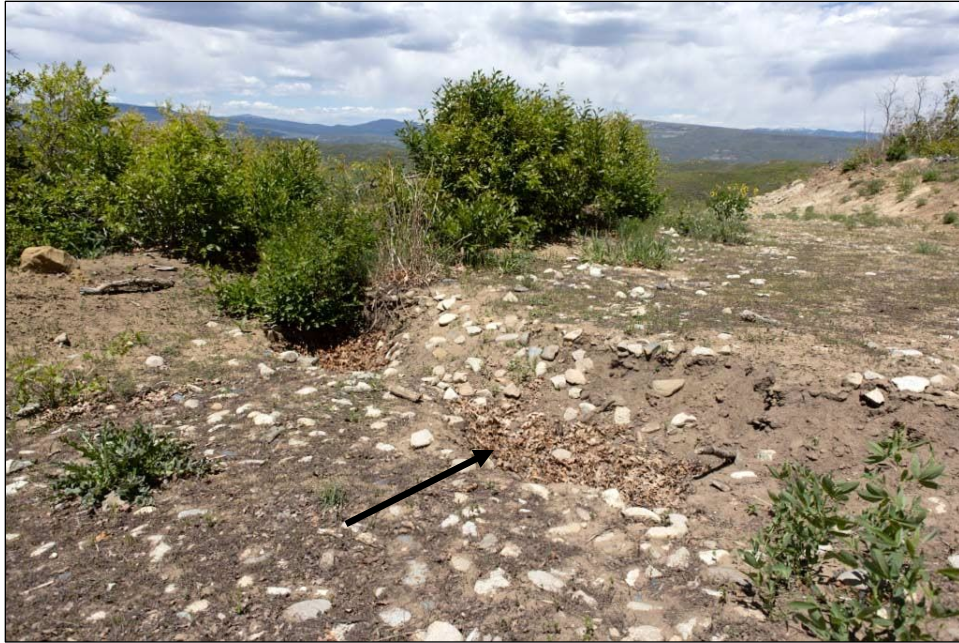
Observations made during the spring 2021 field visit found that the crack was still evident with signs of weathering that had filled a large portion of the crack and rounded the edges (Figure 3).

Figure 3. Northwestward view during the spring 2021 field visit of a subsidence crack first observed during our spring 2019 field visit. The 6-inch elevation offset from north to south (right to left) is still present, but materials have filled the deepest portions of the crack and rounded the edges. This location is approximately 1,000 feet north of the MVB E6-14 pad.

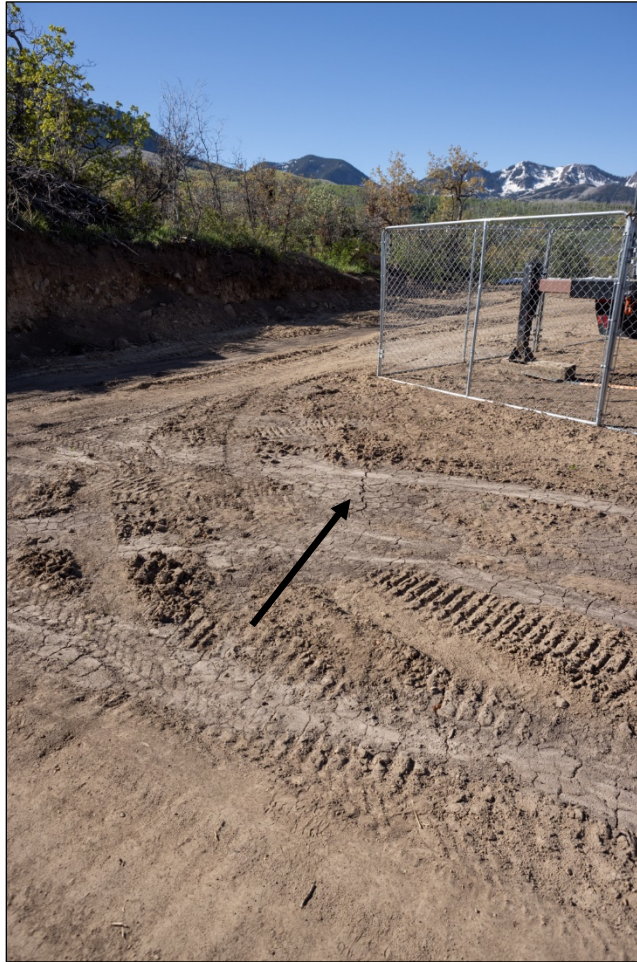
Multiple sub-parallel subsidence cracks were observed on the MVB SS1-6 pad. The most dominant cracks appear to be spaced approximately 6 to 8 feet apart and located within and north of the fenced area around the well head. These cracks are oriented in a direction between N20°W and N40°W. At the time of our spring 2021 field visit, the observed maximum dimensions of these cracks were 0.75 inch in width, 4 inches in depth and 25 feet in length. One of the cracks in the northeast portion of the pad is shown in Figure 4 with others further west shown in Figure 5. The E-seam overburden thickness beneath this pad is approximately 1,090 feet.

Figure 4. Southward view during the spring 2021 field visit of one the subsidence cracks located in the northeastern portion of the MVB SS1-6 pad. This particular crack is visible directly beneath the corner post of the fence as indicated by the black arrow. Several sub-parallel cracks (about 6-8 feet apart) were observed at this location with an orientation of about N20-40°W.

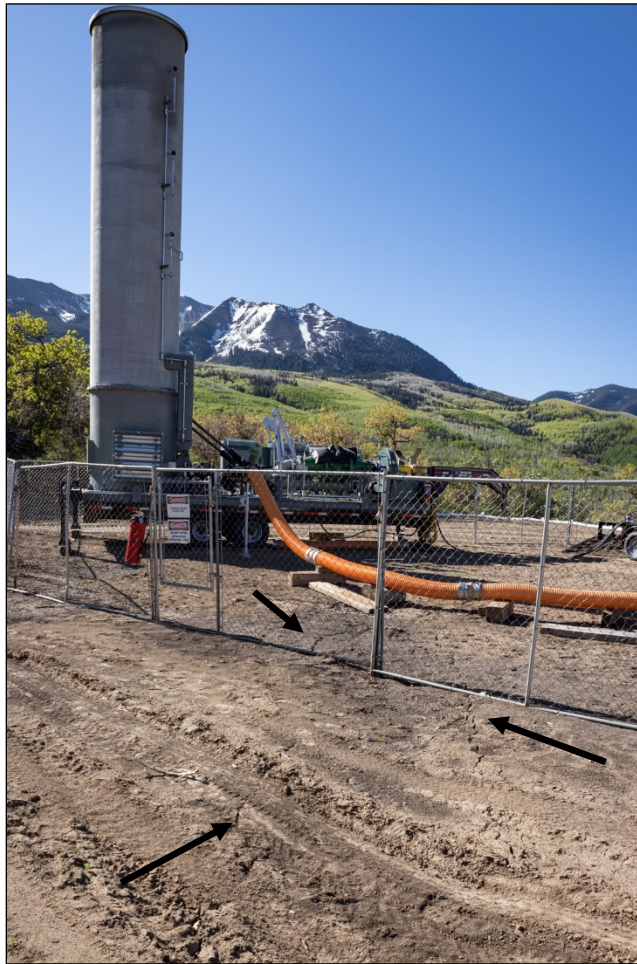
Figure 5. Southeastward view during the spring 2021 field visit of two additional sub-parallel sets of cracks located within and north of the fenced area around the wellhead on the MVB SS1-6 pad.

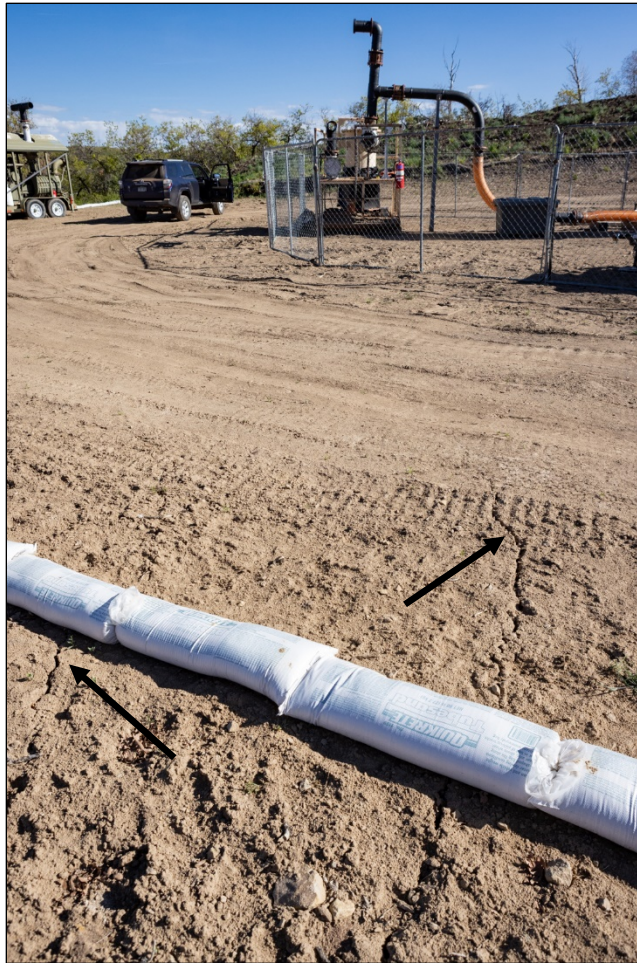
In addition to the larger sub-parallel subsidence cracks on the northern portion of the MVB SS1-6 pad, several additional smaller subsidence cracks were observed along the south side of the pad. These cracks were smaller in dimension but with similar orientation (Figure 6) suggesting subsidence as the source rather than differential settlement.

Figure 6. Northward view during the spring 2021 field visit of a two smaller subsidence cracks on the southern portion of the MVB SS1-6 pad (see black arrows).

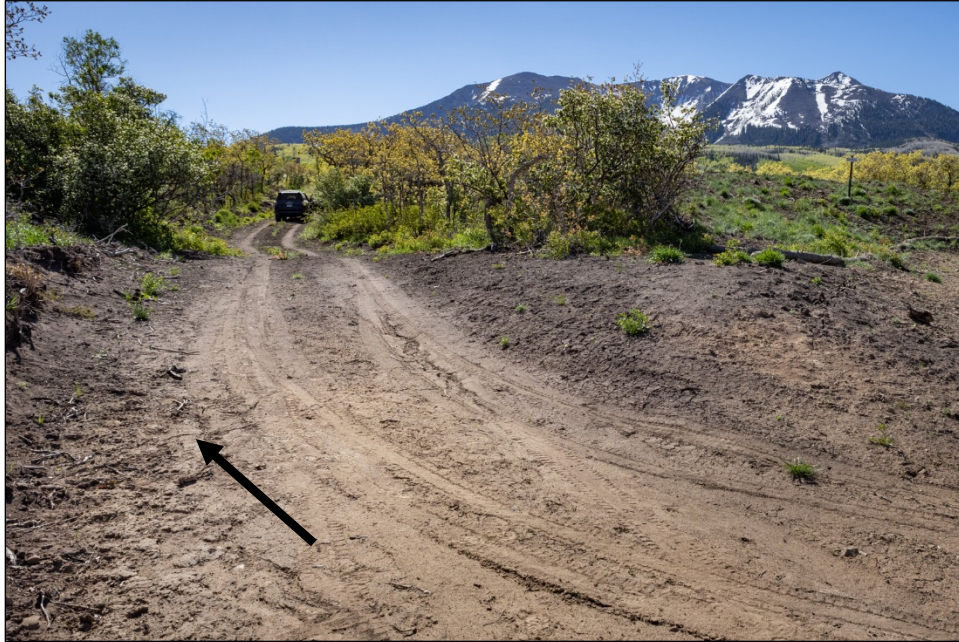
Location 5 is a series of at least three sub-parallel cracks observed over a distance of approximately 120 feet on the access road east of MVB SS1-7. The crack orientation in all cases is about N25°W, which is similar to that of the cracks observed on MVB SS1-7 (Location 6). One crack is located where the access road enters the pad (Figure 7) and has maximum dimensions of 0.5 inch in width and 5 inches in depth. This crack is most obvious on the north side of the road is non-contiguous and does not extend beyond the road edge. The second crack is located about 30 feet to the east of the first and has smaller maximum dimensions. This crack is also most obvious on the north side of the road (Figure 8).

Figure 7. Eastward view during the spring 2021 field visit of a subsidence crack located where the access road meets the MVB SS1-7 pad. This, and nearby cracks on the pad and road are the result of active mining occurring beneath this area.

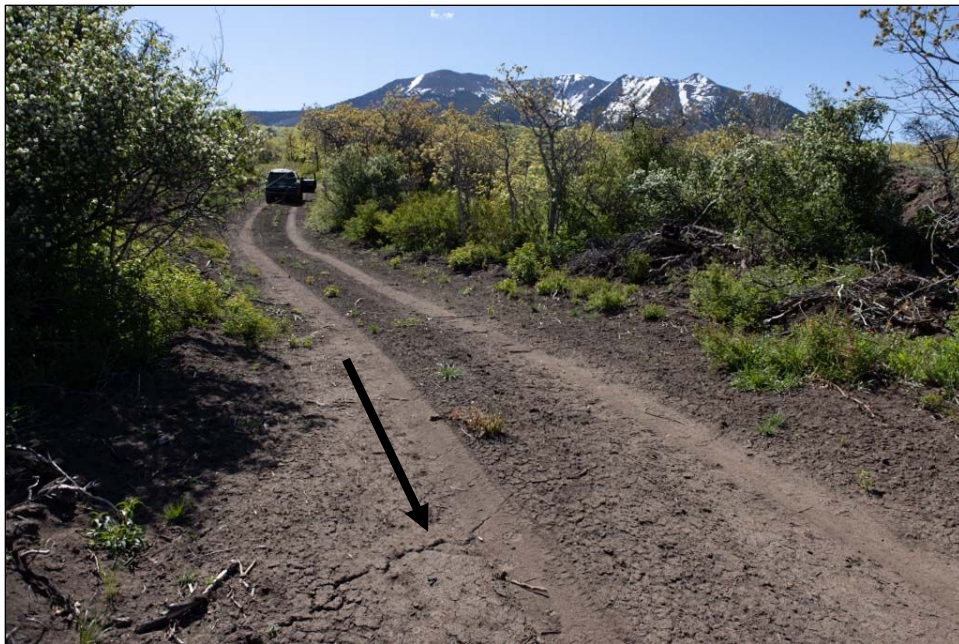
Figure 8. Eastward view during spring 2021 of a second subsidence crack located approximately 30 feet east of the one shown in Figure 7 and with smaller maximum dimensions. Both cracks are most obvious on the north side of the road.

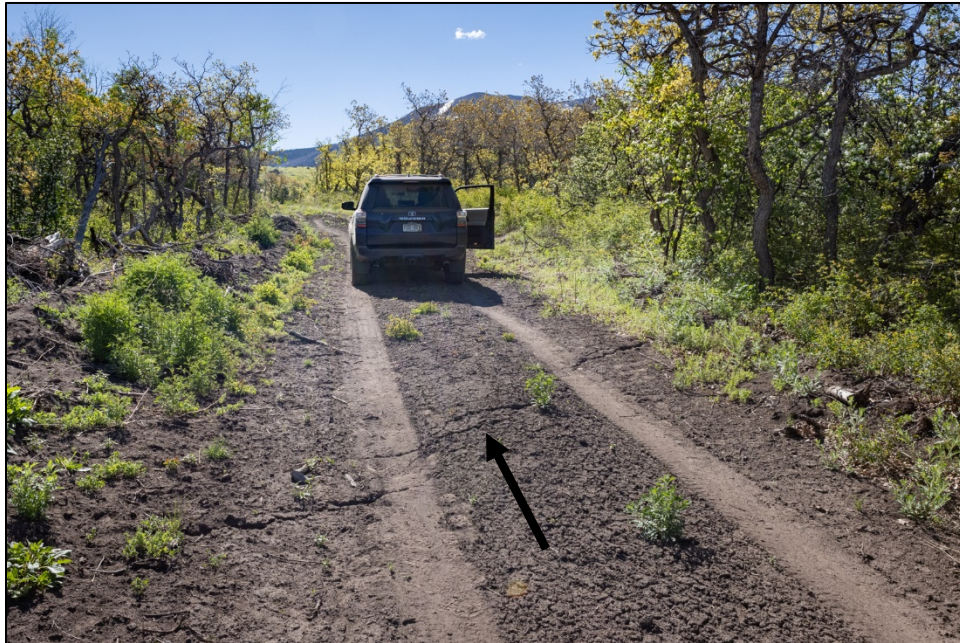
The third crack east of MVB SS1-7 is actually a series of three cracks located about 90 feet east of the second crack. This series crosses the road discontinuously with maximum dimensions of 1.75 inches in width, 18 inches in depth, and about 20 feet in length (Figure 9). E-seam overburden thickness in this area varies from about 1,000 to 1,050 feet. Longwall mining had recently passed beneath this area at the time of our observations.

Figure 9. Northwestward view during the spring 2021 field visit of a subsidence crack first observed during our spring 2019 field visit. The 6-inch elevation offset from north to south (right to left) is still present, but materials have filled the deepest portions of the crack and rounded the edges. This location is approximately 1,000 feet north of the MVB E6-14 pad.

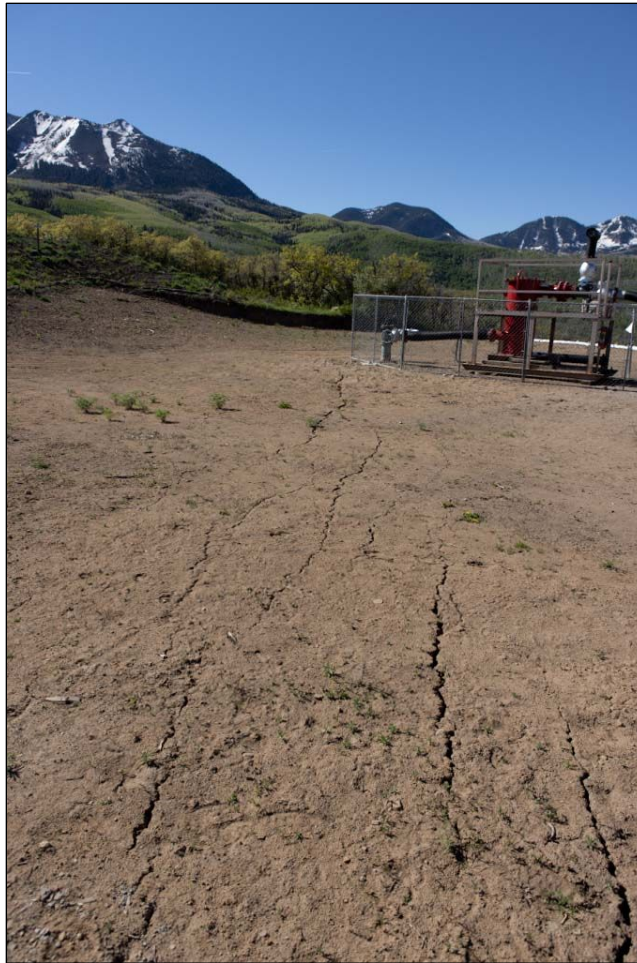
A group of sub-parallel subsidence cracks with an orientation of N25°W were observed in the northwestern portion of the MVB SS1-7 pad as shown in Figure 10. The orientation was not consistent with differential settlement even though this appeared to be an area of the pad with the most fill placement. E-seam overburden thickness beneath this pad is about 1,000 feet. The maximum dimensions observed with these cracks was about 1 inch in width, 18 inches in depth, and approximately 40 feet in length.

Figure 10. Southeastward view during the spring 2021 field visit of a group of sub-parallel cracks on the northwest portion of the MVB SS1-7 pad. Longwall mining had recently passed beneath this area.
