Inspection report

Permit Number: C-1981-028 Mine Name: Keenesburg Strip Mine Operator: Coors Energy Company Operator Address: Mr. Ben Moline PO Box 4030 Golden, CO 80402	County: Weld Operation Type: Surface Permit Status: Permanent Cessation Ownership: Private
	Operator Representative Present: None
Operator Representative Signature: (Field Issuance Only)

Inspection Start Date: September 17, 2021 Inspection Start Time: 08:15 Inspection End Date: September 17, 2021 Inspection End Time: 10:00		Inspection Type: Coal Partial Inspection Inspection Reason: Normal I&E Program Weather: Cloudy	
Joint Inspection Agency: None		Joint Inspection Contacts: 	
Post Inspection Agency: None		Post Inspection Contacts: 	
Inspector(s): Robert Zuber, P.E.	Inspector's Signature: <i>Robert D. Zuber</i>		Signature Date: 9/17/2021

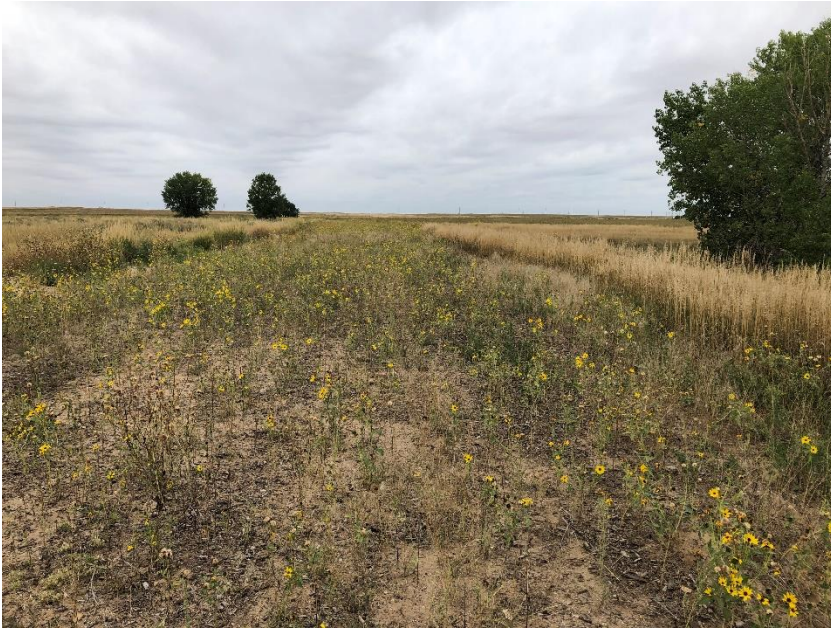
Road next to Sediment Pond 2

Sunflowers and undesirable species (Russian thistle, cheat grass, kochia, and pigweed) are the predominant species in most of the newly reclaimed areas. These include the reclaimed road adjacent to Sediment Pond 2, Area 42, reclaimed topsand piles, and the southern part of the Long Term Spoil Area. Grasses were sparse at many newly reclaimed areas.

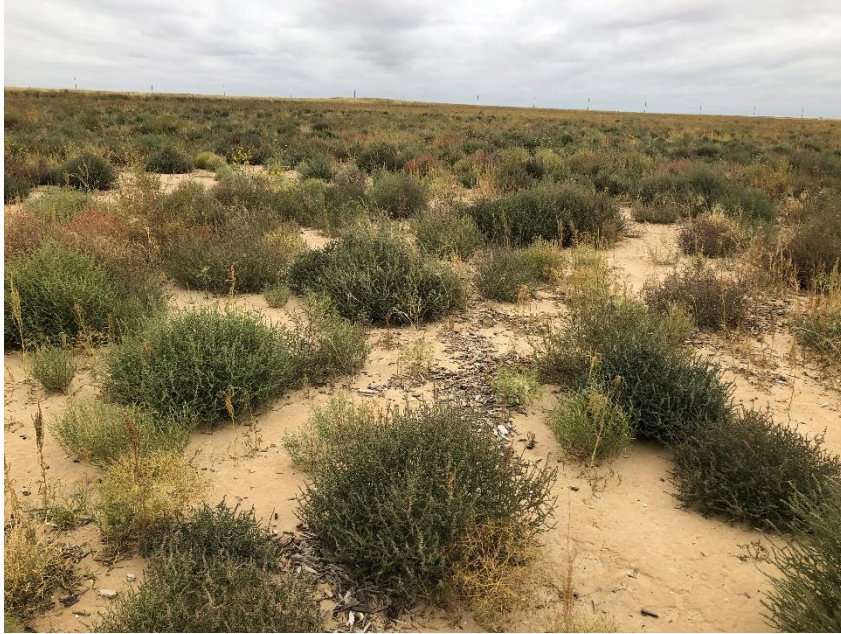
Long Term Spoil Area, southern portion

No erosion problems were seen at the site. Some large bare spots were seen on reclaimed roads and at the eastern portion of the Long Term Spoil Area.

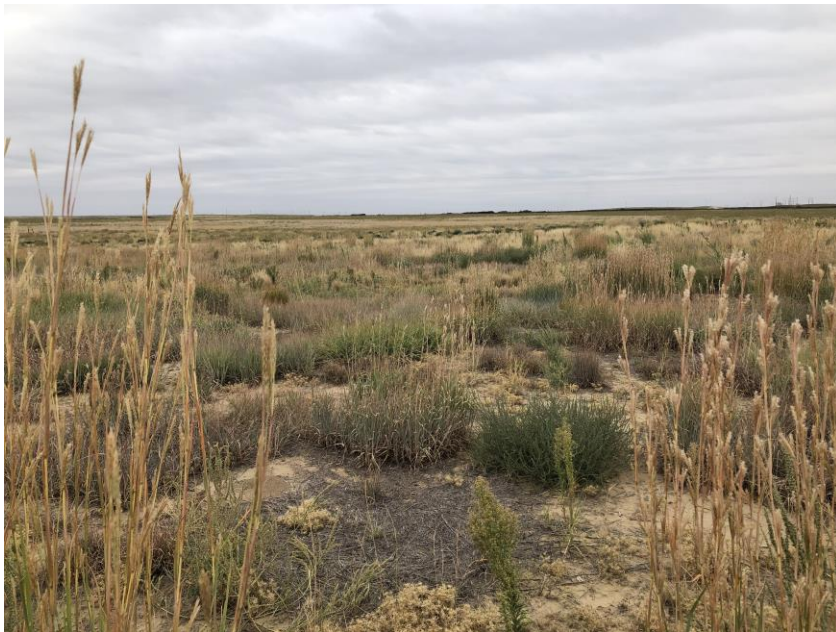
Area 30 (foreground) and Area 29 (background)

Good grass stands were seen in the areas at the southwest portion of the permit area: Areas 23, 29, 30, 31, 32, and 33.

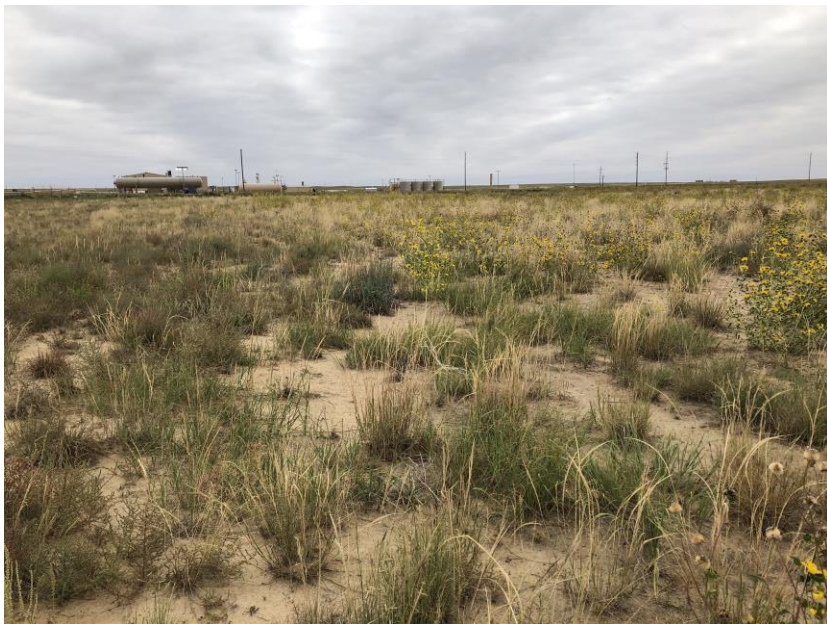
Area 34

Grasses are emerging in the southern portion of the reclaimed B Pit and in Area 34, but less desirable species are common in these areas also.
