MINERALS PROGRAM INSPECTION REPORT
PHONE: (303) 866-3567

MINE NAME: Kester Pit	MINE/PROSPECTING ID#: M-2021-037	MINERAL: Sand and gravel	COUNTY: Costilla
INSPECTION TYPE: Preoperation Inspection	INSPECTOR(S): Lucas West	INSP. DATE: August 24, 2021	INSP. TIME: 13:30
OPERATOR: RMS Utilities, Inc.	OPERATOR REPRESENTATIVE: Kaitlyn Gallardo	TYPE OF OPERATION: 110c - Construction Limited Impact	
REASON FOR INSPECTION: Pre-operation Inspection	BOND CALCULATION TYPE: None	BOND AMOUNT: No Bond Held	
DATE OF COMPLAINT: NA	POST INSP. CONTACTS: None	JOINT INSP. AGENCY: None	
WEATHER: Clear	INSPECTOR'S SIGNATURE:

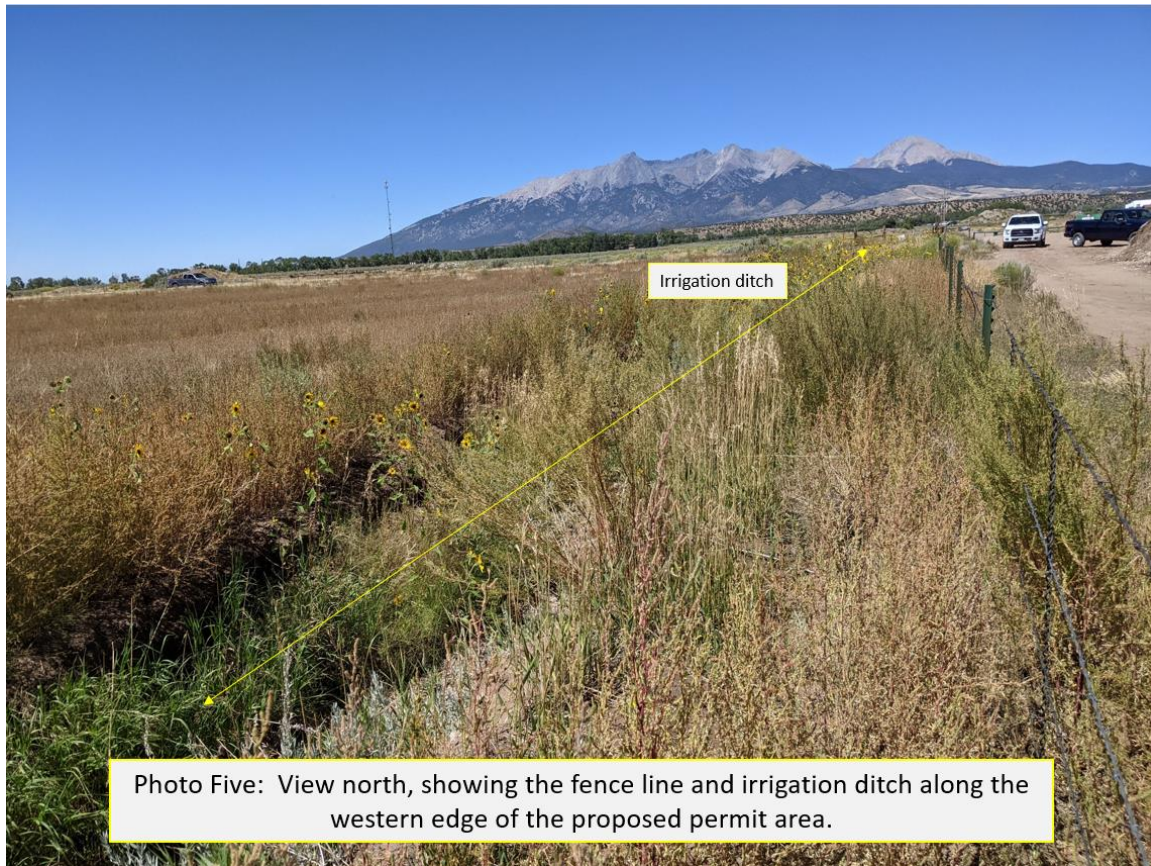
The only notable permanent man-made structures located within 200 feet of the proposed permit area include County Road GG, the fence-lines that border the north and west side of the site, and an irrigation lateral that runs along the west side of the site. The irrigation lateral ditch, shown in Photo Five, was observed and contained no running water at the time of the inspection. The ditch is overgrown with vegetation and shows no signs of recent maintenance. It is unclear at this time if the ditch is owned and operated by an irrigation company, and is addressed in the Division's adequacy Review. The application details a set back from the property line, which puts the mining extents approximately 20 feet to the east of the ditch. On site discussions detailed that a structure agreement would need to be executed for the ditch, however if the agreement cannot be executed an engineering evaluation may be performed to demonstrate mining and reclamation activities will not affect the ditch pursuant to Construction Materials Rule 6.3.12(b).
