**MINERALS PROGRAM INSPECTION REPORT**  
**PHONE: (303) 866-3567**

<b>MINE NAME:</b> Mask Ranch Pit #2	<b>MINE/PROSPECTING ID#:</b> M-2018-015	<b>MINERAL:</b> Aggregate and grave	<b>COUNTY:</b> Archuleta
<b>INSPECTION TYPE:</b> Surety Release Inspection	<b>INSPECTOR(S):</b> Lucas West	<b>INSP. DATE:</b> August 24, 2021	<b>INSP. TIME:</b> 16:45
<b>OPERATOR:</b> Fremont Paving & Redi-Mix, Inc.	<b>OPERATOR REPRESENTATIVE:</b>	<b>TYPE OF OPERATION:</b> 111 - Construction by Government Agency	
<b>REASON FOR INSPECTION:</b> Surety Release Requested	<b>BOND CALCULATION TYPE:</b> None	<b>BOND AMOUNT:</b> \$16,822.00	
<b>DATE OF COMPLAINT:</b> NA	<b>POST INSP. CONTACTS:</b> None	<b>JOINT INSP. AGENCY:</b> None	
<b>WEATHER:</b> Clear	<b>INSPECTOR'S SIGNATURE:</b>

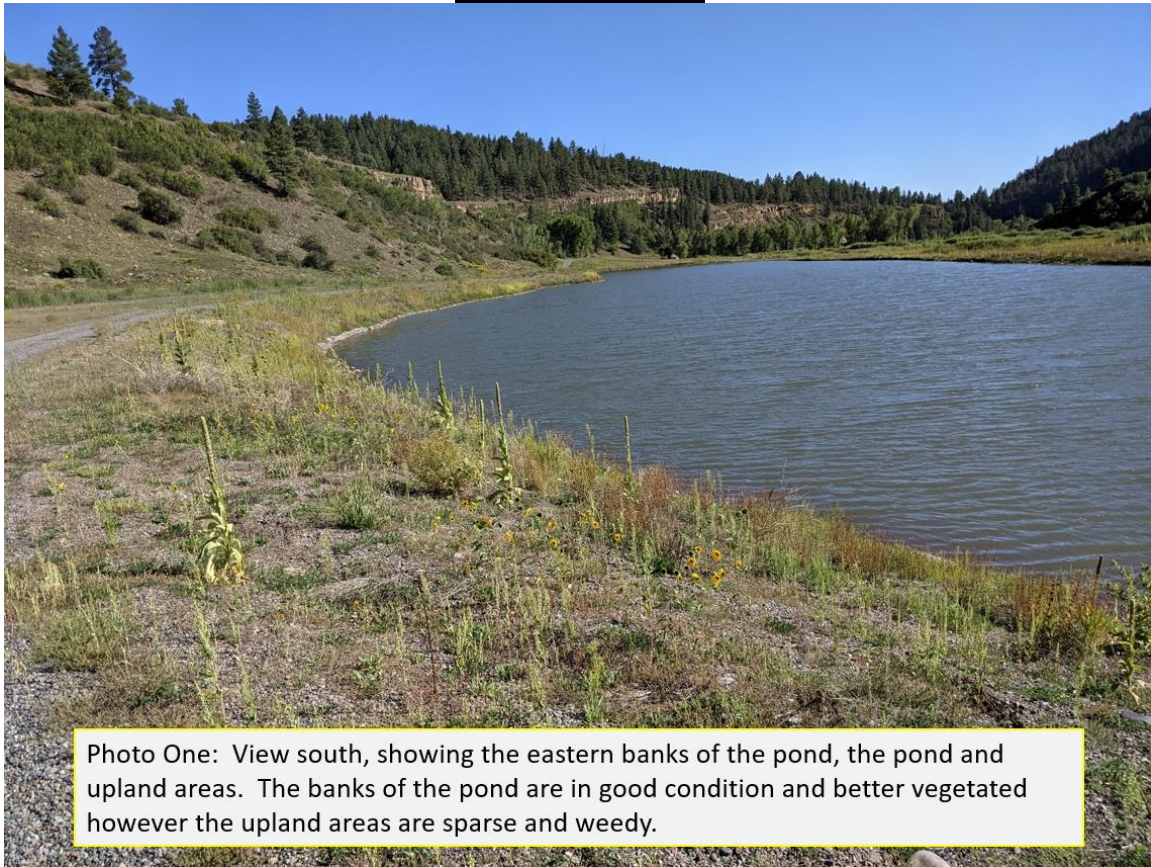
The mine identification sign was not posted at the entrance to the site, however this is not considered a problem at this time as the mining activities have concluded on site. The 7.5 acre portion of the permit that makes up the site contains a large pond with undulating shoreline as well as upland areas that were used for stockpiling and processing of material. The grading and earthwork has been completed and is in excellent condition. No evidence of settling, slumping or erosion was noted. The pond is also in good condition, the undulating shoreline aids in defending against erosion and evidence of heavy wildlife traffic was observed. The upland areas exhibit positive drainage and showed no signs of impounding storm water. The pond, shoreline and upland areas can be seen in Photos One through Three.

Photo One: View south, showing the eastern banks of the pond, the pond and upland areas. The banks of the pond are in good condition and better vegetated however the upland areas are sparse and weedy.

Based on the large populations of State Listed Noxious weeds as well as dominating annual weeds, the Division has determined that further revegetation and weed control efforts are required prior to full and final release of the permit area. The request for full and final release of the entire permit area has been denied. Please see the enclosed Surety Release (SL-1) Denial Letter for more details. In an effort to facilitate coordinated weed management, this report has been copied to Ethan Proud, Archuleta County Weed and Pest Supervisor for possible consultation and assistance with the Operator. The Operator should contact Mr. Proud at 970-264-6773 or by email at [eproud@archuletacounty.org](mailto:eproud@archuletacounty.org).

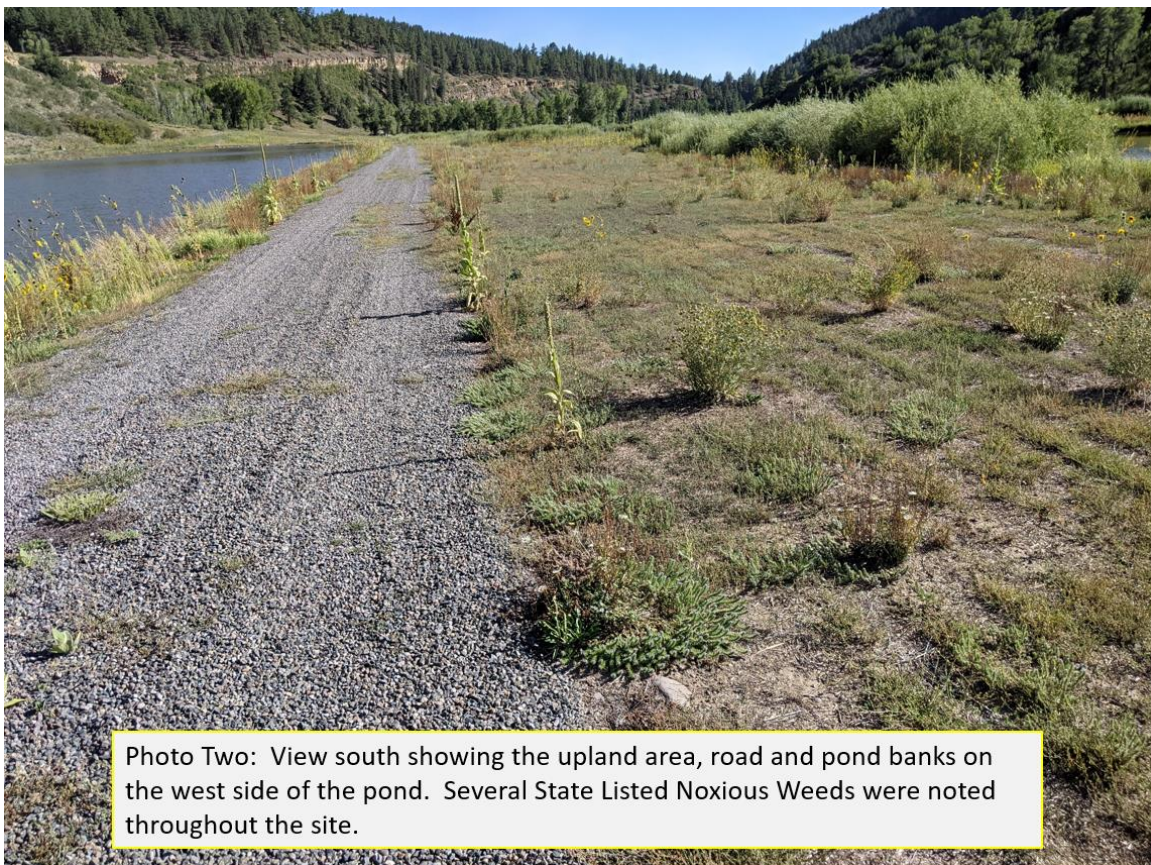
Photo Two: View south showing the upland area, road and pond banks on the west side of the pond. Several State Listed Noxious Weeds were noted throughout the site.

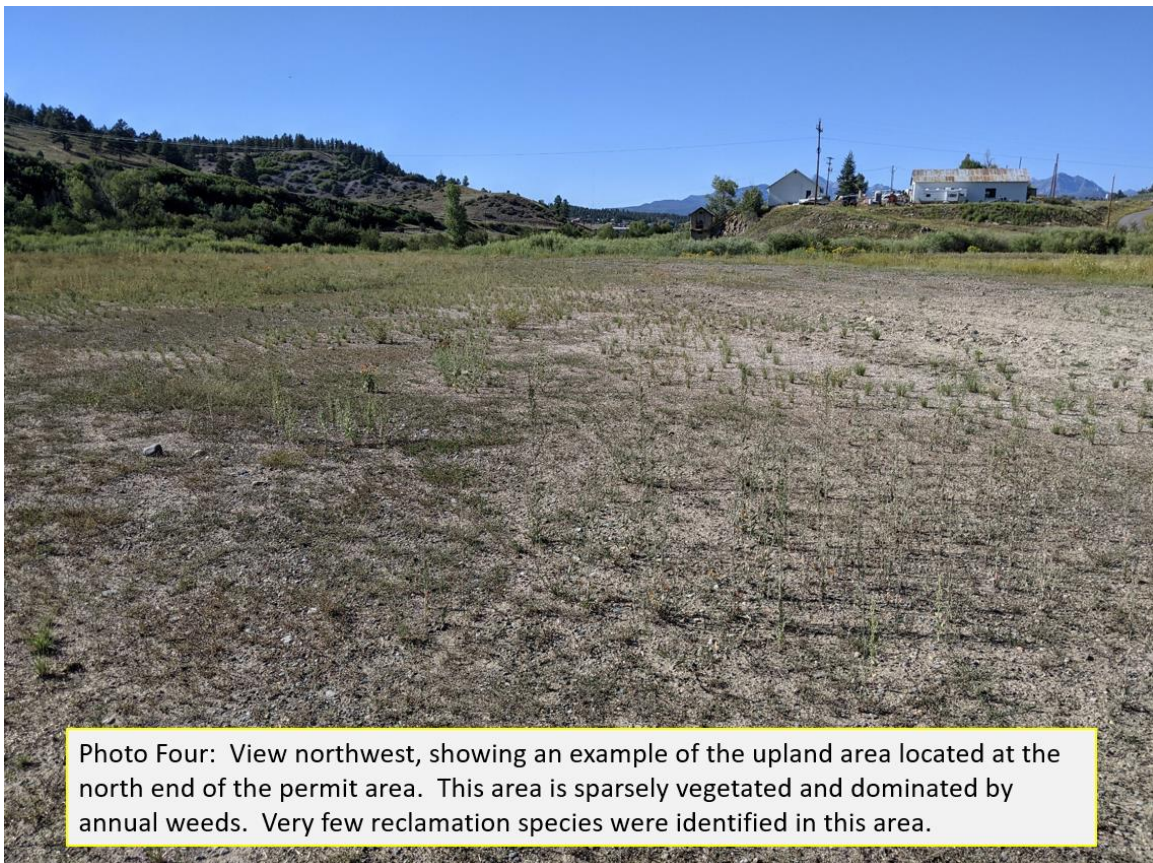
Throughout the site, evidence of revegetation efforts were observed. Evidence included drill seeding track marks as well as the presence of reclamation species. The riparian species that were seeded around the banks of the pond is in good condition, several reclamation or beneficial species were identified. In the upland areas however, the reclamation species become more sparse with areas filled in with a mixture of annual and Noxious Weeds. A good majority of the area is dominated by Russian thistle (tumbleweed) and Kochia. Some of the noxious species identified in large populations included Meadow Knapweed (A list), Oxeye Daisy (B list) and Canada thistle (B-list). Also, the upland area located at the north end of the permit area, shown in Photo Four, is sparsely vegetated and with very few reclamation species present.
