**MINERALS PROGRAM INSPECTION REPORT**  
**PHONE: (303) 866-3567**

<b>MINE NAME:</b> J & P Caliche Pit	<b>MINE/PROSPECTING ID#:</b> M-2021-050	<b>MINERAL:</b> Gravel	<b>COUNTY:</b> Baca
<b>INSPECTION TYPE:</b> Preoperation Inspection	<b>INSPECTOR(S):</b> Jared Ebert	<b>INSP. DATE:</b> September 13, 2021	<b>INSP. TIME:</b> 11:15
<b>OPERATOR:</b> J & P Trucking	<b>OPERATOR REPRESENTATIVE:</b> Jeff Chenoweth	<b>TYPE OF OPERATION:</b> 112c - Construction Regular Operation	
<b>REASON FOR INSPECTION:</b> Preoperation Inspection	<b>BOND CALCULATION TYPE:</b> None	<b>BOND AMOUNT:</b> No Bond Held	
<b>DATE OF COMPLAINT:</b> NA	<b>POST INSP. CONTACTS:</b> None	<b>JOINT INSP. AGENCY:</b> None	
<b>WEATHER:</b> Clear	<b>INSPECTOR'S SIGNATURE:</b>

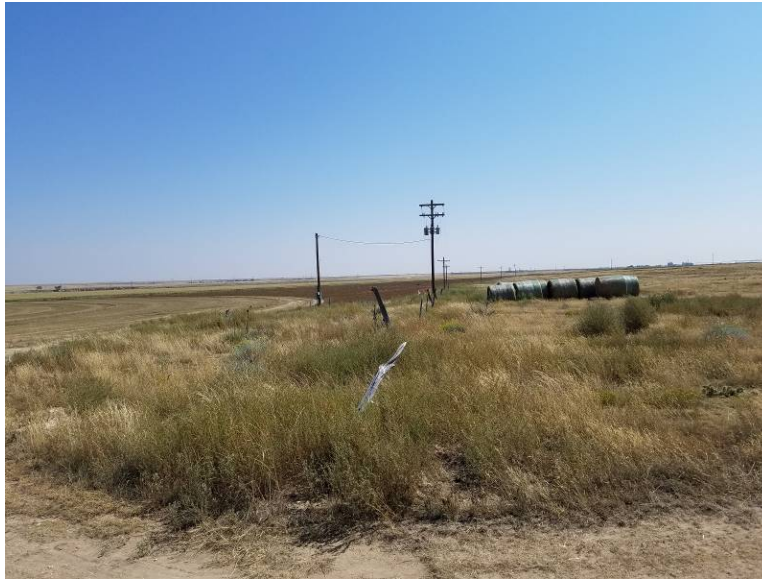
**Figure 1. From the north end of the Phase 1 area looking east along the proposed northern boundary line.**

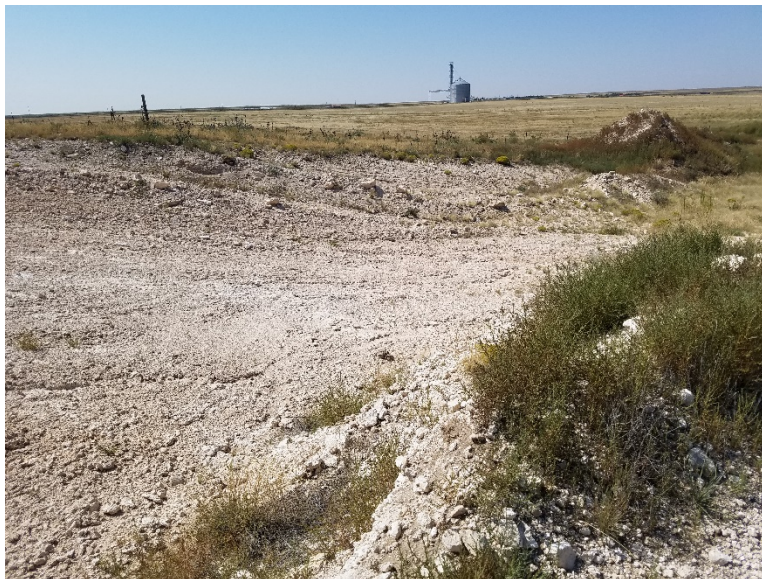
A map highlighting several observations made by the Division is included at the end of this report. It appears a small excavation has occurred in the northwest corner of the site in the proposed Phase 1 area. According to Chuck, the landowner had this area excavated for material used on their own property. This small excavation is about .4 acres in size. The excavation was shallow with a west by northwest aspect with a gentle less than 3:1 slope. It appears a piece of equipment, likely a dozer, pushed the material downslope creating the excavation. The topsoil/growth media from the excavation is piled northeast of the shallow excavation. As described in the permit application, there is a small rise in elevation in the Phase 1 area the Applicant intends to mine in order to bring the topography lower in this location to better fit the irrigated field north of the Phase 1 area. A water well is located within the irrigated field north of the proposed permit area.

**Figure 2. Pre-existing excavation in the Phase 1 area, from the north east end looking west.**

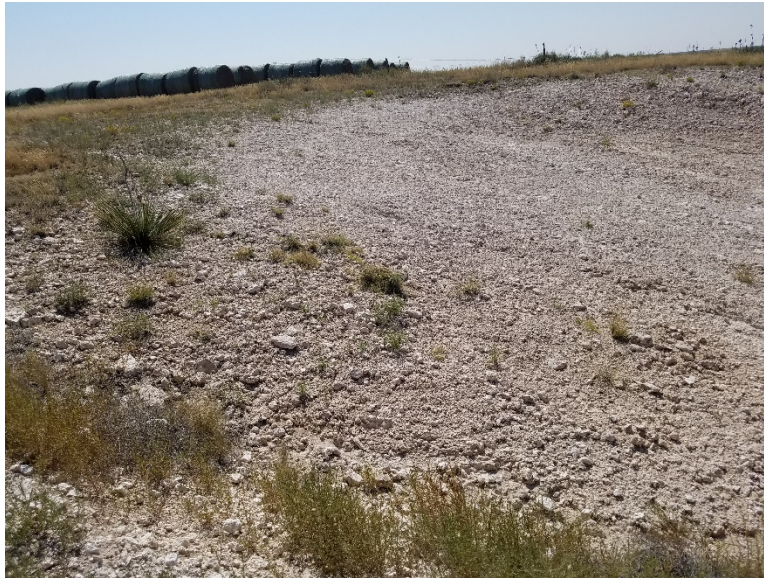
Figure 3. Pre-existing excavation from the northeast corner looking south.

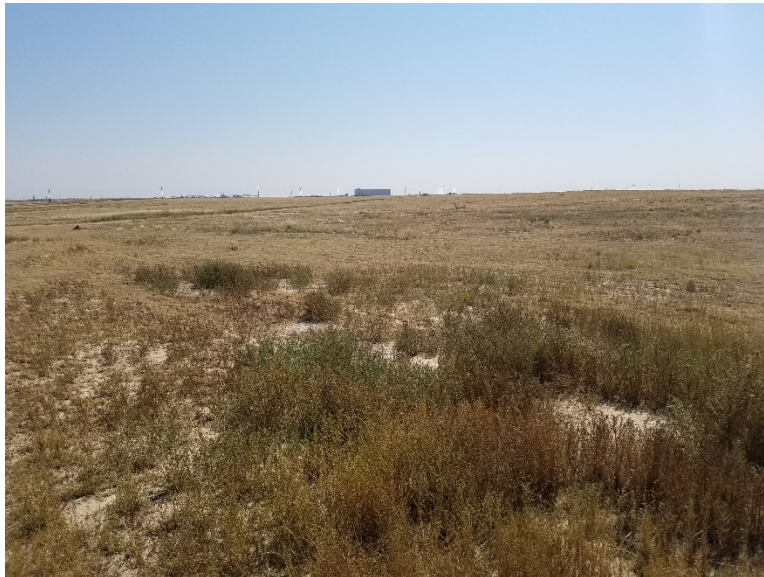
Figure 4. From the Phase 2/3 area looking east.

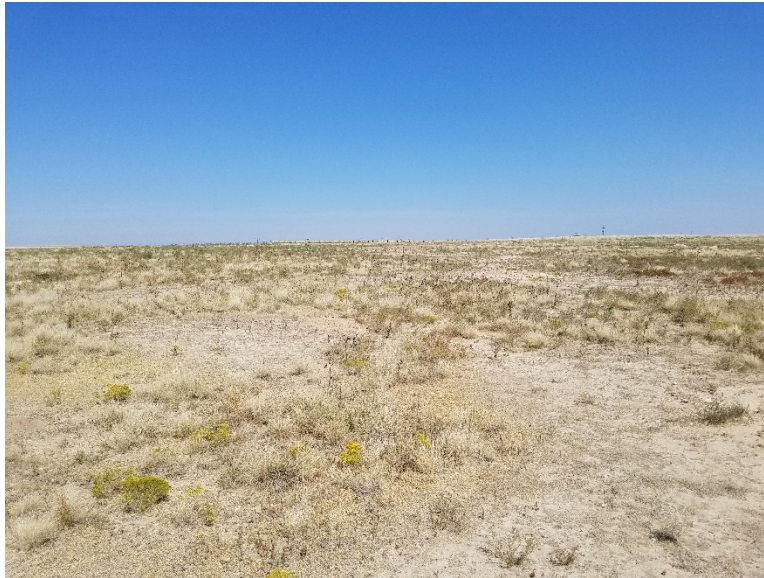
Figure 5. From the south end of the proposed affected area looking north.

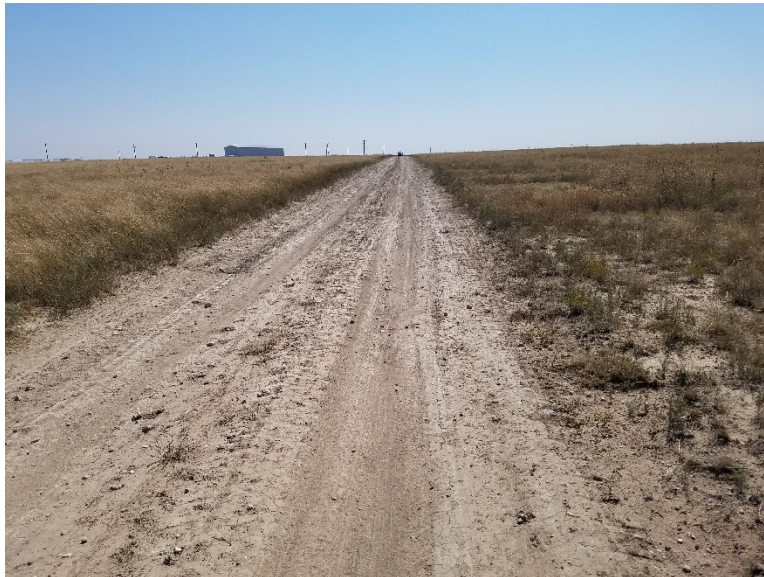
The proposed mine area was walked. The area can be characterized as dry rangeland. The dominant vegetation observed included, blue grama grass, sand dropseed, ragweed, and yucca. An existing access road is in place and runs from the southeast corner to the northwest corner of the site. It is a dirt road about 15 to 20 feet in width. According to Mr. Chenoweth, this road may move during the life of the operation as well as the location of the screener and crusher. The applicant proposes to strip topsoil/growth media in advance of mining in each phase and stockpiling it on the west side and east side of Phases 1, 2, and 3 as shown on the Exhibit C Map (labeled "DIRECTION OF MINING; PROPOSED HAUL ROAD LOCATION; TOPSOIL STOCKPILE LOCATIONS).

Figure 6. Existing access road from the northwest looking southeast.
