# **Horse Gulch Fill Quarterly Inspection Report**

**Third Quarter 2021**

**Trapper Mining Inc.**

**Trapper Mine**

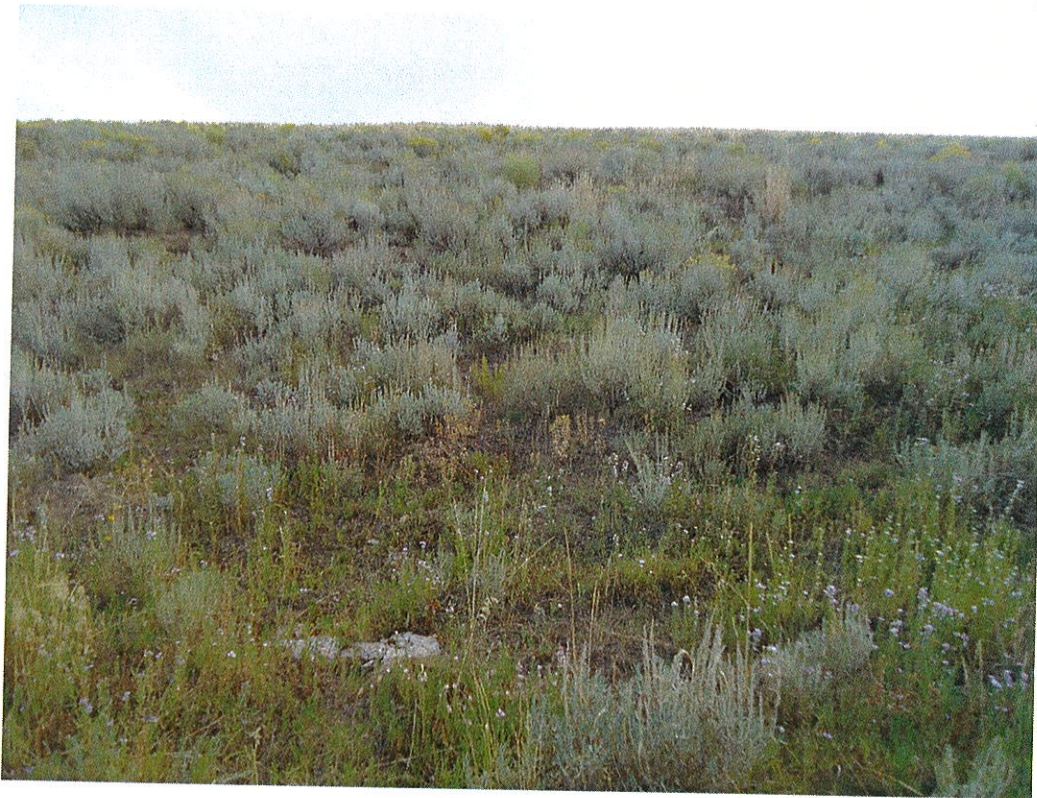
The two spots above the 7350' elevation on the south side of the dump that showed some differential settling in the second quarter of 2013 were inspected and there was no additional settling (Photographs 1 and 2).

Photograph 1: South Site above the 7350 Bench Elevation (9/14/2021)

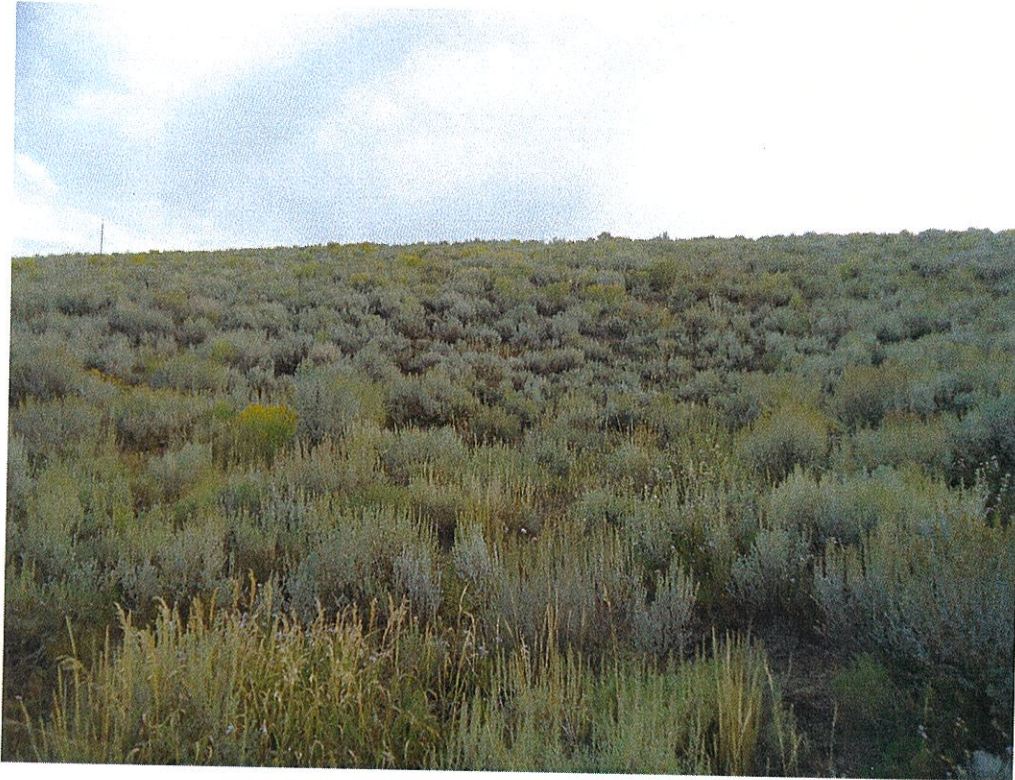
*Photograph 2: North Site above the 7350 Bench Elevation (9/14/2021)*

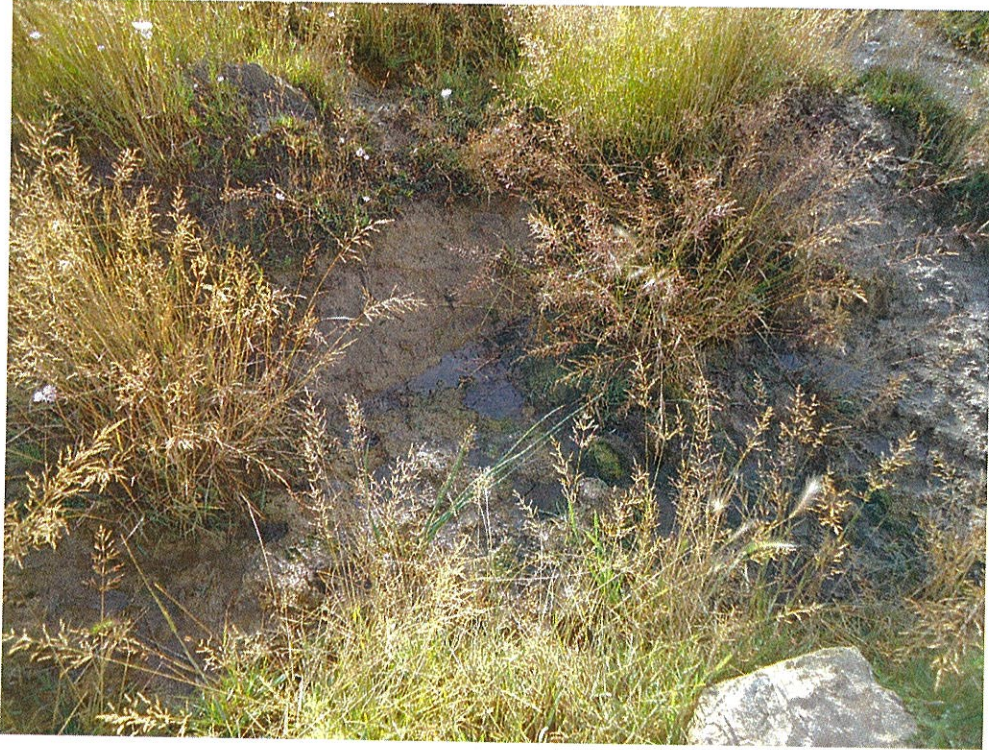
The underdrainage system was completed in the first quarter of 2010; additional work on this system is not anticipated. During the time of the inspection, there was approximately a tenth of a gallon per minute of water flow. (Photograph 3).

*Photograph 3: Water from the Underdrainage System (9/14/2021)*

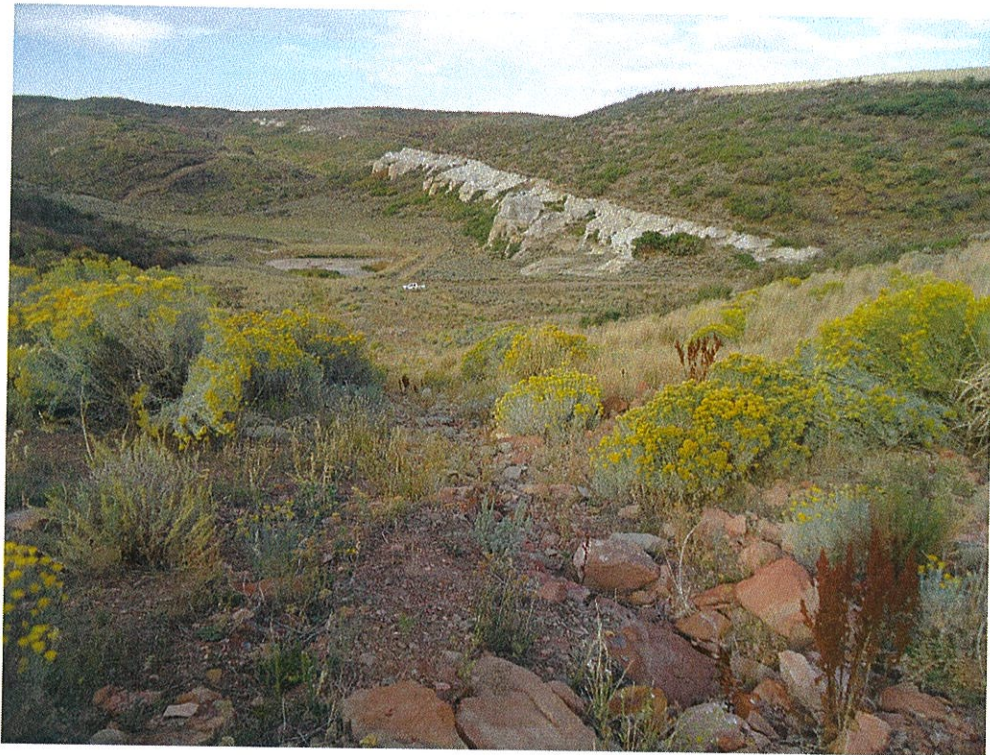
Both the north and south surface drains were inspected (Photographs 4 and 5). At the time of the inspection there was no water flow.

*Photograph 4: North Surface Drain Looking West (9/14/2021)*

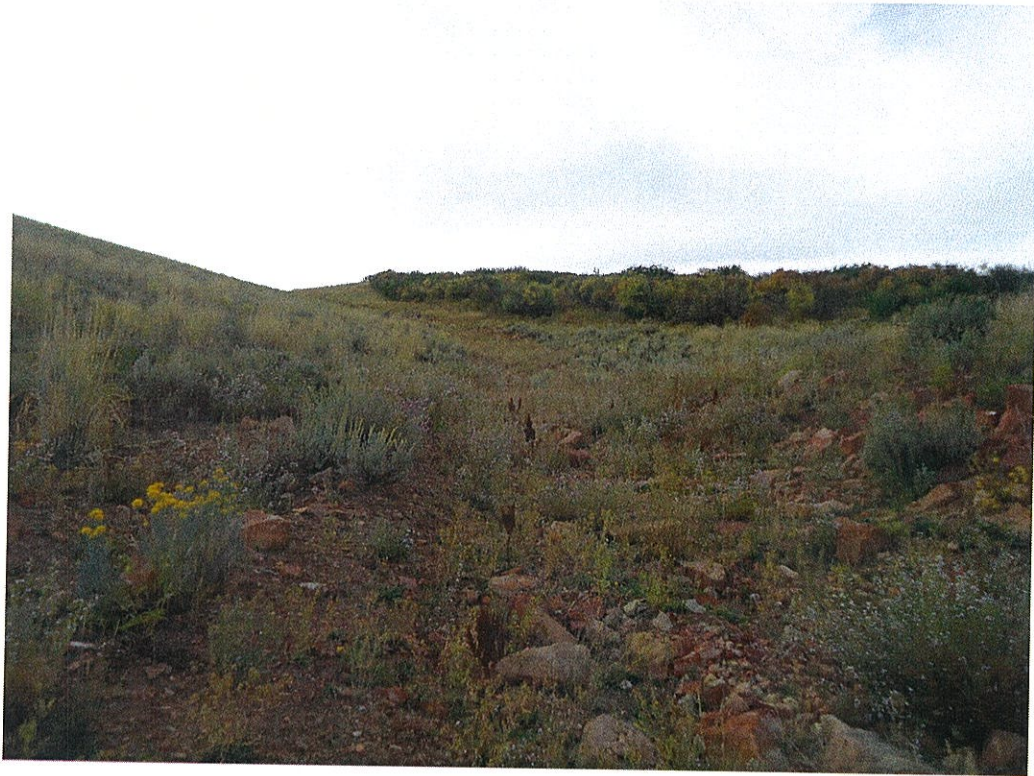
*Photograph 5: South Surface Drain Looking South-east (9/14/2021)*

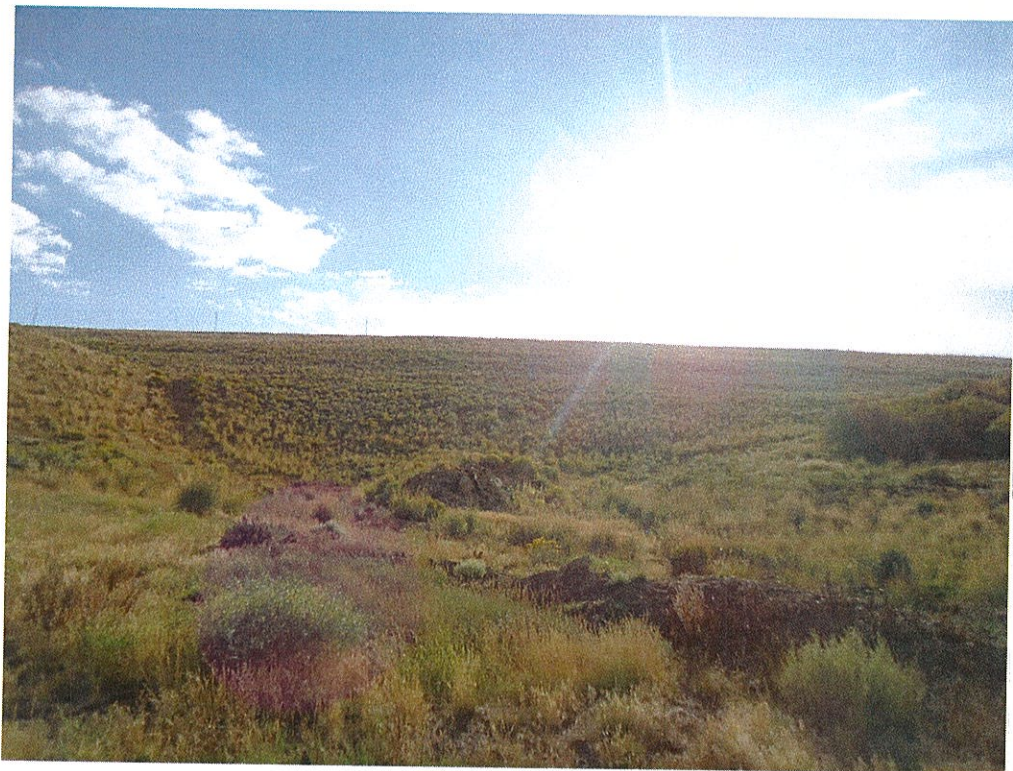
Photograph 6 depicts the west facing slope of the fill in the area where the slope of the fill is at 3H: 1V.

*Photograph 6: West Side Fill 3H: 1V Face Looking East (9/14/2021)*
