## MINERALS PROGRAM INSPECTION REPORT

<b>MINE NAME:</b> Schwartzwalder Mine	<b>MINE/PROSPECTING ID#:</b> M-1977-300	<b>MINERAL:</b> Uranium	<b>COUNTY:</b> Jefferson
<b>INSPECTION TYPE:</b> Preoperation Inspection	<b>INSPECTOR(S):</b> Amy Eschberger, Michael Cunningham	<b>INSP. DATE:</b> September 14, 2021	<b>INSP. TIME:</b> 13:00
<b>OPERATOR:</b> Colorado Legacy Land, LLC	<b>OPERATOR REPRESENTATIVE(S):</b> Elizabeth Busby, Billy Ray	<b>TYPE OF OPERATION:</b> 112d-2 - Designated Mining Operation	
<b>REASON FOR INSPECTION:</b> Preoperation Inspection	<b>BOND CALCULATION TYPE:</b> None	<b>BOND AMOUNT:</b> \$7,674,022.00	
<b>DATE OF COMPLAINT:</b> NA	<b>POST INSP. CONTACTS:</b> None	<b>JOINT INSP. AGENCY:</b> None	
<b>WEATHER:</b> Clear	<b>INSPECTOR'S SIGNATURE:</b>

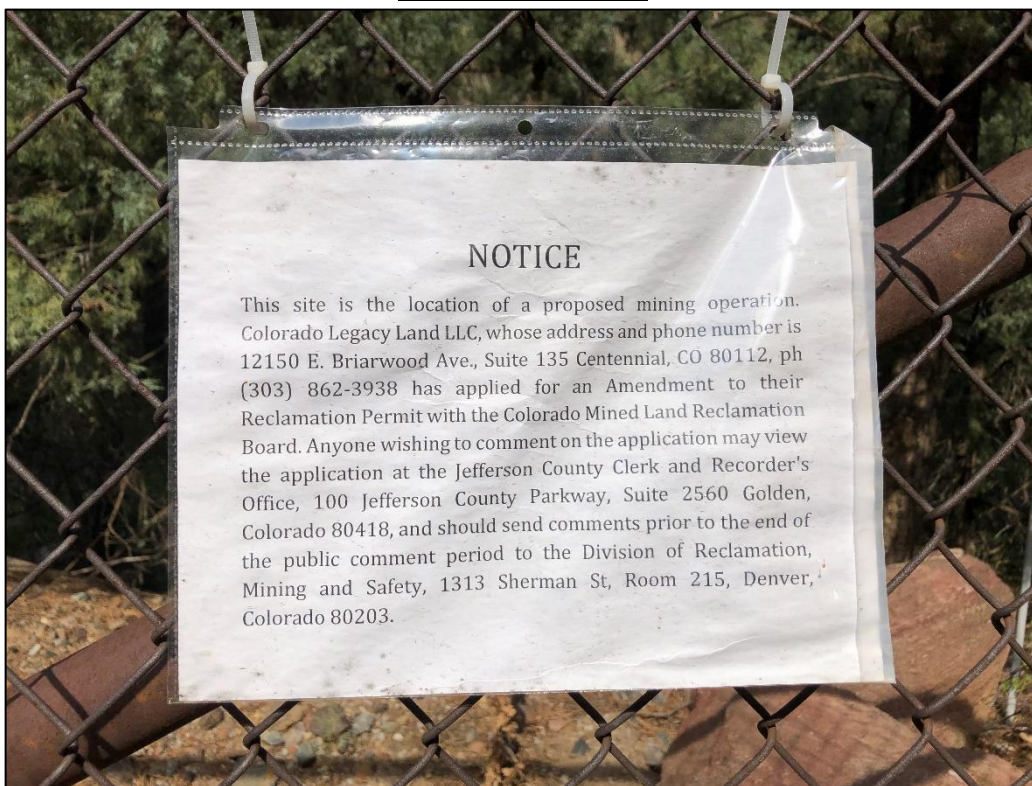
**Photo 1.** View of public notice of AM-6 application posted at main entrance to site in accordance with Rule 1.6.2(1)(b).

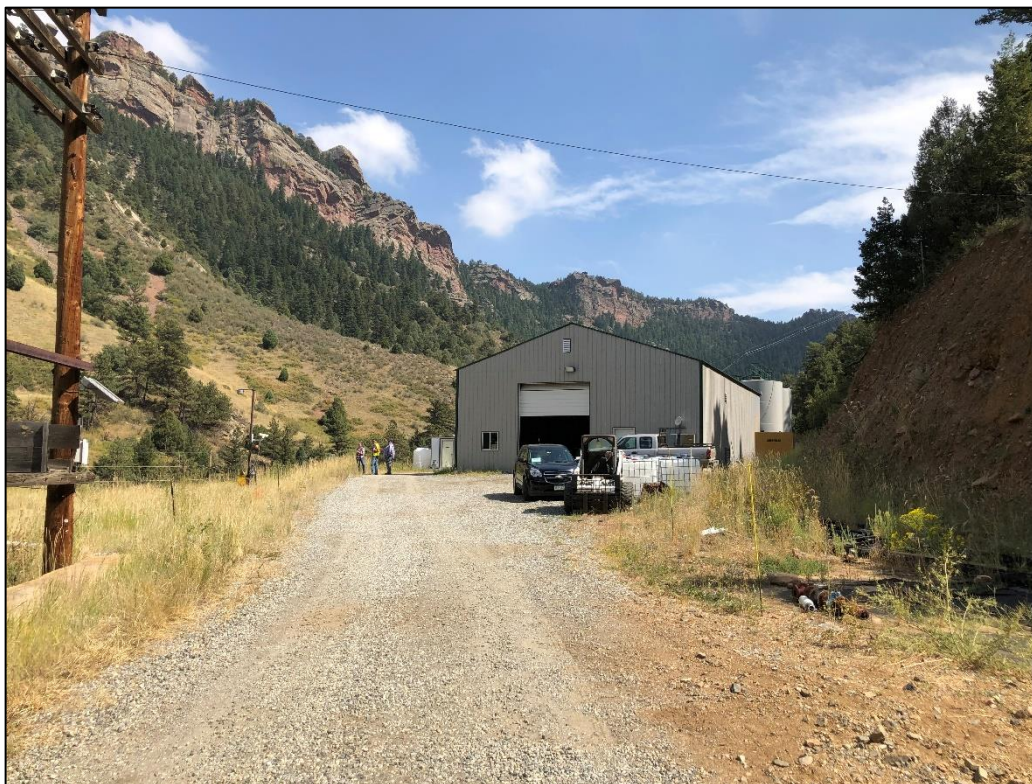
**Photo 2.** View looking southeast at reverse osmosis (RO) water treatment plant situated on top of mesa along southern edge of valley. Mine water is treated in this plant then discharged to Ralston Creek under a CDPHE discharge permit.

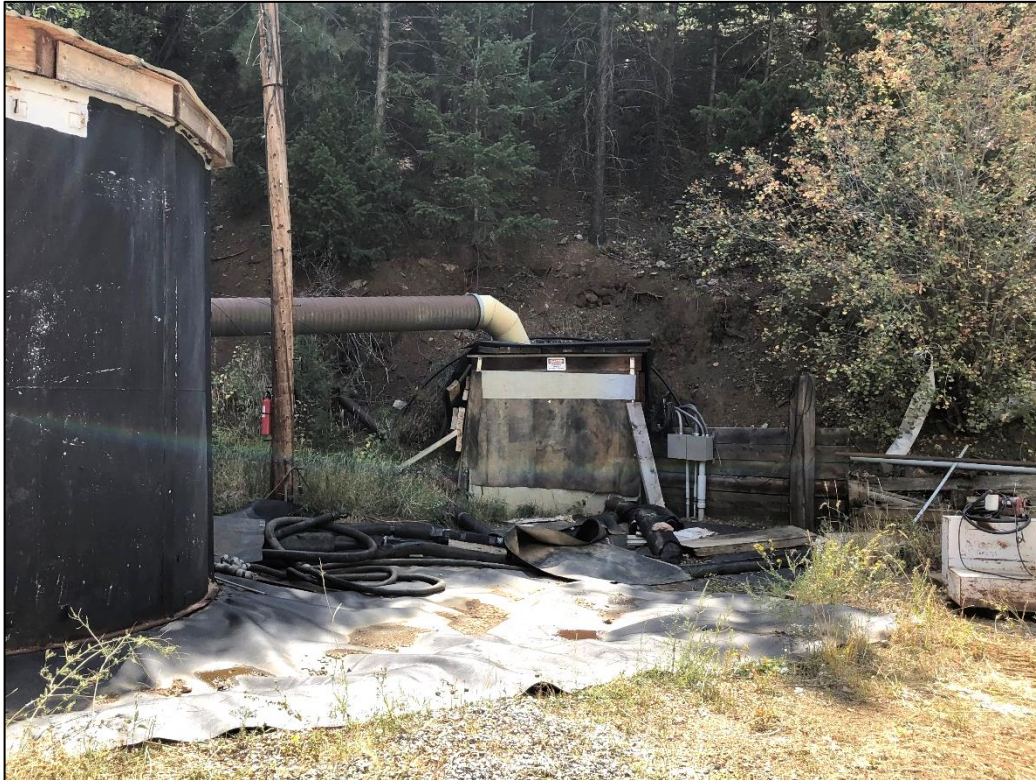
**Photo 3.** View looking west/southwest at Steve Adit, located just northwest of water treatment plant on top of mesa. Mine water was previously pumped from this adit to treatment plant. However, mine water is now pumped from Jeffrey Air Shaft located on hillside above treatment plant. It is not clear what continued use the operation has for this adit and what infrastructure remains inside.

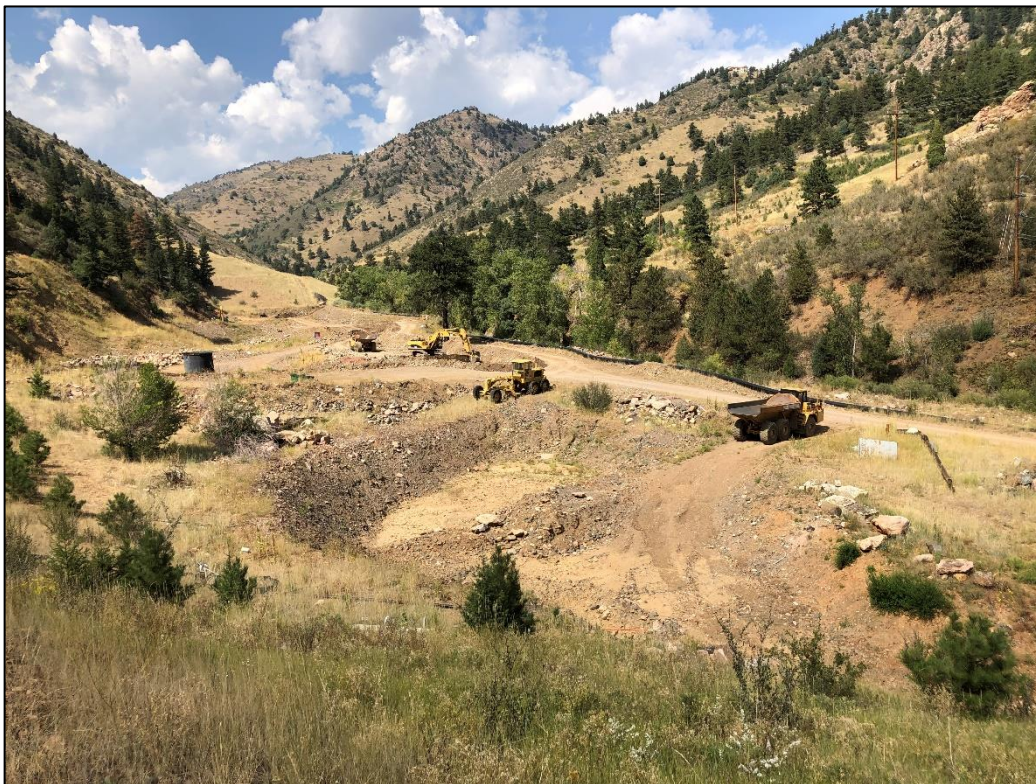
**Photo 4.** View looking northwest (from top of mesa with water treatment plant) across northern portion of valley excavation project, in which, excavation activities were occurring during inspection. Radionuclide-impacted alluvial valley soils are excavated and disposed of underground per the approved permit.

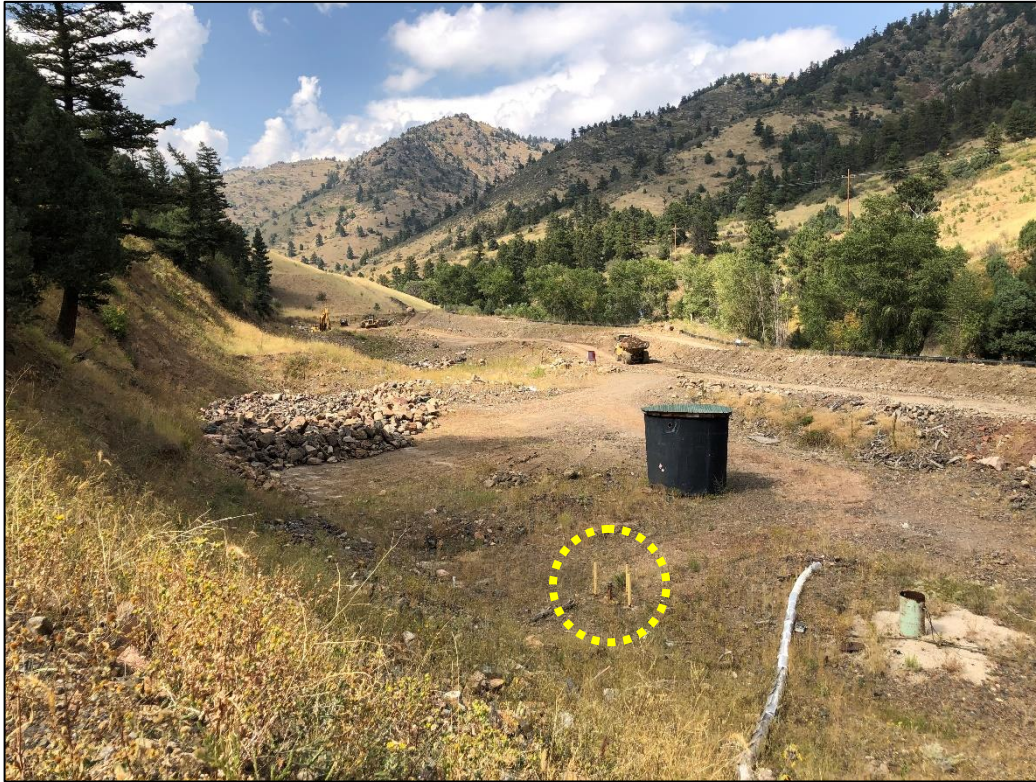
**Photo 5.** View looking northwest across northern portion of valley excavation project, in which, excavation activities were occurring during the inspection. Bedrock groundwater monitoring well MW-18 (circled) is visible in foreground.

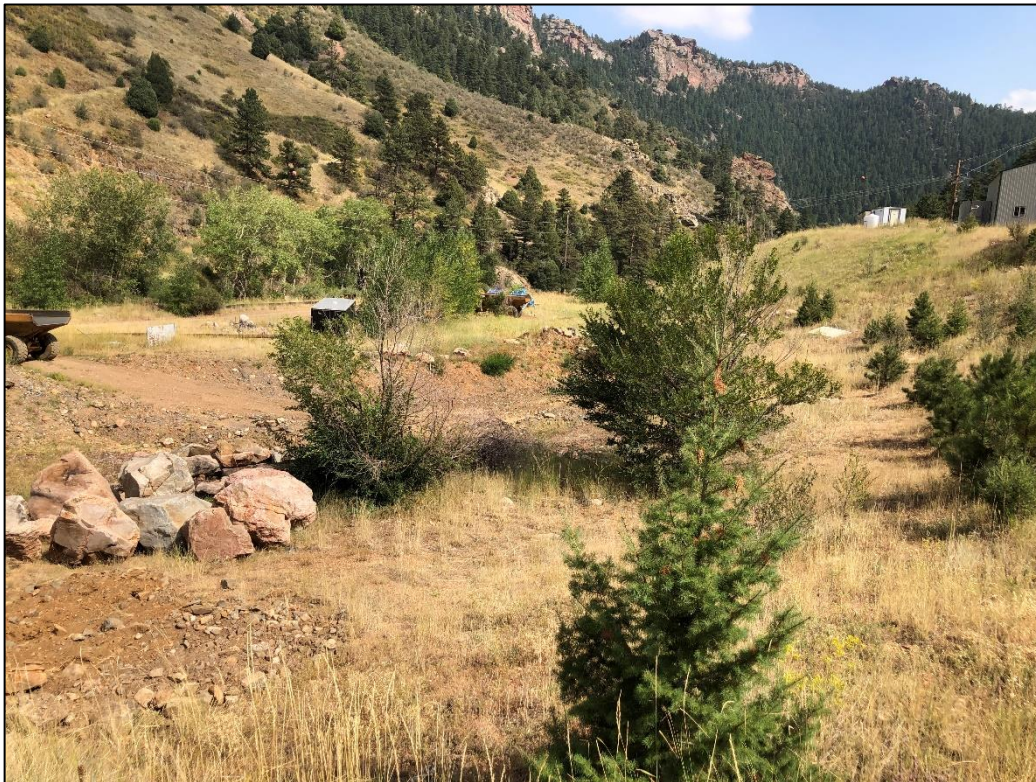
**Photo 6.** View looking southeast across central portion of valley excavation project at base of mesa with water treatment plant (plant visible at top, right).

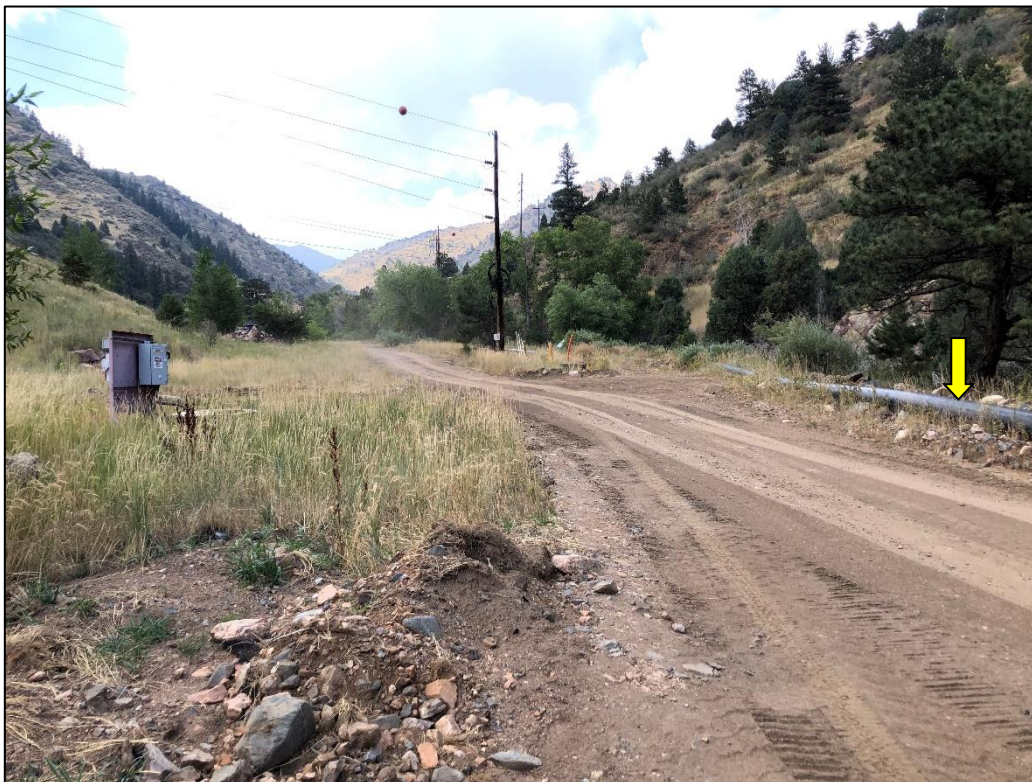
**Photo 7.** View looking northwest at central portion of valley (east of mesa with water treatment plant) which may need to be excavated to remove radionuclide-impacted soils. The access road and adjacent bypass pipeline (indicated) may need to be temporarily relocated during this project.

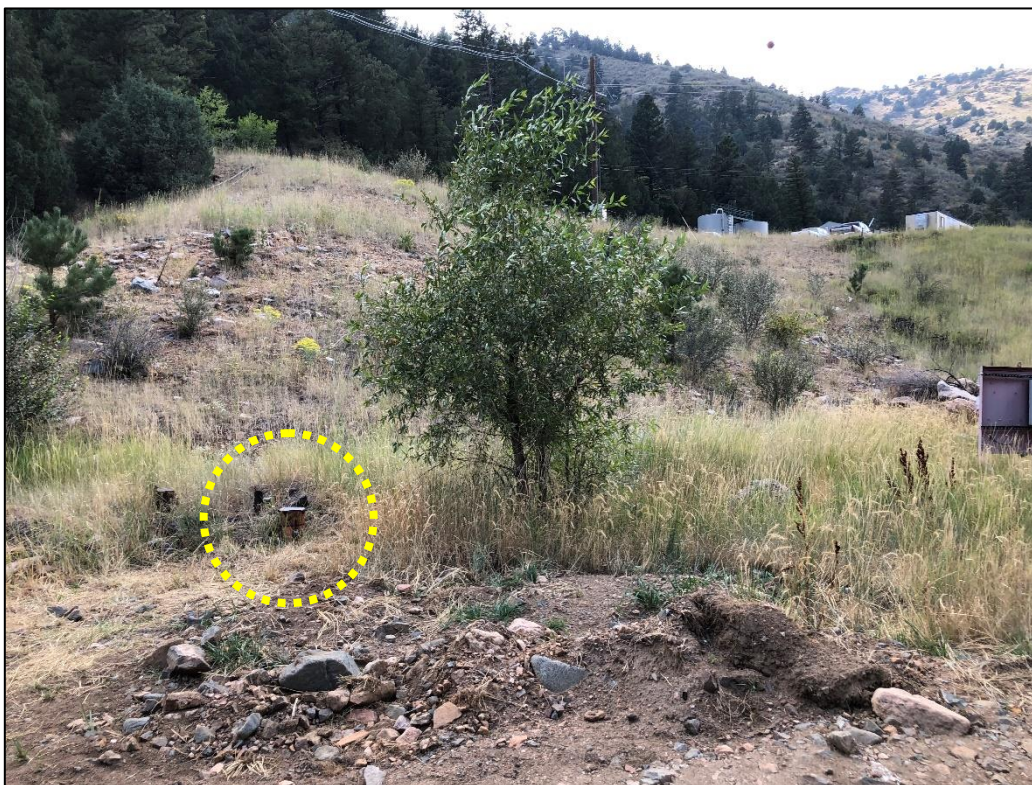
**Photo 8.** View looking west/northwest at alluvial groundwater monitoring well MW-6 (located southeast of mesa with water treatment plant), which operator may propose (in an upcoming Technical Revision) to abandon, if alluvial material surrounding well must be removed for valley excavation project.

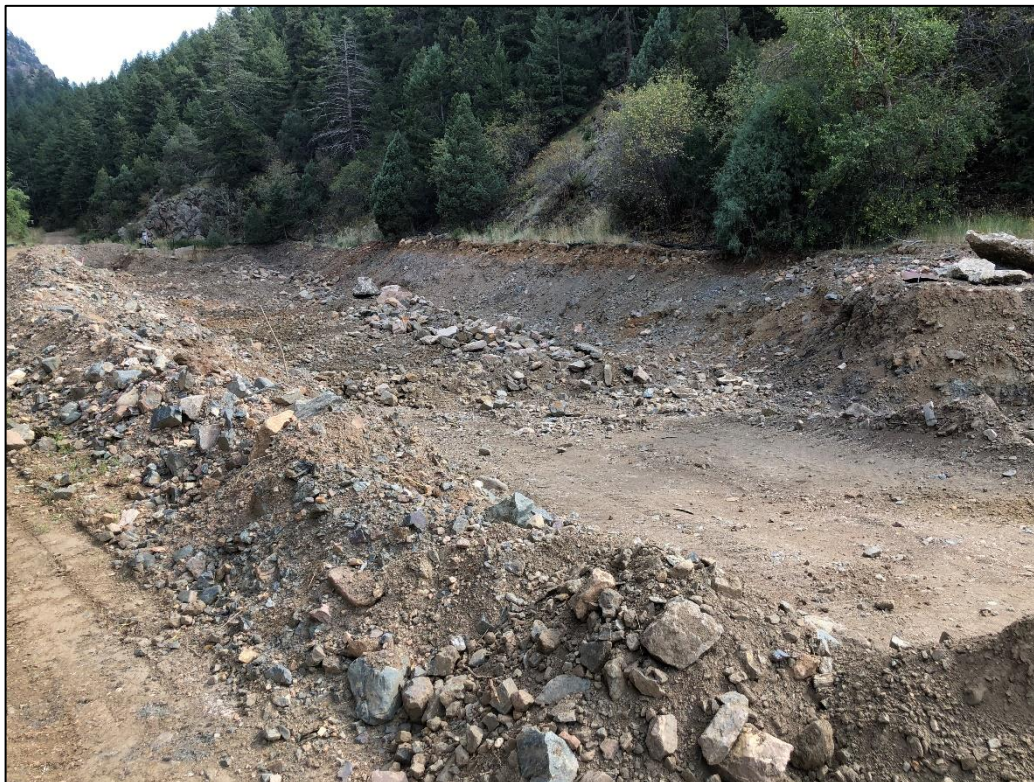
**Photo 9.** View looking southeast across southern portion of valley excavation project, which was recently excavated. Radionuclide-impacted alluvial valley soils are excavated and disposed of underground per the approved permit.

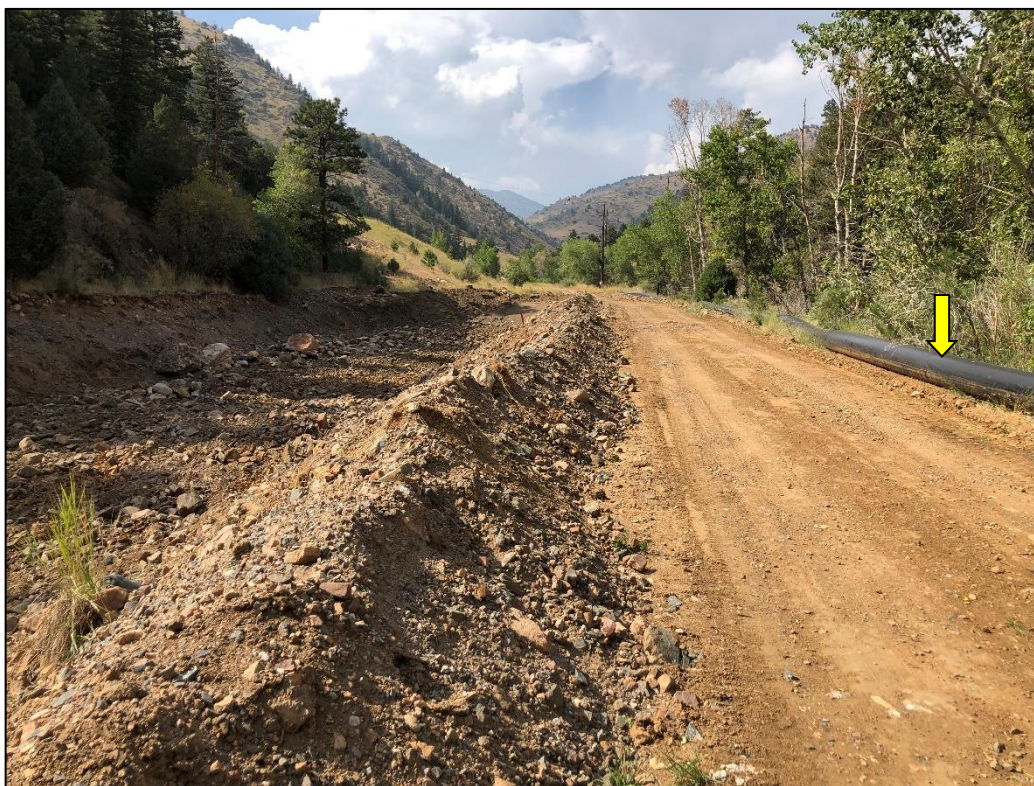
**Photo 10.** View looking northwest across southern portion of valley excavation project, showing recent excavation along south side of access road. Road and adjacent bypass pipeline (indicated) may need to be temporarily relocated during this project.

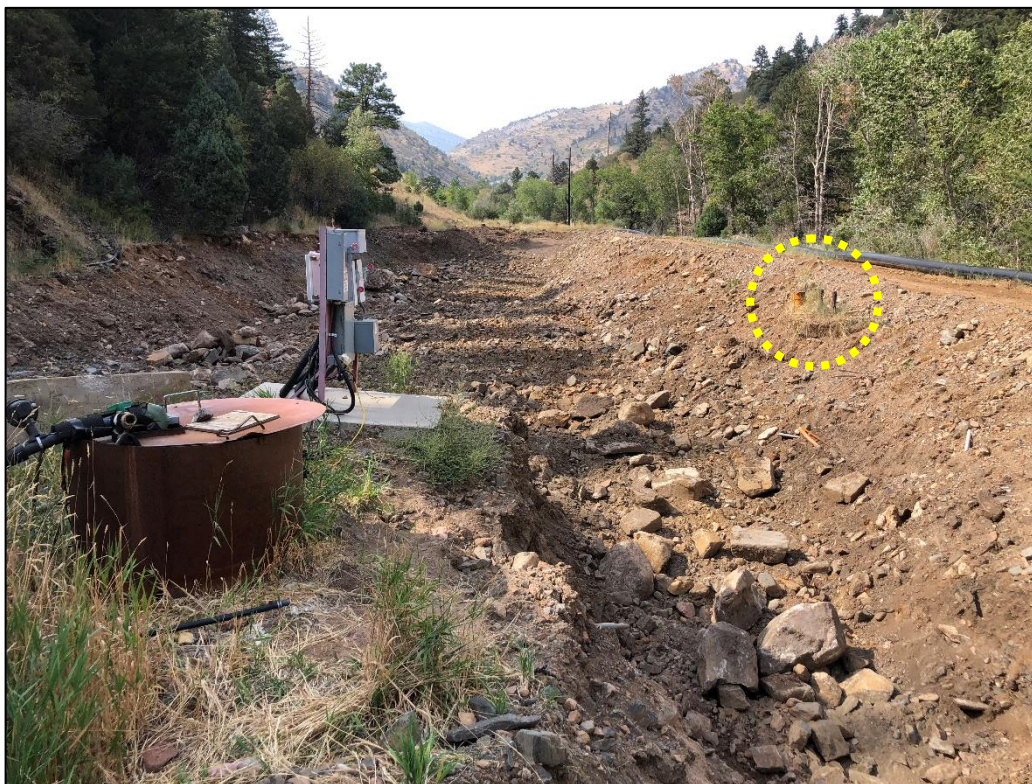
**Photo 11.** View looking northwest across southern portion of valley excavation project. Note alluvial groundwater monitoring well MW-7 (circled) which operator may propose (in an upcoming Technical Revision) to abandon, since alluvial material surrounding well must be removed for valley excavation project. Sump #1 (at left; the last functional sump on site) may also become redundant.

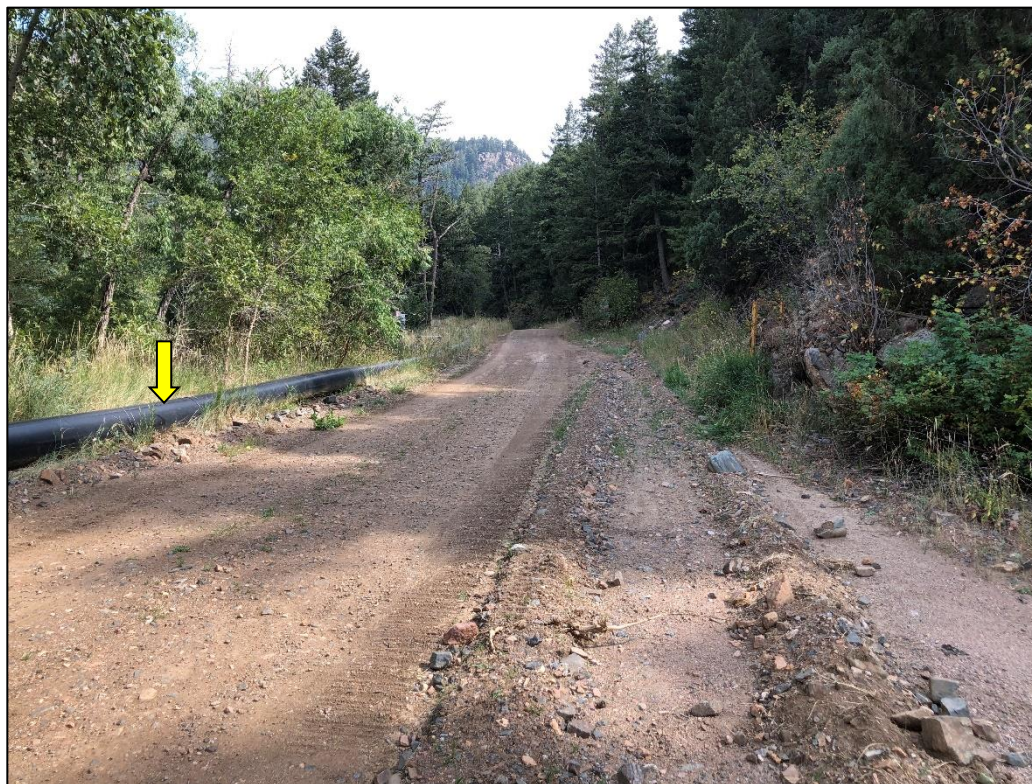
**Photo 12.** View looking southeast across southern-most portion of valley inside permit area, which may need to be excavated for the valley excavation project. The access road and adjacent bypass pipeline may need to be temporarily relocated during this project.
