**MINERALS PROGRAM INSPECTION REPORT**  
**PHONE: (303) 866-3567**

<b>MINE NAME:</b> Hale Pit aka Earl's Pit	<b>MINE/PROSPECTING ID#:</b> M-1981-121	<b>MINERAL:</b> Sand and gravel	<b>COUNTY:</b> El Paso
<b>INSPECTION TYPE:</b> Surety-Related Inspection	<b>INSPECTOR(S):</b> Timothy Cazier, P.E.	<b>INSP. DATE:</b> September 10, 2021	<b>INSP. TIME:</b> 11:50
<b>OPERATOR:</b> S & K No. 1, LLC	<b>OPERATOR REPRESENTATIVE:</b> Joe Kraig	<b>TYPE OF OPERATION:</b> 110c - Construction Limited Impact	
<b>REASON FOR INSPECTION:</b> Surety Related	<b>BOND CALCULATION TYPE:</b> Partial Bond	<b>BOND AMOUNT:</b> \$17,570.00	
<b>DATE OF COMPLAINT:</b> NA	<b>POST INSP. CONTACTS:</b> None	<b>JOINT INSP. AGENCY:</b> None	
<b>WEATHER:</b> Clear	<b>INSPECTOR'S SIGNATURE:</b>

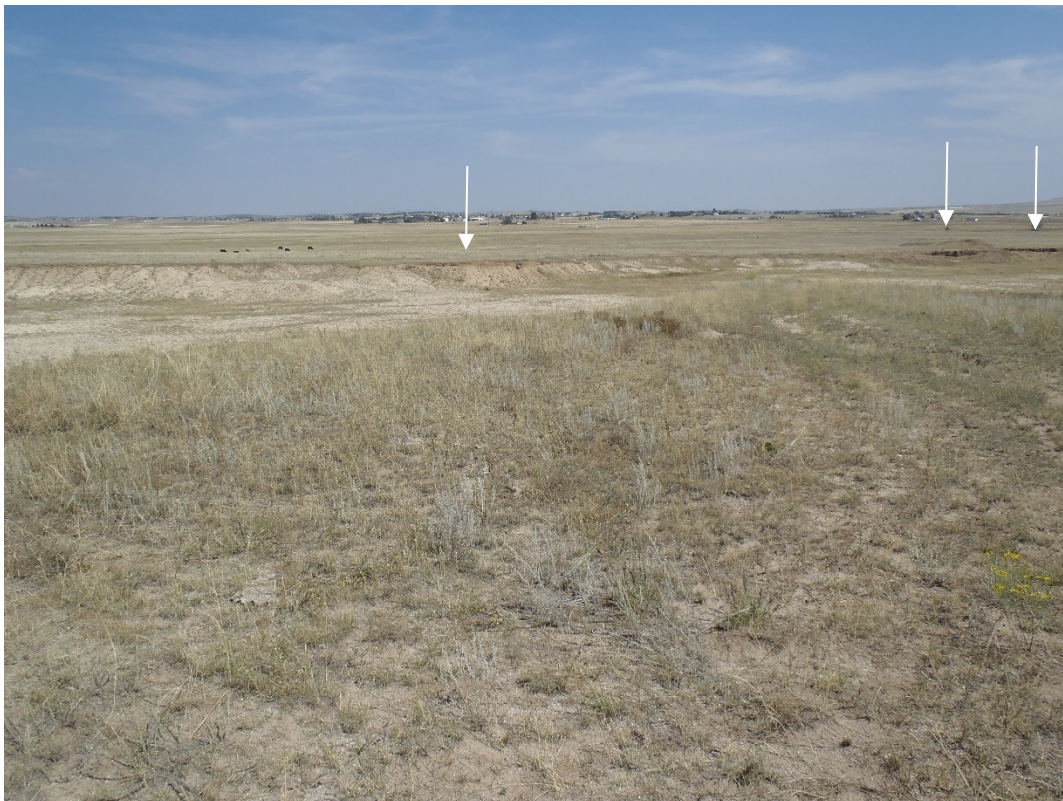
Gen. Compliance with Mine Plan: No activity has taken place since the previous inspection. The maximum allowed disturbed area is 9.9 acres. Google Earth was used to measure the disturbed area, which was estimated to be 2.5 acres, based on 2019 imagery. Highwalls were estimated to vary between 6 and 10 feet in height (see **Photo 1**).

Photo 1. Three highwalls from southwest corner (looking NE).

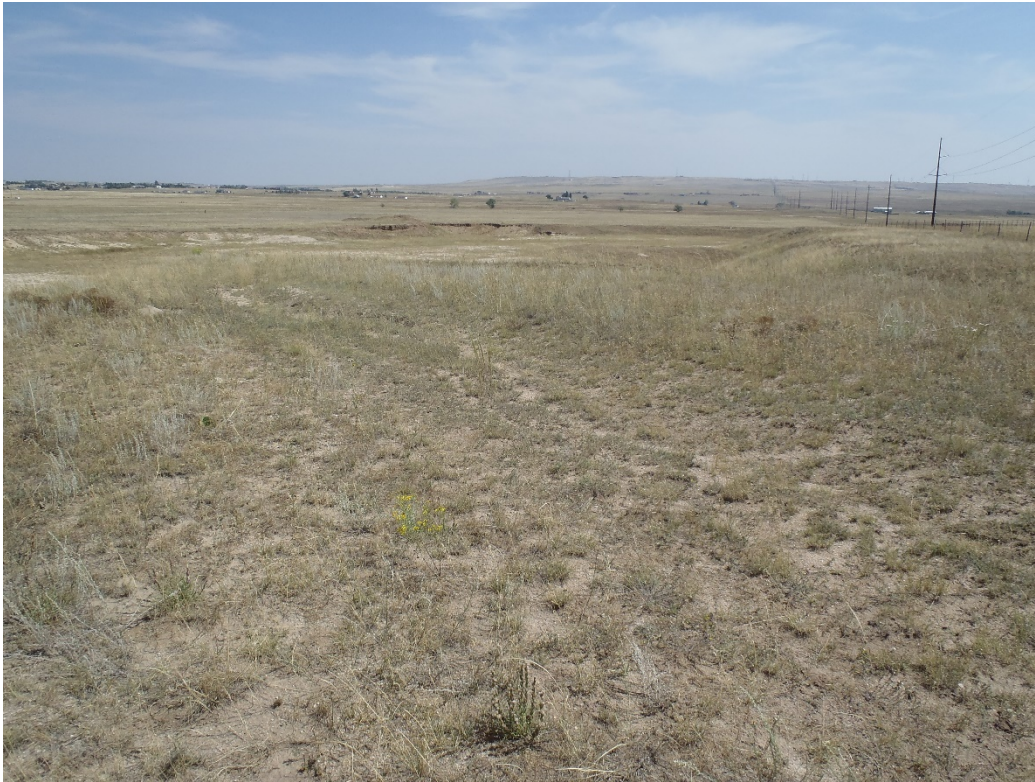
Reclamation Success: More than half of the 2.5 acres of disturbance have self-reclaimed (see **Photo 2**). Three highwall segments (see **Photos 3** through **5**) require slope reduction for stability (see yellow lines on **Figure 1**). Approximately 0.9 acres need grading and seeding (see blue outlines on **Figure 1**). This includes the three highwall segments plus the area in the northeast where erosion headcutting was observed (see **Photos 6** and **7**).

Photo 2. Mostly reclaimed site (looking NE from pre-law access road).

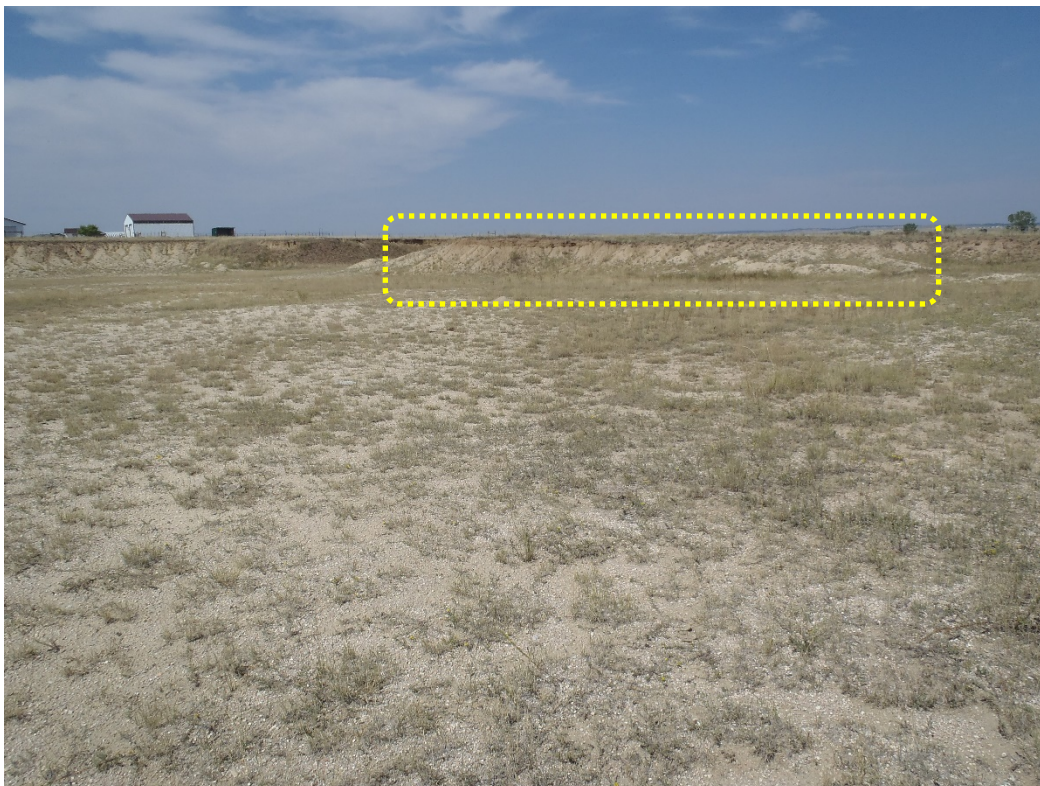
Photo 3. West highwall needing flattening (looking NW).

Backfilling and Grading: Sufficient backfill material appeared to be available. There is adequate room within the permit boundary to push material down to slope existing highwalls to 3H:1V.

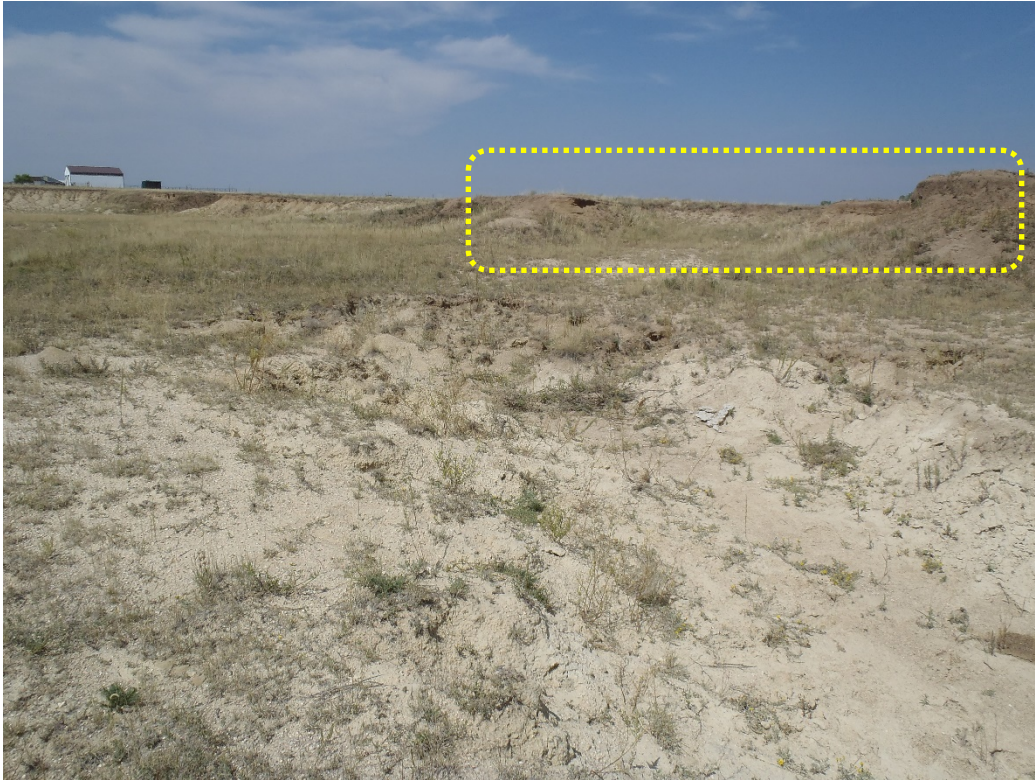
Photo 4. North central highwall needing flattening and west end of headcut (looking NNW).

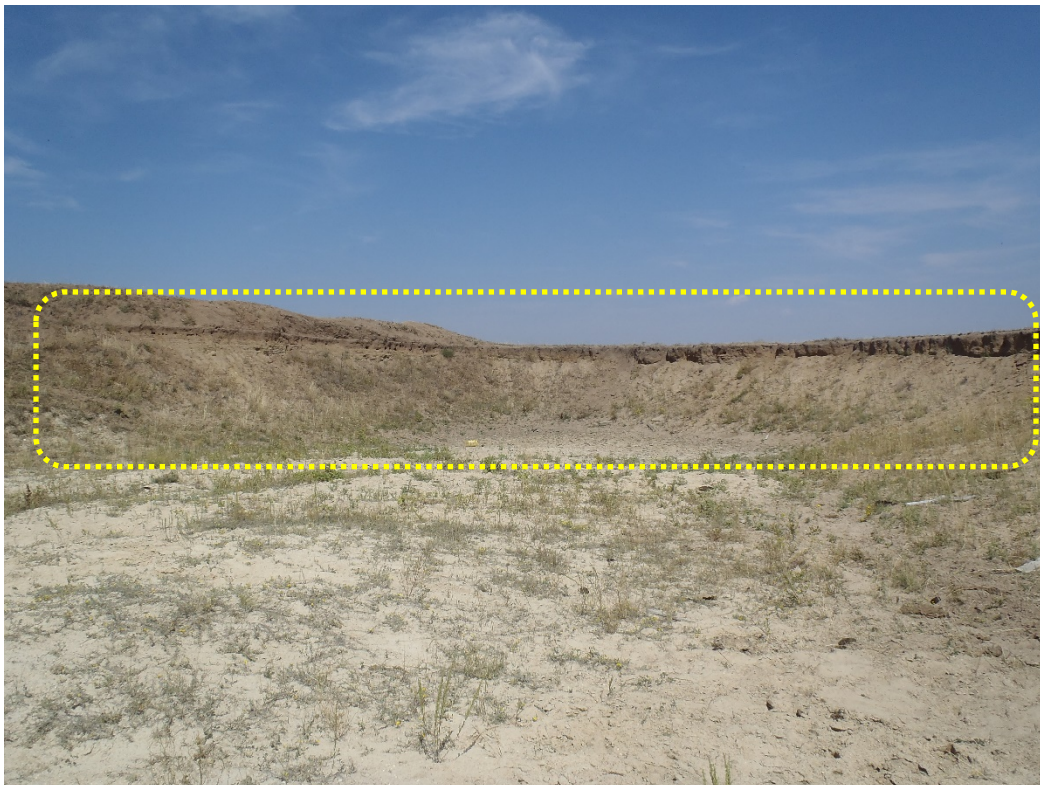
Photo 5. East highwall needing flattening (looking north).

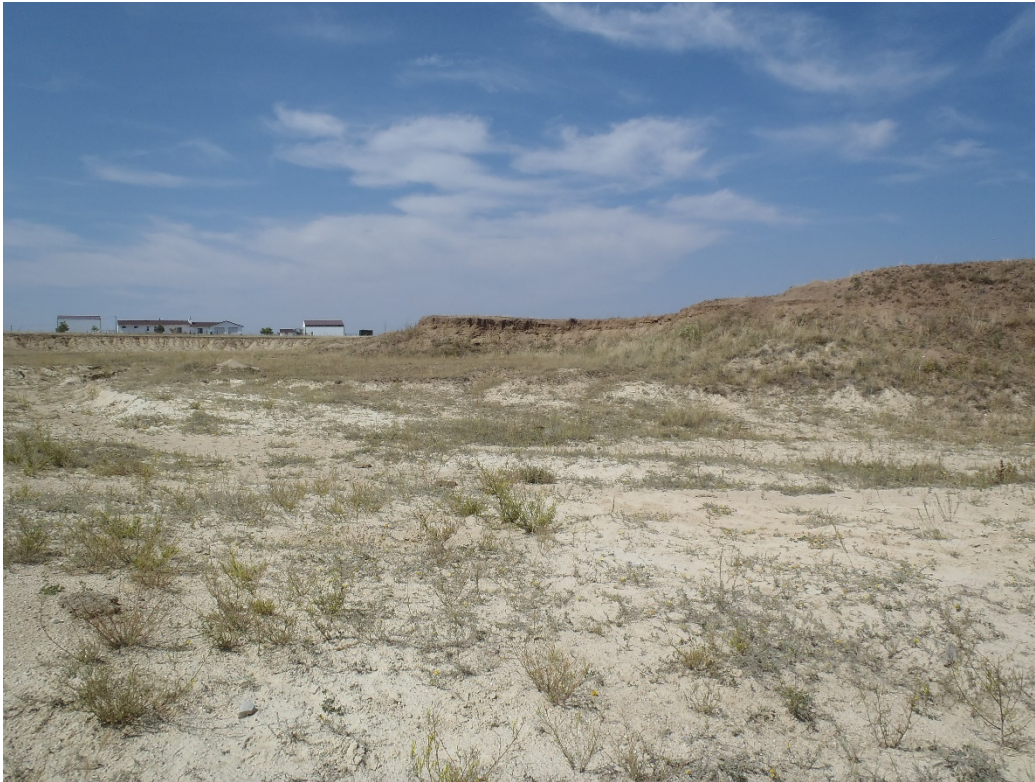
Sediment Control: As stated above, headcutting was observed in the northeast portion of the pit. Mr. Kraig stated the erosion was the result of a poorly maintained roadside ditch along McClelland Road, causing an overflow of stormwater into the pit. He said the ditch has been repaired.

Photo 6. Erosion headcut needing repair (looking NW).

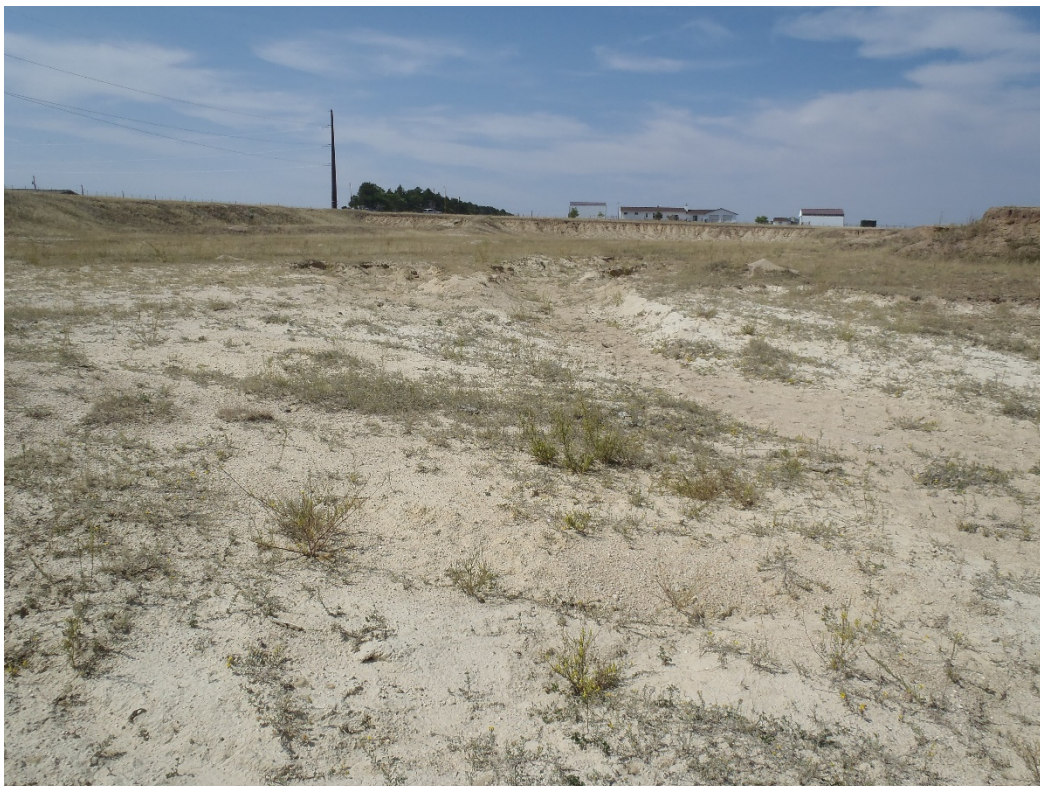
Photo 7. Erosion headcut needing repair (looking west).

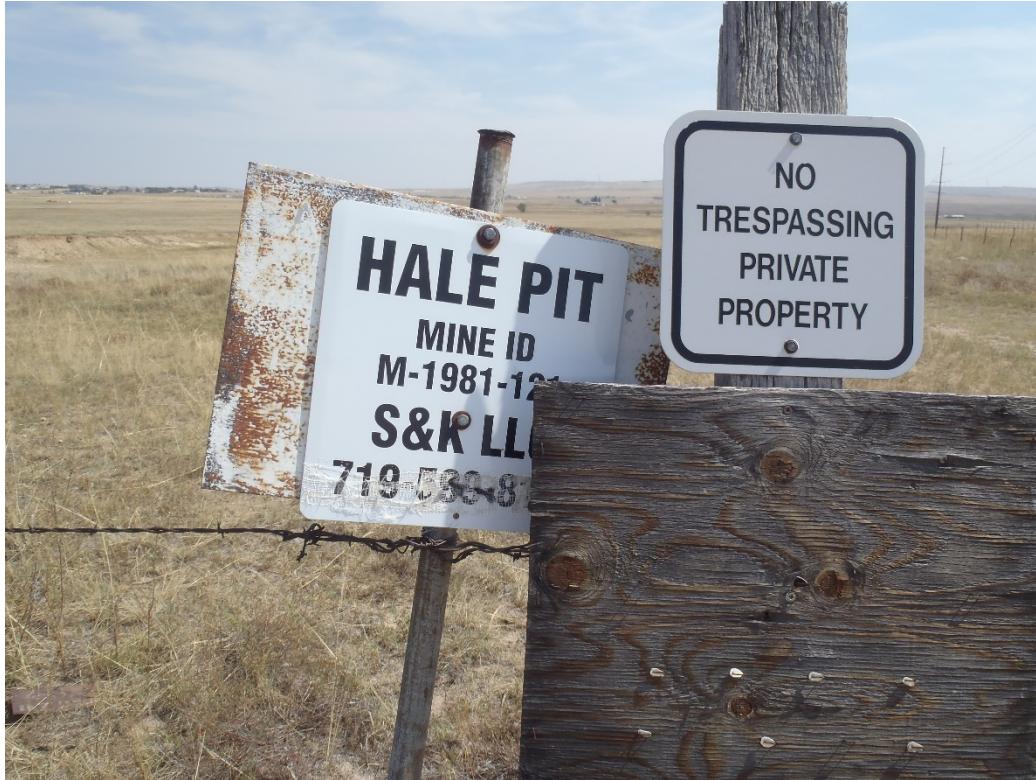
Signs and Markers: The permit sign was properly posted (see **Photo 8**). Boundary markers are still absent as indicated in the March 29, 2019 inspection report (where the DRMS indicated they needed to be replaced prior to the re-initiation of mining activity). The DRMS recommended Mr. Kraig place markers on the southwest and southeast corners of the permit boundary to aid in delineation of pre-law vs permitted area reclamation for final release.

Photo 8. Permit sign off McClelland Road.

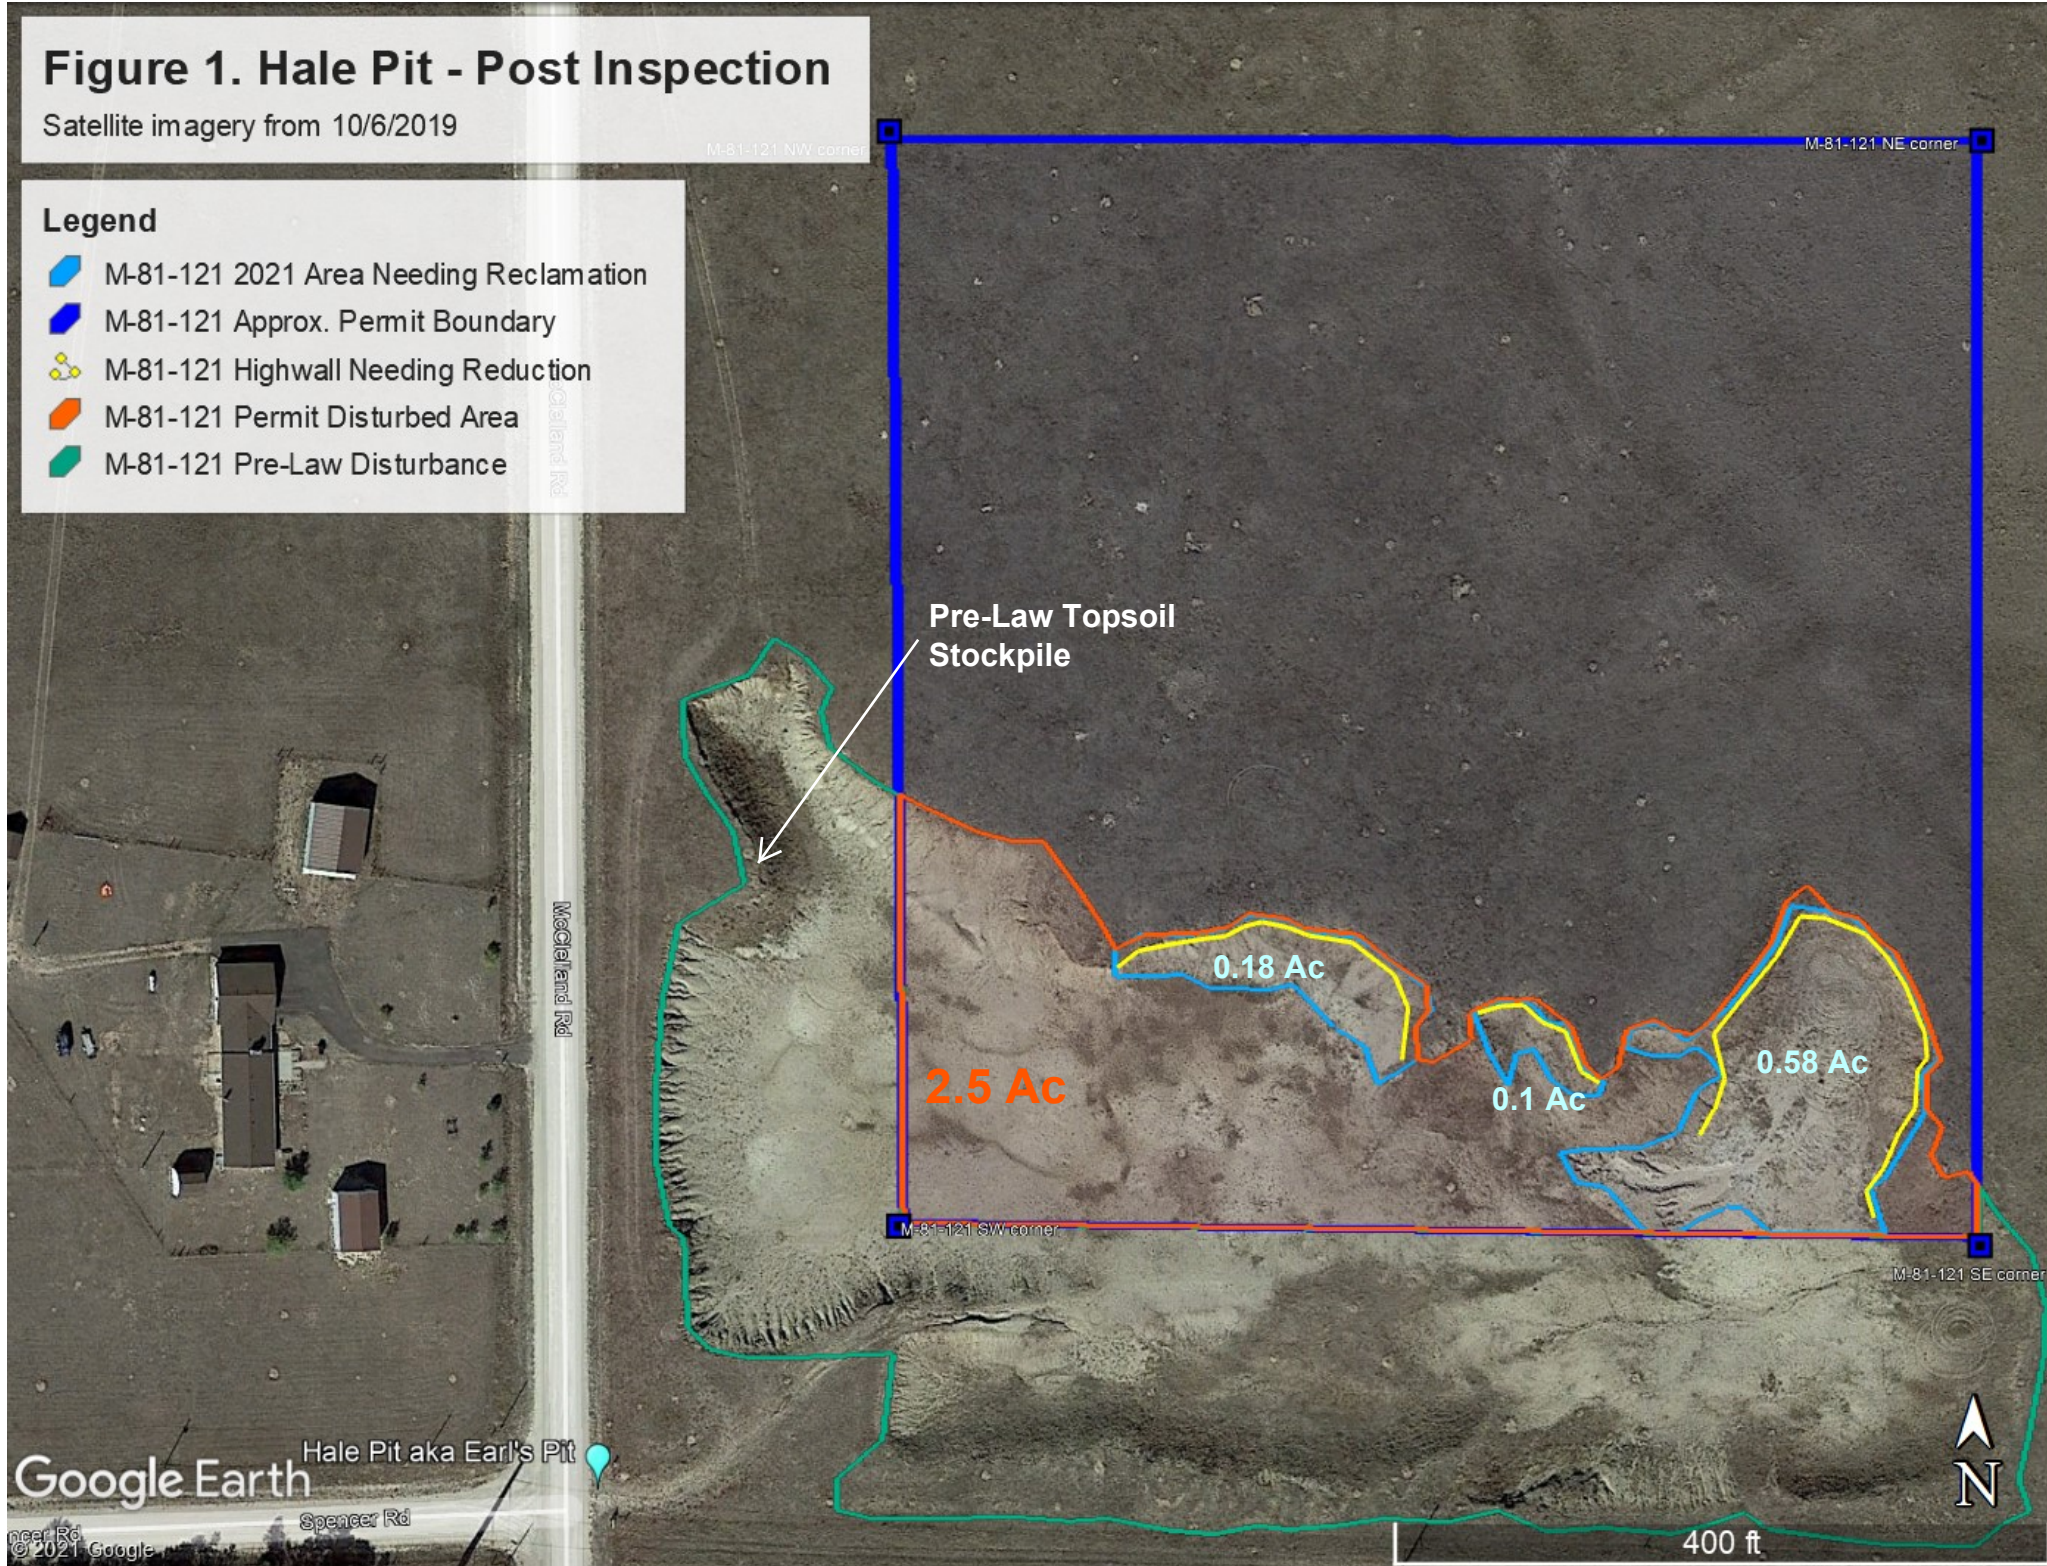
# Figure 1. Hale Pit - Post Inspection

need seeding (see **Figure 1**). No noxious weeds were observed.

Topsoil: There appears to be a pre-law topsoil stockpile on the west side of the pit, near the north end of the pre-law disturbance (see **Figure 1**).
