MINERALS PROGRAM INSPECTION REPORT
PHONE: (303) 866-3567

MINE NAME: Valco T Pit	MINE/PROSPECTING ID#: M-2004-043	MINERAL: Sand and gravel	COUNTY: Las Animas
INSPECTION TYPE: Monitoring	INSPECTOR(S): Jared Ebert	INSP. DATE: September 13, 2021	INSP. TIME: 02:15
OPERATOR: Larry and Christine Tortorice	OPERATOR REPRESENTATIVE: None	TYPE OF OPERATION: 112c - Construction Regular Operation

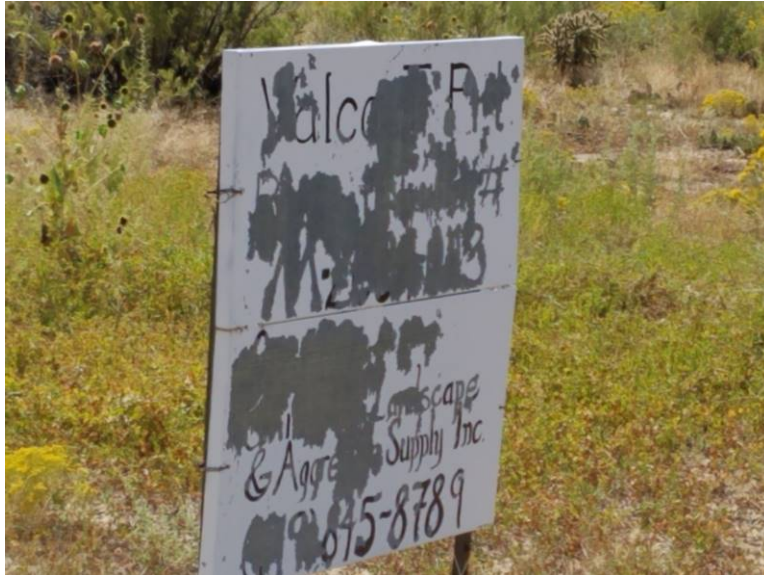
PROBLEM: The mine identification sign was damaged and unreadable. This is a problem for failure to post a mine identification sign as required by Section 3.1.12(1) of the rule. The Operator shall, at the entrance of the mine site post a sign, which shall be clearly visible from the access road, with a minimum size equaling one

The mine identification sign was nearly unreadable at the entrance of the site. The permit boundary markers were missing. These issues are cited as a problem at the beginning of this report.

Figure 1. Unreadable mine entrance sign.

CORRECTIVE ACTIONS: The operator shall, at the entrance of the mine site, post a sign which shall be clearly visible from the access road with the following: the name of the operator, a statement that a reclamation permit for the operation has been issued by the Colorado Mined Land Reclamation Board; and the permit number. The operator shall submit photo documentation that a proper sign has been posted by the corrective action date.

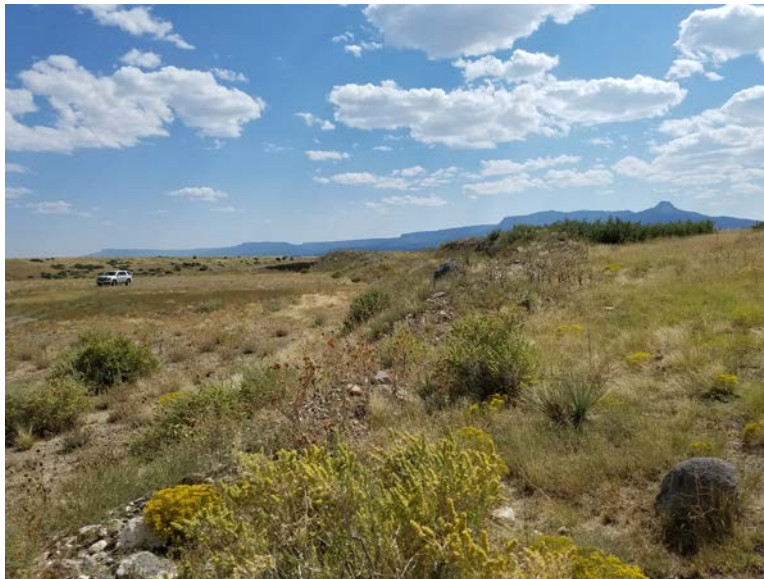
Figure 2. From the northwest corner of the site looking south.

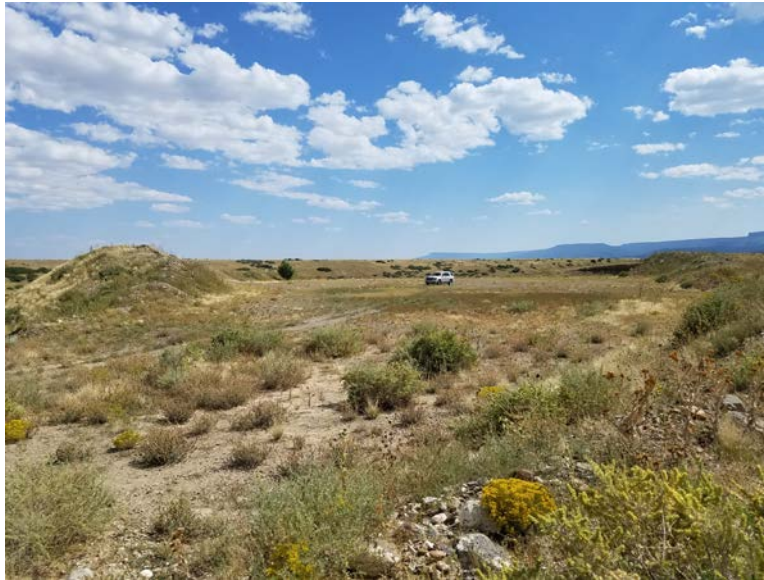
Figure 3. From the northwest corner of the site looking southeast

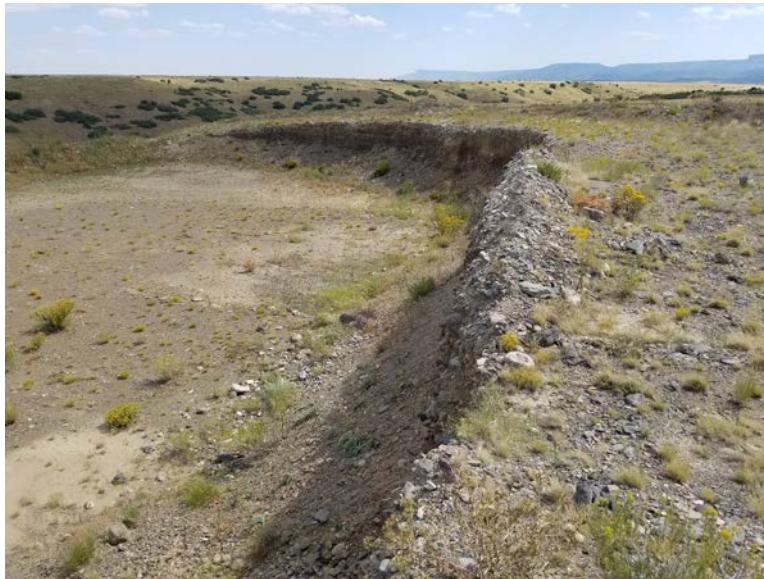
Figure 4. From the southwest corner of the highwall looking southeast.

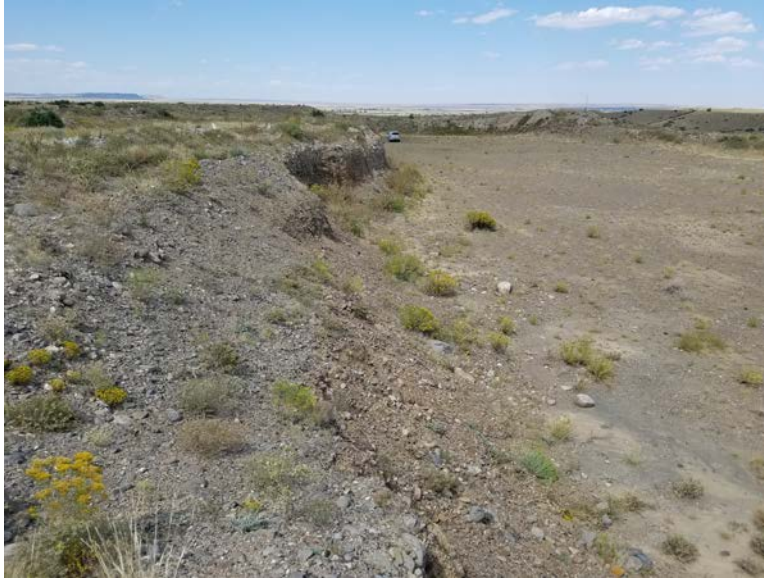
Figure 5. From the southwest corner of the highwall looking north.

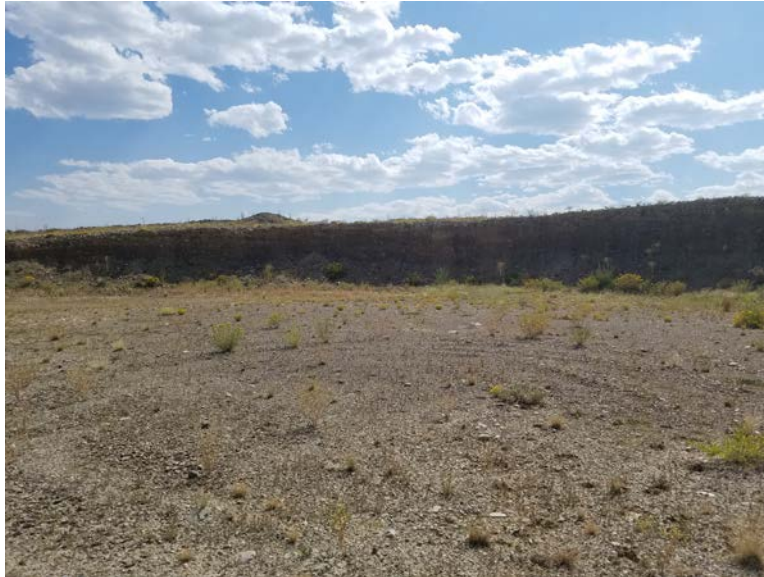
Figure 6. From the pit floor looking south at the highwall.
