**MINERALS PROGRAM INSPECTION REPORT**  
**PHONE: (303) 866-3567**

<b>MINE NAME:</b> Byzantine Quarry	<b>MINE/PROSPECTING ID#:</b> M-2007-014	<b>MINERAL:</b> Limestone (general), granite, granite gneiss and (silica, stone, quartzite)	<b>COUNTY:</b> Fremont
<b>INSPECTION TYPE:</b> Monitoring	<b>INSPECTOR(S):</b> Timothy Cazier, P.E.	<b>INSP. DATE:</b> June 15, 2021	<b>INSP. TIME:</b> 11:00
<b>OPERATOR:</b> Byzantine Quarry LLC	<b>OPERATOR REPRESENTATIVE:</b> Dan Tezak	<b>TYPE OF OPERATION:</b> 112c - Construction Regular Operation	
<b>REASON FOR INSPECTION:</b> Normal I&E Program	<b>BOND CALCULATION TYPE:</b> Partial Bond	<b>BOND AMOUNT:</b> \$90,052.00	
<b>DATE OF COMPLAINT:</b> NA	<b>POST INSP. CONTACTS:</b> None	<b>JOINT INSP. AGENCY:</b> None	
<b>WEATHER:</b> Clear	<b>INSPECTOR'S SIGNATURE:</b>

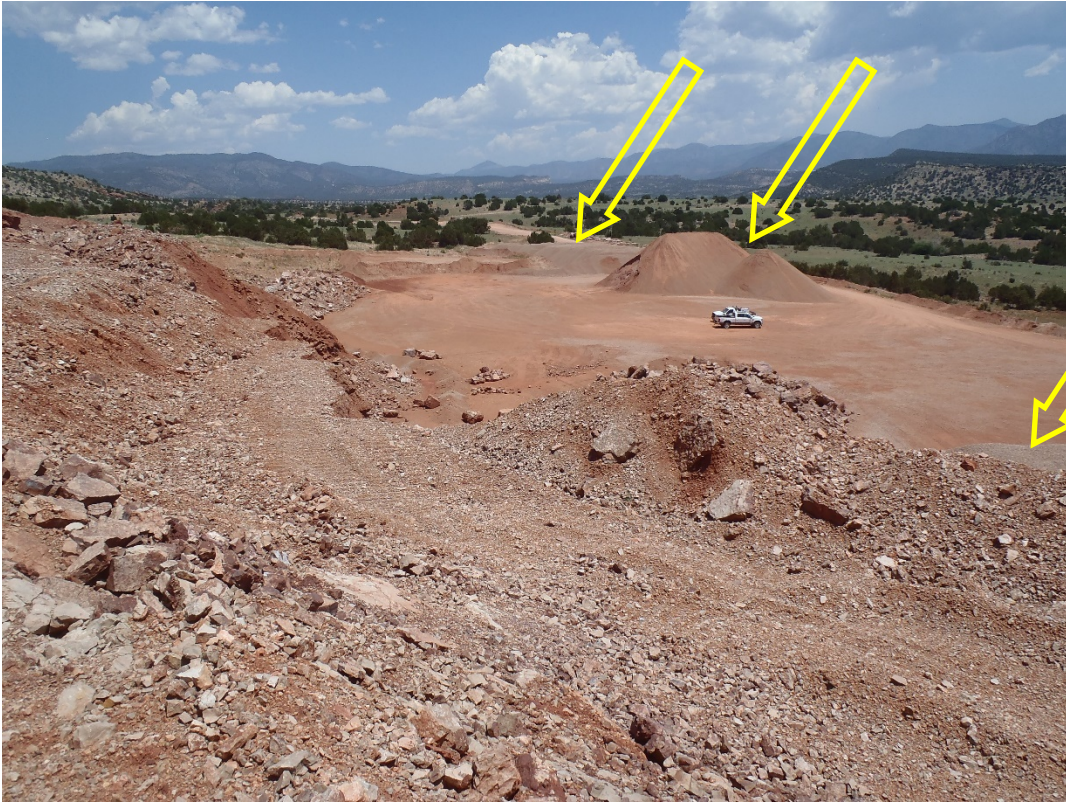
This inspection was conducted as part of the regular monitoring program. The Permittee (Byzantine Quarry LLC) was represented by Mr. Daniel Tezak. The Byzantine Quarry access road is located approximately 2.5 miles north of Hwy 50 on Fremont Co Rd 69. This is a 112c mine producing primarily decorative stone for landscaping. It was not operating at the time of the inspection. However, evidence of recent activity was observed in the form of product stockpiles (see **Photo 1**).

Photo 1. Product stockpiles on pit floor (looking NNE).

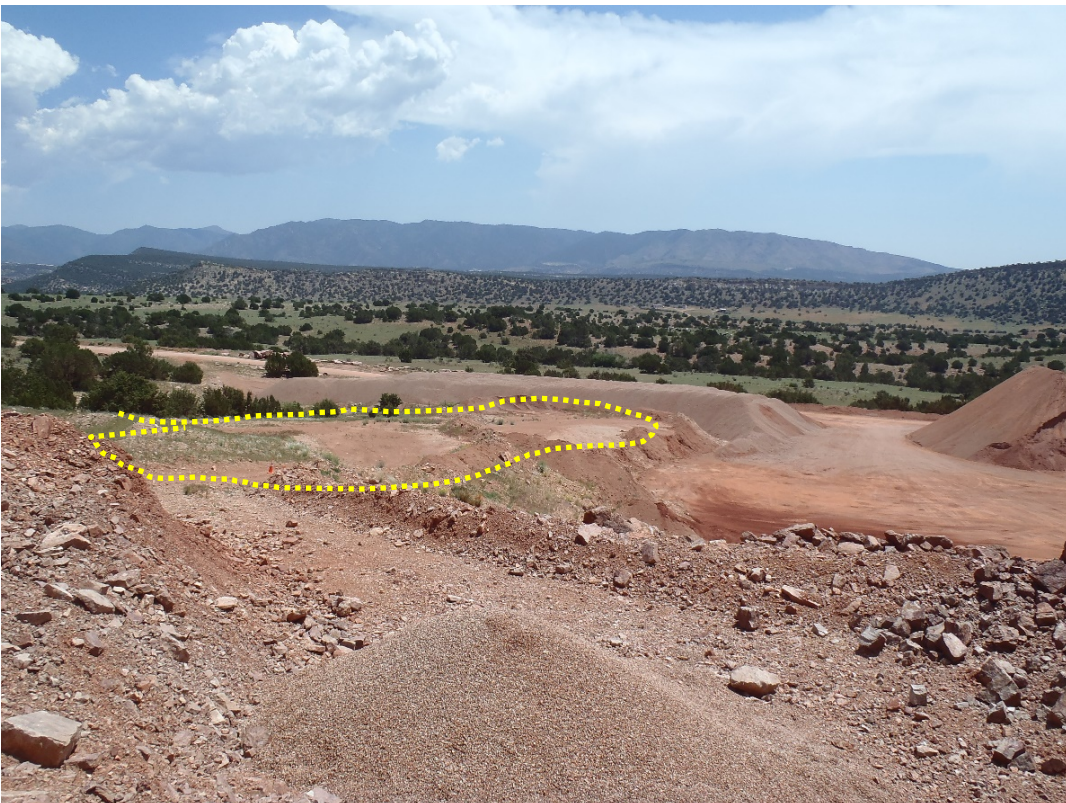
Excess Spoil and Dev. Waste: There are two overburden storage areas on site stockpiled by the first Permittee (Larsen Colorado): one west of the access road across from the truck scale and one on the north end of the active pit (see **Photo 2**).

Photo 2. Overburden stockpile (north end of active pit, looking NE).

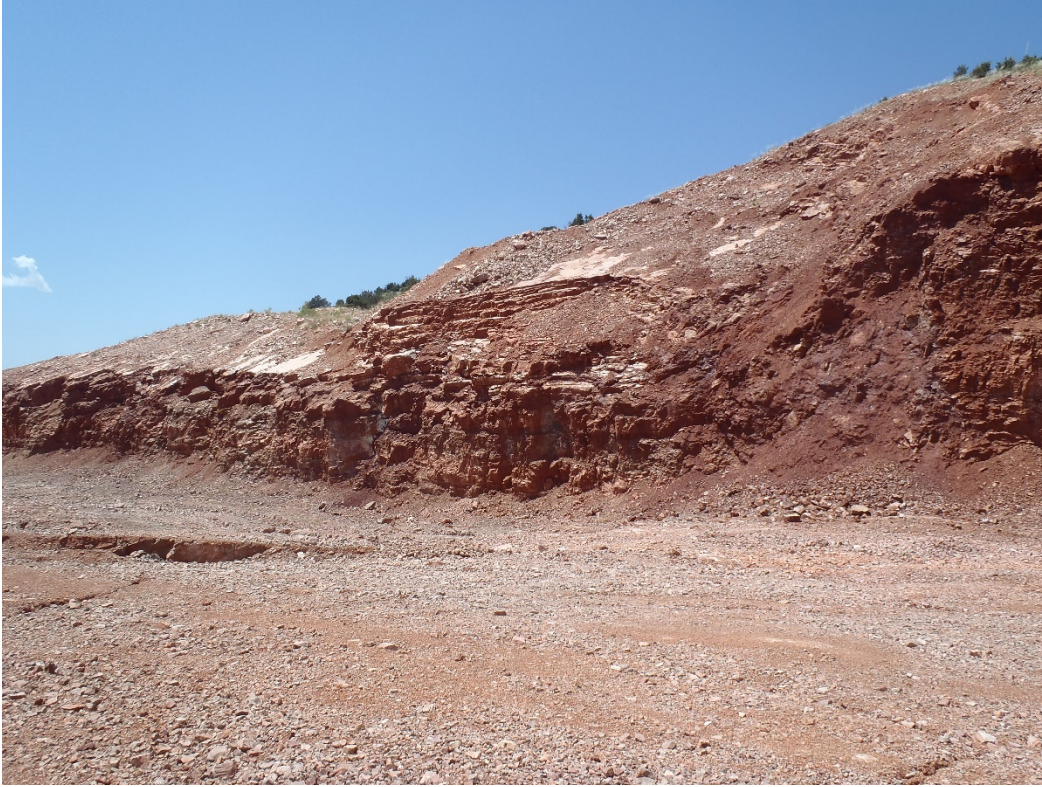
Gen. Compliance with Mine Plan: The operation is in Phase I (about 60 acres) and appeared to be in compliance with the approved mine plan. The maximum allowed disturbed area is 104 acres. Google Earth was used to measure the disturbed area, which was estimated to be approximately 16 acres, based on 2019 imagery. The annual report states 18 acres are disturbed. Highwalls were estimated to be 30 feet in height (see **Photo 3**). Benches are well over the required minimum of 55 feet in width (Google Earth measurements indicate the bench width varies between 120 and 160 feet). These wide benches are needed to limit large slope failures due to the dipping slope of the bedrock geology (see **Photo 4**). Some tension cracks (see **Photo 5**) and evidence of movement (see **Photo 6**) were observed on the bench.

Photo 3. Typical highwall (mid bench looking SW, note dipping bedrock at crest).

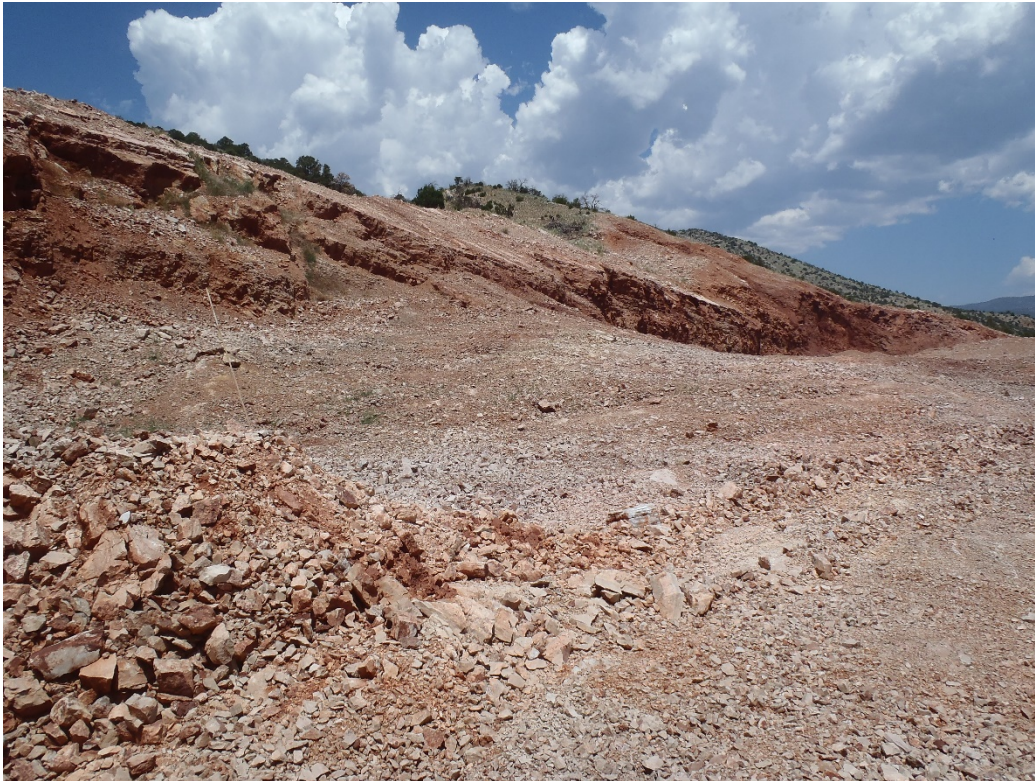
Photo 4. Exposed dipping bedrock (looking NNW).

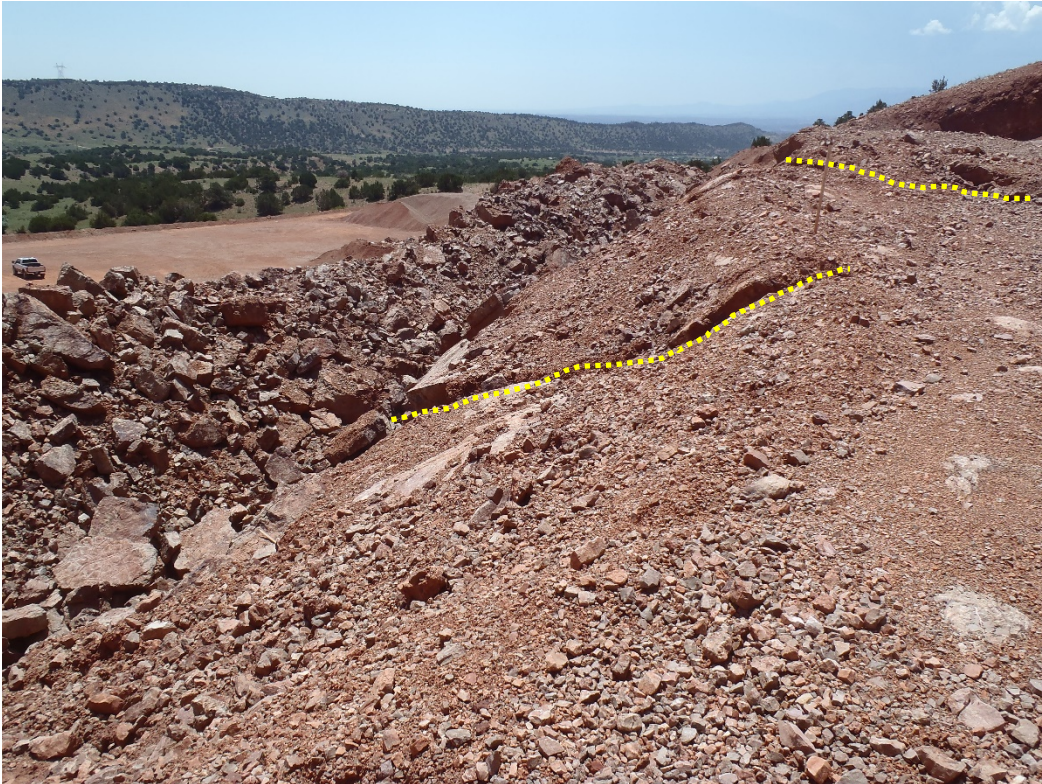
Photo 5. Tension crack and evidence of movement (mid bench, looking south).

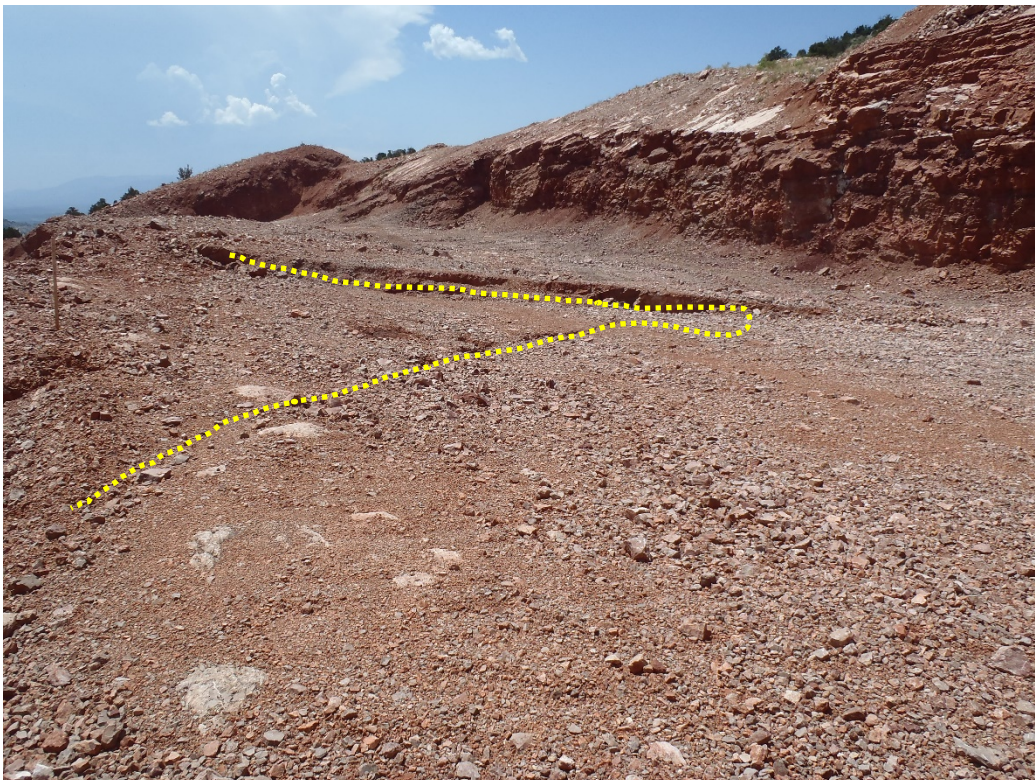
Photo 6. Evidence of bench movement – limit appears to be safely offset from highwall.

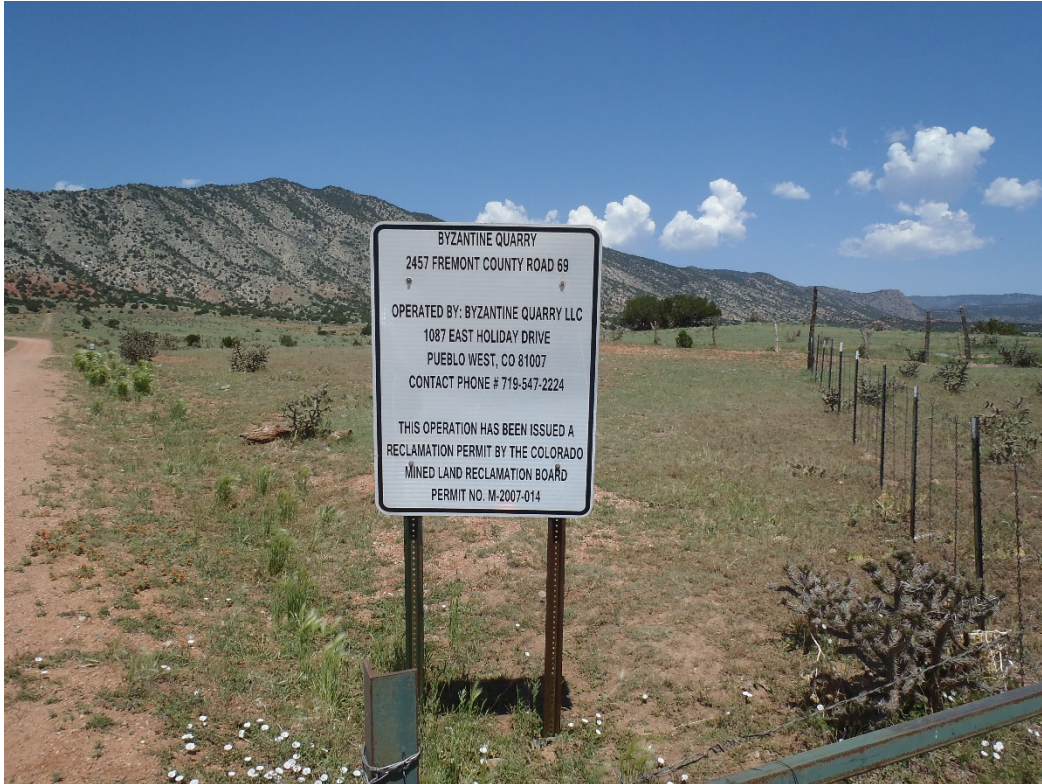
Signs and Markers: The permit sign was properly posted (see **Photo 7**) and affected area boundary markers were observed on the east side (see **Photo 8**). The drainage on the south end is essentially coincident with the south affected area currently being mined. The west side of the Phase 1 area is over 900 feet west of the current disturbance limit. The affected area boundary on the north is north of the access road from CR 69 and approximately 1500 feet north of the truck scale. As such, the current boundary markers are considered adequate.

Photo 7. Permit sign (at gate approximately 800 ft west of CR 69).

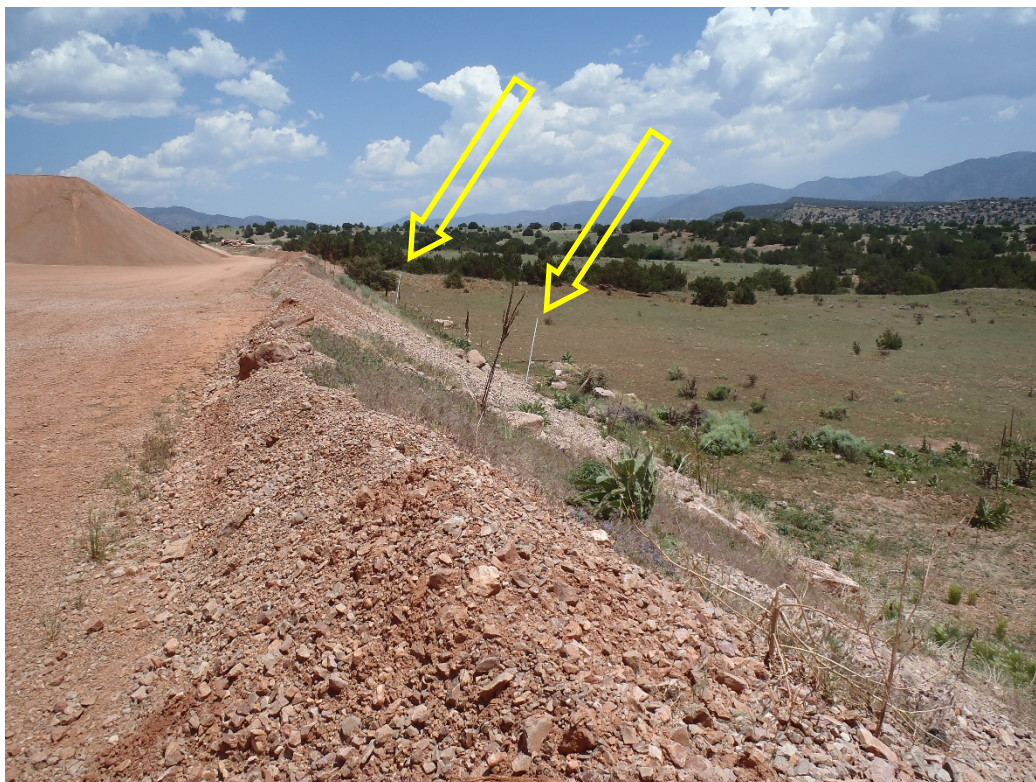
Photo 8. East side affected area markers (looking north).

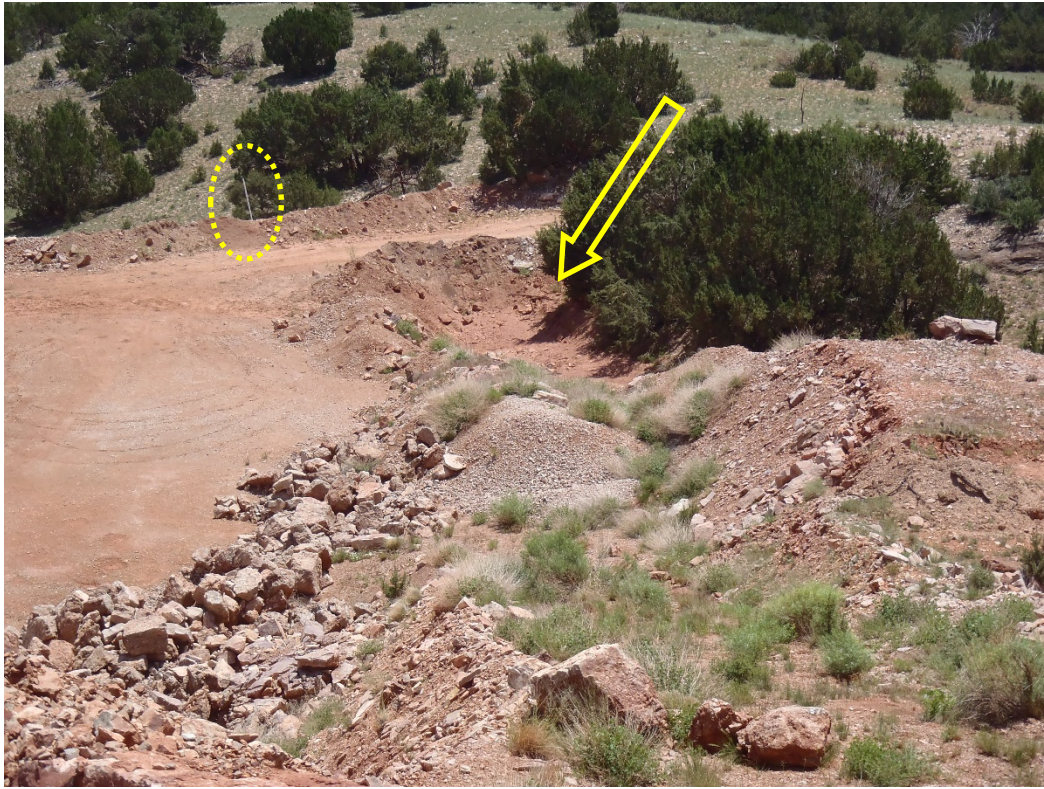
Storm Water MGT Plan: No oil or fuel spills observed. Mr. Tezak stated there are six discharge points and one sediment pond (see **Photo 9**). The stormwater management plan is kept in the office in Pueblo. Stormwater drains to the pit and infiltrates.

Photo 9. Sediment pond (south end looking east, east boundary marker circled).
